Ancient Monuments Laboratory  
Report 53/97

WALL PAINTING CONDITION AUDIT,  
PORTCHESTER CASTLE, HAMPSHIRE

T Manning  
S Stewart

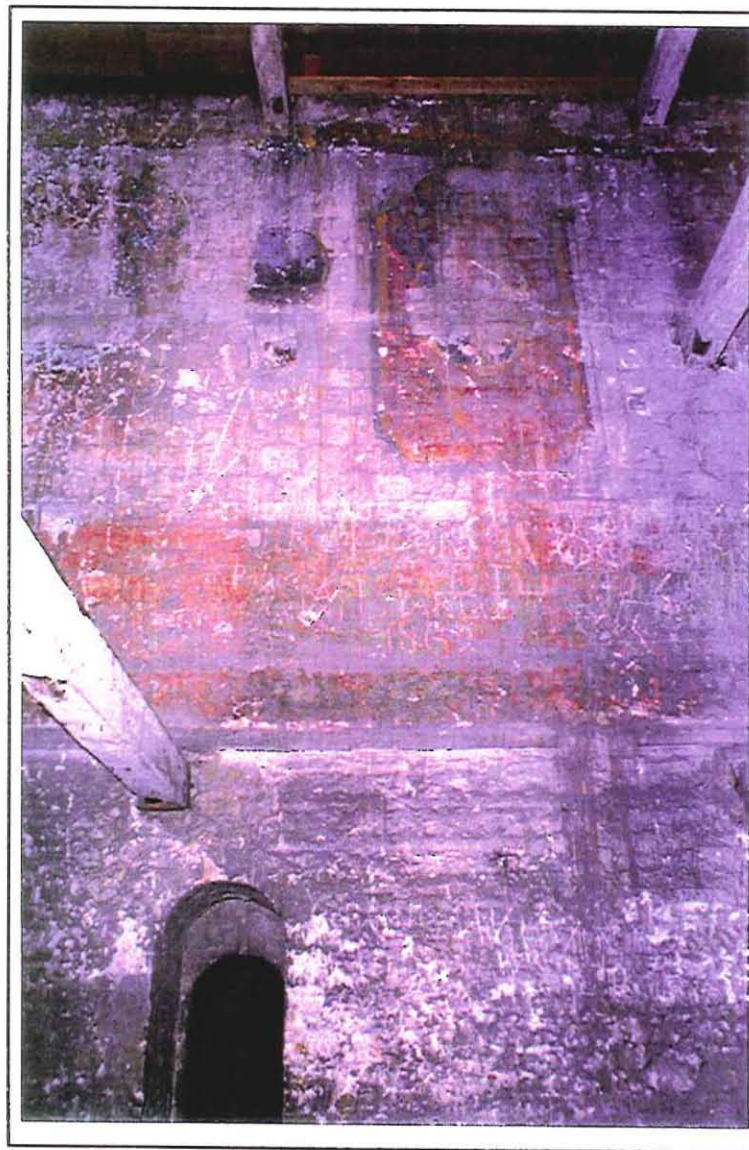
Detail, south side of spine wall, painted cartouches
