Ancient Monuments Laboratory  
Report 54/97

WALL PAINTING CONDITION AUDIT,  
STROOD, TEMPLE MANOR, KENT

J Davies  
S Stewart

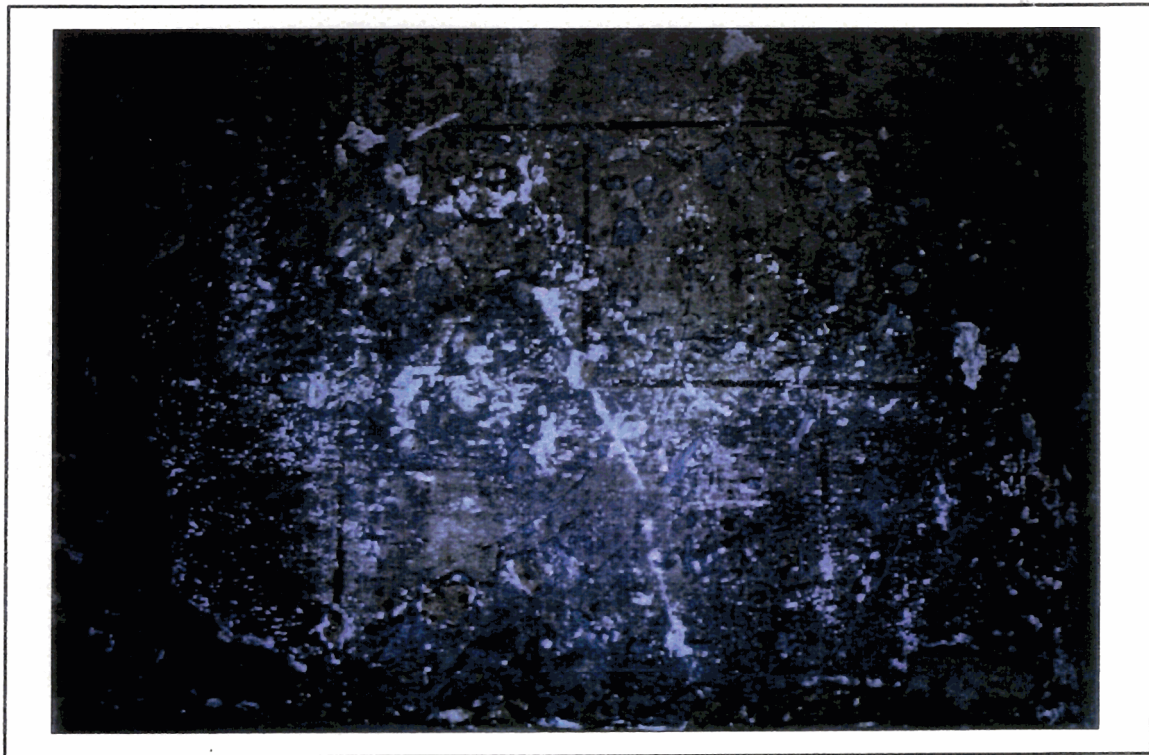
First floor, east wall, south side, detail

400x400cms. This wall was pierced by insertion of a wide seventeenth-century extension. The southern portion of the remaining wall has a fragment approximately 300x75cms. The northern portion of the remaining wall contains a fragment approximately 300x55cms. The original masonry pattern has been overpainted with layers of grey, red and green 'distemper'.

**Comments** A plaster layer containing hair extends over areas of the east wall, south and north sides and may be covering original decoration. The layer has been covered with blue-green 'distemper'.
