Ancient Monuments Laboratory
Report 55/97

WALL PAINTING CONDITION AUDIT,
TITCHFIELD ABBEY, HAMPSHIRE

T Manning

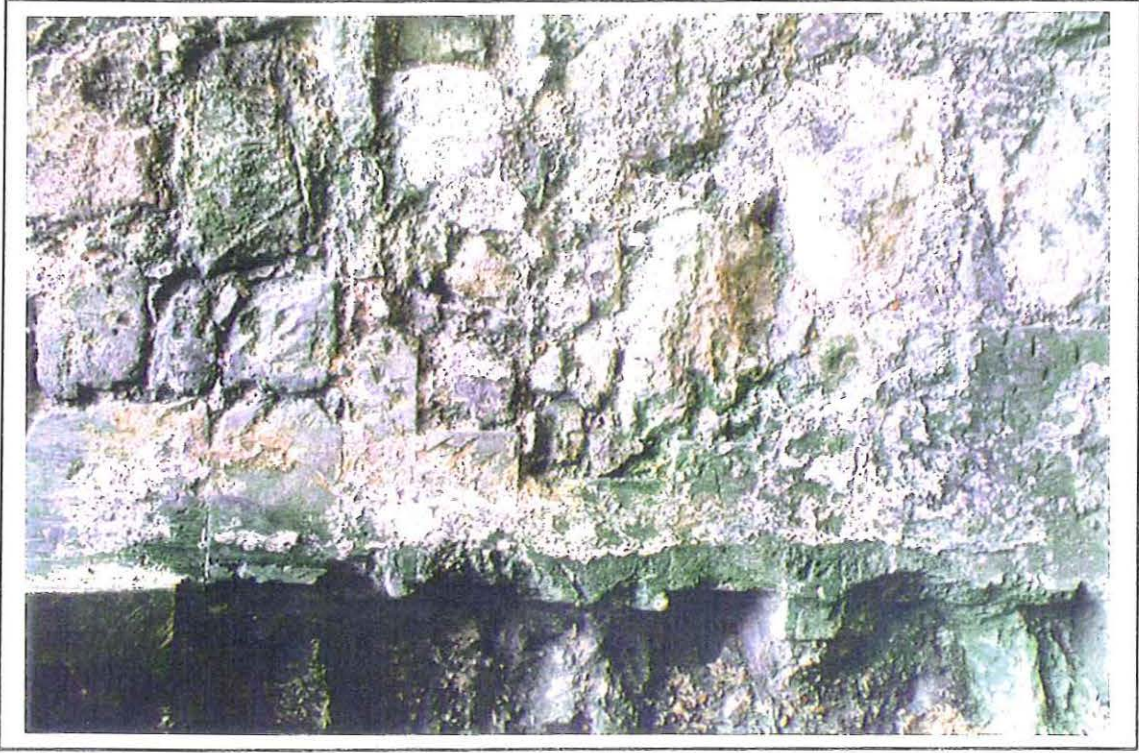
West wall, south corner

Keyser noted masonry pattern remains on 'various parts of walls'. M. Bardswell, for Tristram, noted this as 'not visible' in 1935. The traces consist of painted fragments measuring no more than 3 x 5 cm each. However, an area of approximately 50 x 30 cm retains traces of the original render and ground layers.

Comments Exposed site: wind, rain, etc have eroded surface.

Comments Painting only survives in small fragments.

Comments Extensive lichen growth throughout site.

The fragments are an important archaeological record, and have been documented and photographed. Although the site is exposed and some deterioration of the fabric may continue to occur, conservation at such a small scale, and in such an exposed environment, is practically very difficult. Periodic visual inspection (every 5 years or so) is recommended.

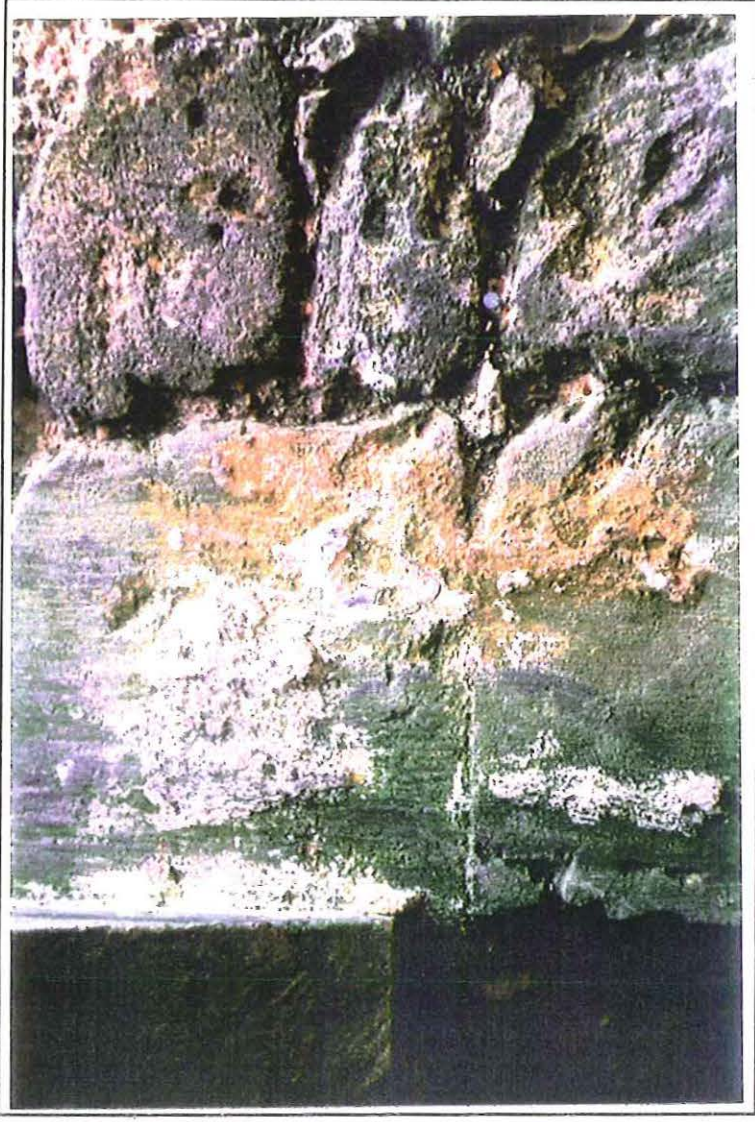
Yellow and red pigments visible.

Detail, faint traces of painted decoration
