Ancient Monuments Laboratory
Report 58/97

WALL PAINTING CONDITION AUDIT,
BERRY POMEROY CASTLE, DEVON

J Davies
T Manning

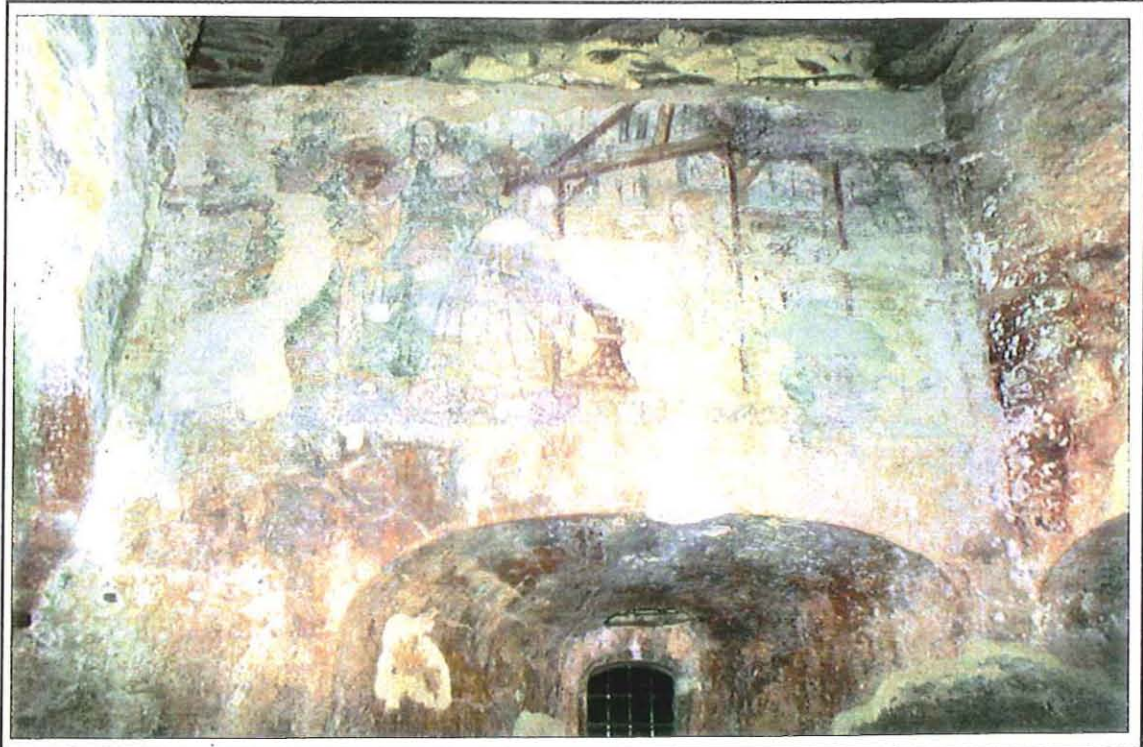
Type delamination (render layer)
Location Virgin's robe and areas below.
Comments These areas are hollow but appear to be stable.

Type salt activity
Location efflorescences visible in areas of loss below and to the right edge of the painting
Comments Fine white powder and crystalline efflorescences surrounding losses.

Type delamination (paint layer)
Location localised areas
Comments Some limited flaking.

Type minor losses
Location general
Comments There are numerous losses and the painting generally has an abraded appearance. This is probably a result of the previous mechanical action of ivy suckers and roots plus other vegetation and micro-biological growth.

Comments The veil, previously identified as a crust of soluble salts, was thinned during treatment in the 1980's but is still present over much of the surface. Comparison of photographs dating to the early 1980's and the current condition of the painting indicates that the white veil is relatively stable. However, Barakan noted that it appeared to re-form several years after treatment. The technical examination in 1995 identified that this veil is possibly cerussite, an alteration product of the red lead pigment present in the paint layer, which would explain its constant re-formation.

East wall, *Adoration of the Magi*

The painting has been treated in recent years and would appear to be in a relatively stable condition. However, there is some limited flaking of the paint layer which should be stabilised in the near future. Bat excreta should also be removed from the surface of the painting. [Timescale: 1-2 days within one year].

Comments Removal of bat excreta. 1 day within 1 year.

Type FLAKE FIXING **Date** 01/10/95
Person SS/TM
Comments 1-2 days within 1 year.
