Ancient Monuments Laboratory  
Report 59/97

WALL PAINTING CONDITION AUDIT,  
CLEEVE ABBEY, SOMERSET

Summary

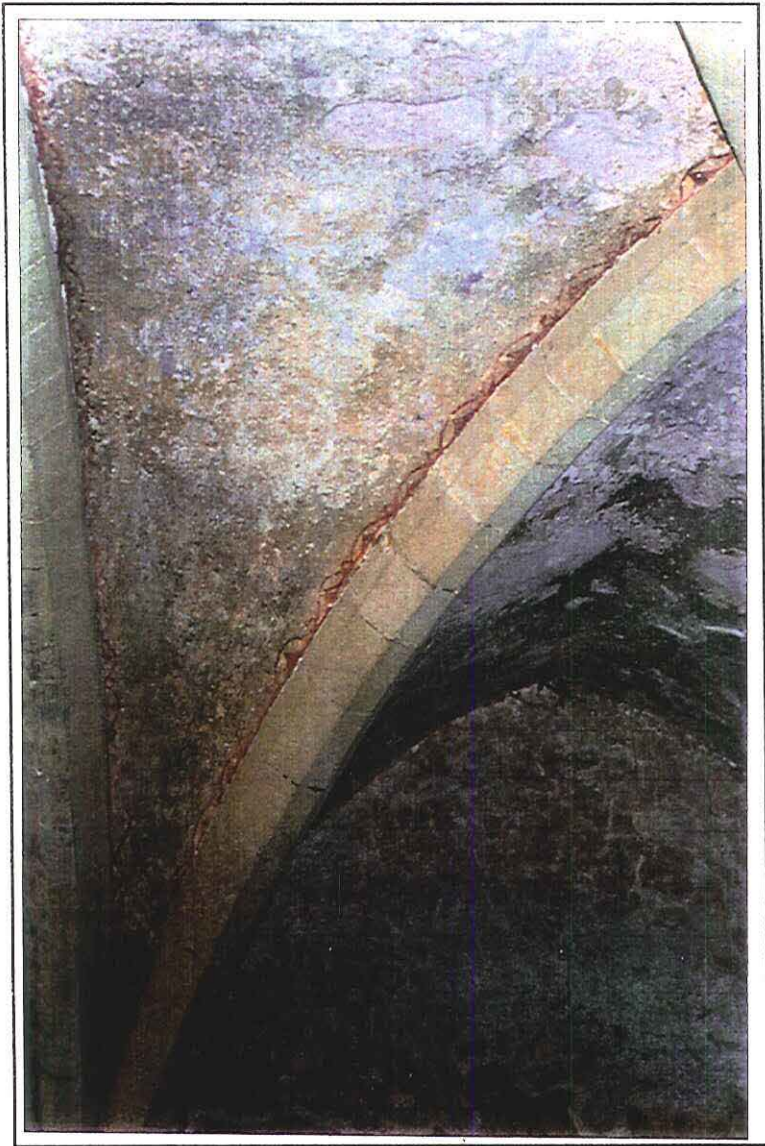
Chapter house, detail of decoration on vaults

**VAULTS:** Remedial treatment appears necessary but should follow a more thorough investigation [Timescale: 2 conservators, 1 week]. Treatment will probably include: flake fixing, grouting, removal and replacement of repairs [Approximate Timescale: 2 conservators, 6 weeks].

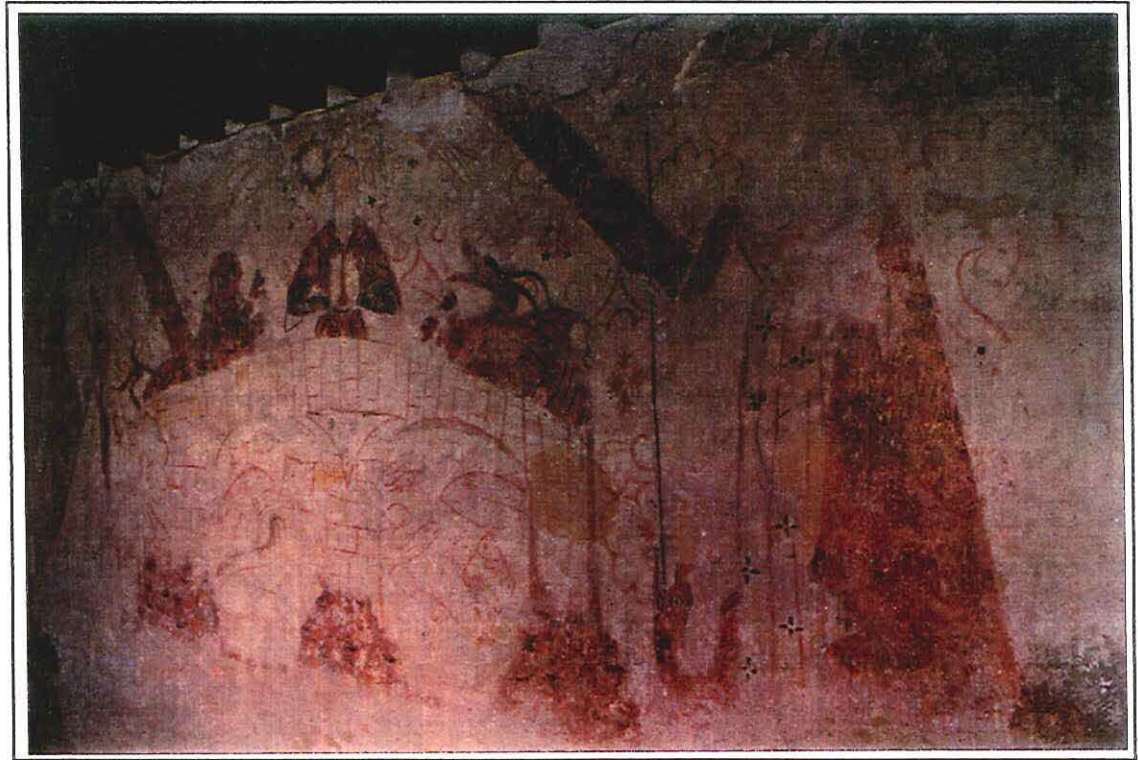
Painted Chamber, general view

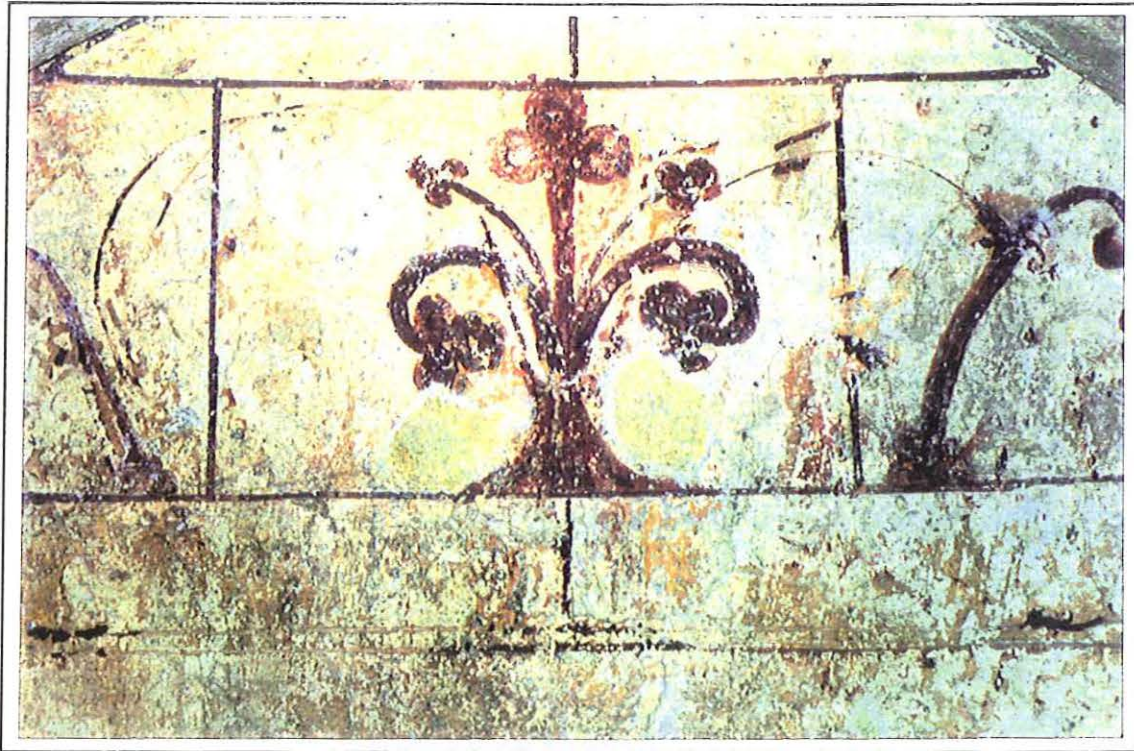
Sacristy, piscina, detail painted decoration

**Type** salt efflorescences  
**Location** VAULT: centre; SOUTH WALL PISCINA; SOUTH WALL generally; EAST WALL  
**Comments** VAULT: efflorescences on central area of vault;  
SOUTH WALL PISCINA: substantial quantity of fluffy crystals over surface, NB. salts effloresce preferentially through original plaster rather than the 1962 repairs at base, suggesting they are too hard and compact.  
SOUTH WALL: extensive fluffy efflorescences throughout, identified as potassium nitrate in 1993.  
EAST WALL: Efflorescence on walls and window splay up to 140 cms height, but evidence of damage throughout; crystal growth in window splay has a 'cotton wool' appearance.

**SOUTH WALL:** The piscina requires removal and re-insertion of repairs, removal of salt crystallization as necessary and possible desalination trials [Timescale: 1 conservator, 2-3 weeks within 1 year].

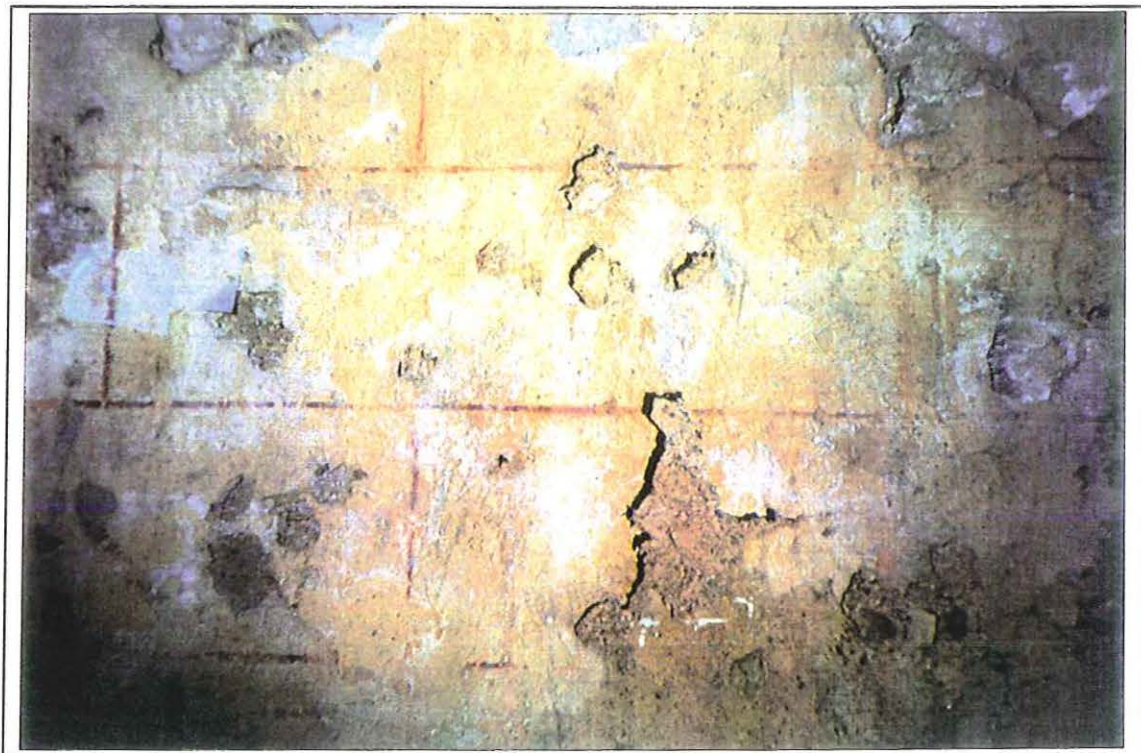
Dorter, north wall, detail of single red-line masonry pattern,  
before conservation in 1993
