Ancient Monuments Laboratory  
Report 60/97

WALL PAINTING CONDITION AUDIT,  
FARLEIGH HUNGERFORD CASTLE,  
SOMERSET

J Davies  
T Manning

## Farleigh Hungerford Castle Somerset

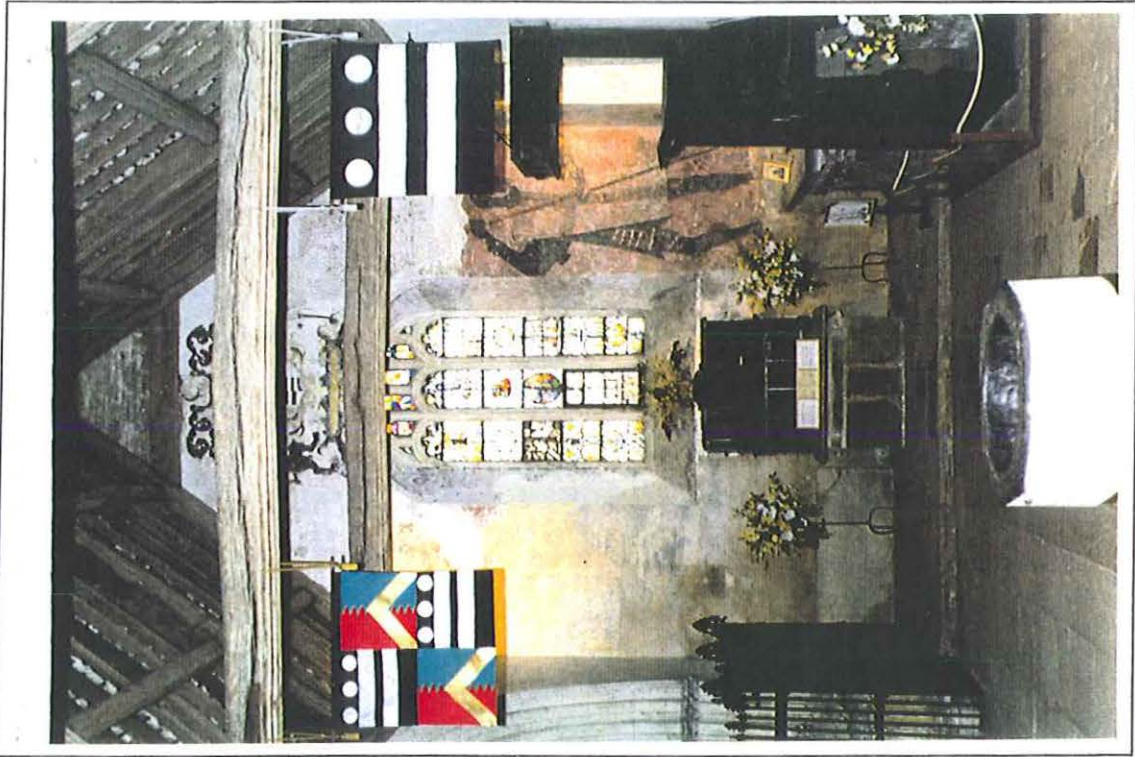
Nave, general view to east

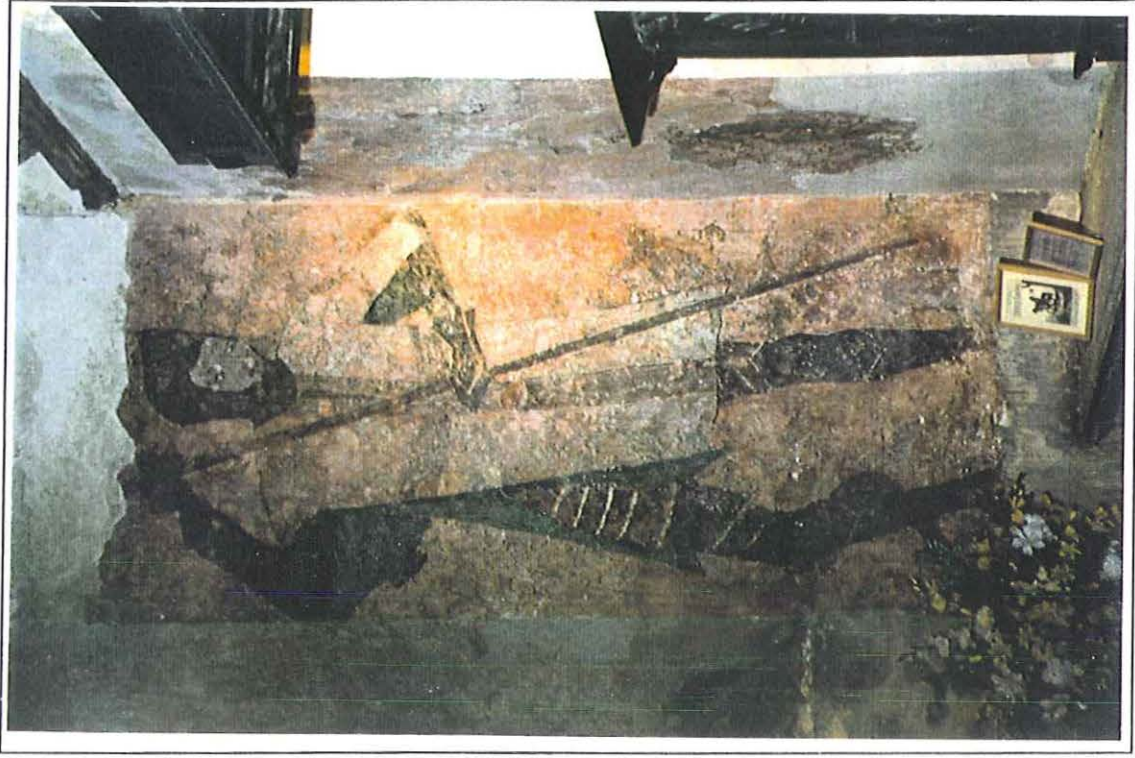
Nave, east wall, south side, detail of St George (15C)

**Comments** Cracking of the render layer occurs on the lower part of the St George. The cracks are now filled with wax. Those on the south wall are associated with recent repairs made by Barakan. The cracks through and above the Kneeling Knight (towards the window) appear extremely vulnerable and require treatment.

The St George was heavily waxed twice during the first half of this century and it is clear that this has caused continued deterioration. The insertion of a tomb at the base of the painting in the 16C, and later, a wash-house situated directly behind the chapel, with a flue and air vents built into the east wall itself, have almost certainly contributed to the painting's rapid decay.

- Grouting and appropriate repairs are fairly urgently required to within and above the Kneeling Knight scheme and areas of the St George scheme to stabilise the vulnerable render layer [Timescale: 2 weeks within 1 year].

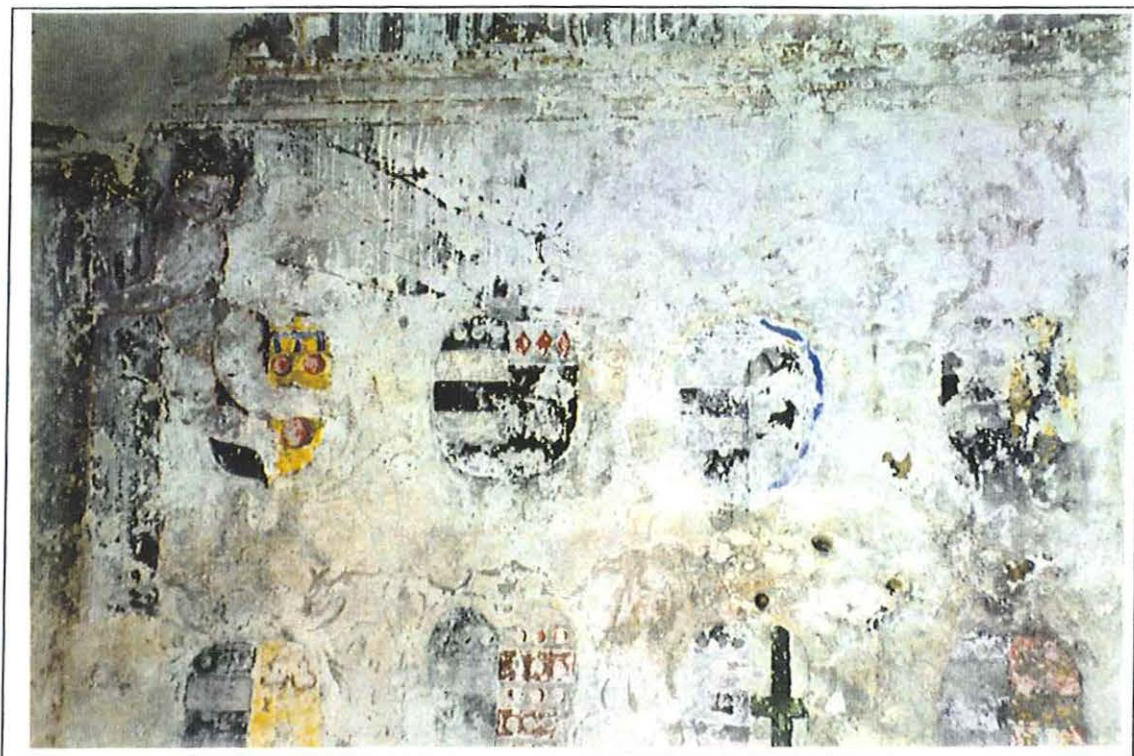
St Anne's Chapel, north wall, detail of 17C decoration with later (19C) additions

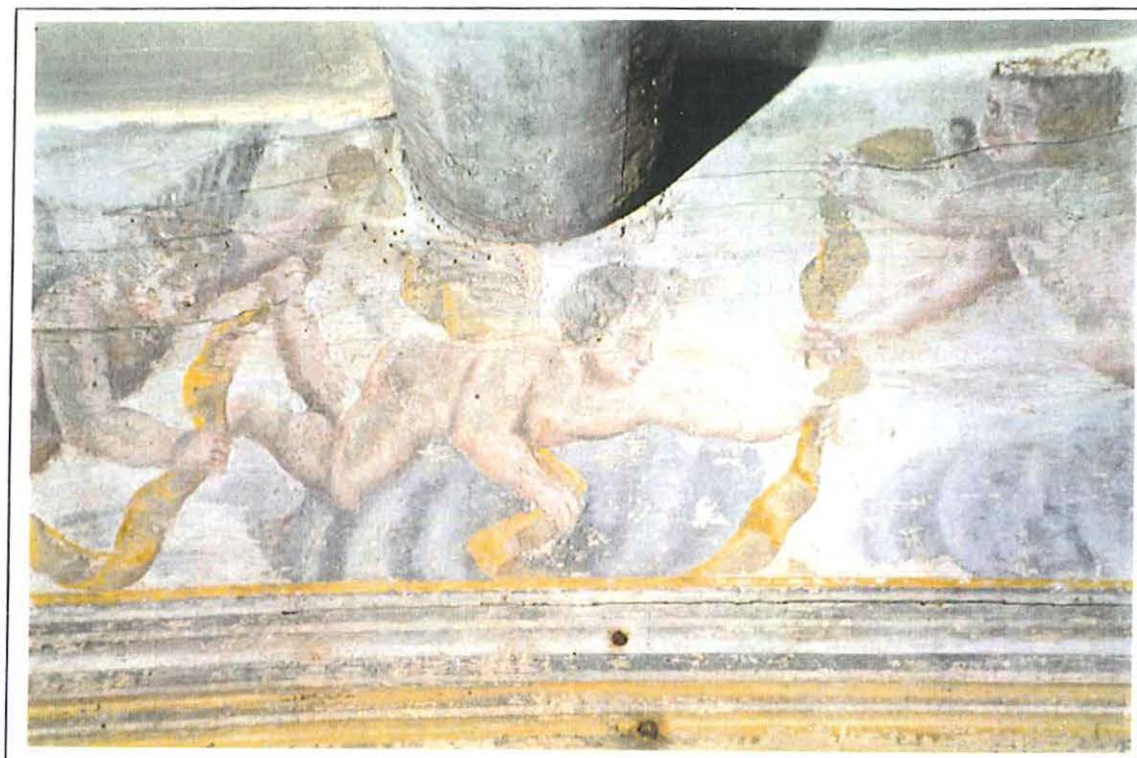
St Anne's Chapel, detail of painted beams
