Ancient Monuments Laboratory
Report 61/97

WALL PAINTING CONDITION AUDIT,
FIDDLEFORD MILL HOUSE, DORSET

Fiddleford Mill House Dorset

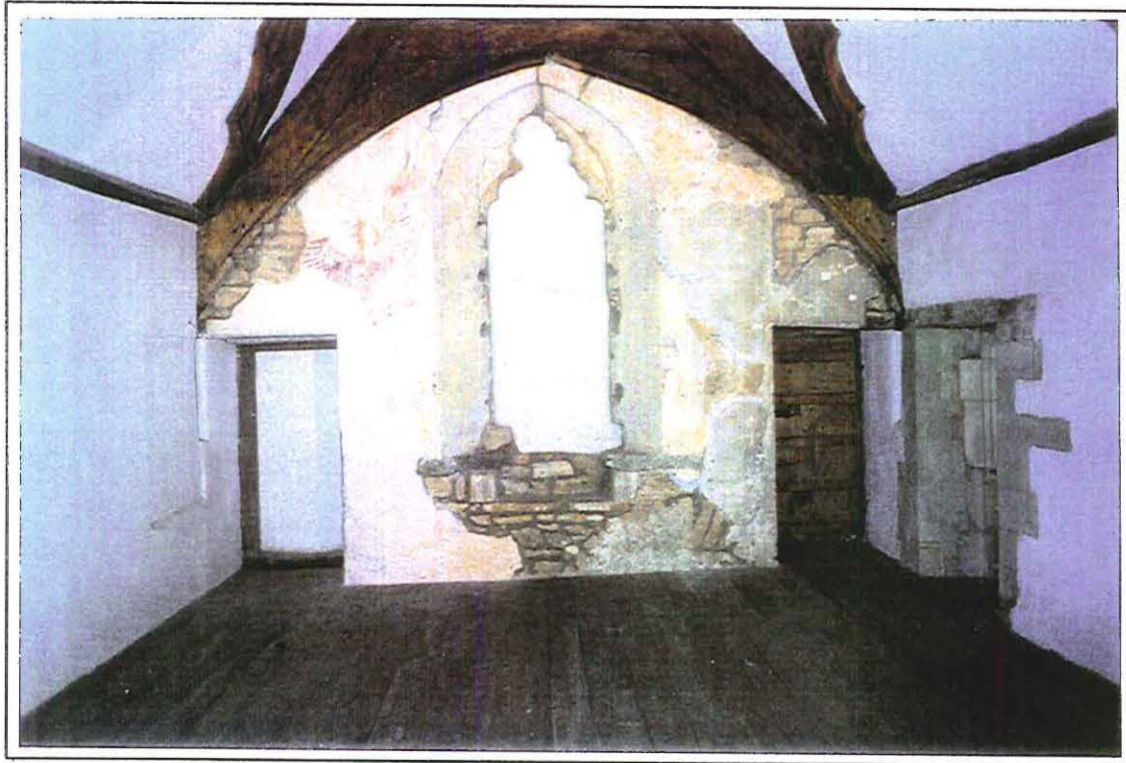
Solar, general view of north wall

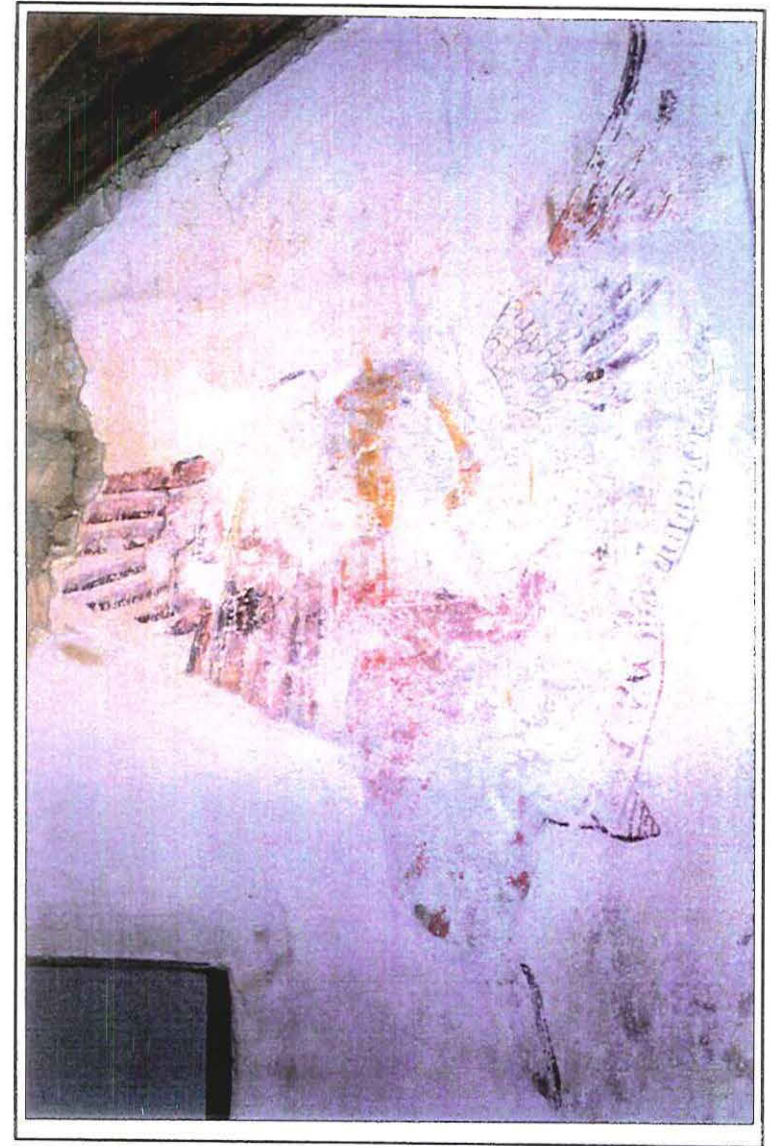
Location head of Archangel Gabriel

Comments Cracks occurred prior to 1991. They have been repaired. The painting now appears structurally stable.

Detail, archangel Gabriel, west side of north wall
