Ancient Monuments Laboratory
Report 62/97

WALL PAINTING CONDITION AUDIT,
GLOUCESTER, BLACKFRIARS,
GLOUCESTERSHIRE

J Davies
T Manning

Summary

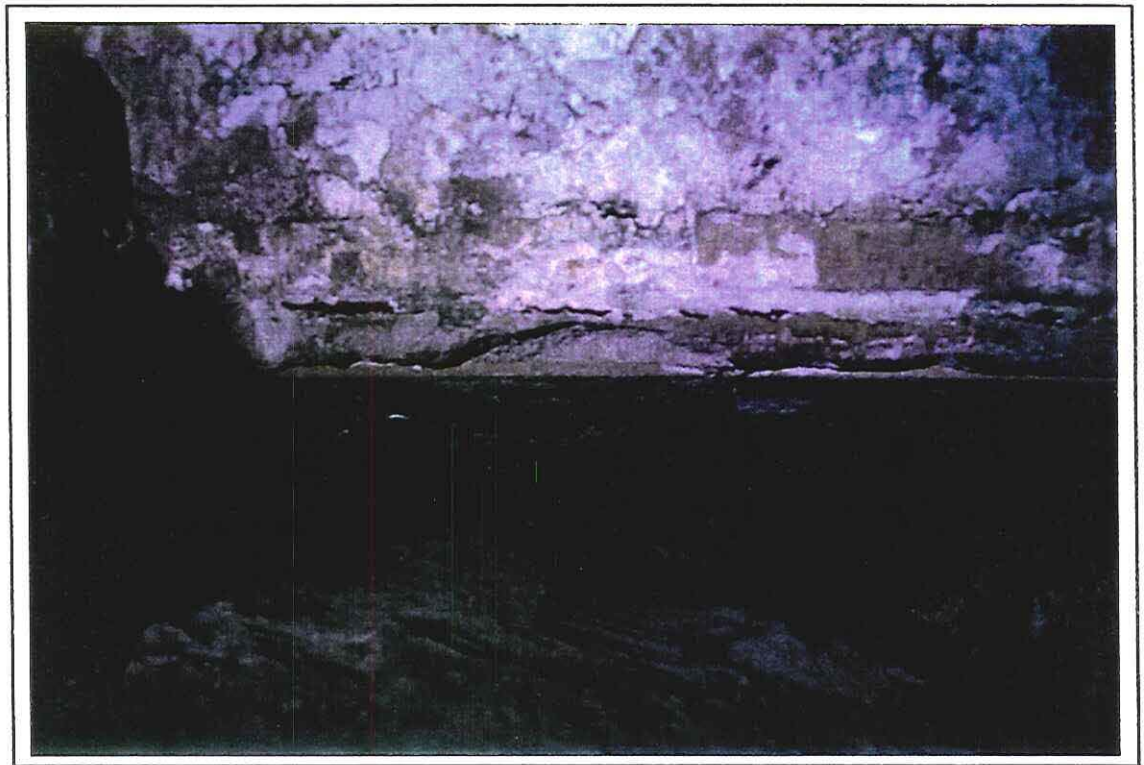
Cloister, south side, laver, third niche from west, detail painted inscription

The inscription is painted on a thick limewash ground which is severely delaminating. Urgent treatment is required including flake fixing and small repairs to the edges of the delaminating limewash. [Timescale: 1 day asap].

Comments The flaking limewash ground was consolidated and flakes fixed on 22/12/94 in response to recommendations in first condition audit. The area below the inscription (still formed by partial unblocking) was dusted using a soft bristle brush, directing dust away from the paintings. The flakes were pre-wetted using a distilled water:acetone (1:1) solution which was injected behind the flakes. Plextol B500 10% in water was injected behind the flakes. Where possible the flakes were gently pressed back against the stone support using a pad of cotton wool covered with a nitrile rubber sheet. Proud edges and pockets of limewash which it was not possible to fully read here were supported by injection of lime milk:Plextol B500 (5:1) which formed miniature edge repairs. A photographic record of treatment was made kept in Studio.
