Ancient Monuments Laboratory
Report 66/97

WALL PAINTING CONDITION AUDIT,
OKEHAMPTON CASTLE, DEVON

J Davies
T Manning

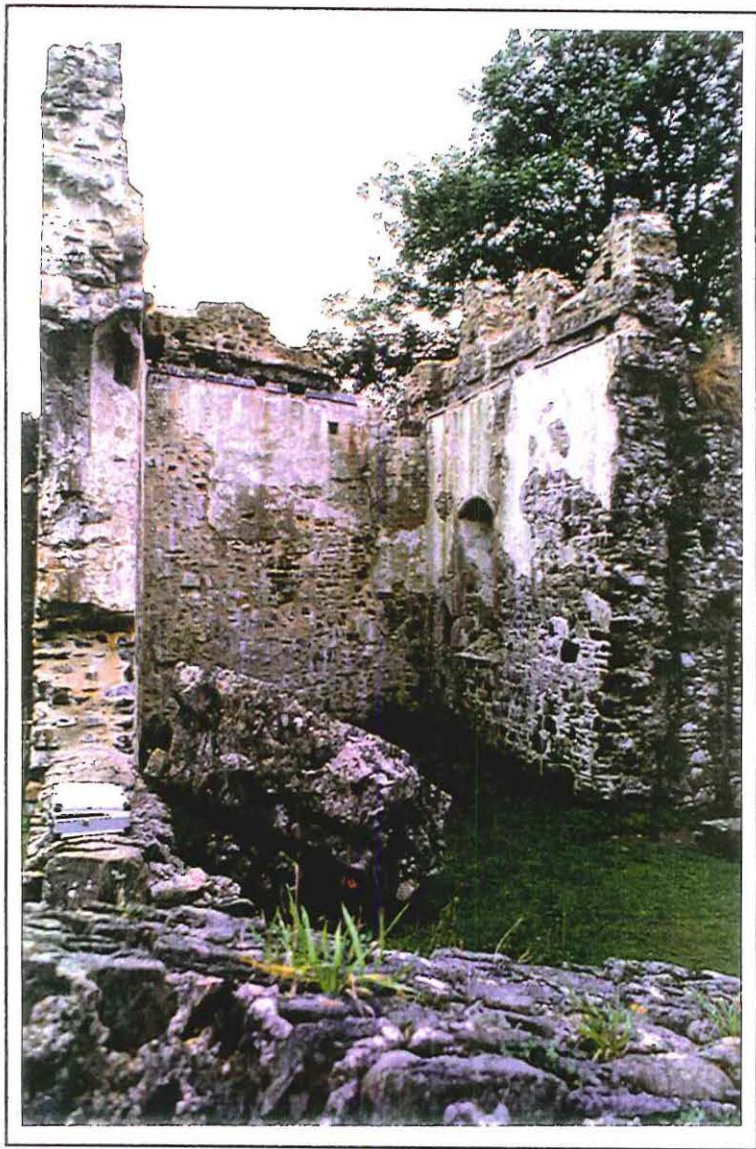
General view of chapel to southeast

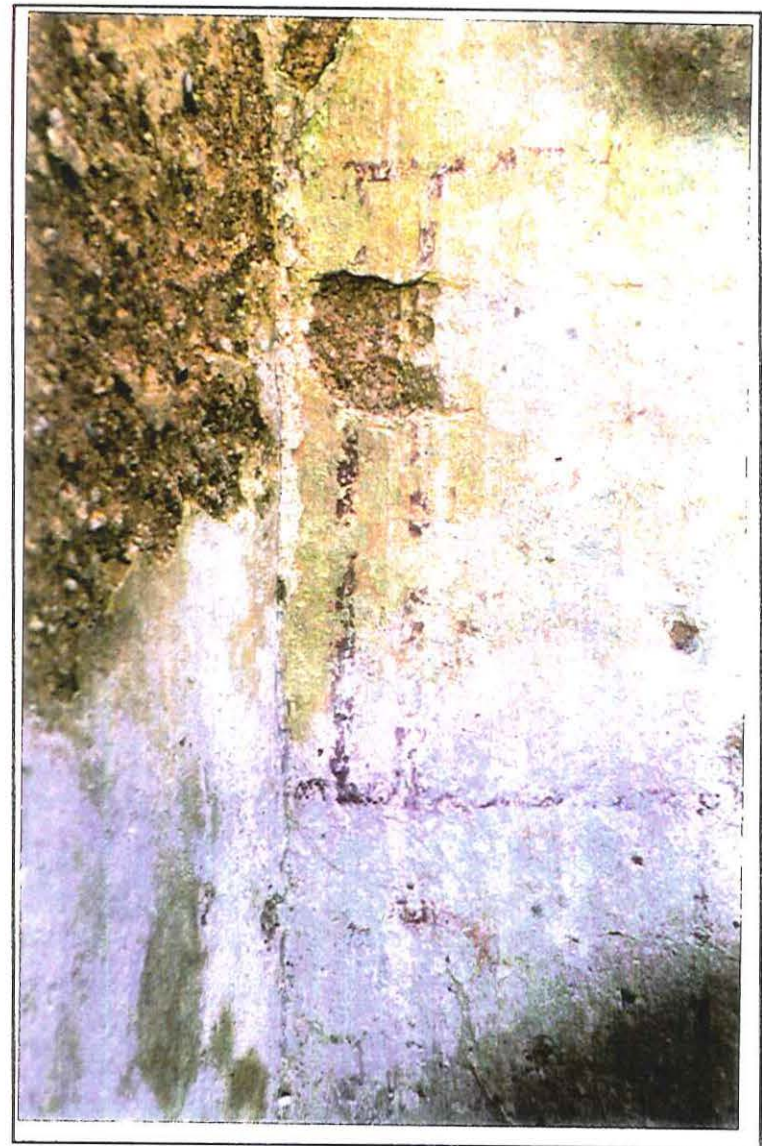
Fragments of red and white paint survive in patches over the south wall of the chapel and there are traces of red, black, yellow and white on the window splay. The scheme comprises a simple double red line masonry pattern on the walls, with a black chevron pattern against traces of red and yellow within the window splay.

Detail, south wall, double-line masonry pattern
