Ancient Monuments Laboratory
Report 67/97

WALL PAINTING CONDITION AUDIT,
RYCOTE CHAPEL, OXFORDSHIRE

J Davies
T Manning

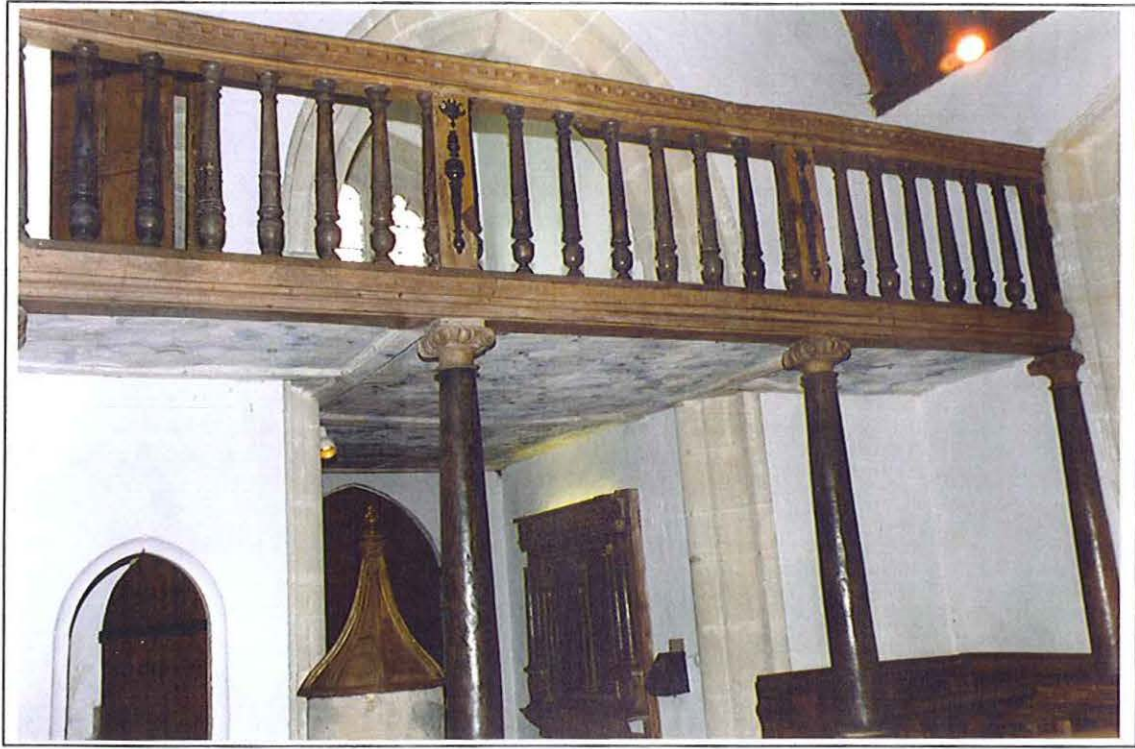
Western Gallery, general view to west

Further to this, the recommendations made in 1990 by C. Babington with regard to the Western Gallery have not been addressed. The heating system directly below the Western Gallery is still in place (and on 'high' in mid-August), and although it does not seem to have provoked any localised damage, this should be examined further. It was found to have caused damage in 1985 (shortly after it was installed) and at that time, A. Wright, the London Area Architect, requested M&E to monitor the environmental conditions of the chapel. It is not known if this ever happened; but if it did, it would be useful to gain access to this data. In addition, the fluorescent tube lighting in the Norreys Pew is still in place, giving, as noted in 1990, an insensitive 'raking light' appearance to the paintings. Its proximity to the paintings is surely not necessary, and visually detracts from both the paintings and the surrounding woodwork.

The paintings appear to be stable since treatment in 1990, and no conservation treatment appears necessary at present. However, because of the uncertain effects of the heating system, and the presence of bats, it is highly recommended that the paintings be inspected on a regular basis.

Comments The ceiling appears to be stable. However, the condition should be monitored, especially in light of the fact that the heating system has not been removed from directly below the painting. This was recommended in 1990.

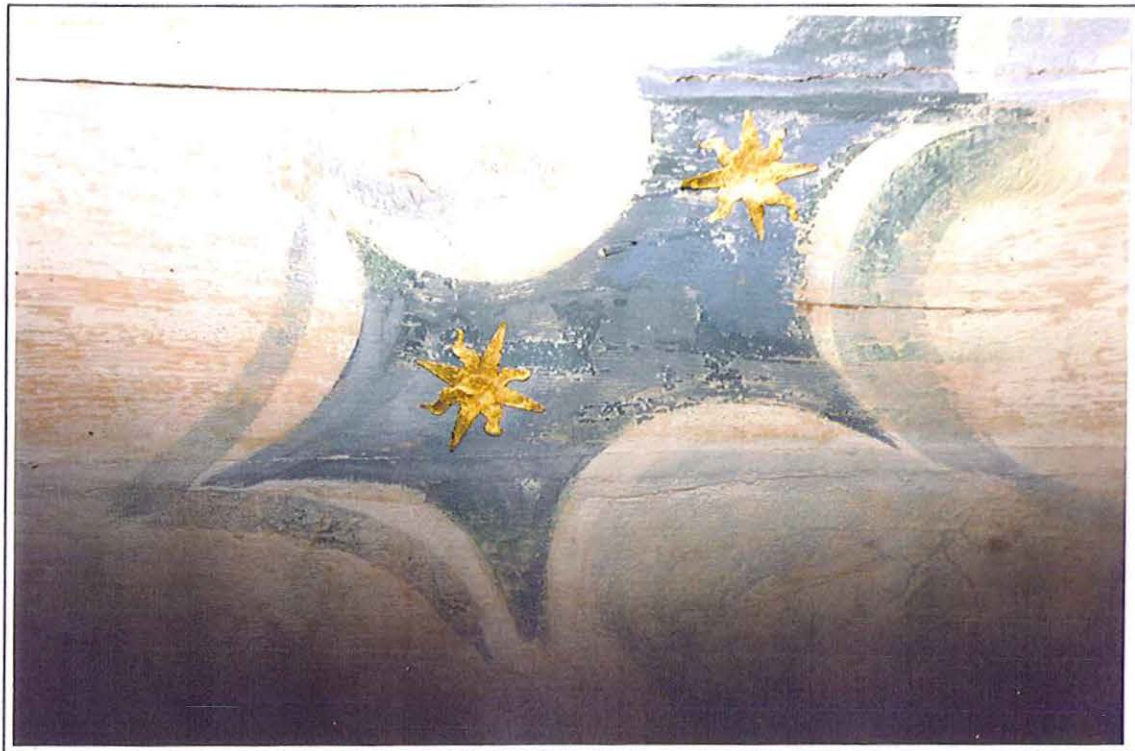
Norrey's Pew, ceiling, detail of condition: note various past retouchings, and flaking

The areas treated in 1990 appear to be stable, but the deterioration in the Norreys Pew seems to be active. Considering the importance of the paintings, it may be necessary within the next five years to consider further treatment in this area. For the moment, visual monitoring (i.e. of rate of flaking, spread of MBG) should be sufficient. However, before embarking on any conservation programme in the Norreys Pew, it would be most helpful to look further at the samples, both of pigment and microbiological growth, taken from the Western Gallery in 1990. As this painting has both a similar original technique and conservation history to the Norreys Pew, it should yield some valuable information.

Comments The most immediate problem is that of micro-flaking. It seems that the Norreys Pew is now in much the same condition that the Western Gallery was in before it was treated in 1990, and the latter appears stable, therefore a similar methodology might be employed (i.e. a lime-based adhesive such as lime milk and Plextol B500).

Conservation treatment of the Norreys Pew painting is recommended following further technical analysis. This will mainly involve minor flake-fixing in order to prevent the loss of original material. [Timescale: 2 people, 1 week, within 5 years].

Comments The flaking, MBG, and cracking should be monitored (visually) regularly over the course of the next few years in order to assess the rate of deterioration, and whether or not it is still active.
