Ancient Monuments Laboratory Report 68/97

WALL PAINTING CONDITION AUDIT, ST
BRIAVEL'S CASTLE, GLOUCESTERSHIRE

St Briavel's Castle Gloucestershire

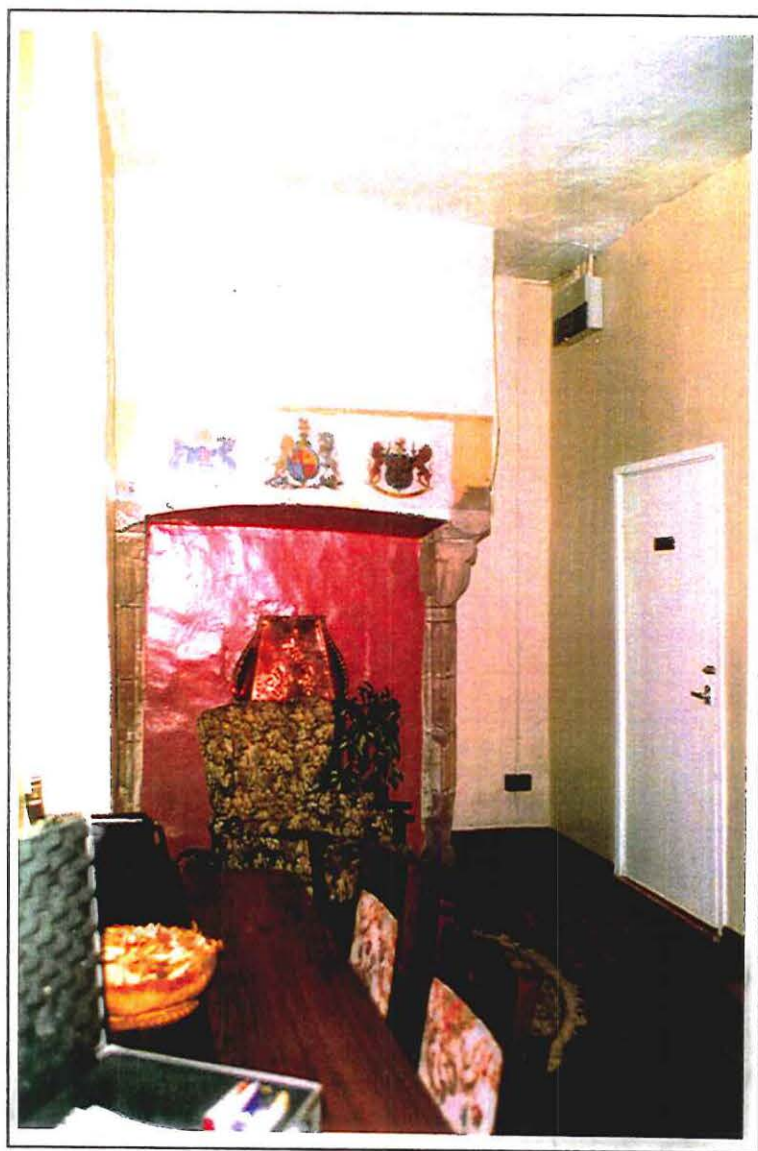
First floor, guardroom, view toward east wall, fireplace

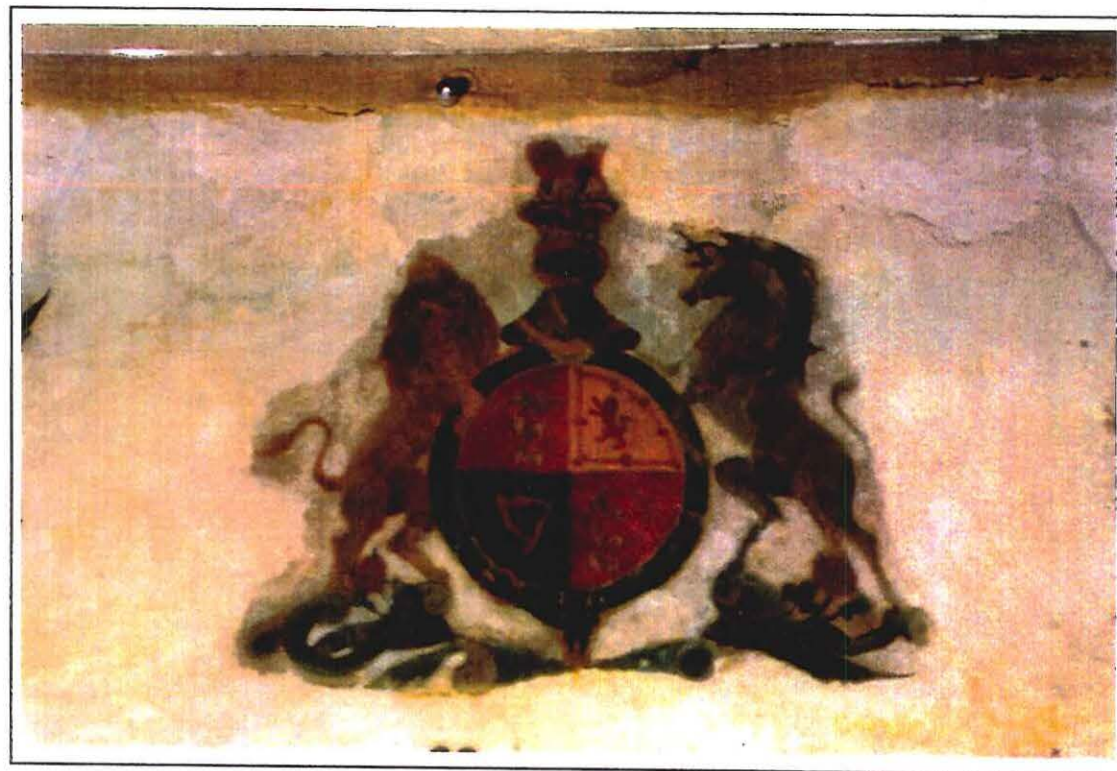
Comments Several small bulges are present in the render and appear fragile, although it was not possible to physically examine the surface due to the presence of the perspex covering sheet.

Comments There is a crack running horizontally across the upper edge of the painting. This line could be an indication of an underlying joint in the support or render, or it could possibly be a result of the presence of the perspex sheet, as the crack corresponds to the upper edge of the perspex.

Comments Fixings to hold the perspex sheet have been inserted into the wall and painting layers.

Comments 'The vandal has hacked a hole into the centre of the Royal-Arms, approximately 6" in diameter in the area of the central shield in its top right quarter. The plaster has, in places, been removed down to the stonework. There is also considerable loosening to the paint film around the damage. Some of the flaked-off paint has been collected and saved.' (P.J.Keevil correspondence, 30-9-87).

This damage is not now clearly visible due to repairs and deceptive retouching.

Comments The emulsion may inhibit the wall from 'breathing'. It overlies some areas of the painting, especially the lower edge. In several areas it appears as though it has been 'thinned', possibly during conservation in 1987.

Comments It appears that the background has been rather crudely painted over.

Comments There are several 'greyish' repairs to cracks within the painting.

Detail, painted heraldry over fireplace

Type GROUTING **Date** 22/06/95
Person TM/JD
Comments Following full inspection the delaminating render may require grouting.

Comments The perspex covering should be temporarily removed to allow full assesment of the condition of the painting. It may be worthwhile considering the merits of permanent removal of the covering as the room is no longer used as a games room.
