RESEARCH REPORT SERIES no. 36-2012

BEXWELL BARN, BEXWELL, NORFOLK ANALYSIS AND INTERPRETATION

Olivia Horsfall Turner

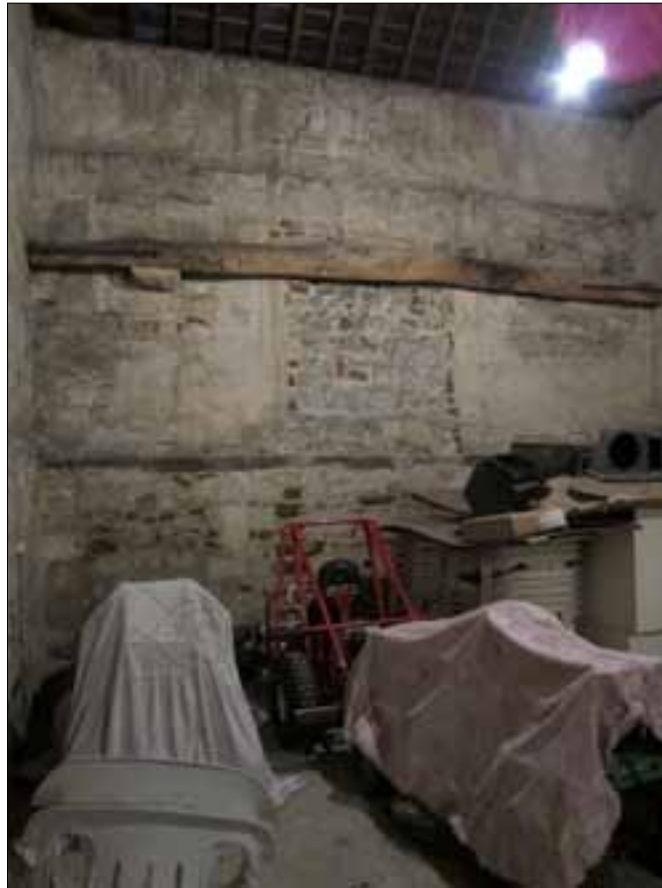
This is confirmed by interior evidence, which shows there were two different openings in the north wall (Figure 3). The first was at ground level – potentially a wide doorway providing access directly from the road – and the second at upper level – probably a window or opening for taking-in. Above the head of the lower aperture is a wooden beam which runs across the wall's entire face and appears to be an integral part of the wall construction, suggesting that the doorway was primary. Whether or not the upper aperture was primary is impossible to say, but its infill appears to be slightly rougher and higher in brick content than that of the infill of the lower aperture, suggesting that they may have been infilled in different phases.

Figure 3. North wall, interior, showing evidence of earlier openings.

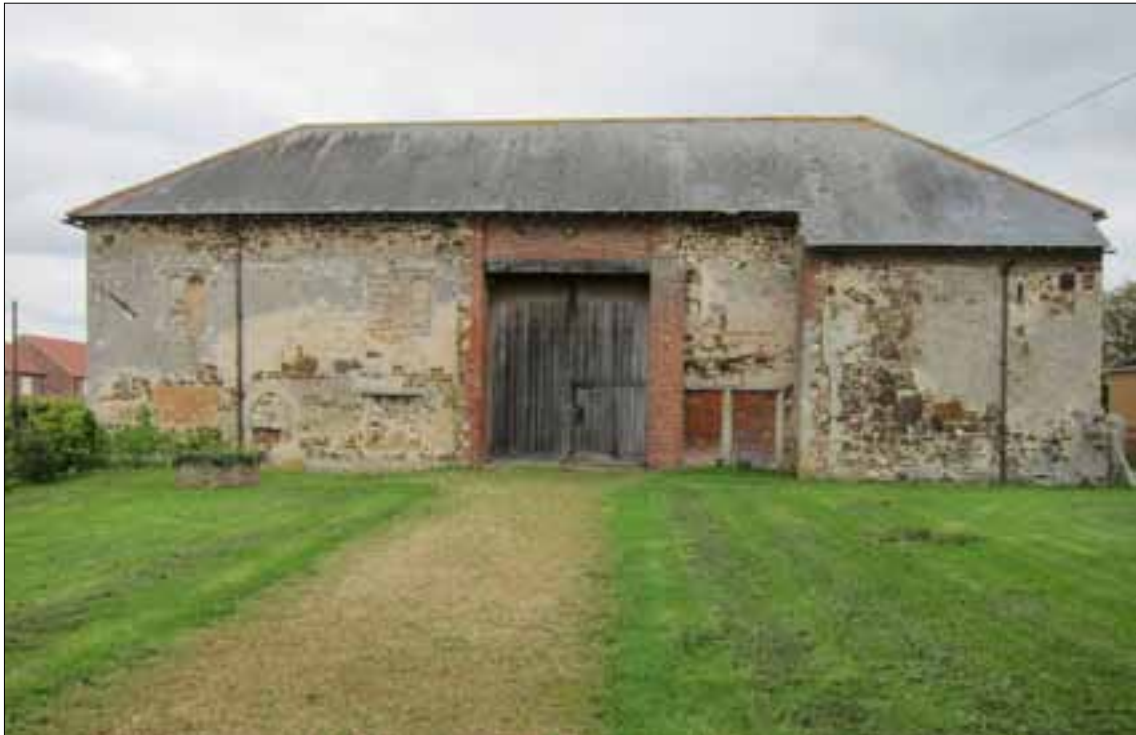
The west face is constructed of a combination of ashlar, stone rubble – including some carstone – and brick, with a number of ashlar windows and one ashlar door surround (Figure 4). There is also evidence of worked-stone fragments, as well as ashlar mullions and mouldings, used as walling material. At eaves level a break in the masonry and a change in building materials from the variety of materials outlined above to small carstone blocks suggest that the wall height has been raised at some point. This also appears to be expressed on the interior, though subsequent plastering makes it difficult to discern the change in materials.

Figure 4. West façade.

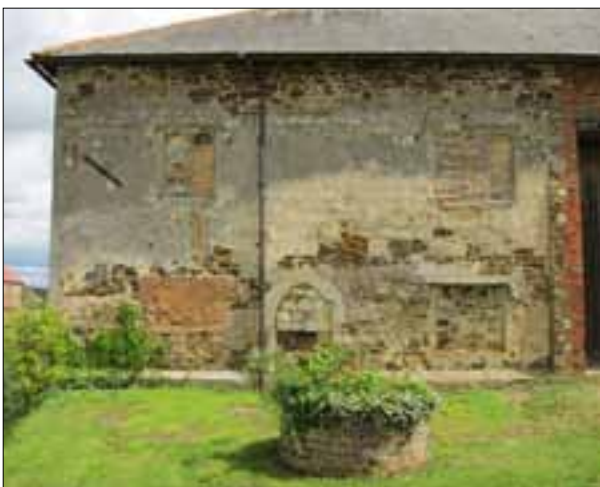
Figure 5. Blocked features on west façade.

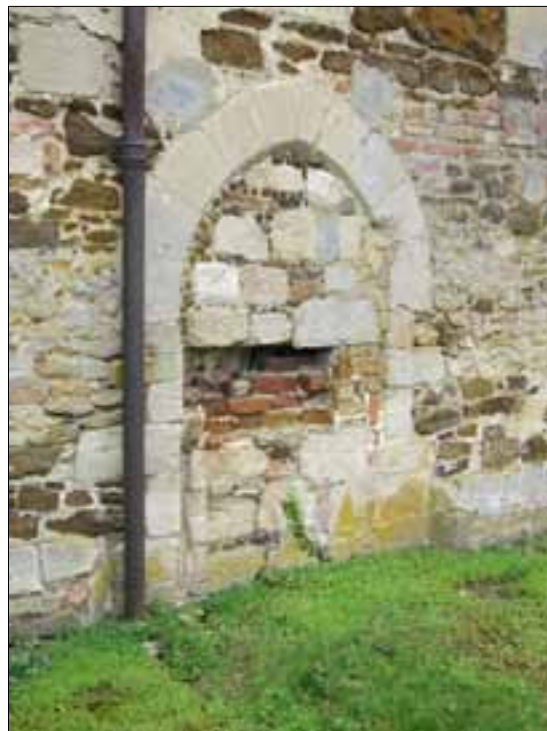
The extant lower-level apertures are a doorway (Figure 8) and a three-light window (Figure 9). In addition, an area of brick infill in the lower left-hand corner which corresponds to the sizes of the other three-light windows indicates that there was probably another three-light window in that location. The infill is of small light-salmon-pink bricks – different again from those of the upper-level windows and therefore suggestive of yet another phase of infilling. The infill is also visible on the interior, suggesting the former window aperture in that location was fully open at some point. Like the windows at the upper level, the extant ground-level window has a hood mould and flat head over shallow, cusped, trefoil-headed arches with simply carved spandrels. Only an indication of these details survives, however, as the arches and spandrels have been damaged and mostly lost. The door surround is a two-centred arch of ashlar blocks with chamfered edges on the inner face.

Figure 8. Infilled doorway on west façade.

The doorway and lower-level window are both infilled with a mixture of stone rubble (including carstone), worked-stone blocks, and brick. The infill is neatly coursed, and in places the mortar is galetted with small carstone chips – a decorative finish suggesting it was intended to be visible. The relation between the infill and the damaged window suggests that the damage occurred at some point prior to the infilling. The infill is visible on the interior, which would suggest that this window and the doorway were open at some point, but the fact that the infill is of the same type and size of material that is used in the main wall face suggests the possibility that these apparent 'apertures' may have been blocked from the original date of construction. Furthermore, if the windows had been open, their position is so low that they would not have afforded interior light at a useful level (the original interior floor level does not appear to have been substantially altered even though the interior floor surface has been covered in concrete). This also suggests that the ashlar features are not in situ.

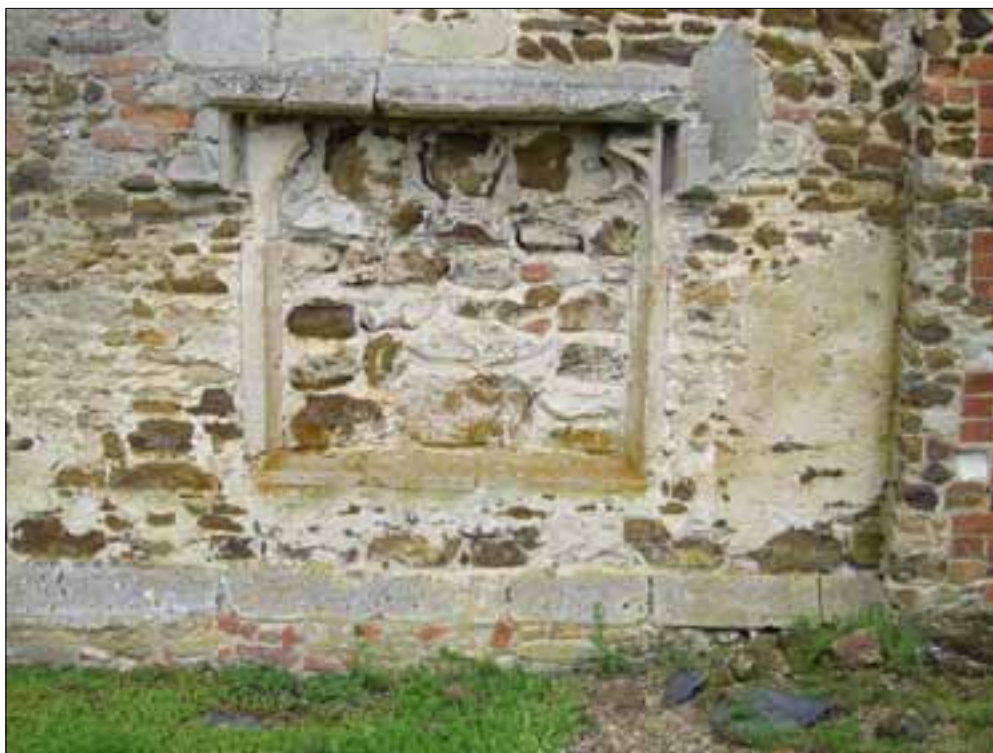
Figure 9. Infilled window at ground level on west façade.

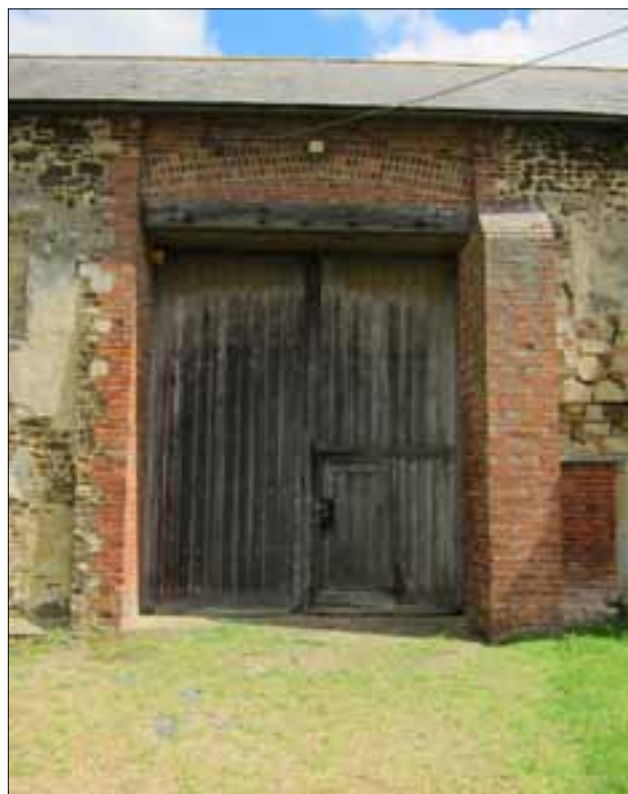
The central section of the west wall is dominated by a large wooden taking-in door which rises to almost the full height of the building (Figure 10). The large-scale jambs for the taking-in door are constructed of bricks which appear to be 19th century. The right-hand-side jamb is flush with the wall face at the top, but gradually projects to form a small buttress. It has brick quoining alternating with carstone and some ashlar. The left-hand-side jamb is entirely of brick and forms a more substantial buttress that rises up to about four-fifths of the height of the building. Above the taking-in door there is a wooden beam and several courses of brick containing a relieving arch. Given that the height of the taking-in door is the same as the original wall height, and that the brickwork above it rises to the same height as the increased wall height, it seems probable that the insertion of this doorway was the spur for the raising of the wall height.

Figure 10. Taking-in door, west façade.

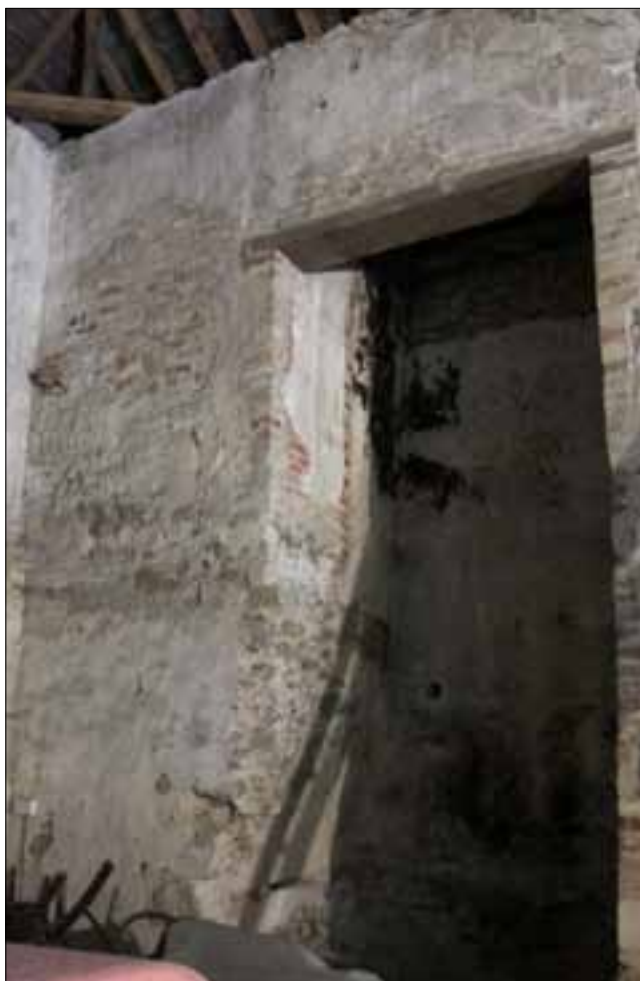
Figure 13. West wall, wing, interior.

The interior evidence reveals that the wing is a particularly complex part of the building (Figure 13). Although its exterior wall face is of one phase (plus the raising of the wall height), the wall depth is of at least two phases. The interior wall of the wing does not have any clear indication that it has been raised, although this may be hidden under the surface plaster. The wing is divided into three spaces, two of which are accommodated within the wall thickness – one of these is partially visible through a hole in the wall at upper level, the other is partially visible through an aperture at ground level. Some of the space is therefore enclosed within the wall thickness and is not accessible. The central section, open to the main interior, has been identified as either a stairwell or a fireplace, while it has been suggested that the two encapsulated spaces to either side might have been garderobes.³ Archaeologically, the

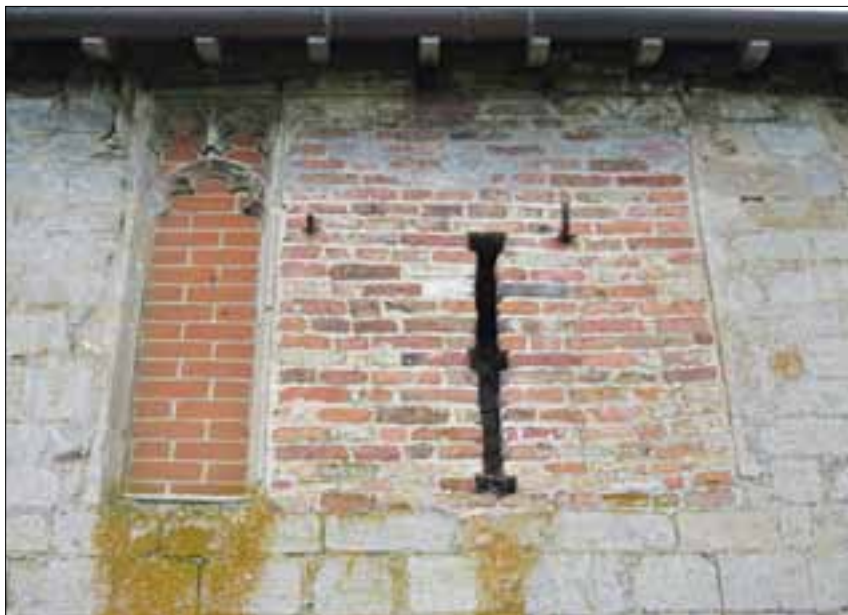
Figure 21. Blocked window, at upper level on south façade.

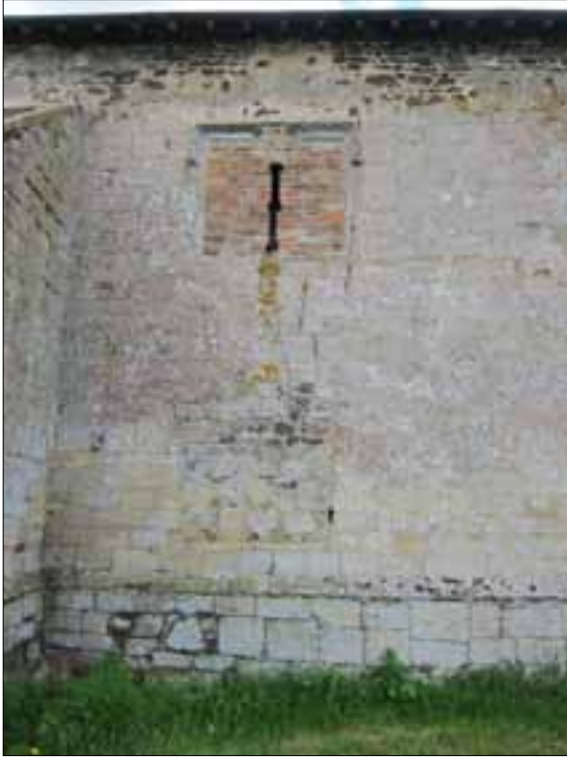
To the north of the porch, there are three medieval ashlar windows that date to the 15th century and evidence of a fourth window that has been removed. The upper-level windows are located very close to the top of what appears to have been the original wall height, below only a half-course of ashlar. At upper level to the left is a flat-headed window aperture that retains its hood mould and its stone surround but which has lost its sides and bottom sill and does not have any surviving mullions or tracery (Figure 23). It has been infilled with early bricks, leaving an 'arrow slit' for ventilation. This is also expressed on the interior wall face, though the infill also includes some rubble. At upper level to the right is a flat-headed two-light traceried window with hood mould (Figure 24). The tracery has been cut down and part of the supermullion is missing, so that the upper cusped arches spring directly from the top of the lower cusped arches (compare with the tracery of the single light on the east face). This window has also been infilled, but with 19th-century brick. This aperture and infilling are expressed on the interior, but the infilling is in what appear to be 18th-century bricks: distinctly different from those used on the exterior. At ground level on the left, scars indicate the location of what was probably a window that has been removed. Its former position has been infilled with ashlar and some carstone. It is also expressed on the interior. At ground level to the right is a three-light traceried window with hood mould (Figure 25). The tracery has cusped arches and simple hollow spandrels. It has been infilled with 19th-century brick. The aperture is expressed on the interior, but the infill is of ashlar blocks, rubble and carstone.

Figure 23. Blocked window at upper level with surviving hood mould on east façade.

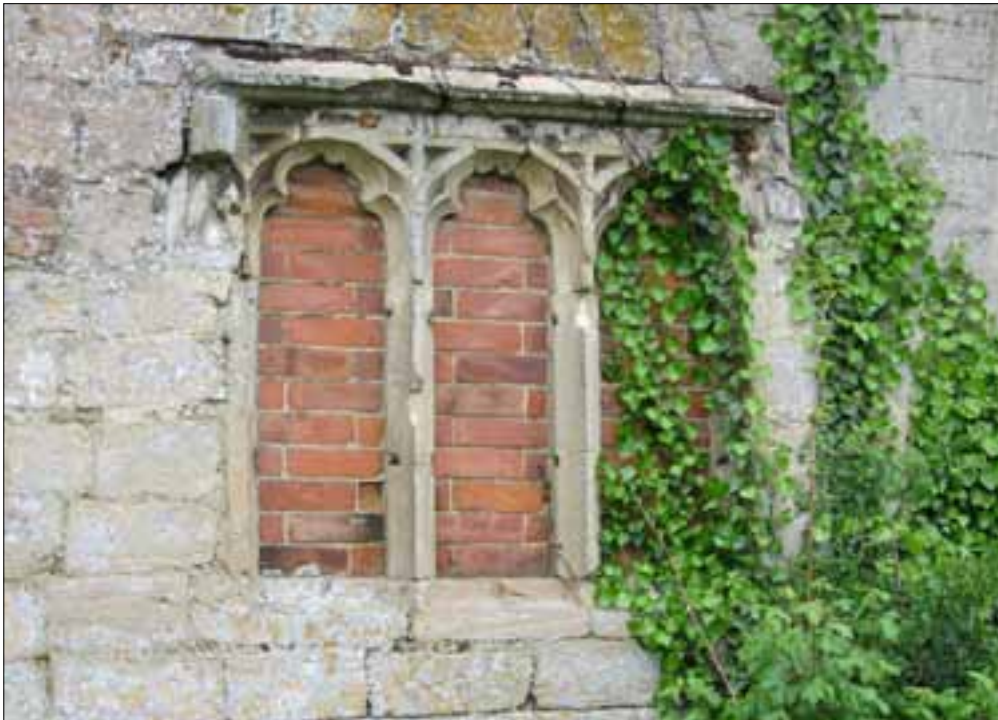
Figure 25. Blocked three-light traceried window at ground level on east façade.
