RESEARCH REPORT SERIES no. 19-2013

APETHORPE HALL, APETHORPE, NORTHAMPTONSHIRE DOVECOTE ROOF

HISTORIC BUILDING REPORT

Nick Hill

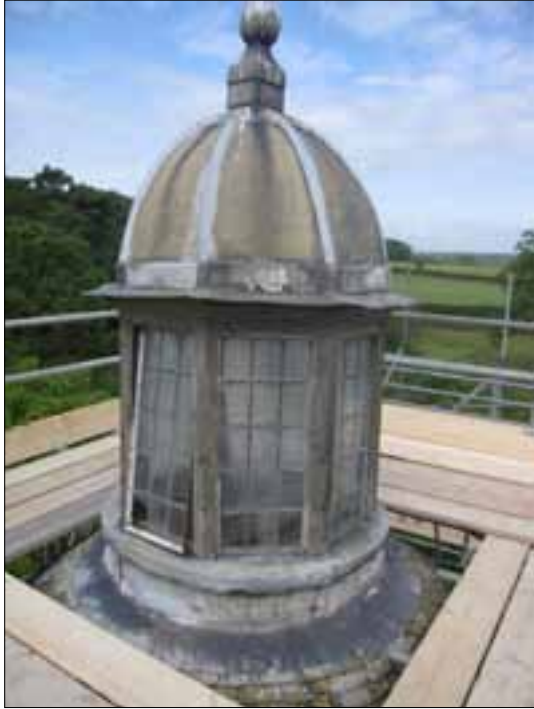
The top lantern is of octagonal form with a leaded cupola roof. During dismantling, it became evident that the leaded cupola roof was original, but the glazed lantern was of early 20th-century date (figs 5-6).

Fig 5 The early 20th-century glazed lantern and original leaded cupola.

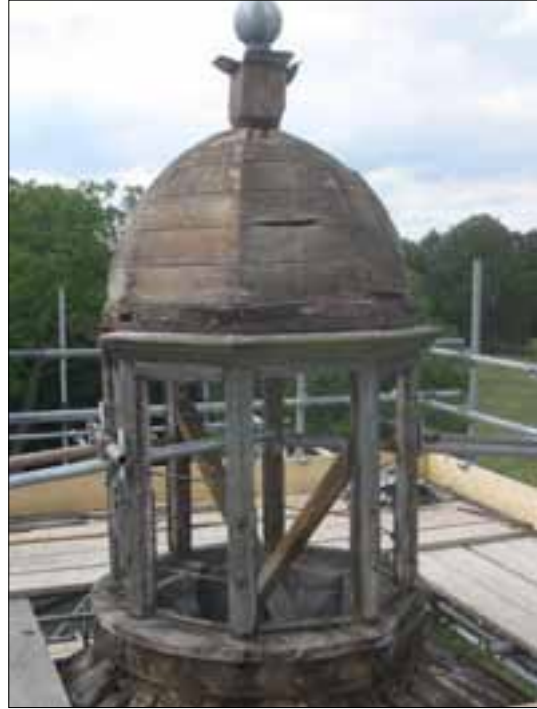
Fig 6 Lantern and cupola after roof stripping. The cupola retains its original boards, but the finial is of 20th-century date.

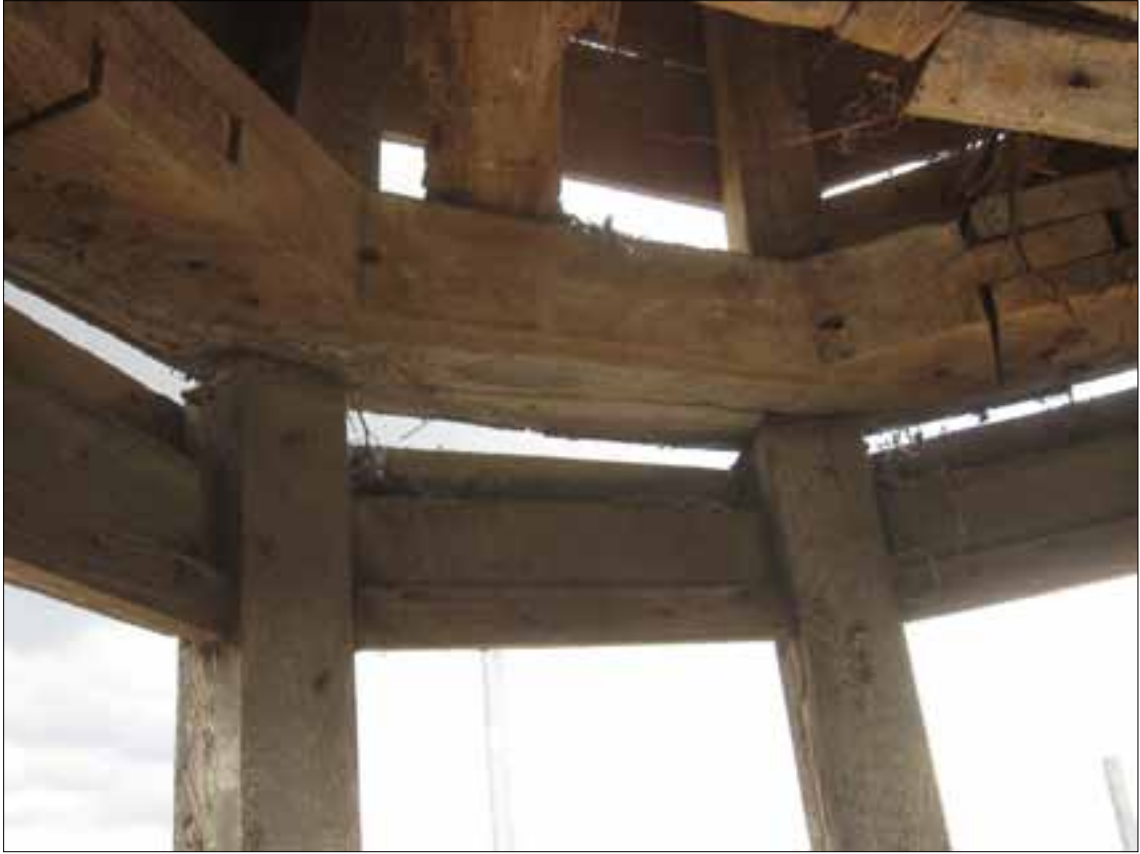
The cupola roof has a neatly framed roof structure, of oak. At the base is an octagonal plate, formed in four sections (fig 7). The sections are jointed with open-tenoned joints, pegged twice. On the lower outside edge of the base plate is a ring of iron straps, formed in four sections, rebated into the base plate and fixed with large, hand-made nails. This appears to be an original detail of 1740. A tie-beam spans across the base plate, with lap dovetail joints at each end, fixed with an iron forelock bolt. Forelock bolts pre-date bolts with screw threads and nuts, having a slot in the bolt end to receive a thin, tapered iron wedge. This bolt type is used widely throughout the 1740 structure. An octagonal kingpost is supported on the centre of the tie-beam, with a tenon passing right through the tie-beam and fixed with a wedge (a tusk tenon joint).

Fig 7 The base of the cupola, with octagonal base plate.

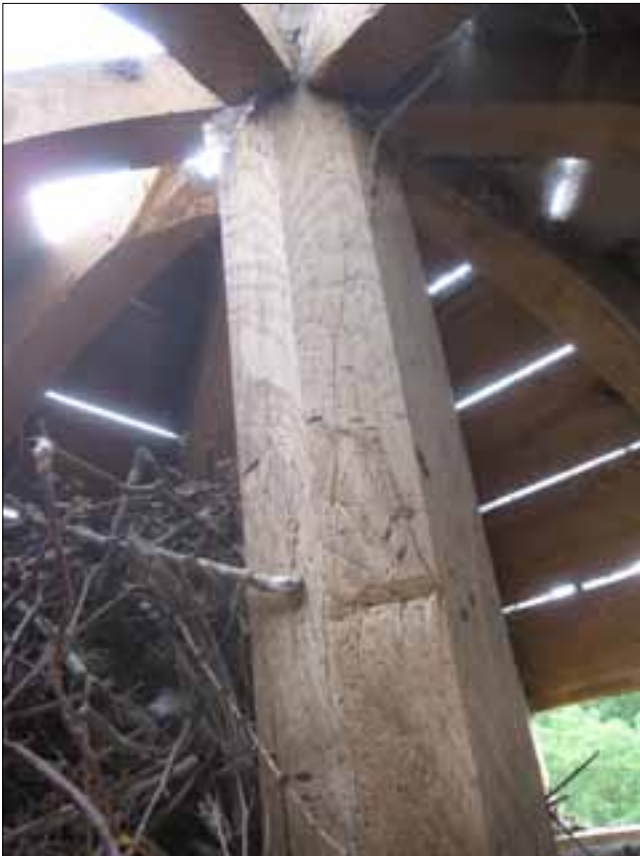
Eight curved oak ribs form the cupola, neatly shaped, with feet tenoned to the base plate and skew-nailed to the kingpost at the top (fig 8). The ribs have carpenter's marks, both knife-cut and chiselled, but these were only partly visible. The cupola is covered with pine boards, largely original, and fixed with hand-made nails. The original kingpost was cut off at the top of the dome, level with the boarding, and a later finial with ball top had

Fig 8 The top of the cupola, with kingpost and curved ribs.

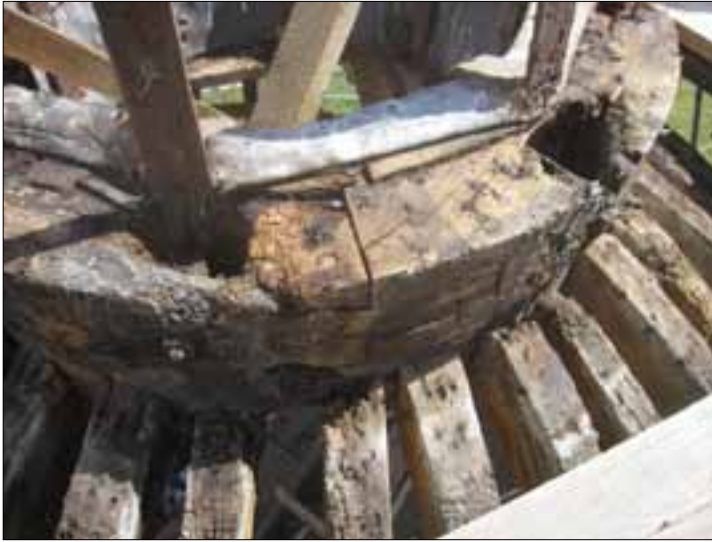
Fig 10 Detail of the upper ring-beam, with pegged, open-tenoned joints and decayed mortices for the original Glover posts.

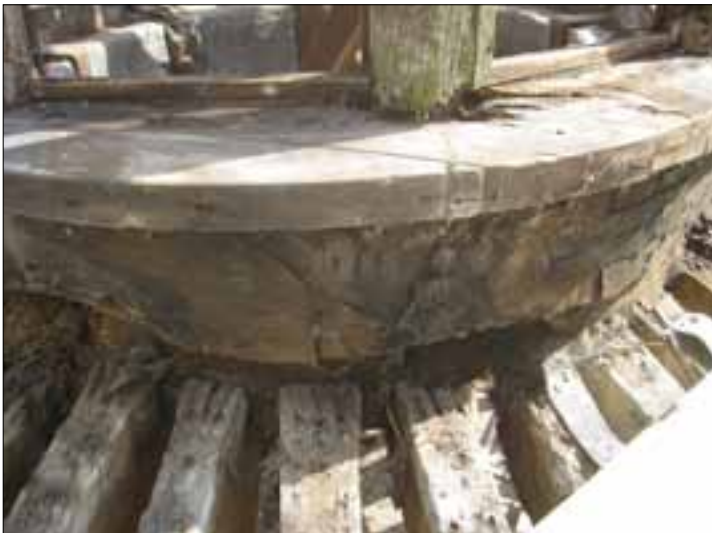
Fig 11 Detail of the upper ring-beam, with early 20th-century applied softwood cill, carpenter's mark 'IIII' and oak peg which fixed the tenon of the original Glover post.

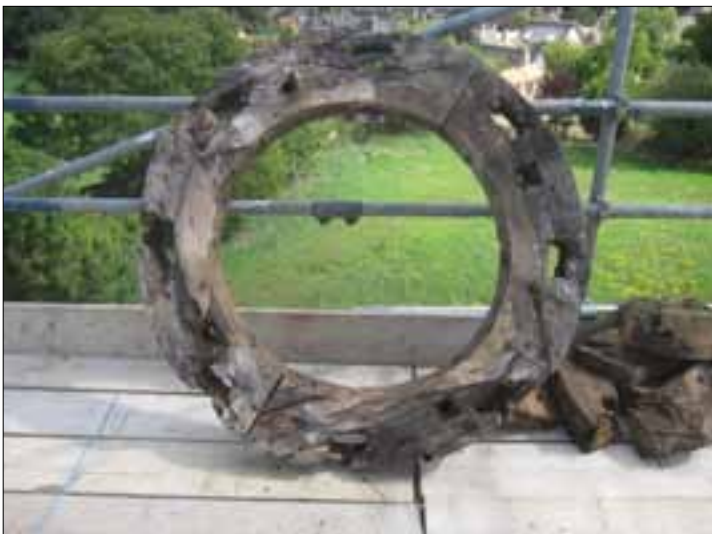
Fig 12 The upper ring-beam, formed in four sections. Note the eight decayed mortices for the Glover posts, and the four holes for forelock bolts, with square countersinking.

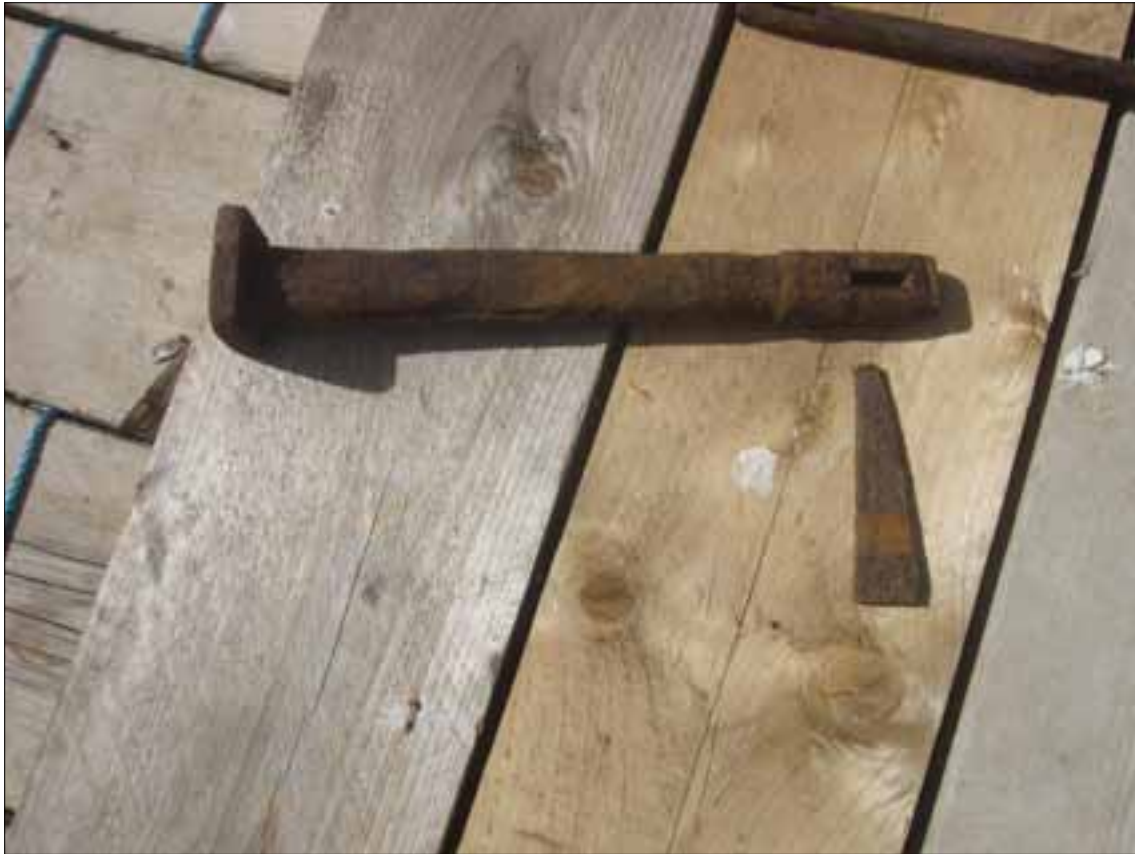
The upper ring-beam sits directly over a lower ring-beam, again formed of four sections, but of slightly smaller diameter. The upper ring-beam is fixed down to the lower ring-beam with four large forelock bolts (fig 13). The lower ring-beam was badly decayed, and further details were not retrieved.

Fig 13 One of the large forelock bolts which were used to fix the upper ring-beam to the lower ring-beam. Driving the thin tapered wedge into the slot tightens up the bolt fixing. The forelock bolts are of various sizes, this being the largest.

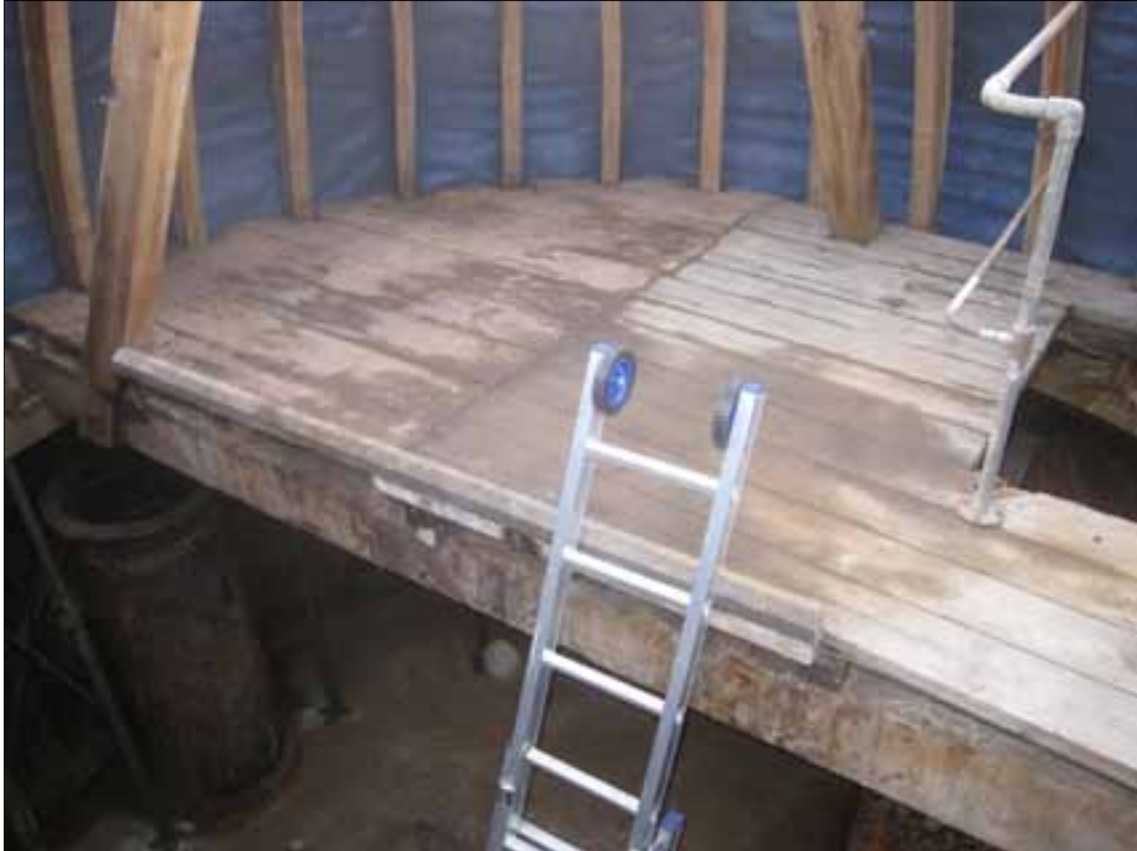
Fig 20 Lower part of a dome principal rafter and the tie-beam – partly covered by the water tank floor.

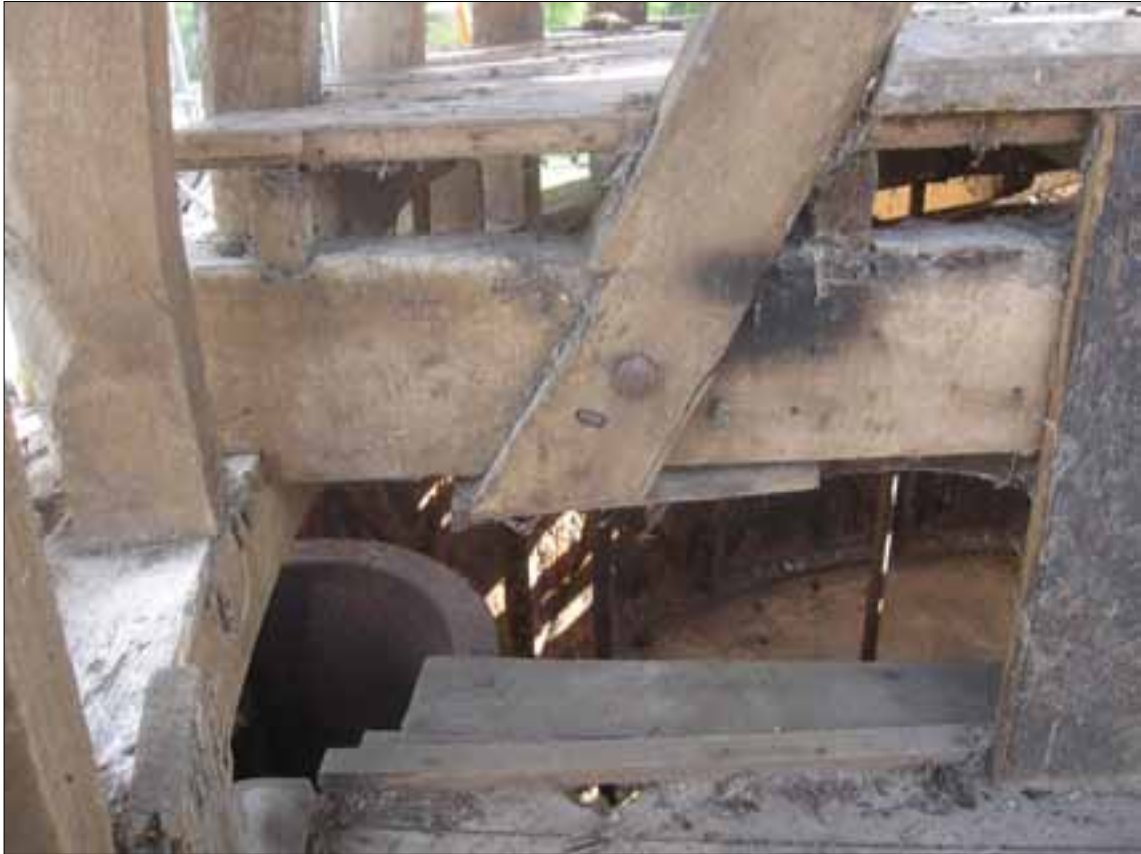
Fig 21 Detail of the joint to dome principal rafter and tie-beam, with lap dovetail, forelock bolt and large-head nail.

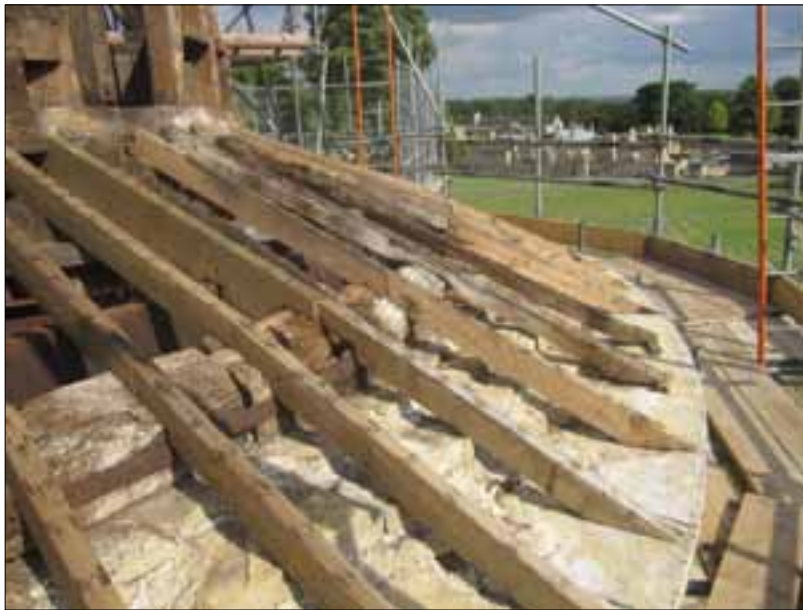
The base beam of the main dome does not bear onto the masonry walls, but is instead supported by the 'skirt' roof structure (figs 23-24). The low-pitched 'skirt' has 16 principal rafters of c.100mm by 200mm section, which are simply birds-mouthed and nailed at top and bottom to the dome base beam and wallplate. A few chisel-cut carpenter's marks survive to the principal rafters, enough to show that there was a complete, ordered sequence from 'I' to 'XVI' (fig 25). Three common rafters (c.60mm by 85mm) are located between the principal rafters, which extend across the thickness of the wall to the outer edge of the roof. Many of these common rafters had previously been replaced in modern softwood.

Fig 23 The lower 'skirt' structure.

However, while the structure of the main dome and lantern/cupola was well-designed and soundly constructed, the support structure of the lower 'skirt' roof was ill-conceived and proved inadequate. The whole weight of the dome had to be supported on the floating dome base plate. The forces imposed on the base plate generated considerable outwards thrust, which was intended to be restrained by the principal rafters of the 'skirt' and the dovetail-jointed ring of wallplate timbers. It was unrealistic to expect the 'skirt' structure, especially given its low pitch, to contain these forces. In spite of their forelock bolts, the wallplate joints failed under the tensile stress, and the dome suffered considerable subsidence. When the water tank structure was added in the early 20th century, with major steel beams, it provided vital support (whether by accident or design) to the dome roof, which by this stage must have been close to collapse.

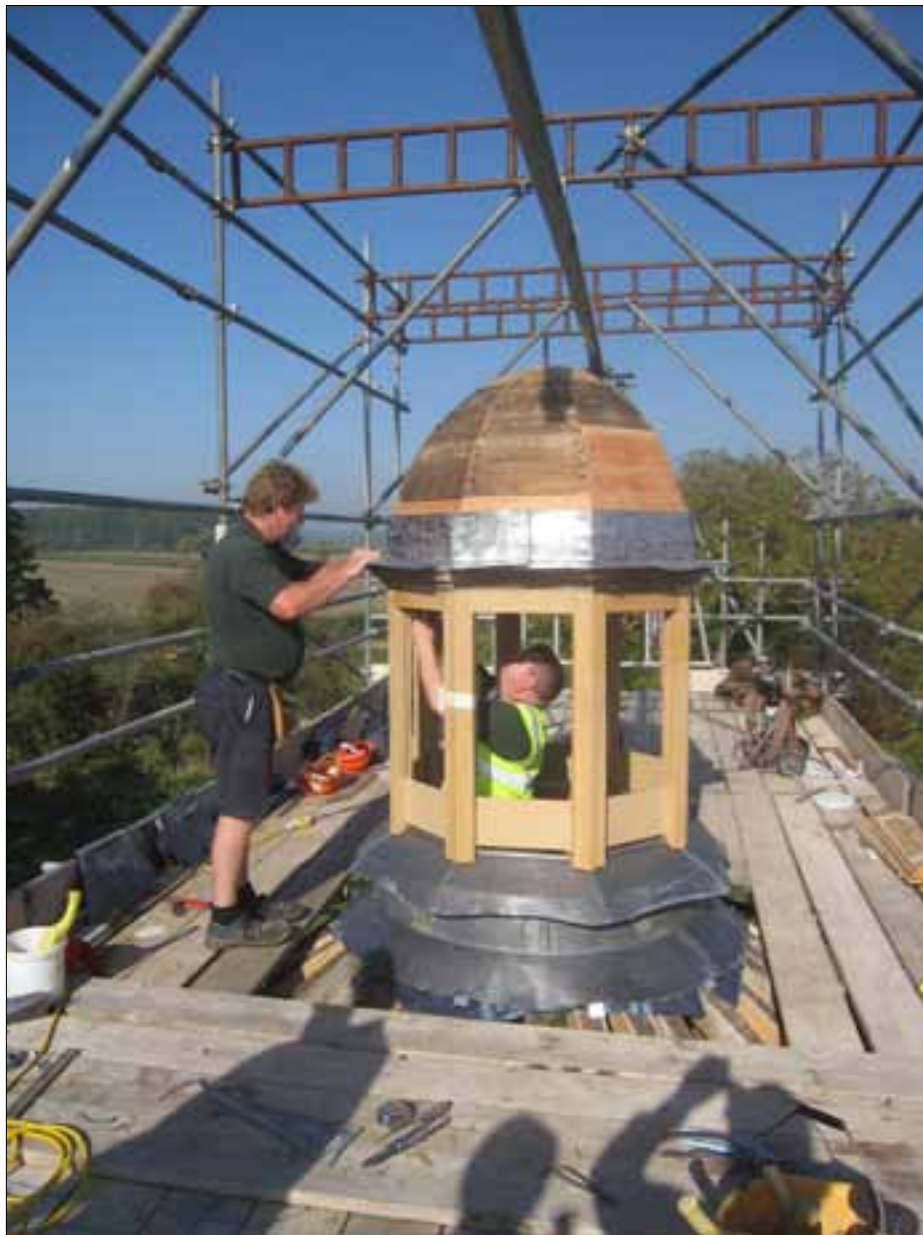
Fig 27 Reinstatement of the lantern and cupola

During the recent repairs, the cupola roof structure to the lantern was retained largely intact, including most of the original roof boarding (figs 27-28). The timber of the early 20th-century lantern structure was fully replaced, with the two iron pivot windows and leaded-light glazing reinstated. Both the upper and lower ring-beams had to be fully replaced, though the intact upper ring-beam has been left inside the building, together with a number of forelock bolts. The main dome ribs and base plate required only minor repair and re-fixing. Quite extensive repairs were needed to the lower 'skirt', but the majority of the wallplate and principal rafters remain in situ. The Collyweston slates and leadwork were fully stripped and reinstated. The water tank structure has been retained, and provides vital support to the dome base beam via added props.

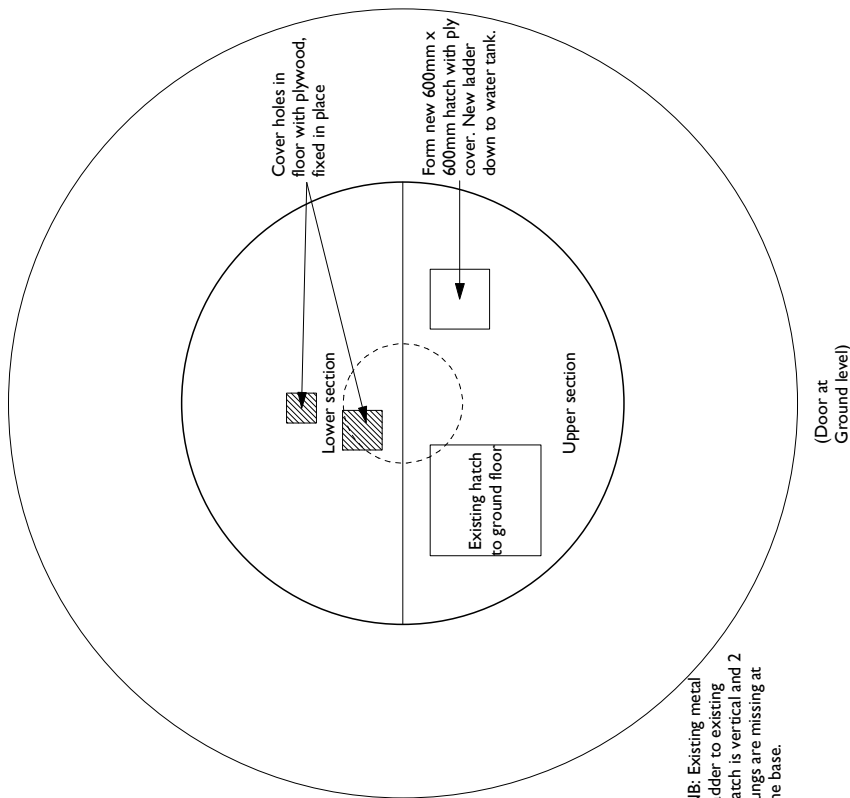
Plan at Upper Level

NB: Existing metal ladder to existing hatch is vertical and 2 rungs are missing at the base.
