APETHORPE HALL,  
APETHORPE,  
NORTHAMPTONSHIRE  
RECORD OF OPENING UP  
VOLUME TWO

HISTORIC BUILDING REPORT

**APETHORPE HALL  
APETHORPE  
NORTHAMPTONSHIRE**

**RECORD OF AREAS OPENED UP  
VOLUME 2**

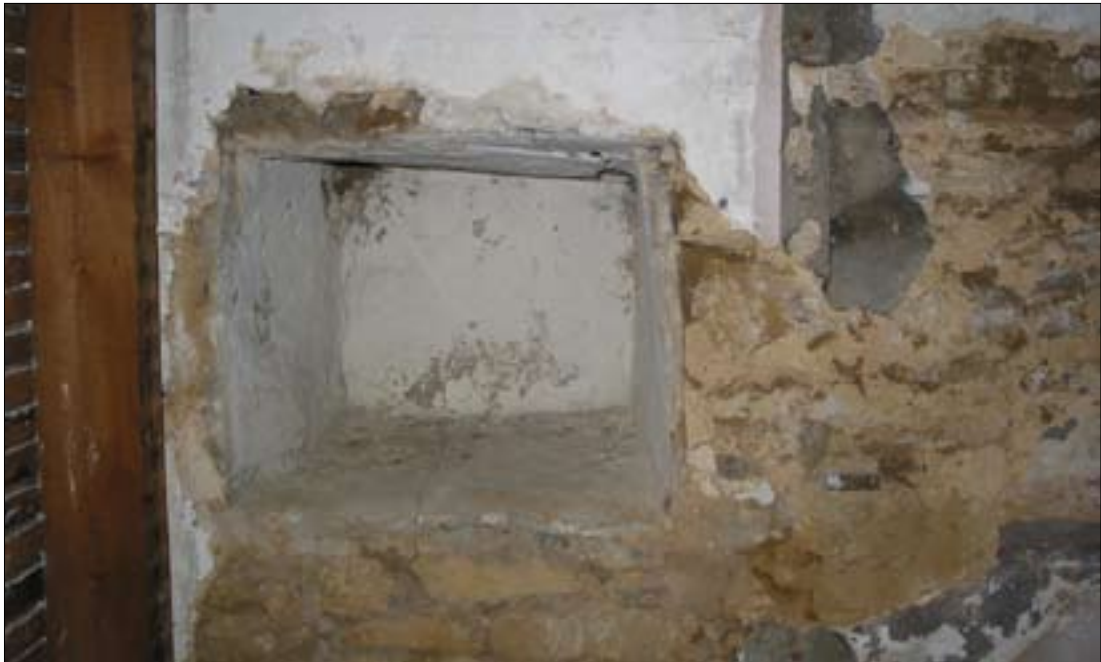
Coursed rubble wall bonded with clay mortar. The hatch is a stone lined recess set into the wall. It has been lime-plastered and lime-washed. The hatch is now blocked at the front (south side) and was presumably accessible from either side before being filled in.

*Figure 1.1 The buttery hatch. Taken from the north.*

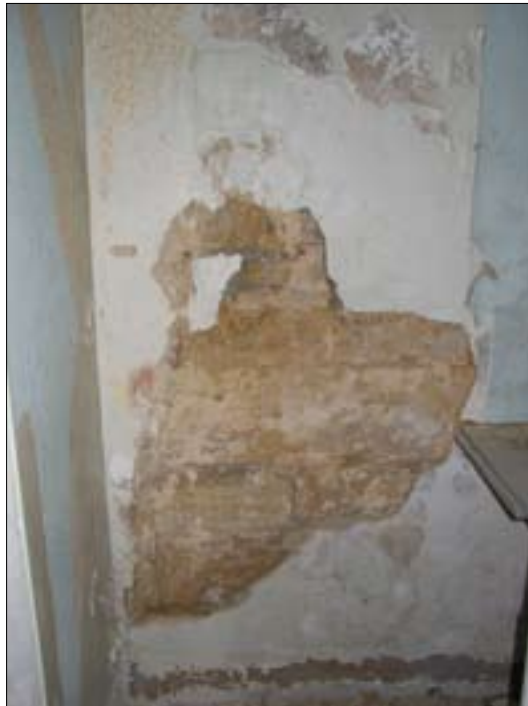
Coursed, neatly dressed and squared stone wall with clay mortar with pecking and two phases of plastering. Presence of red brick suggests some possible repair work.

This wall would have been the outer face of the west porch (H1.02). It would originally have been external, visible from inside a small courtyard.

*Figure 2.1 Taken from the north.*

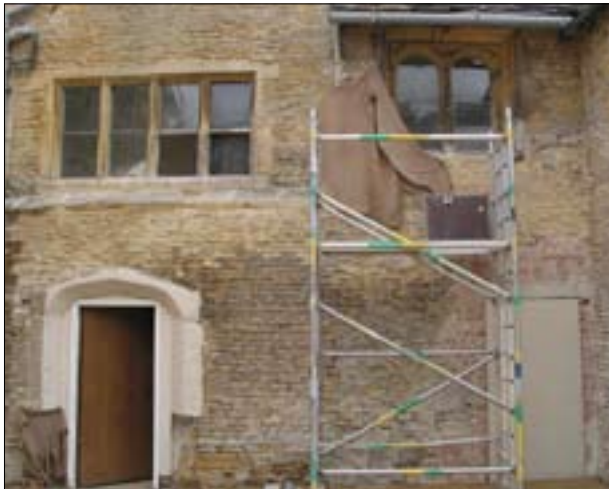
A coursed rubble wall with clay mortar, constructed to first-floor level. A row of coping stones runs below the first-floor windows of N2.12 and H2.01 but they do not continue beyond the quoin stones of H2.05. This is a surviving remnant of a garden wall. A break in the wall at this point, running to the ground, suggests that the remainder of the garden wall was rebuilt, so that the first-floor could be built as a continuous construction.

A 20th-century doorway has been inserted with a concrete lintel for access to the school dining room. The doorway has since been bricked in and the dining room demolished.

*Figure 3.1 External wall from the west.*

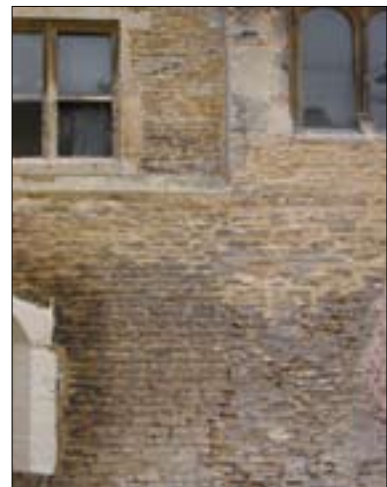
*Figure 3.2 Detail of the coping stones.*

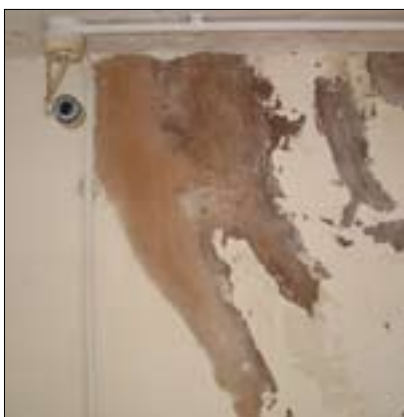
Behind thick 20th-century plaster (0.04m on north wall and 0.02m thick on south wall), is a 20th-century red brick wall.

*Figure 4.1 South wall.*

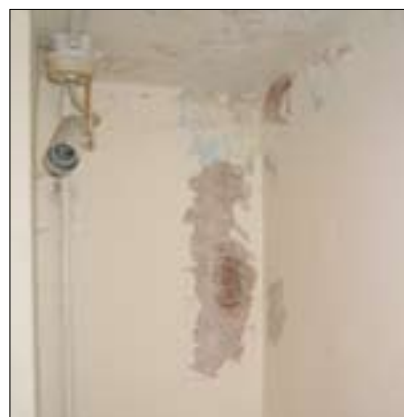
*Figure 4.2 North wall.*

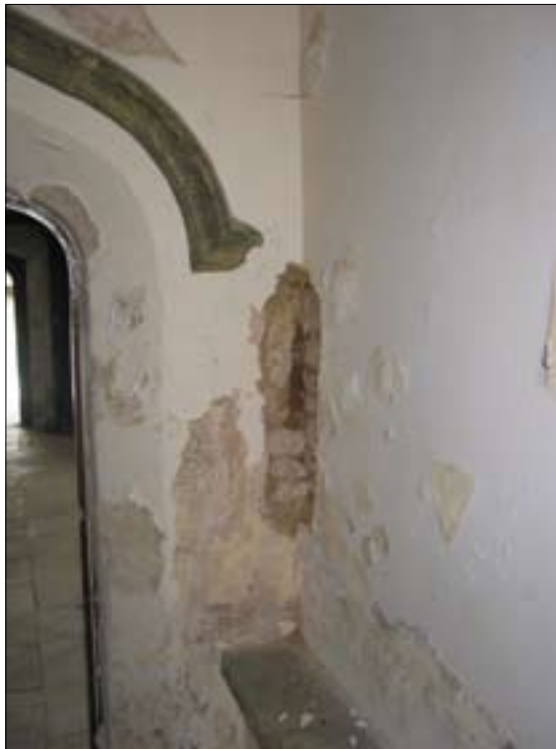
An area of opening up in the internal south-east corner of the west porch, revealed the relationship between the hall wall and the porch. The wall is of coursed rubble with clay mortar and the two walls have been neatly tied in together suggesting that their construction was contemporary.

*Figure 5.1 South-east corner of west porch.*

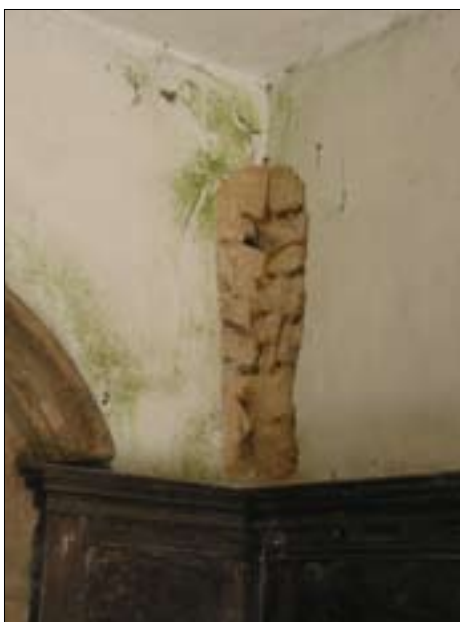
Both areas reveal regular coursed rubble walling with clay mortar below a modern plaster layer (0.02m thick). The rubble has been neatly tied in at the corners implying that the construction of the east porch was contemporary with that of the hall.

*Figure 6.1 North-west corner of east porch.*

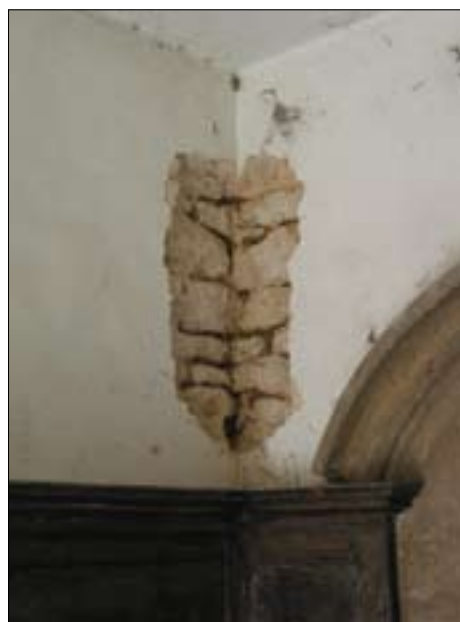
*Figure 6.2 South-west corner of east porch.*

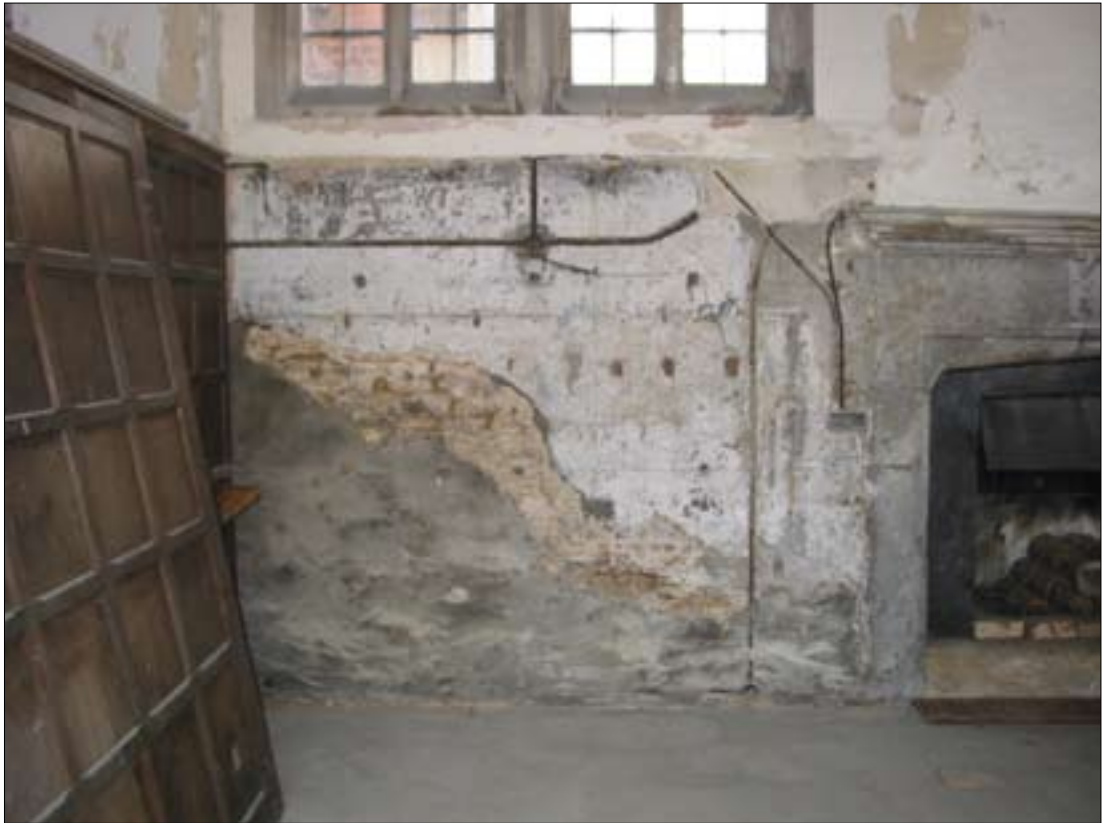
The removal of c.1922 oak panelling on the west wall of the hall, south of the fireplace, revealed continuous rubble stone walling, undisturbed by any joint holes or former openings, with clay mortar and a thin (0.01m) skim of plaster over this. There is no horsehair in this plaster, indicating that it dates from the 19th or 20th century rather than earlier.

Wooden plugs have been driven through the plaster and well into the rubble wall. Blue horizontal chalk lines are extant over the plaster marking out the level where the plugs were to be inserted, probably as supports for the wainscoting. The plugs respect the positioning of the rails of the panelling now in situ. Electric cables (2m from ground level) and a bell pull (1.22m from ground level and 0.11m south of the fireplace) have been embedded in the plaster.

A black horizontal line along the plaster shows the height of earlier panelling (1.71m high) and prior to that the plaster had at least two coats of paint: grey and then white.

*Figure 7.1 Wall and fixings. Taken from the east.*

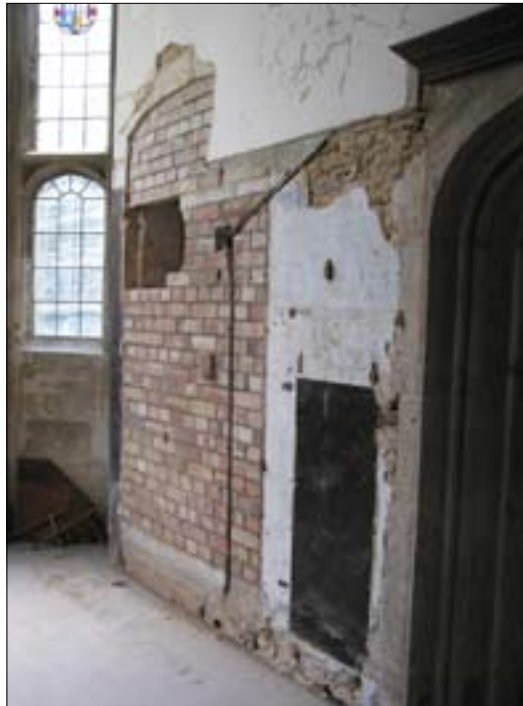
Removal of the c.1922 panelling on the south wall of the hall (to the east of the lobby (H1.09) doorway), lying within the oriel window, revealed a blocked doorway set within a coursed rubble wall with clay mortar. The doorway is particularly high. It has a stone surround, with a segmental head and plain jambs. The east jamb is formed from the quoins on the canted north-east corner of the cross-wing.

**Figure 8.1** Blocked doorway and panelling effect.  
*Taken from the north-west.*

The base of the former aperture is filled with a band of rubble (0.15m high) and above this, a stone block or step (0.17m high). A *Country Life* photograph of 1909 shows a stone step projecting in front of the rubble band, but this has been removed. Above this, the doorway has been filled with Fletton brick laid in English garden wall bond. Embedded within the brick work is modern electric cabling. The removal of part of this brickwork has revealed a rebate on the front of the east jamb in which a door

The wall to the west of the doorway is plastered and painted. An oblong, painted brown, represents the remains of a panelling scheme which can be seen in early 20th-century photographs but which was replaced c.1922. Lines around this oblong mark out the positions for the rails and stiles of the panelling that were affixed to the plaster surface, by means of wooden plugs. The east jamb of the blocked doorway is painted with a wood-grain effect similar to that of the panel.

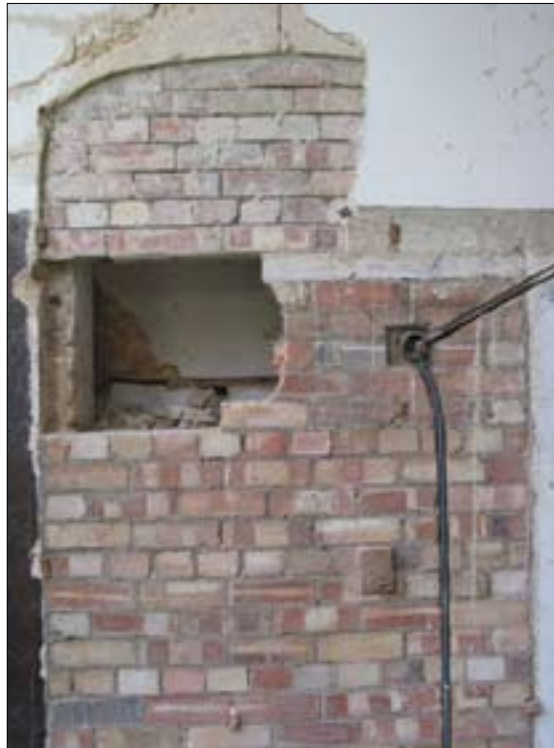
once hung. The photograph of 1909 shows the medieval door which currently hangs inside the east porch, in this position. The space (0.55m deep) behind this door was clearly used as a cupboard as there are brackets for shelving on the back wall of the recess. It does not appear to have originated as a cupboard, however, and the sloping wall on the east side of the recess suggests that it may once have contained a spiral staircase.

**Figure 8.2** *The cupboard space behind bricked up doorway.*

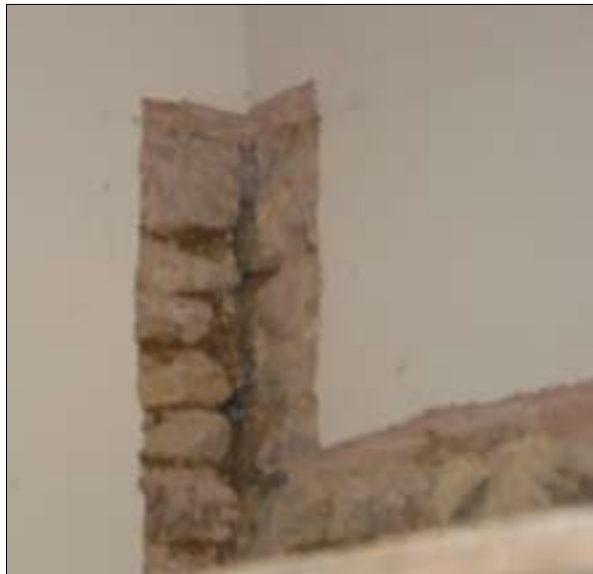
In the corner of a modern cupboard constructed in room H1.08, the plaster has been removed to reveal the join between two walls. There is a straight joint between the north wall of H1.08 (which forms a party wall with the hall) and the dividing wall of H1.07. The walls are of coursed rubble with clay mortar.

*Figure 9.1 Straight joint between two walls.  
Taken from the south.*

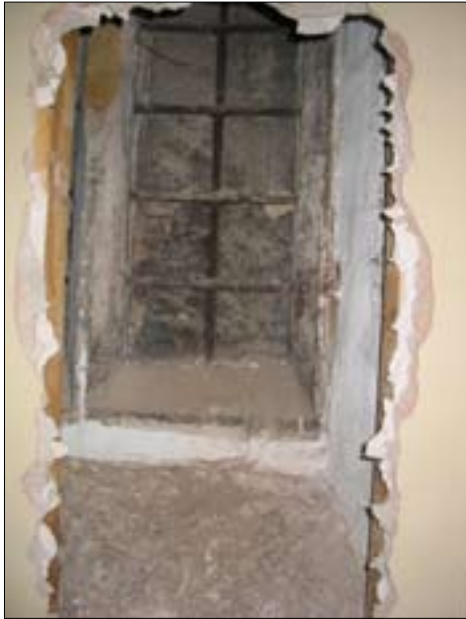
**Figure 10.1** *Blocked two-light stone mullion window. Taken from the north.*

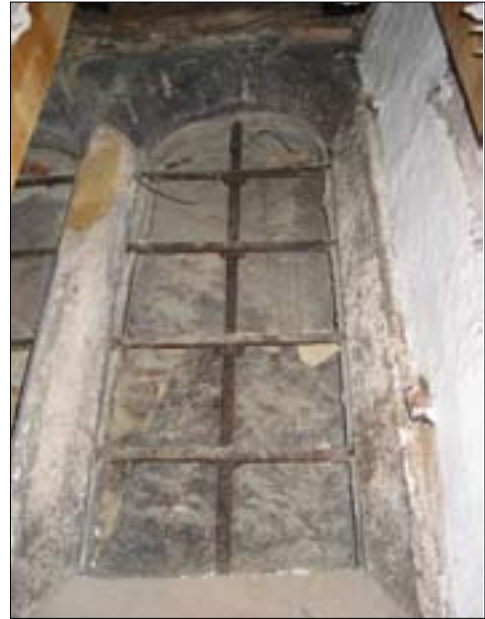
**Figure 10.2** *Detail of window.*

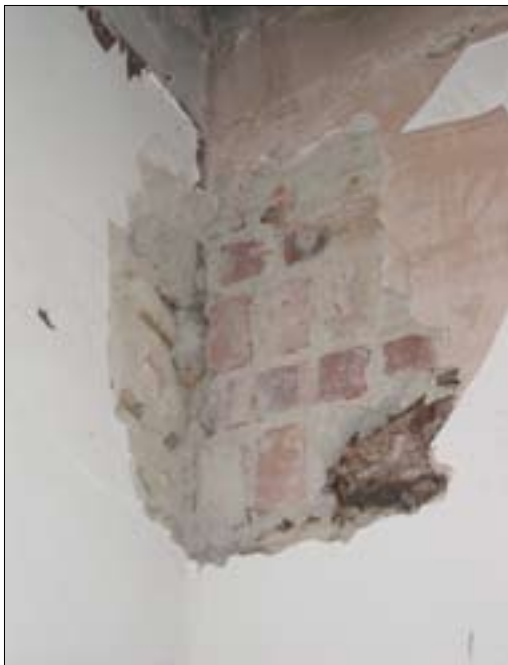
Above this there are some early 20th-century brick repairs and insertions, creating a straight joint between the south and west walls.

*Figure 14.1 Straight join between stone and brick wall. Taken from the north east.*

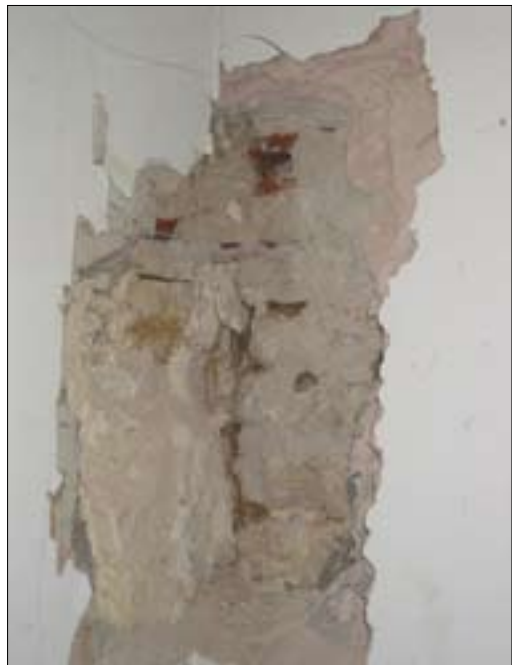
*Figure 14.2 Slate damp-course. Taken from the north east.*

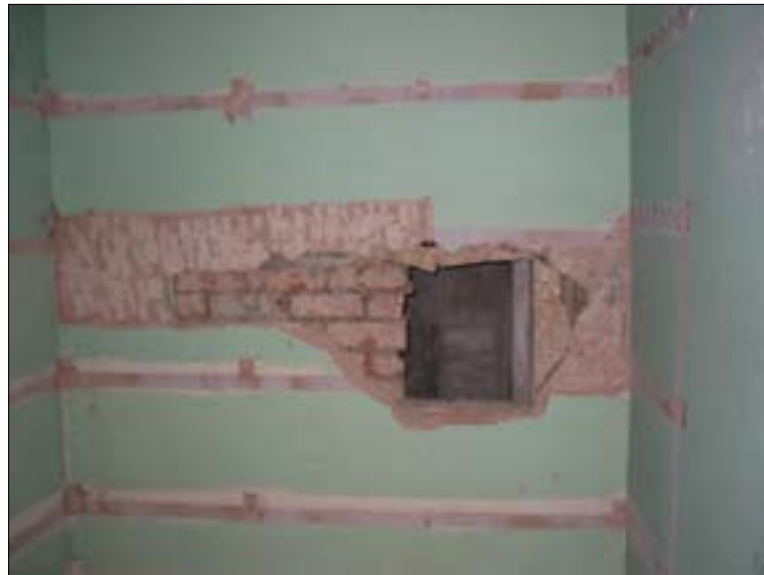
A wide fireplace, with stone on the right, but red brick on the left, has been revealed in the south wall of S1.05. Internally the bricks have been bonded with lime mortar and are blackened with smoke. Perhaps the bricks were inserted to make the fire place smaller or more central to the new smaller room. There is a stone lintel to the fireplace, but this is only visible from inside the fireplace as the whole feature was obscured by 20th-century brick infill and plaster work undertaken by the school.

*Figure 17.1 Taken from the north.*

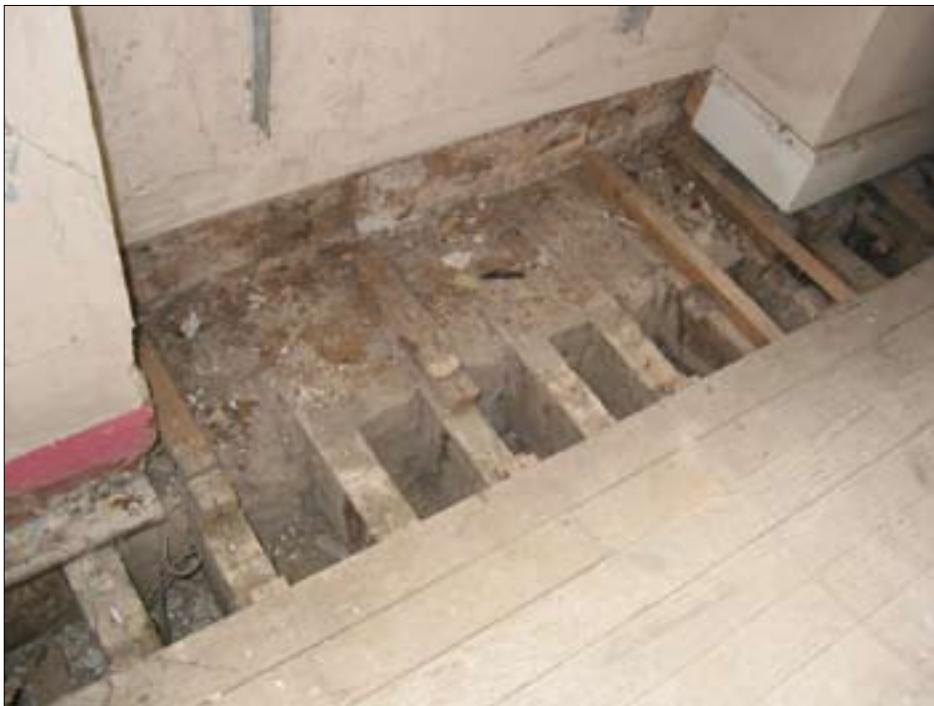
The floorboards however have been raised, and rest on a series on batons measuring 0.04m by 0.04m which have been nailed to the joists, perhaps to facilitate the insertion of wires and cables.

*Figure 20.1 Floor structure. Taken from the south.*

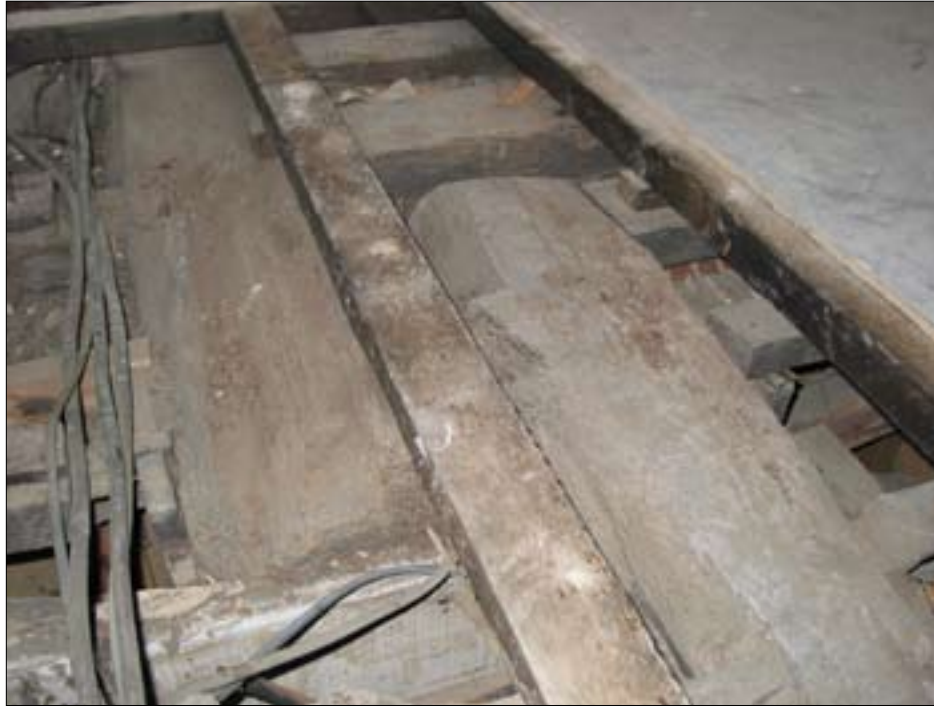
This partition wall marks the likely position of a stone wall that once also divided the Old Dining Room, and a second main beam, overlapping the first, runs parallel for 0.44m and is 3.35m long. It is 0.32m wide on average, but tails off at its northern end. This is probably a result of damp from the stone wall in which it was once embedded.

**Figure 22.2** *Overlapping main beams. Taken from the north.*

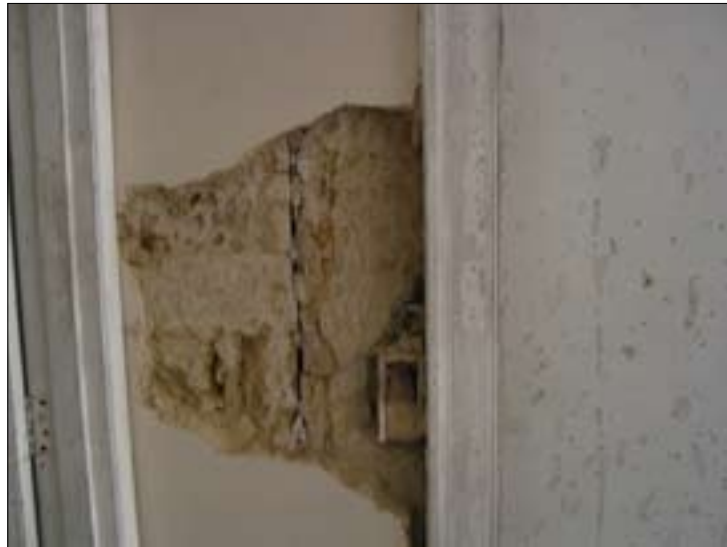
*Figure 23.1 Straight joint between ashlar quoins and rubble walling. Taken from the north.*

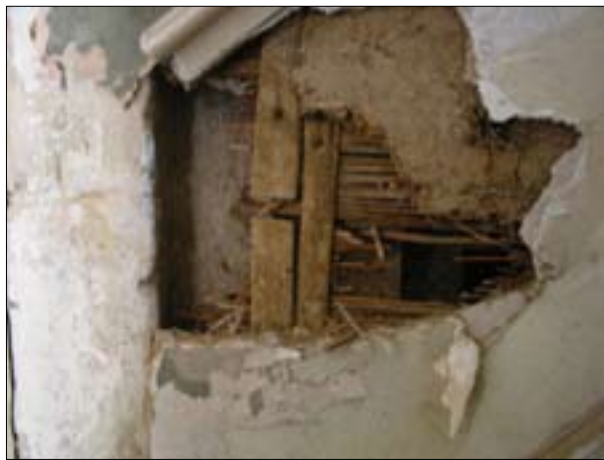
The removal of a small area of plaster in this position has revealed a door jamb which has been erected against west face of the quoin stone of a rubble wall (see No. 23).

*Figure 24.1 Stone door jamb behind lathe, reed and plaster wall.*

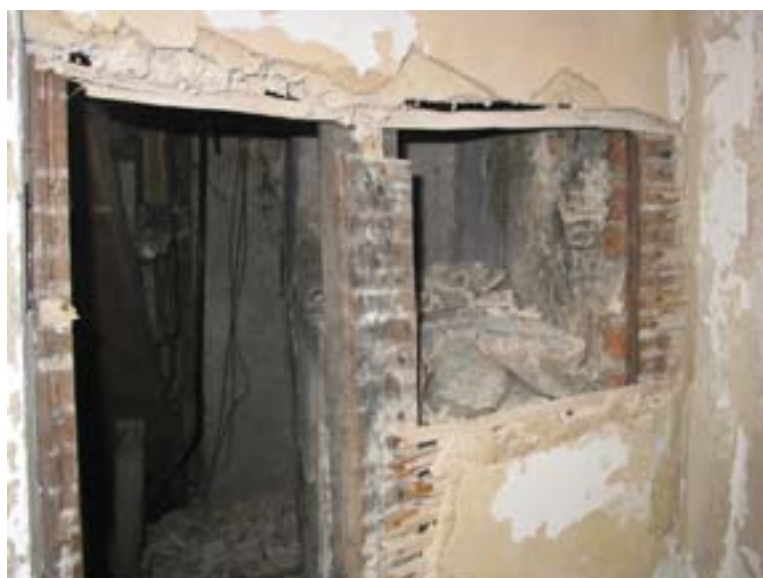
The wall incorporates a recess 0.33m deep which has been used in the past as a cupboard. The south side of the cupboard has been roughly truncated to provide access to a doorway leading on to the hall gallery: some of the 20th-century red brick later used to block this doorway is visible on this side of the wall. The surviving width of the recess is 0.67m. The sill is formed by a 1.00m long timber, located 0.63m above present floor level. Two brackets, at 1.17m and 1.63m above floor level, protrude 0.27m from the back of the recess; these probably supported shelves. Because the corners of the recess do not have ashlar quoins, this feature is likely to be secondary. The walling here has been plastered and lime-washed.

*Figure 25.1 Wall with former cupboard behind.  
Taken from the south.*

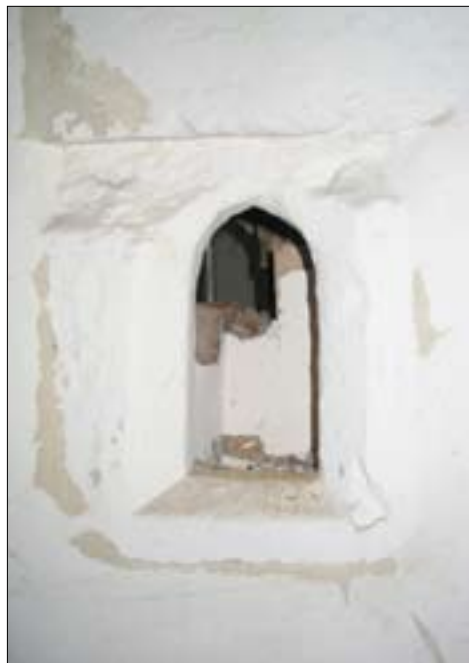
On the south side (H2.03) there is a small niche with a pointed arch stone frame that has been roughly chipped away. It is now lined with 20th-century brick, plastered and painted white, possibly during the c.1922 remodelling of the hall.

*Figure 26.1 Squint from gallery (H2.03).  
Taken from the south*

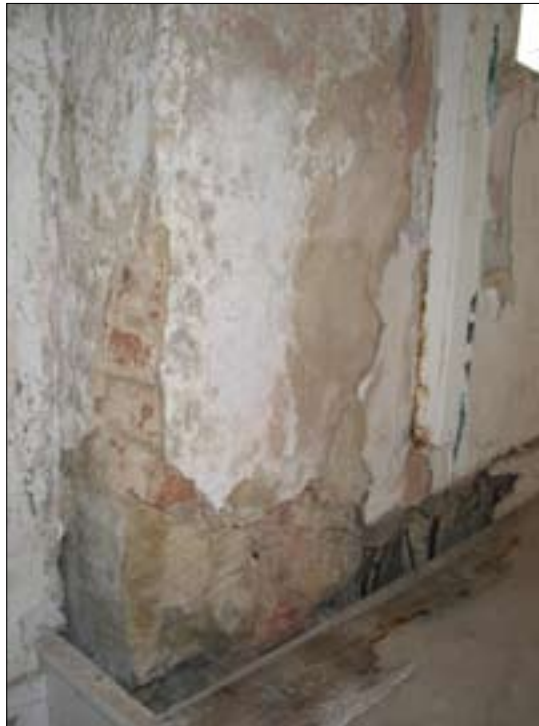
*Figure 30.1 Ashlar quoin with red brick modifications. Taken from the south-east.*

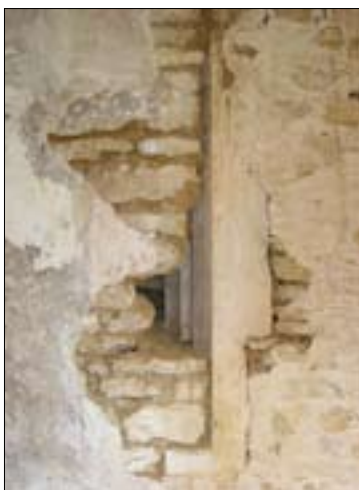
The window jamb is 0.88m from floor level. The window frame has been damaged and removed at the top to create a flat surface, for the new wall face.

Study of floor plans reveals that this is the external face of the window in the north wall of a room which was once Lady Westmorland's Bedroom (H2.11). Therefore, it is likely that the window was infilled with rubble and plastered over at the time when the matted passage was constructed in the 16th-century.

**Figure 33.1** *Blocked window.  
Taken from the north.*

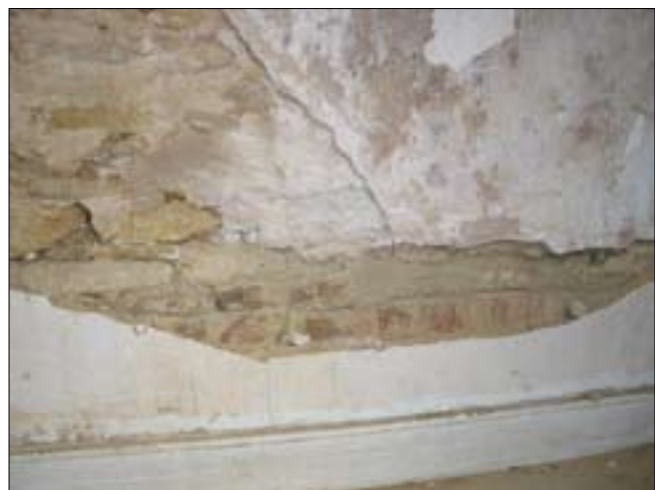
**Figure 33.2** *Brick underpinning.  
Taken from the north.*

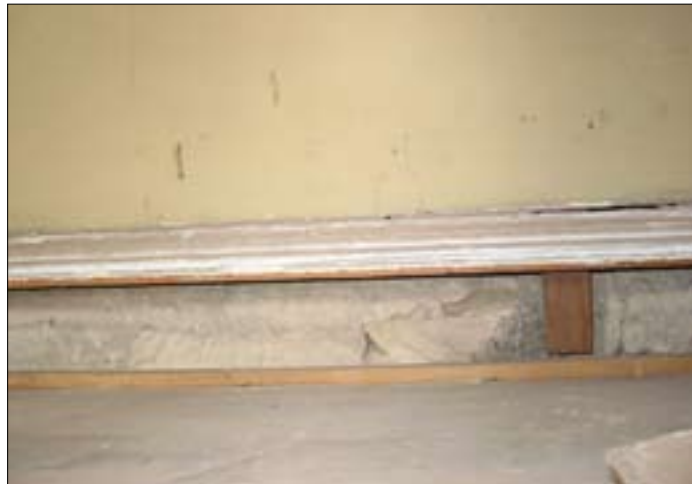
Removed skirting on the south and west walls reveal a coursed rubble wall with clay mortar and 18th-century red brick repairs by the west doorway. There is no evidence for apertures in the wall, or any other features.

*Figure 36.1 Wall surface. Taken from the east.*

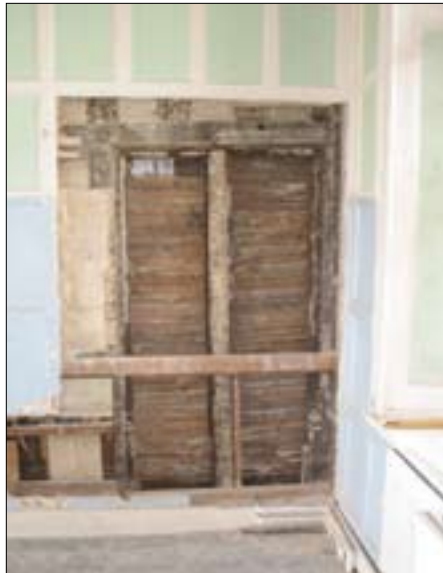
The removal of an area of 20th-century lathe and horsehair plaster panelling revealed a timber doorway of the 1622-24 type. The surround has quadrant (or ovolo) and cyma (or ogee) mouldings, and a number of nails and wooden pegs have been driven into the surface.

*Figure 38.1 Doorway to King's Chamber.  
Taken from the west.*

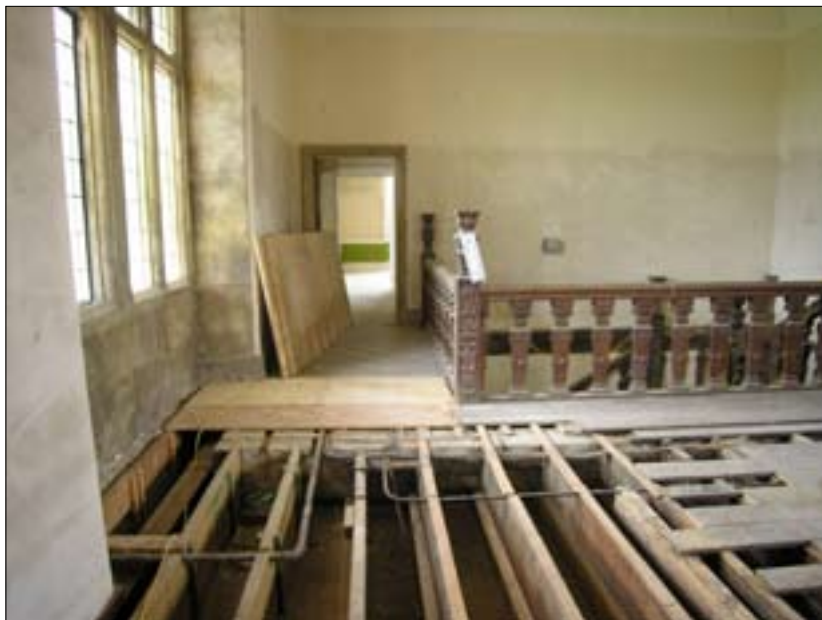
The removal of floorboards in this landing area has revealed a massive timber beam, trimmer beam and indication of the position of a newel post which is evidence of the position of the 17th -century back staircase.

*Figure 39.1 Removal of floorboards has revealed main east-west beam. Taken from the north.*

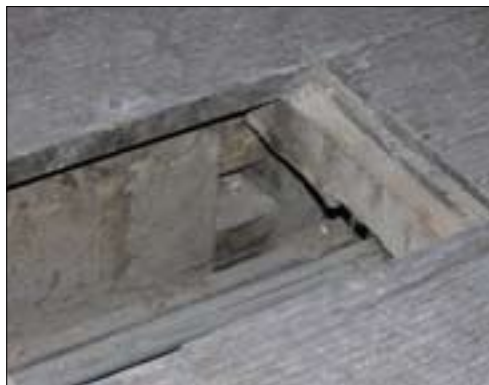
**Figure 39.3** *Detail showing construction of mortise in the wrong position. Taken from the north.*

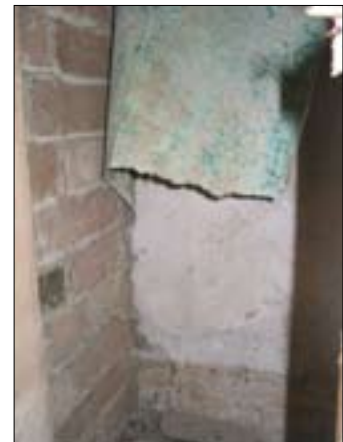
*Figure 40.2 Straight joint between brick wall of fireplace and back wall. Taken from the east.*
