An Analysis of Drying Data from a Medieval Hall after Flooding

Prepared for Historic England by
Dr Brian Ridout and Iain McCaig

2016

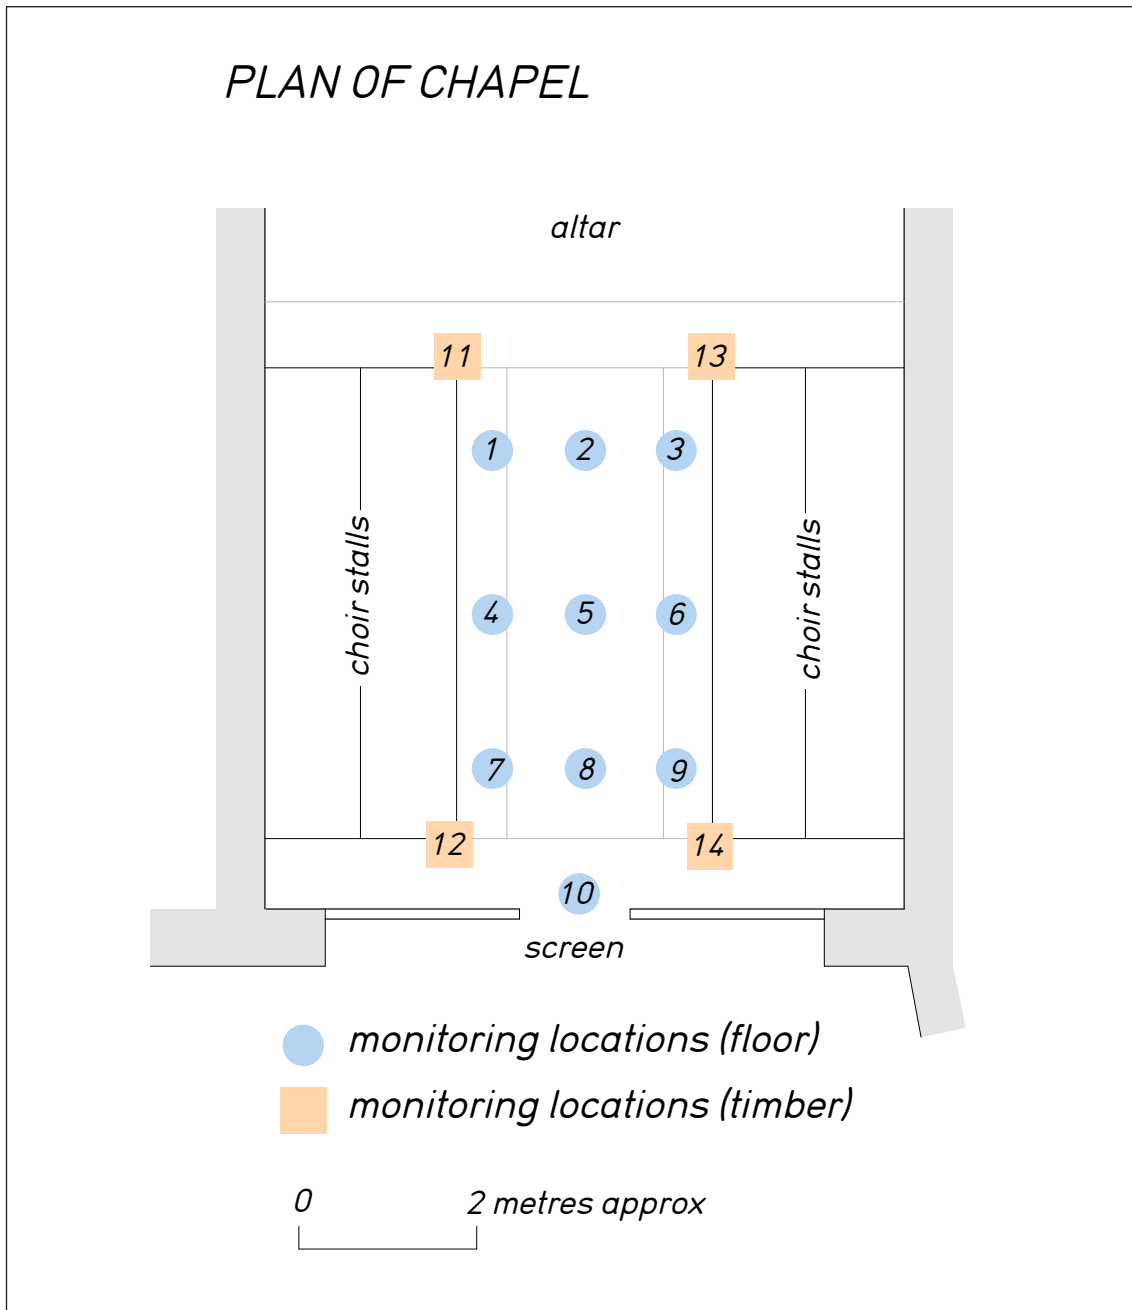
Figure 1: Plan of the chapel.

Figure 1 shows the sketch from the first Drying Sheet showing the locations where measurements were taken during each visit. Presumably the meter was placed on the floor in approximately the correct position each time, but there must be material variation. There are no indications of the heights above floor for the pew end measurement (11 to 14). Figure 2 indicates the construction.

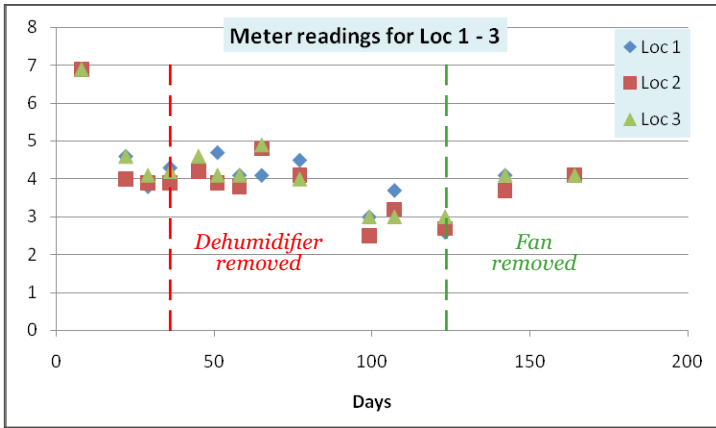
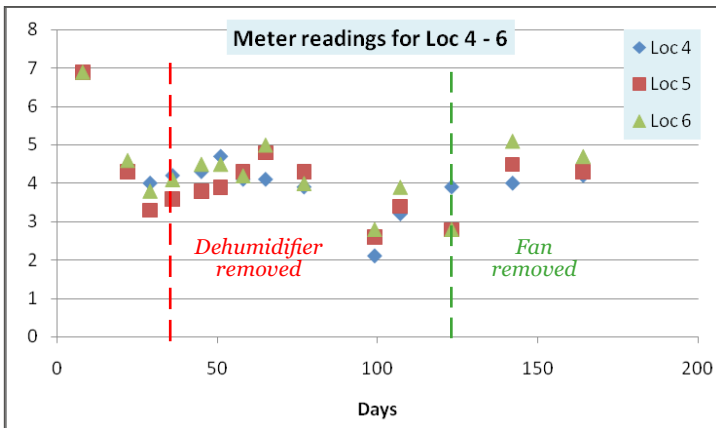
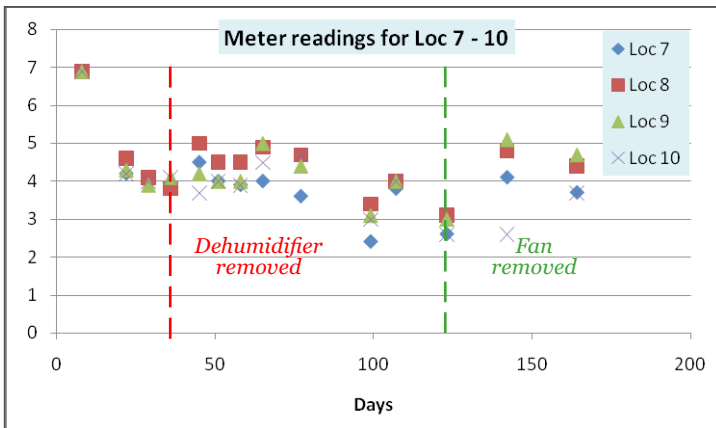
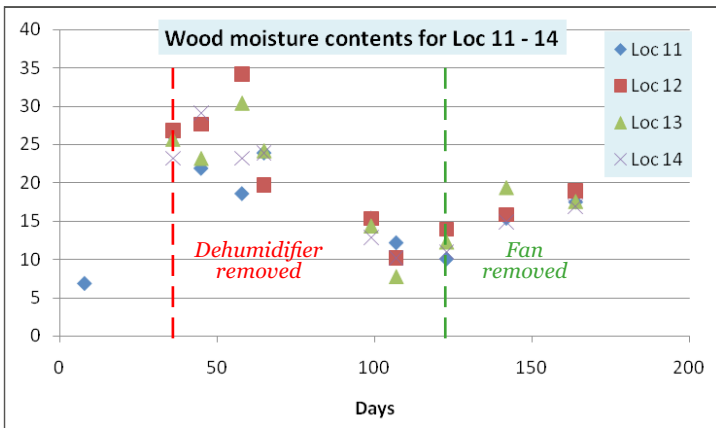
Figures 3–6: The Chapel: Meter readings from locations 1–14.

On Day 65 (21st March) the mean readings had risen to 4.6 ± 0.40 despite the fan. However readings taken when the fan was removed on Day 123 (19th May) gave 2.8 ± 0.18 . This suggests that air movement had some effect, at least at the surface, although the year was getting steadily warmer which might have an effect.

But by Day 142 (7th June) the mean had risen again to 4.2 ± 0.74 . On Day 164 (29th June) it was still 4.2 ± 0.35 , but by Day 245 (23rd September) it had risen to 4.4 ± 0.39 . This all suggests that 4.0–4.6 would be the normal readings expected from the floor and that range was obtained during the second visit on Day 22 (3rd February) when the mean was 4.4 ± 0.21 . That is 22 days after the dehumidifier and fan were installed.

The table shows the drop around Day 123, which is either caused by seasonal change (now May and so the floor was warmer) or by the laminar fan. However the same drop did not occur at the same time in the adjoining Hall where the seasonal change would have been the similar but there was no fan. It therefore seems likely that the accelerated laminar air flow caused a surface drying that was interpreted as ‘the dry point’ but the effect was lost when the fan was removed.

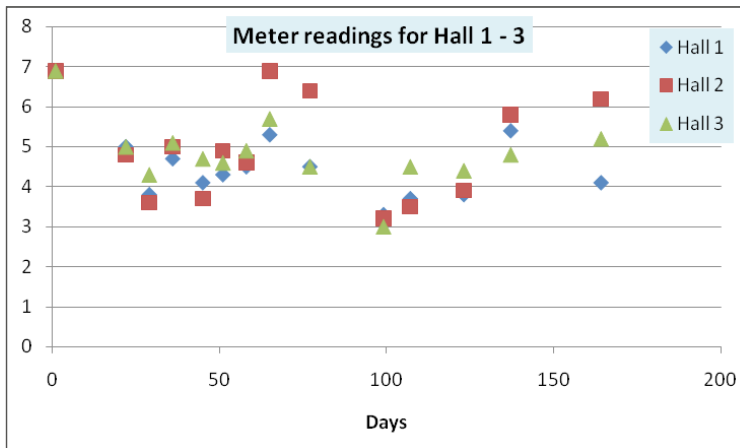
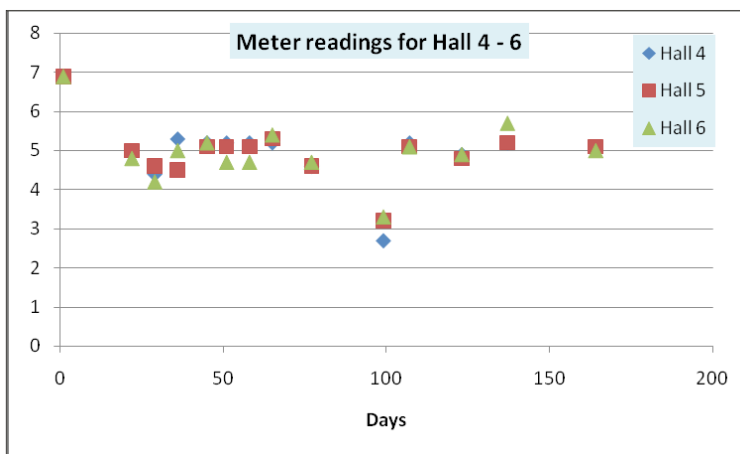
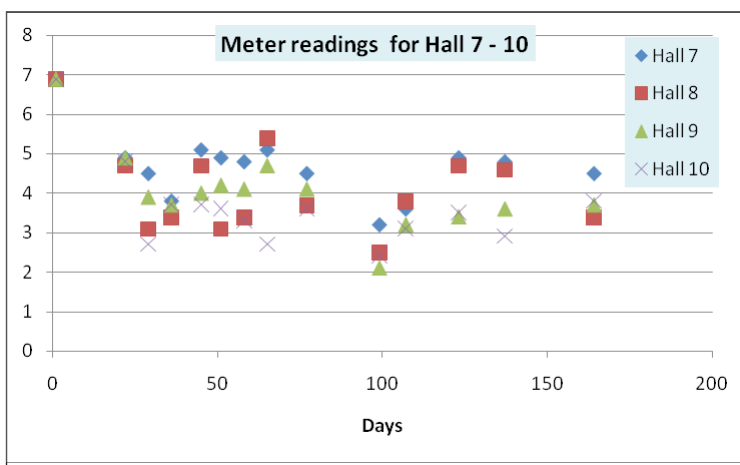
Figure 8–10: The Hall: Meter readings from locations 1–10.

The first set of readings for Hall 1–10 all start again at 6.9, which would seem to be some form of default value. A final set of readings, which could not be included in the graphs, was taken on the 23rd September (Day 253). The following table compares results from the beginning of the monitoring period with the end (shown in red).

The mean of the meter readings taken from the floor flag stones (Hall 1–10) on Day 23 was 4.9 ± 0.11 . After 230 days using 6 -8 dehumidifiers the mean was 4.9 ± 0.76 .

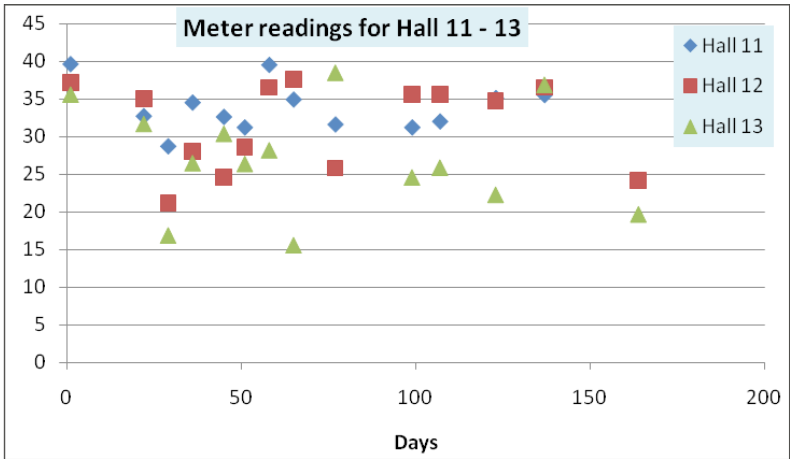
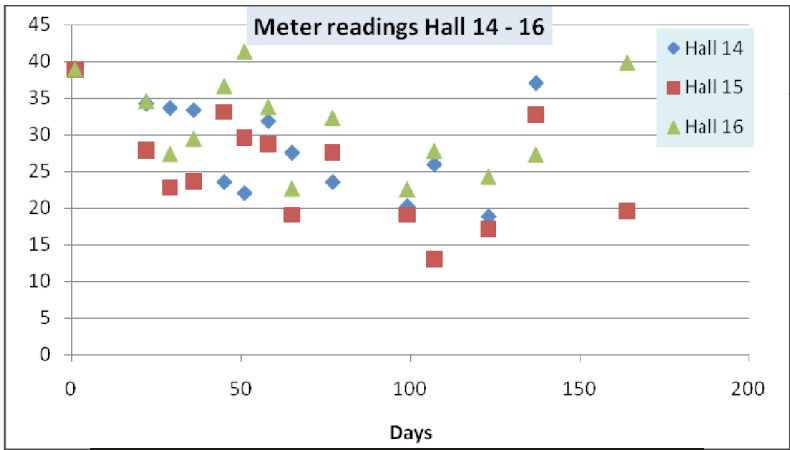
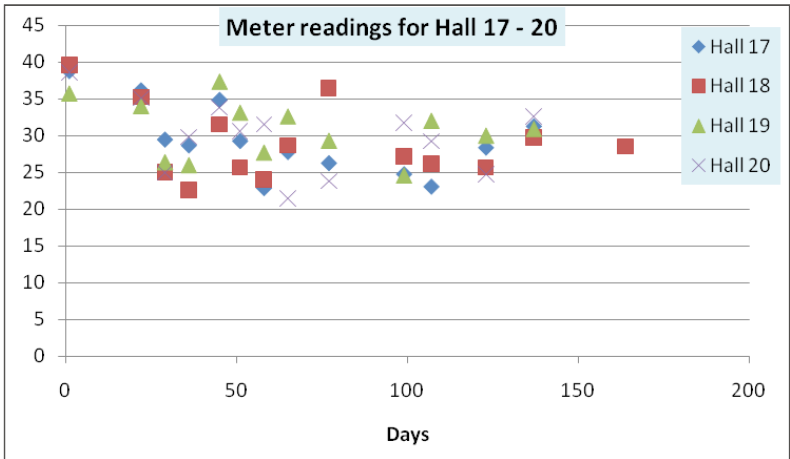
Figures 11–13: The Hall: Meter readings from locations 11–20.

Wall measurements taken from brick (apparently 1 ft above the floor according to the data sheets) are much higher and may be ‘wood moisture equivalents’. The starting mean (Hall 11–20) was 33.6 ± 2.50 and by Day 230 it had dropped to 30.3 ± 4.17 . If this does represent moisture then the drop would be insignificant.

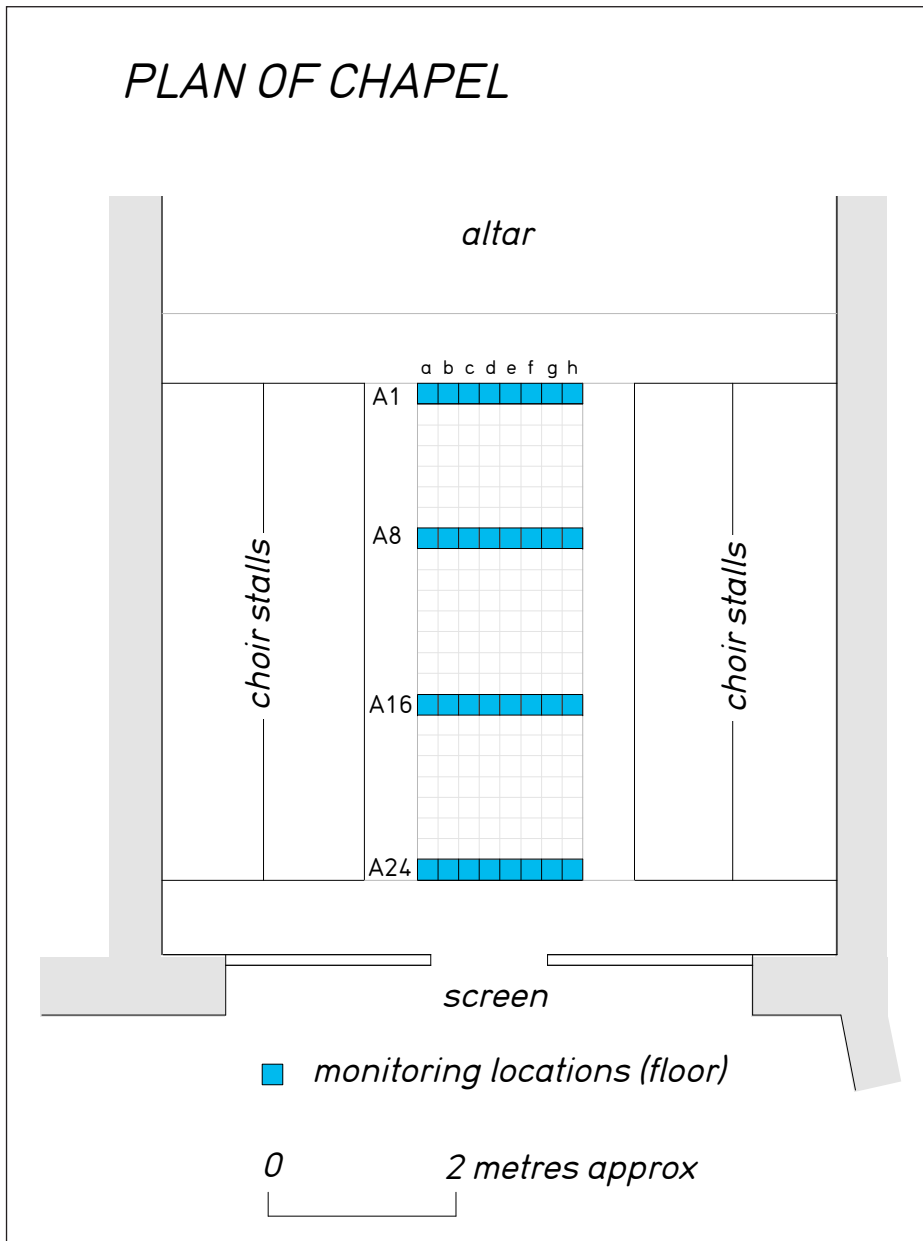
Figure 14: Measuring locations on the tile floor of the chapel.

Some individual tiles (eg A1a & A8g) give variable readings depending on surface coarseness, but the means from the width of the chapel (a to h) and its length (A1 –A24) are so similar that moisture distribution can be considered uniform with no gradients. The mean for the entire data set was 5.6 ± 0.88 ($n = 96$). The drying company results may be compared with this statistic, which is generally a little higher than the readings they obtained. Some of this may be basic instrument variation.

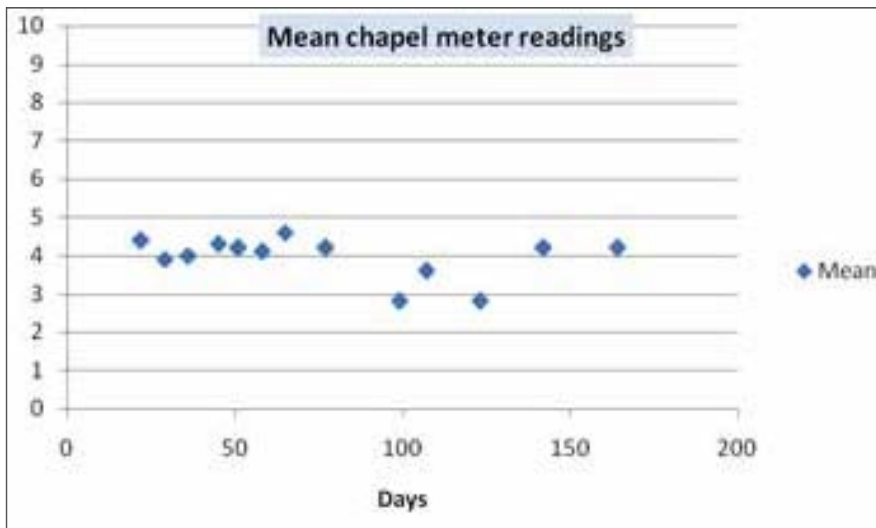
Figure 15: The Chapel: Mean meter readings.

The table and the graph show that the tiles were dry at the time the first set of readings were taken. The fan had a surface effect and dropped the readings a little around day 120, but they increased again when the fan was removed.

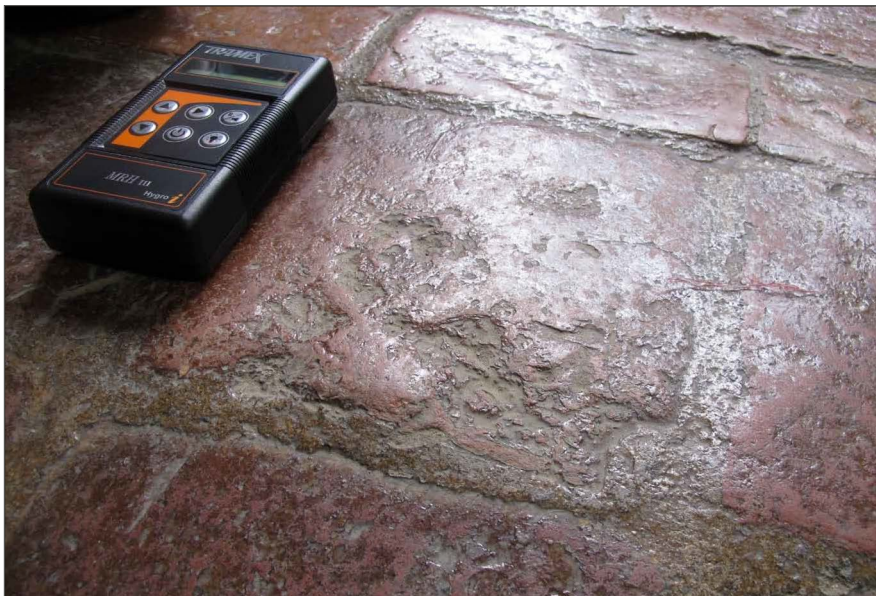
Figure 16: Readings were affected by surface coarseness.

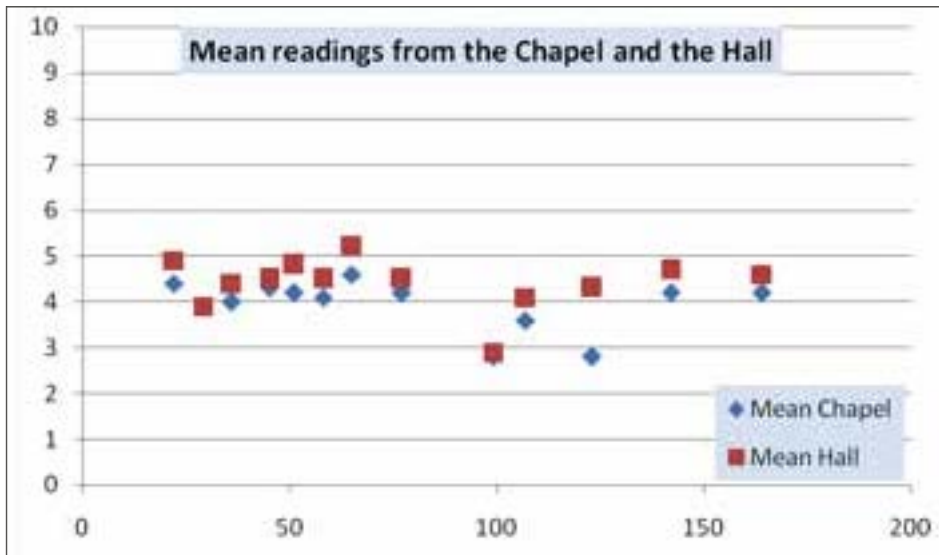
Figure 18: The Chapel and the Hall: Mean meter readings.

The graph of these mean values is so similar in outline to the graph from the chapel that there may be meter user variation at each visit - the monitoring sheets bear the initials eleven different surveyors. We found that the capacitance readings obtained depended on the pressure applied to the meter. We positioned the meter under its own weight, but if it was held at the surface or held down then there was a significant reduction or increase in the readings. Method standardisation is evidently essential.

This analysis does indicate the need to turn off the equipment after a few days and allow the building to equilibrate so that the moisture being drawn from the structure can be evaluated. It also suggests that the method used to take the readings must be standardised.
