A Preliminary Study of Flood Remediation in Hebden Bridge and Appleby

Prepared for Historic England by
Dr Brian Ridout, Chris Wood and Iain McCaig

This report presents some preliminary findings of site visits to properties in Hebden Bridge, West Yorkshire, and Appleby-in-Westmorland, Cumbria, ten months after the severe flooding that occurred in December 2015. The purpose of the visits was to investigate different responses and remediation methods, and assess how successful they have been.

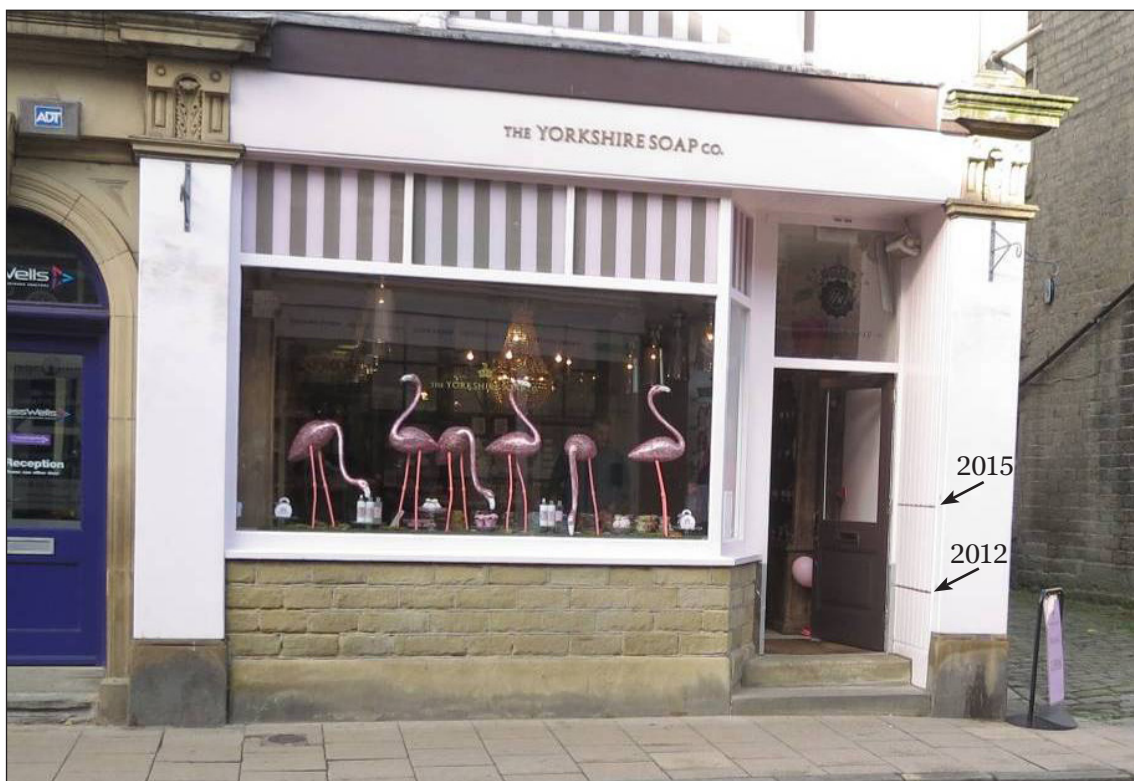
Flooding occurred on 26th December 2015. An idea of the depth of water is gained from a marker on the wall of the Yorkshire Soap Co shop (indicated by the arrows in the image below). The lower mark was the height of the previous flood water and was used to select the height of flood barriers. Unfortunately barriers that were supposed to keep water out helped to keep it in when water went over the top.

Figure 1: Shop front in Hebden Bridge showing levels reached by flood water in 2012 and 2015.

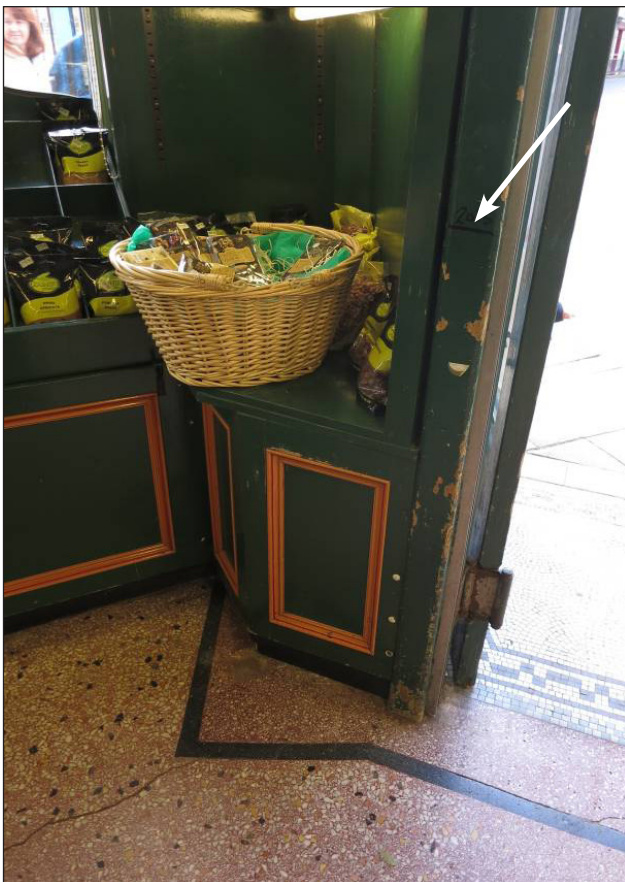
1m (indicated by arrow in Figure 3).

Figure 3: Arrow indicates the approximate depth of water above ground floor level.

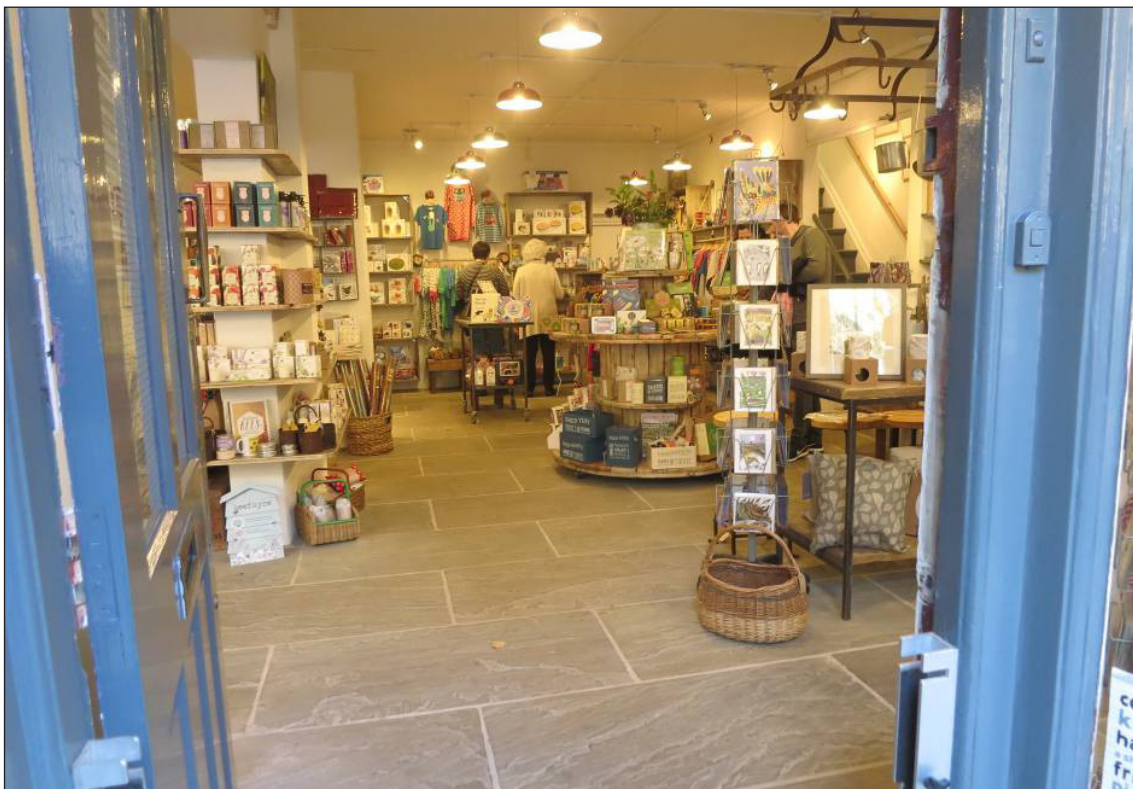
Figure 6: The timber floor was removed and replaced with stone flags.

Professional drying. Heaters and dehumidifiers used. The timber floor was removed and replaced with stone flags on a concrete slab (Figure 6) and plaster was hacked from the walls to a height of 1.5m.
