The Use of Multi-Image Photogrammetry to Record At-Risk Archaeological Material from the Wreck of *Invincible*

Dan Pascoe, Ben Jones and Grant Cox

**PROJECT REPORT
2017**

Ref: 7235

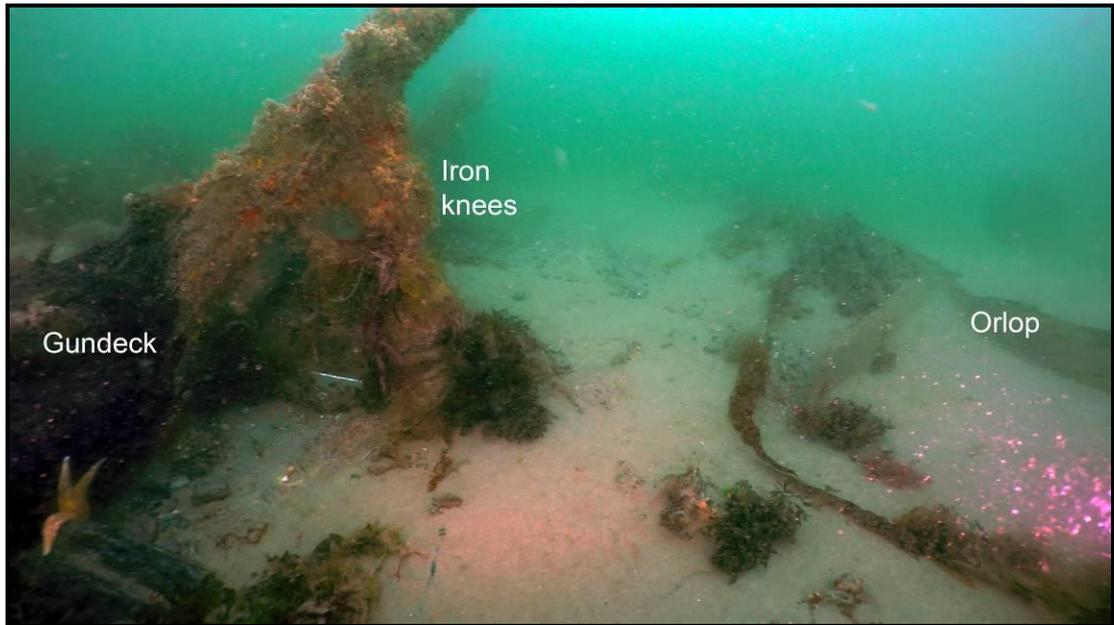
- 5.2.1. This area extends from the very point of the bow back to the third gunport and down to the floor of the hold. In this area, the entire remains of the gundeck are exposed. Below the remains of the gundeck are three upstanding iron knees, below which is the orlop. The space between the knees and deck beams of the orlop has been scoured exposing more of the ship's cable and a pine-clad deck. There is a 10m exposed section of the orlop consisting of the tops of deck beams, half beams and sections of deck planking clad with pine. Lying on top of much of the orlop are piles of cable (Figure 2-4).

Figure 2: View looking NW between gundeck and orlop © PAS.

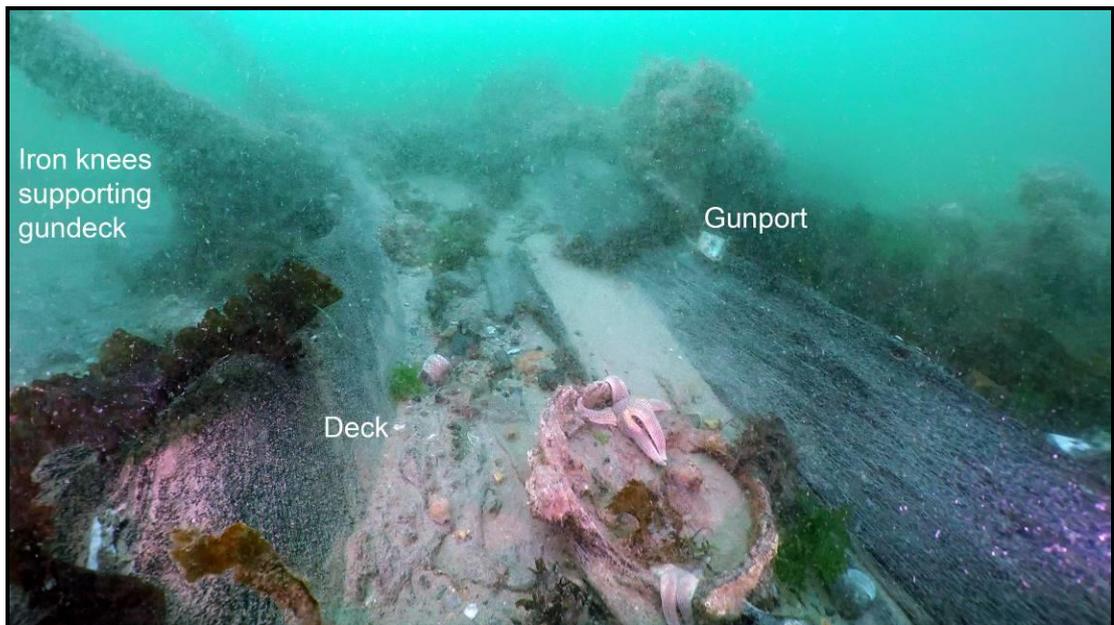
Figure 3: View looking SE along gundeck © PAS

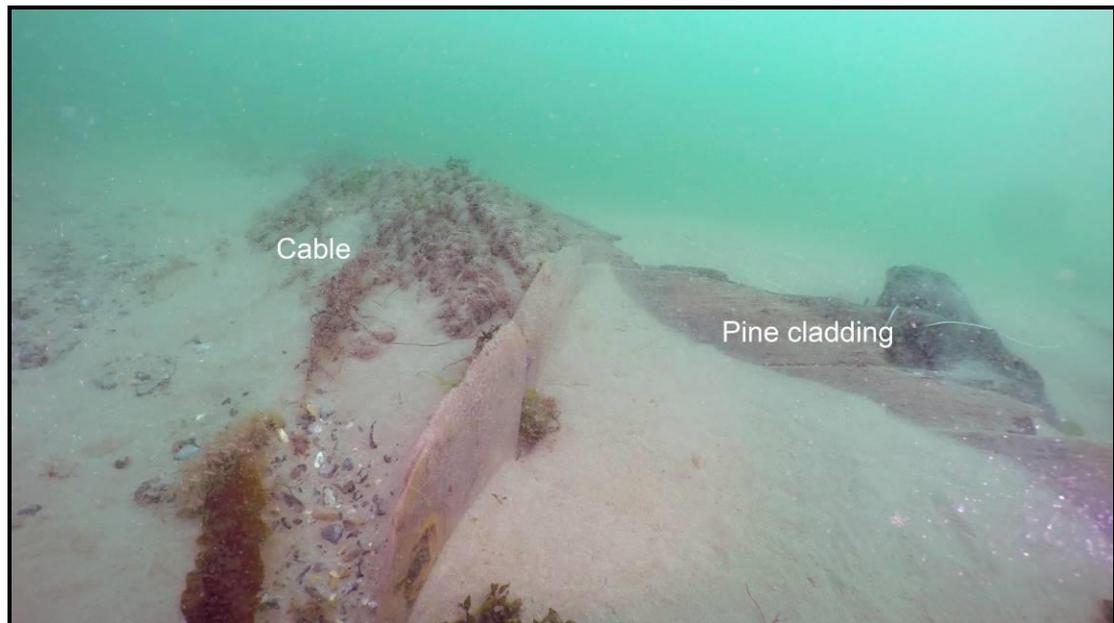
Figure 4: View looking North with cable lying on the pine clad orlop © PAS

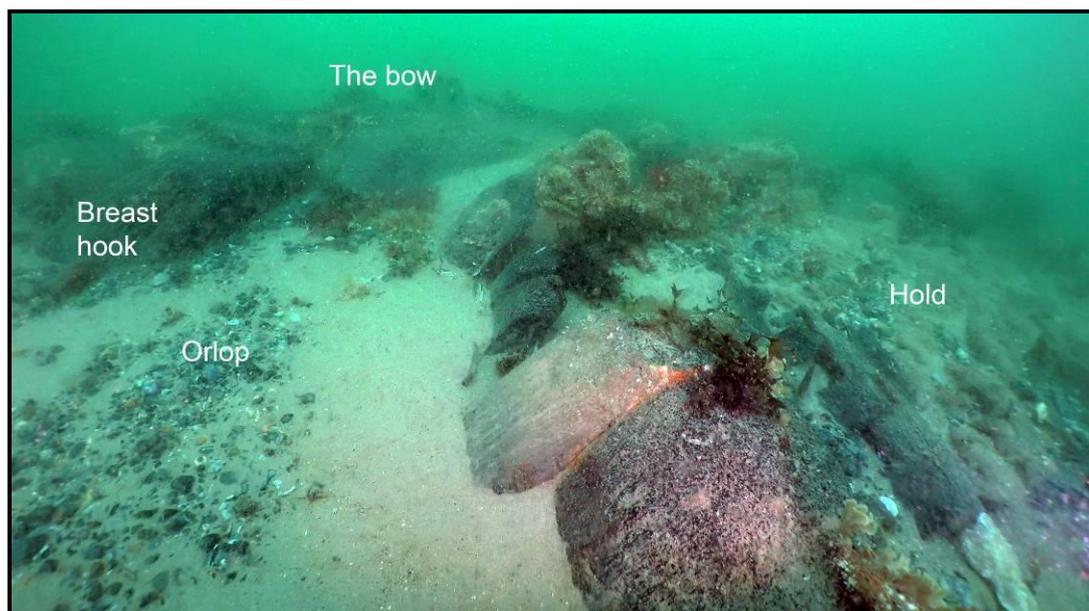
- 5.2.1. Towards the forward-most part of the bow, structural features of the orlop and internal structures and artefacts within the hold are exposed. Immediately below a section of exposed deck and half beams of the orlop are the remains of a compartment or shelving structure (Figures 5-6). Below this is an area of ship's cable and a partial barrel that have all been exposed since 2011. Although the cable and barrel have been observed for a number of years, the internal structures have only recently become clear. The height of exposure of the deck and half beams from the orlop has increased by 150mm. This would explain the recent exposure of the internal structures immediately below.

Figure 5: View looking NW towards the bow with the orlop deck and half beams aligned through the centre of the image © PAS

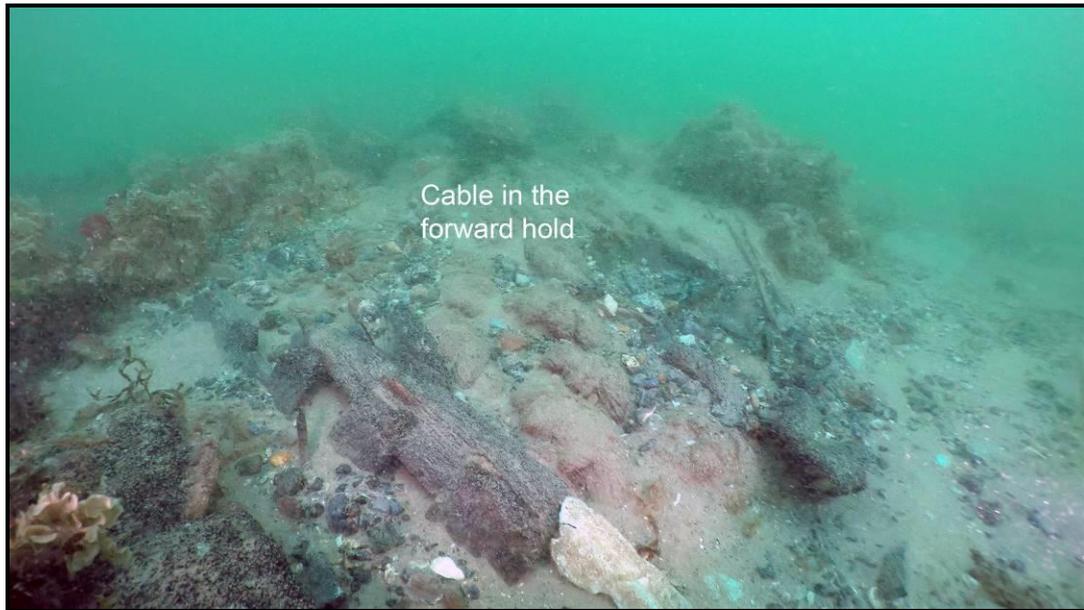
Figure 6: View looking North from orlop into the forward hold. Note the slighter constructed internal structures above a bundle of cable © PAS.

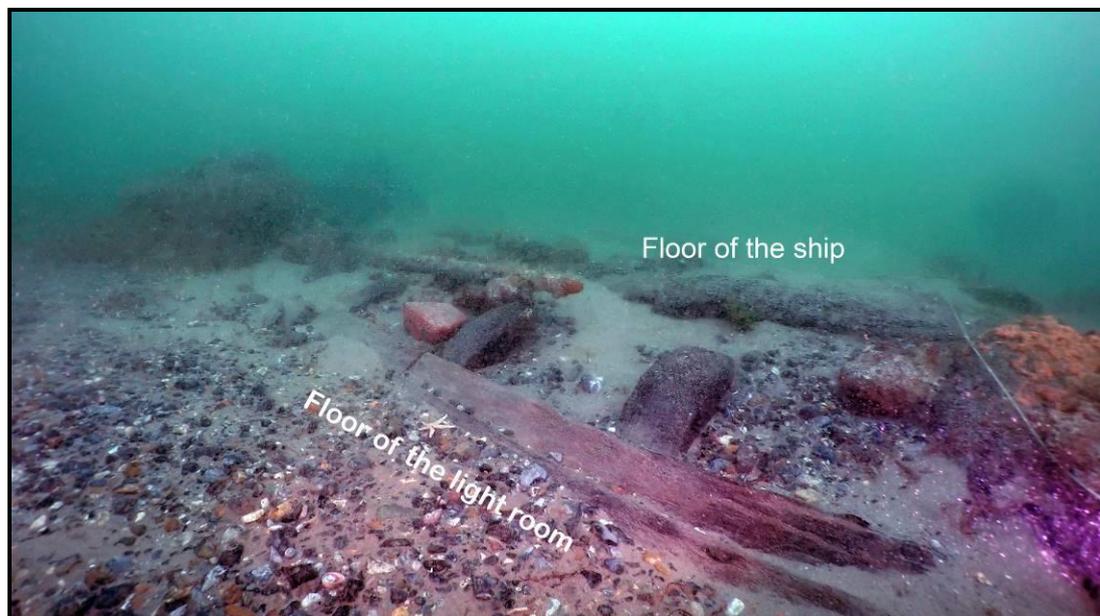
- 5.2.1. At the bottom of the forward hold are exposed floor timbers and futtocks and immediately above these large timbers are the remains of frames and planking of a slighter construction. These most likely represent the floor of a storeroom which was suspended above the ceiling of the hold (Figures 7-9).
- 5.2.2. From studying the internal forward plan of *Invincible* in Bingeman's 2010 publication following her major refit in 1752-56, this internal structure could be related to the light room or filling room (Figure 7). Above the light room and filling room was the gunner's store. On the seabed, scattered on the planks of this floor structure, are musket shot, probably originating from the gunner's store.

Figure 8: Internal floor of a compartment above the ceiling of the forward hold, possibly the light room © PAS

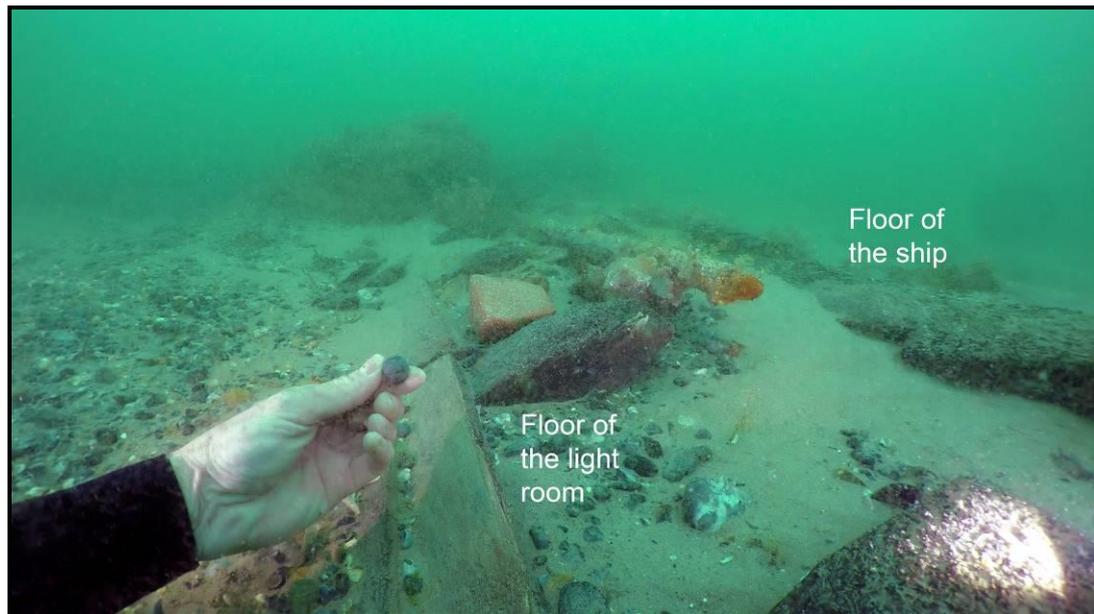
Figure 9: View looking NW, scattering of musket shot on the floor of a forward compartment, possibly the light room © PAS.

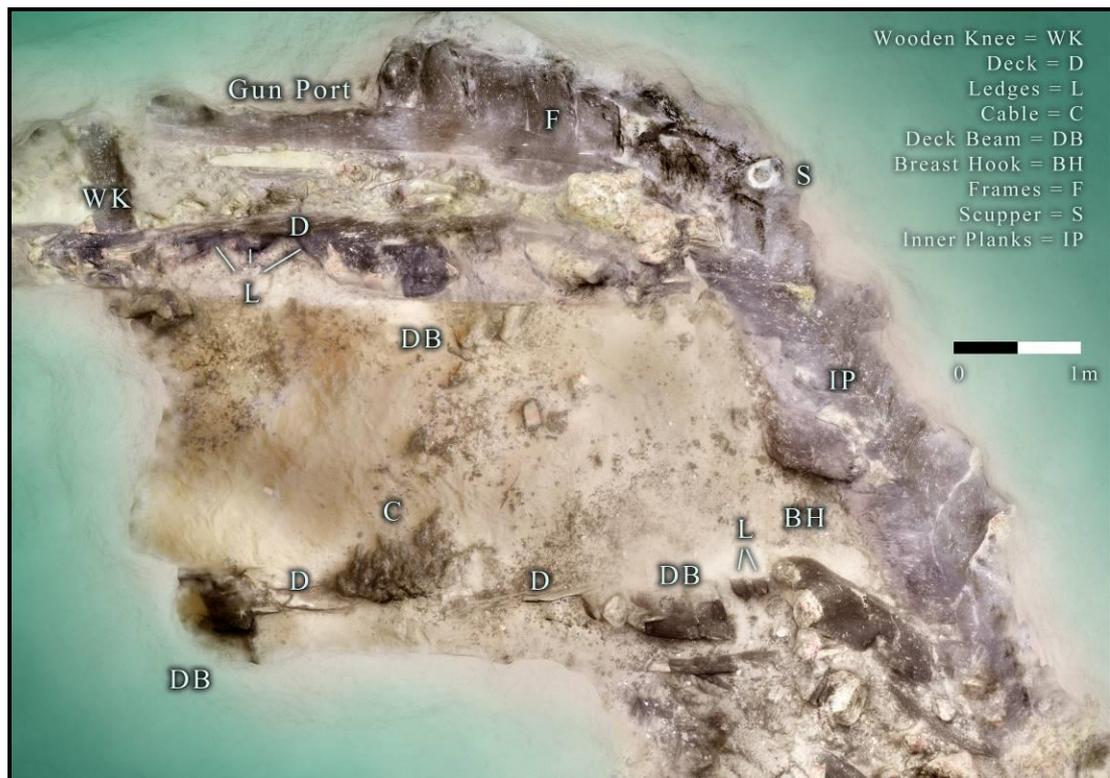
- 5.2.6. Figures 13 and 14 are close-up images from the photogrammetry model of Area 1, which focus on the exposed remains of the gundeck and orlop. Identified in these images are features that relate to the remains of the most forward gun station on the gundeck and a section of the orlop immediately below.
- 5.2.7. The gun station can be identified by the gap in the frames, which represents the location of the gunport. Immediately aft of the gunport are the remains of a hanging wooden knee. Below the gunport are the remains of the deck, which can be seen to be supported by ledges and deck beams. The deck only survives 0.5m out from the

side of the hull. Forward of the gunport the frames are clear to see, which are constructed and fastened in pairs. There are two lead scuppers at the end of the gundeck. One can be clearly seen lying in the sand just outside the frames. The other is still in its original location between the frames.

Figure 13: Close-up view of the forward gundeck and orlop © PAS.

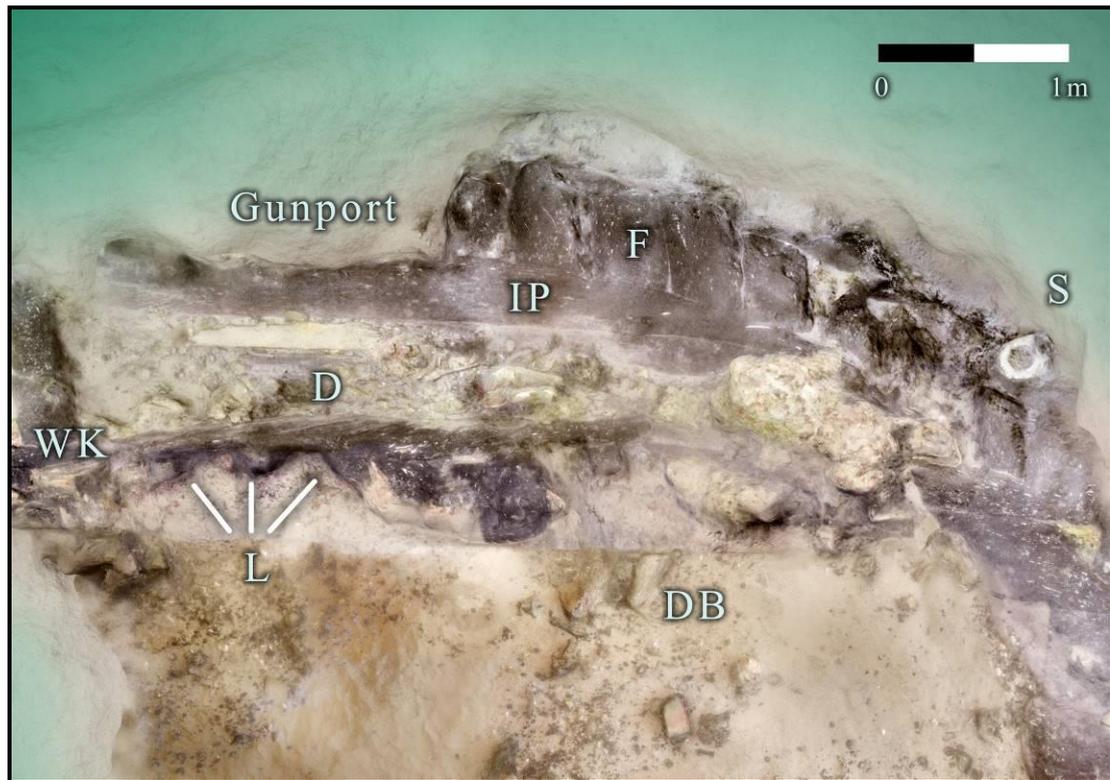
Figure 14: Close-up view of the forward most gun station (see annotations from Figure 11) © PAS.

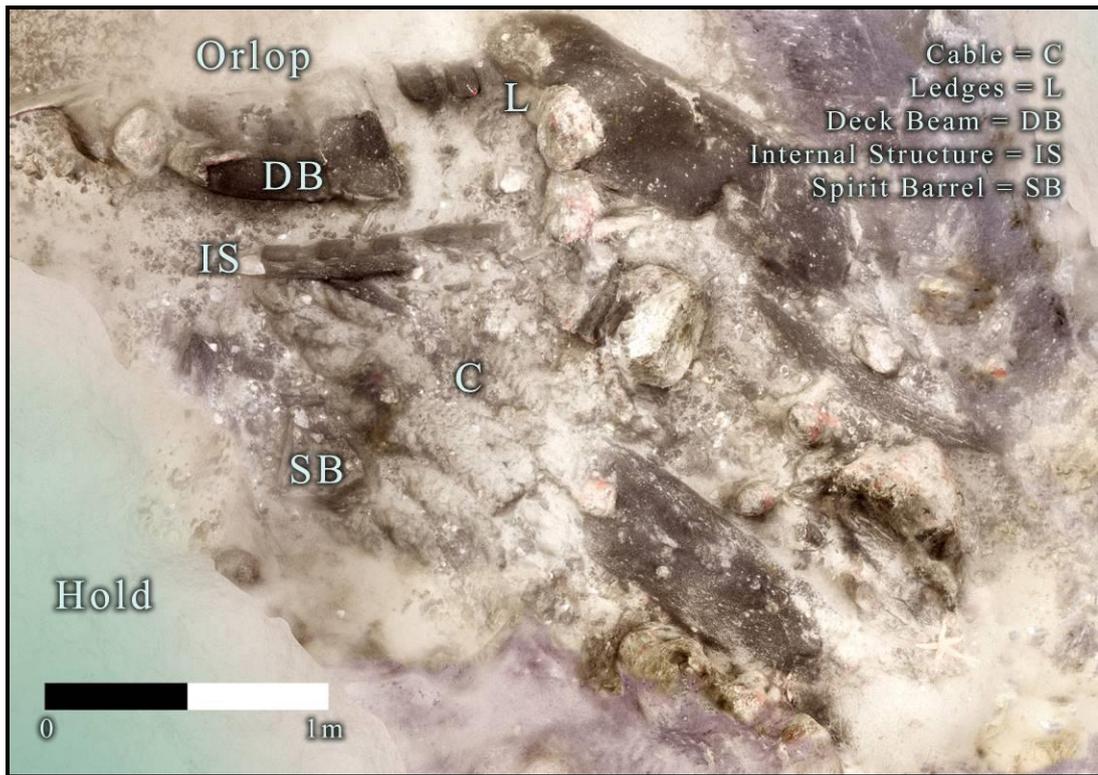
- 5.2.9. Figure 15 is a close-up view of a section of the forward hold. Within it is a jumble of cable and the remains of a spirit barrel. It is also possible to identify a section of an internal structure just below the beams and ledges of the orlop, which can also be seen in Figures 5 and 6. Looking closely, it is also possible to see that some sections of cable are served. This means the cable has been wrapped with a smaller gauge of rope which acts as protection against wearing and chaffing.

Figure 15: Close-up view of the forward hold immediately below the orlop © PAS.

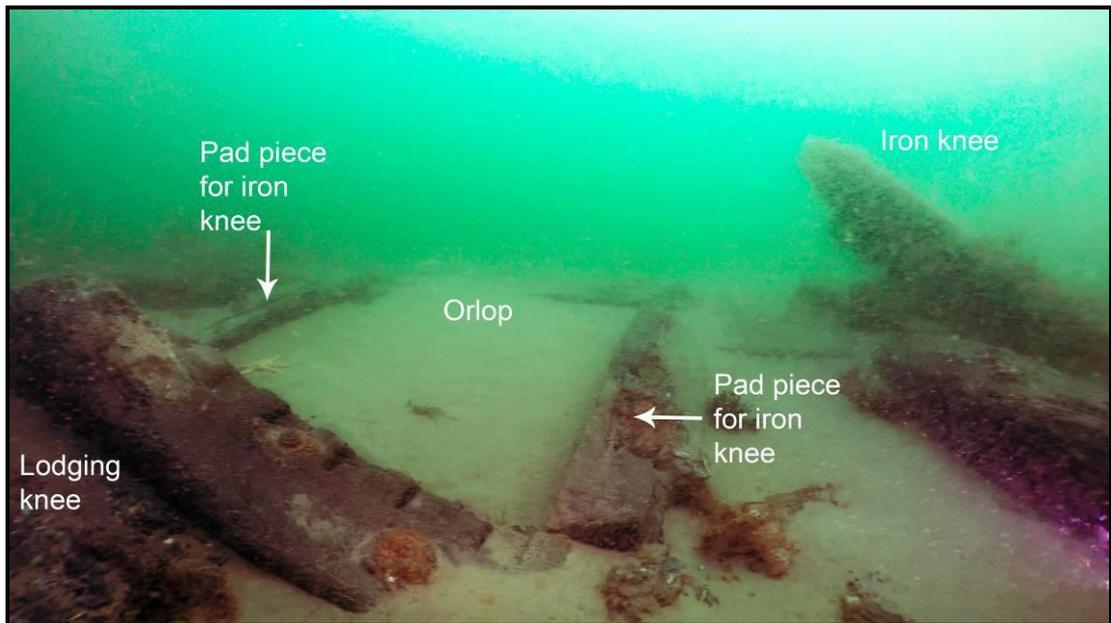
- 5.3.2. Further exposure over the winter led to the identification of structural features relating to the support of the decks. An in-situ lodging knee marks the line between the hold and the orlop. Above each end of the lodging knee is a section of deadwood known as an oak pad piece. This is where the iron knees were counter sunk into the pad piece and then bolted through the hull (Figures 16-18). The iron knees are missing from this particular location but there are a number surviving in locations either side. Although some iron knees have survived they are no longer in the upright position as found in Area 1 of the coherent port bow.

Figure 17: Exposed section of the orlop within Area 3, showing lodging knee and pad pieces © PAS.

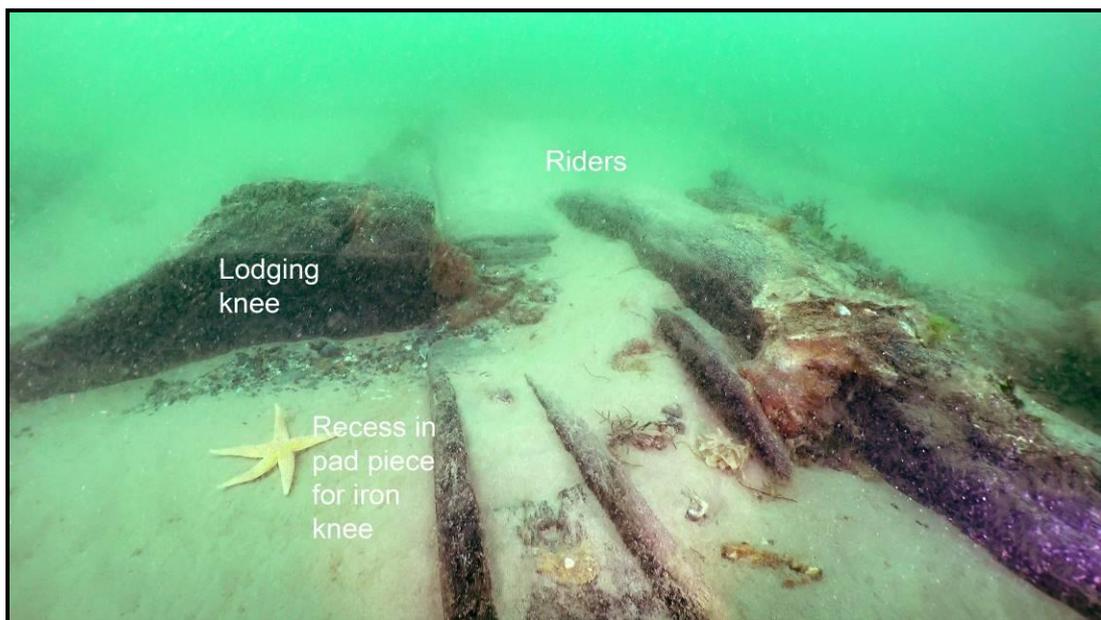
Figure 18: Close-up view of the recess in the pad piece for the iron knee © PAS.

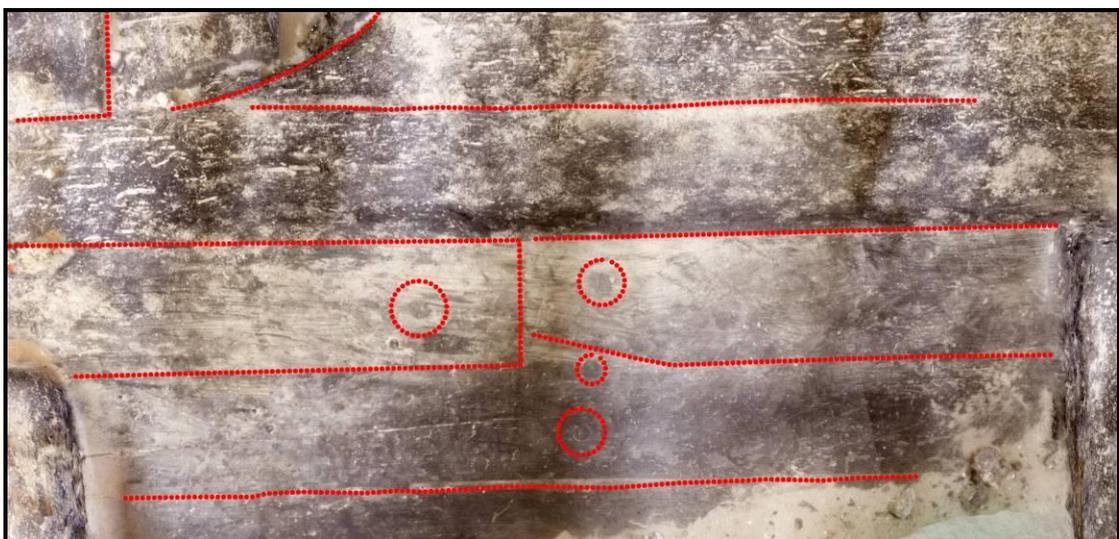
- 5.3.1. Immediately below the riders are the ceiling planks, which are exposed at the west end of the riders. The planks have been fastened to the frames below using wooden treenails. The high-resolution renders provide an immense amount of detail, allowing for the visibility of very small details like treenails, plank joints, biological damage and even wood grain (Figure 21).
- 5.3.2. In Figure 21 it is possible to identify the planks that had only recently become exposed against the planks that had been exposed for some time. The planks immediately to the west of the ends of the riders are heavily eroded by marine borers. This is clearly evident from the white calcareous tunnels left behind by the borer. The planks immediately below the riders are smooth with pristine surfaces.

Figure 21: Close-up of a section of exposed planking in Area 3 © PAS.

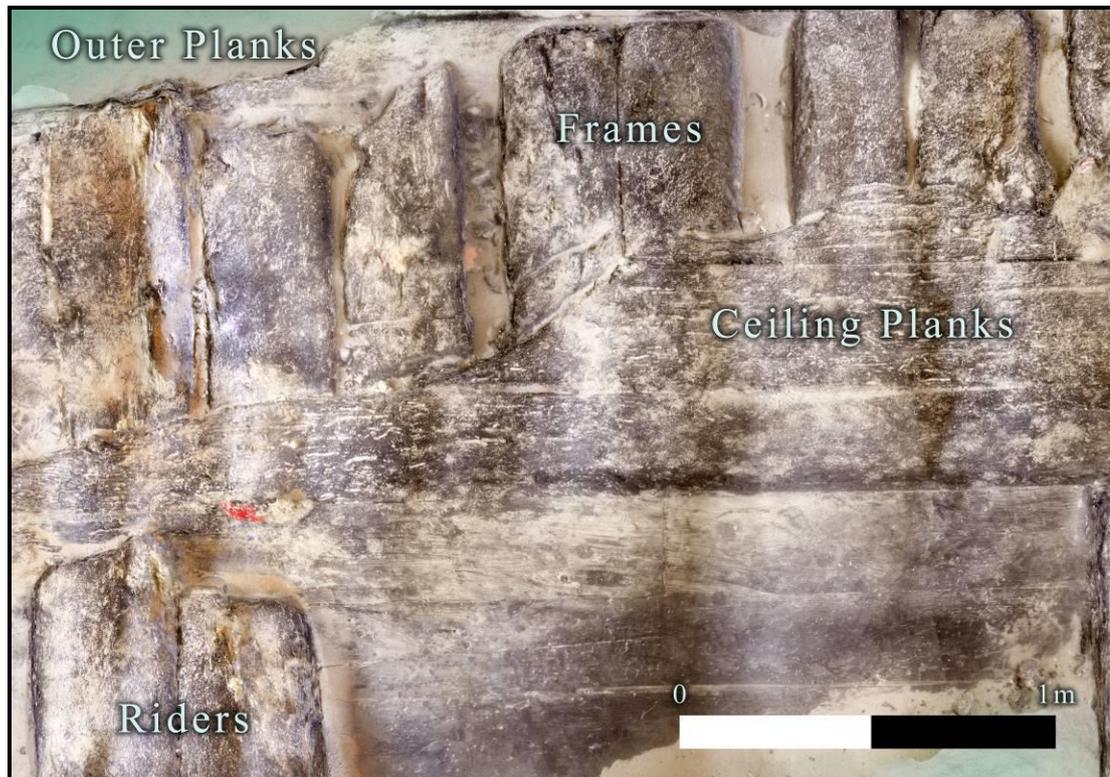
- 5.3.3. The photogrammetry survey also clearly shows the framing pattern in the construction of *Invincible*. She has been constructed with frames fastened in pairs followed by a space before the next pair. The model identifies that the space between the frames is not always uniform (Figures 19, 20 and 22).
- 5.3.4. Where the frames join is also obvious and it is clear to see from the model that this section of the starboard side broke at the joins of the framing timbers (Figure 22), which was a clear weak point.

Figure 22: Close-up showing framing pattern and joint lines where frames are joined together © PAS.

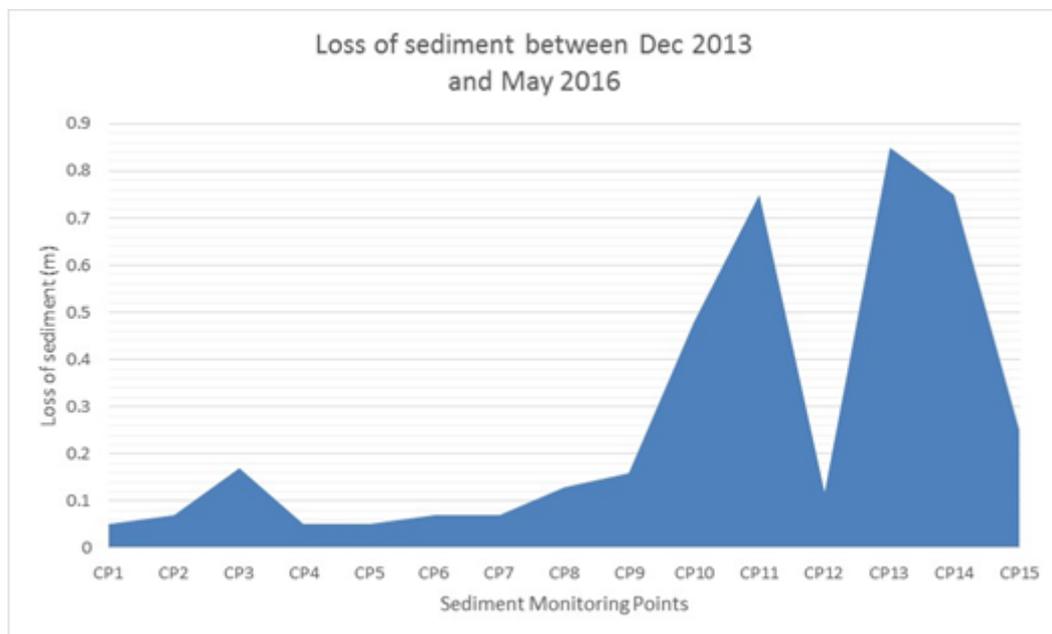
- 6.1.1. Monitoring of the sand levels has revealed that the site has not recovered from the 2014 storms and further reductions in sediments are still occurring, most noticeably in the northern areas (Figure 27). On the western edge (out-board) of the main site from CP1 to CP6 there has been an average loss of sediment of 0.08m. However, the recording of the height above the seabed and the extent of newly exposed structures and artefacts within the hull of the main site (inboard) have revealed a much greater loss. The reduction of sediments within these inboard areas is the most significant, especially towards the bow where it is revealing fragile internal structures and organic artefacts (Figures 1-13). In the northern and eastern areas of the site between CP7 and CP15 there has been an average loss of 0.4m. The loss of 0.4m has exposed large areas of starboard side structure (Figure 27).

Figure 28: Sediment monitoring results

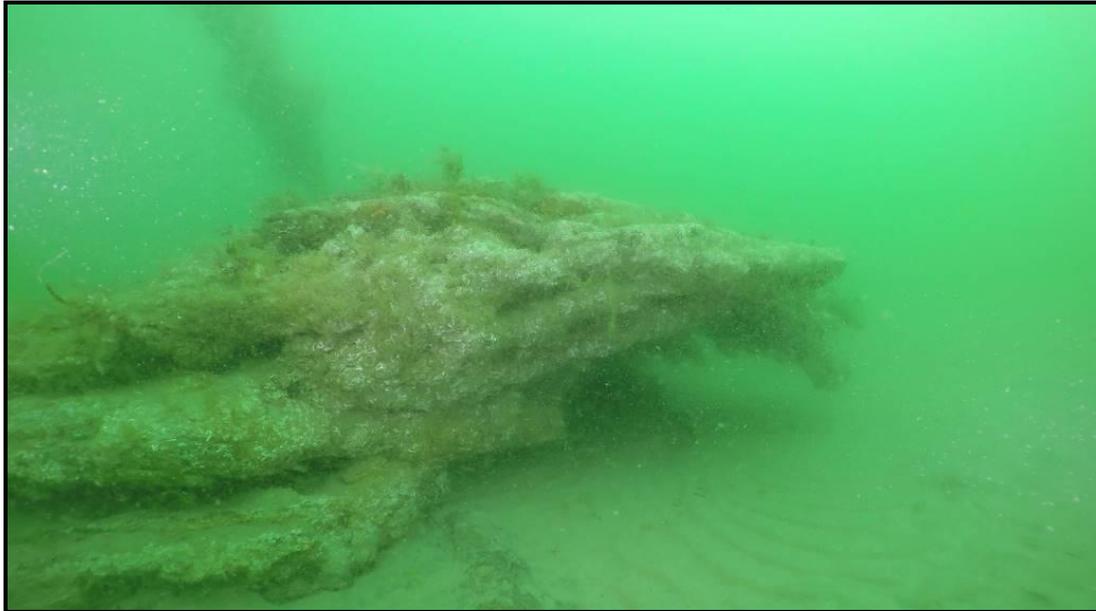
- 6.1.2. In May 2016, a large concretion consisting of strips of iron was noticed at the stern end of the main site. This feature had not been seen on the site by the current licensee and had only uncovered during the winter of 2015/2016. The concretion was upstanding by up to 1m from the seabed level (Figure 29). However, CPs 1 and 2 which lie on the outboard side of the stern only recorded slight reductions in the level of the seabed (Figure 28). This was another example of how the inboard side of the main site experiences a much greater loss of sediments than the surrounding seabed to the west of the site. This means the internal structures of the site are at a much greater risk.

Figure 29: Exposed strip iron at stern.

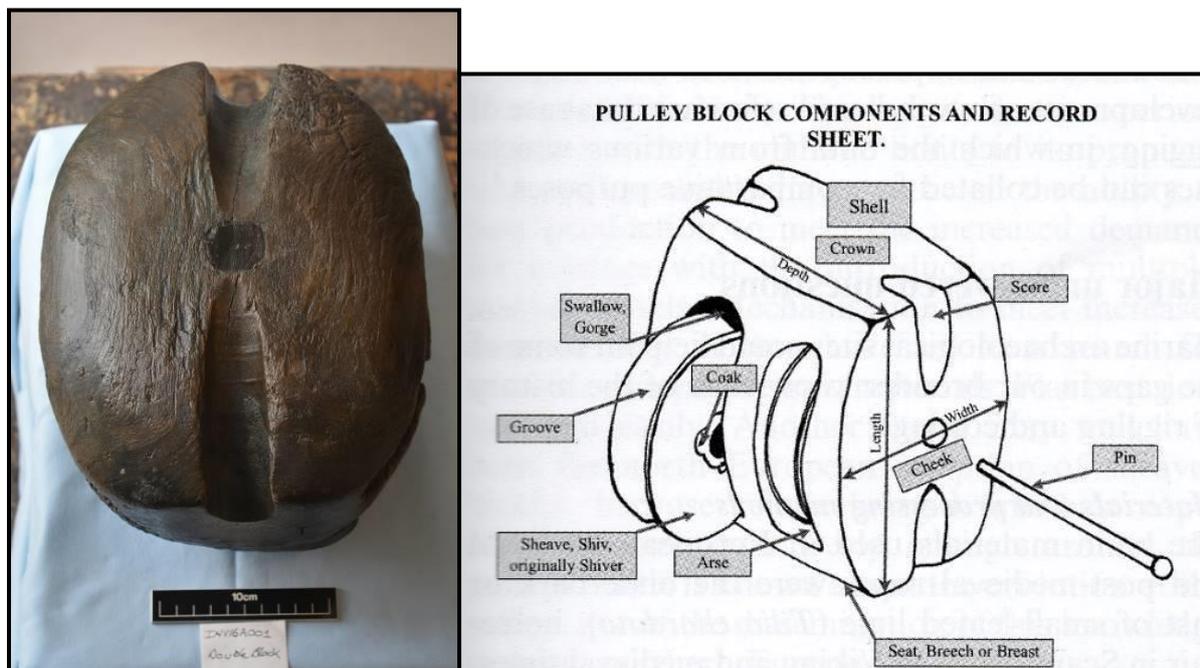
INV16A001 – Double block

- 6.2.1. The double block was recovered from outside the south end of **Area 3**. It is complete with some biological damage on one side. The block has a shell carved from a single piece of wood with two slots to house two wooden sheaves, which turn on a single wooden pin inserted through the centre of the block. There is scoring on the sides of the shell at either end to allow the rigging to fit snugly to the block. The crown end is flat and the other /breech end is eroded.

Figure 30: Photograph of the double block with diagram of pulley block components (Saunders 2010:17).

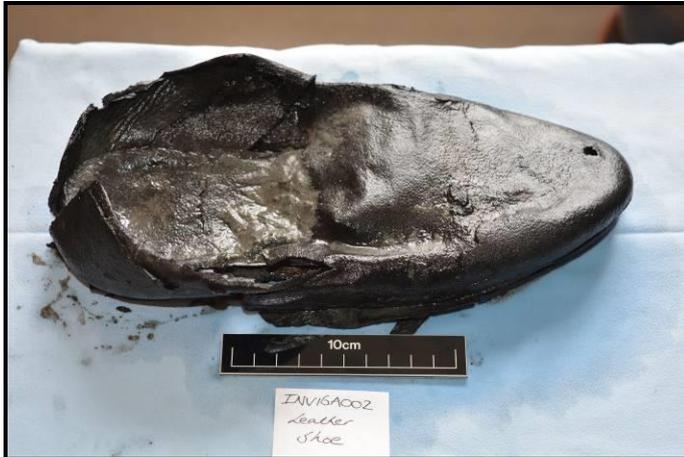
INV16A002 – Leather shoe

- 6.2.2. The leather shoe was found between a section of planking from an area of structure to the west of Area 3. It is complete but very fragile.

Figure 31: Leather shoe

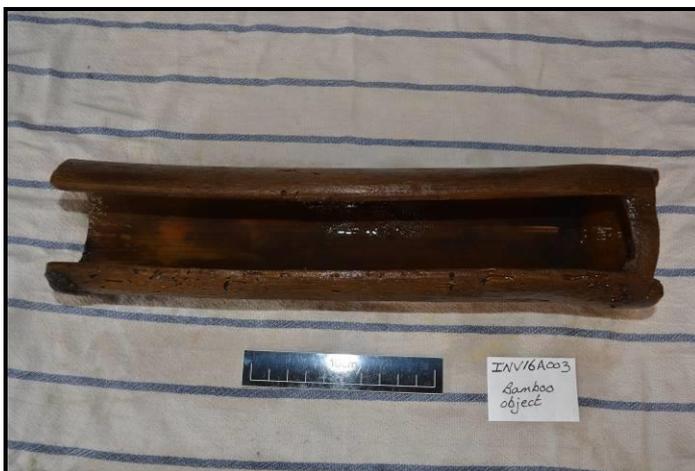
INV16A003 – Unidentified bamboo object

- 6.2.3. This object was found outside Area 1 amongst the disarticulated timbers. It is tubular with a rectangular cut down one side. It is 300mm long with a diameter of 67mm. The slot is 285mm long and 35mm wide. It was possibly used as some sort of container or scoop.

Figure 32: Bamboo object
