# An Assessment of a Second World War Hangar Structure at Tollerton Airfield, Rushcliffe, Nottinghamshire

TOLLERTON AIRFIELD  
RUSHCLIFFE  
NOTTINGHAMSHIRE

AN ASSESSMENT OF A SECOND WORLD WAR HANGAR  
STRUCTURE AT TOLLERTON AIRFIELD,  
NOTTINGHAMSHIRE

NGR: SK 61544 36017

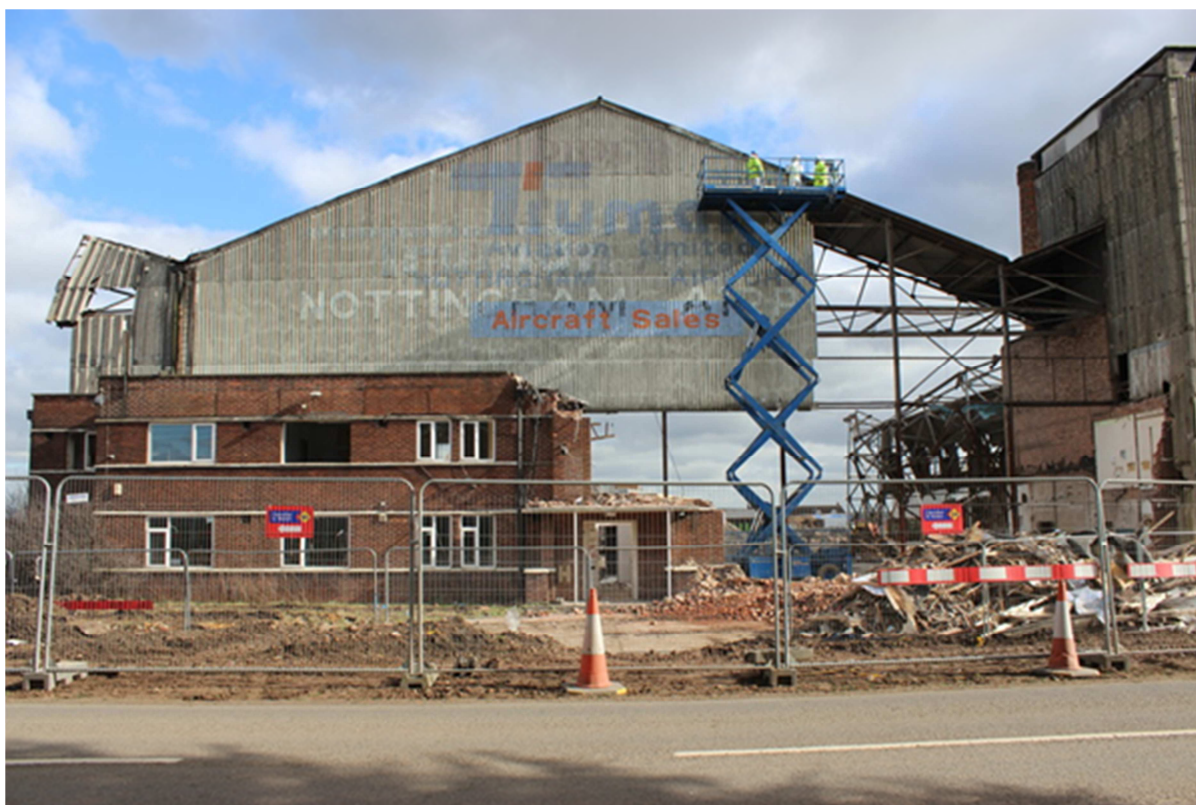
*Figure 4: Main hangar during demolition. [Milan Petrovic February 2017]*

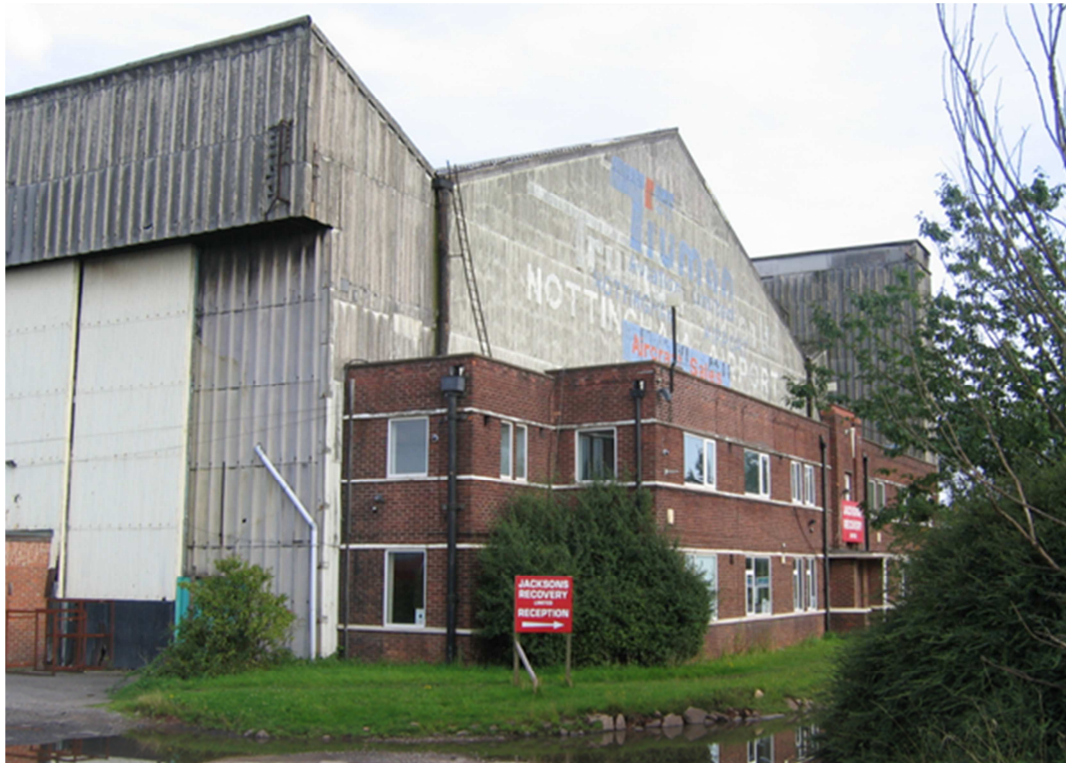
Figure 5: To the left of the rainwater pipe a slightly raised portion of cladding indicates the position of the door that was used by the fire watchers to gain access to the roof. [Milan Petrovic 07-08-2009]

- There is evidence of a doorway at the rear of the structure to the office roof where there are two ladders for access to the hangar roof – for fire-fighting purposes.

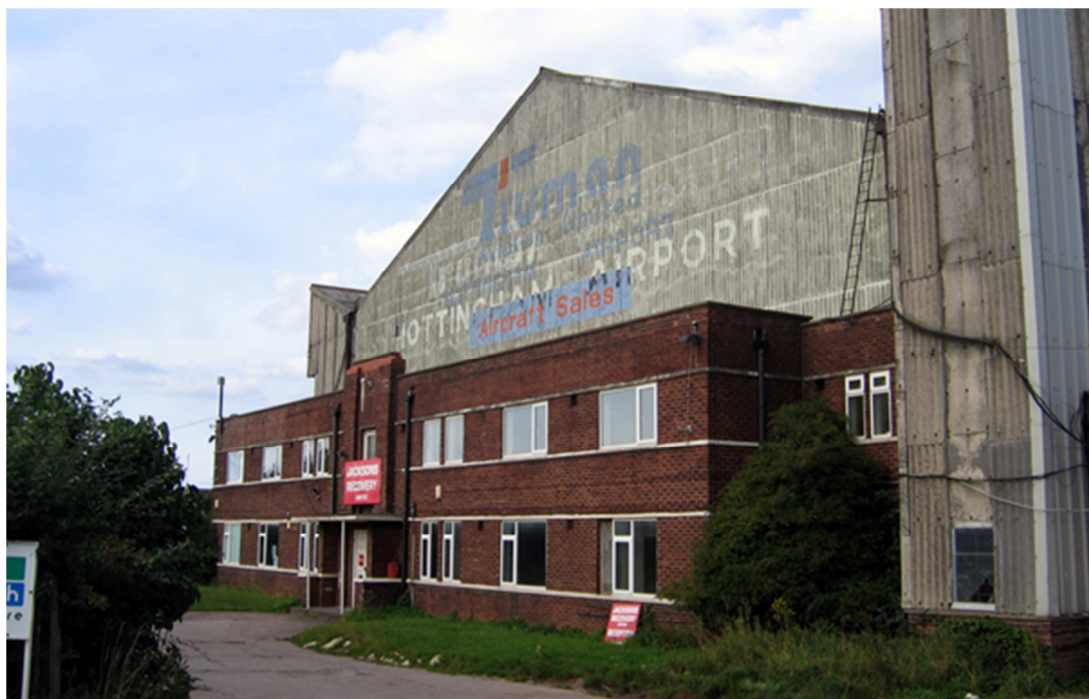
Figure 6: There are two ladders, one at either end of the roof truss, allowing access to the pair of roof gullies. [Milan Petrovic 07-08-2009]

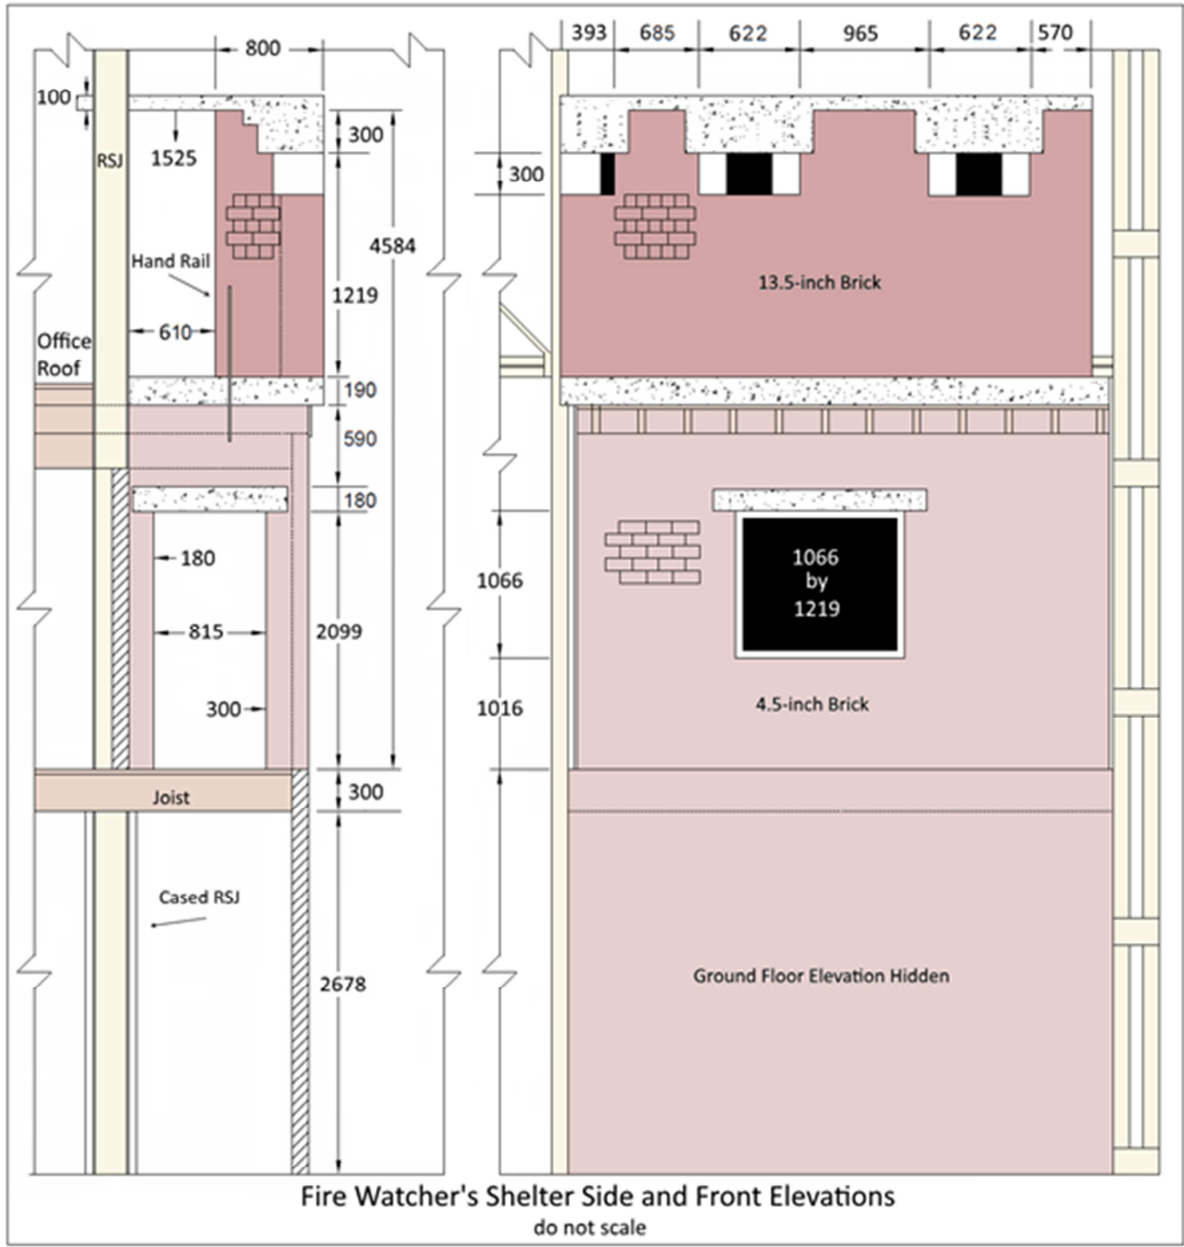
Figure 7: Firewatcher's Post. [Drawing by Paul Francis]

The shelter is constructed of full-width 13.5 inch brick, on the north and east elevations only, these are laid in English bond (9 inch external face and 4.5 inch internal face – laid as English bond but with cut headers). The south elevation is 13.5 inch brick for half of the width, the remaining area is open and forms a doorway. There is an iron hand rail present, indicating that access was from an iron ladder. The west elevation (over the offices) is now completely open, the hangar cladding (Trafford tiles) having been removed exposing some steel framework for supporting the Trafford tile cladding.

There are three 'loop holes', one on the south-east corner and two along the front (east) elevation, the north elevation is 'blind'. These have partly been cast in concrete as part of the roof slab, the sides and lower portion of the loop hole is brick. These allow a view inside the hangar, with a focus on the roof structure. The shelter had limited headroom, the loop holes are positioned only 3 feet from the floor and rises 1 foot, this indicates that the watcher would have been sitting at his post, the low position of the loop hole enabling the floor space directly in front of his position to be easily seen, although the hangar floor space would have been cluttered with aircraft.

The structure appears to have all the hallmarks of being hurriedly built with little thought to fire safety, being reliant on standard off-the-shelf unprotected floor joists. If these had caught fire then it would have come crashing down, despite this, three walls were constructed heavy brick and included a roof that was proof against incendiary bombs and a concrete slab floor (this may be a screeded patent hollow fire-proof floor such as Smith's flooring).

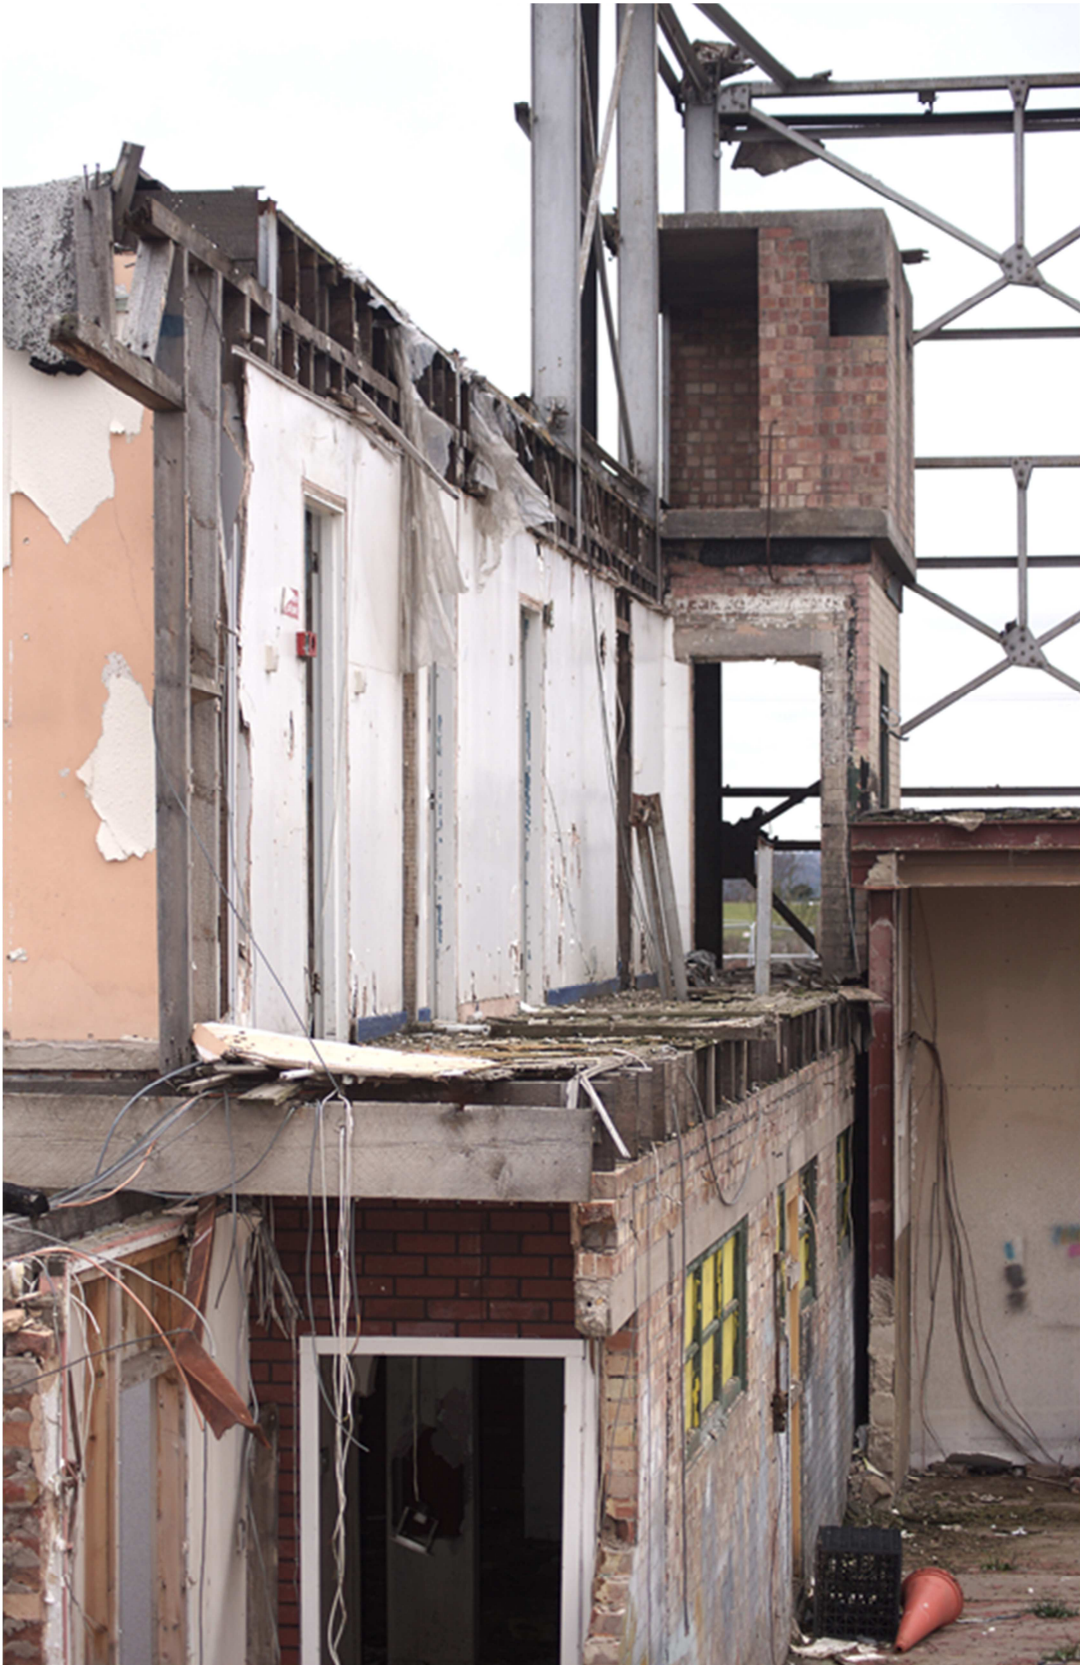
Internally, the ground floor offices extended out by roughly 3 feet from the first-floor offices, the ceiling joists forming a walkway (with railings) at first floor level running full length along the rear elevation of the office accommodation (Figures 7-15). During the Second World War, the walkway could be accessed from the ground floor by a staircase at the main hangar door end, positioned against the supporting structure of the fire watcher's shelter – this was removed post-war when a new steel-framed and breeze block clad storage area was erected adjacent to it and against the door stacking area and first main door. There is a surviving portion of this walkway above the surviving portion of offices.

The roof joists of the first-floor offices have been extended in height to just below the concrete slab floor of the fire watcher's shelter. This may indicate that as originally built, the office roof was lower, and the fire watcher's shelter had yet to be built. This difference in construction, may reflect the publishing of Government's mandatory orders and acts of parliament concerning fire watchers and defence against fire on factory premises (see Part 3). The fire watcher's shelter survives in a precarious condition.

*Figure 8: The ground floor and first floor offices and their relationship with the fire watcher's post. [Paul Francis 05-12-2017]*

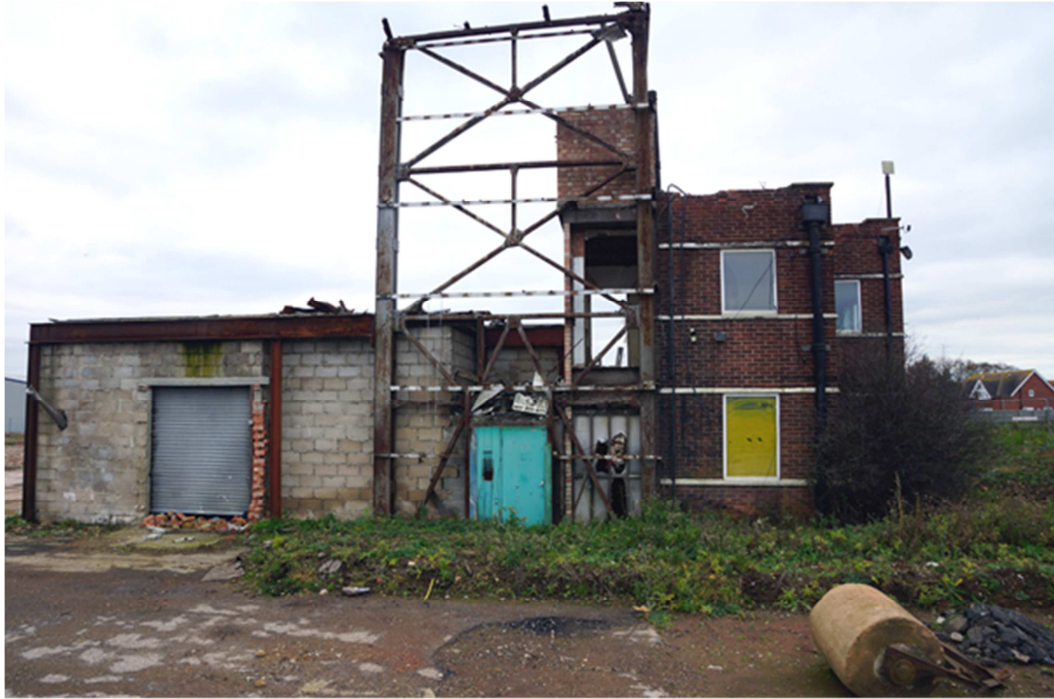
*Figure 8: Exterior view looking south showing blind end of the fire watcher's post and door wind bracing. [Paul Francis 05-12-2017]*

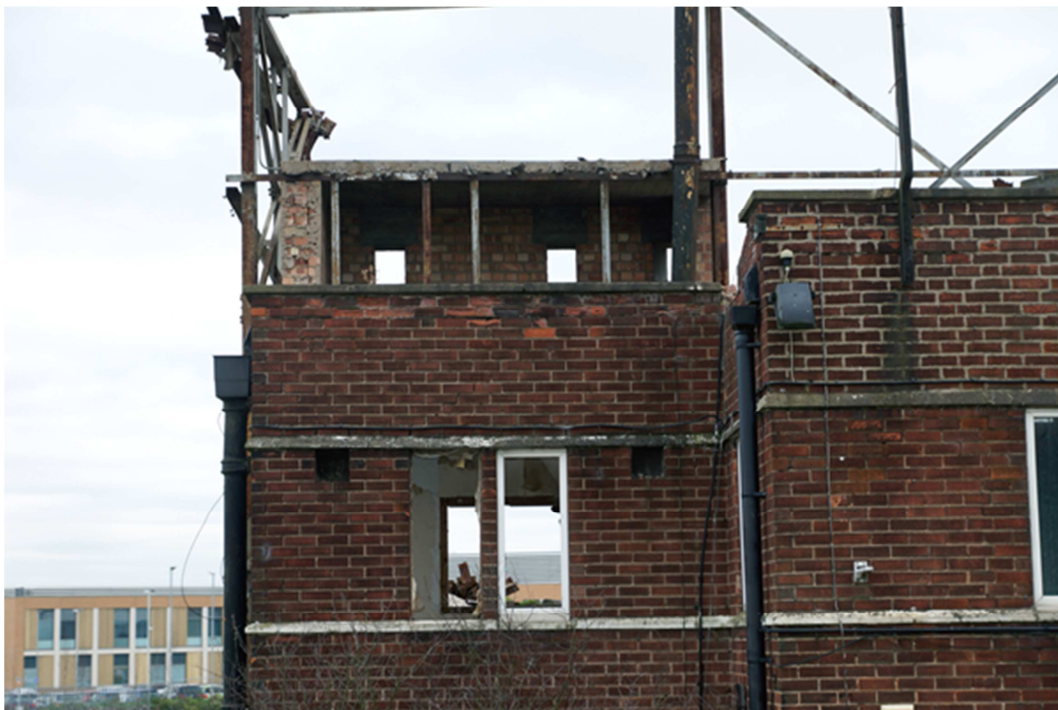
*Figure 9: Exterior view looking east, it is partially hidden by the parapet wall of the flat roof. [Paul Francis 05-12-2017]*

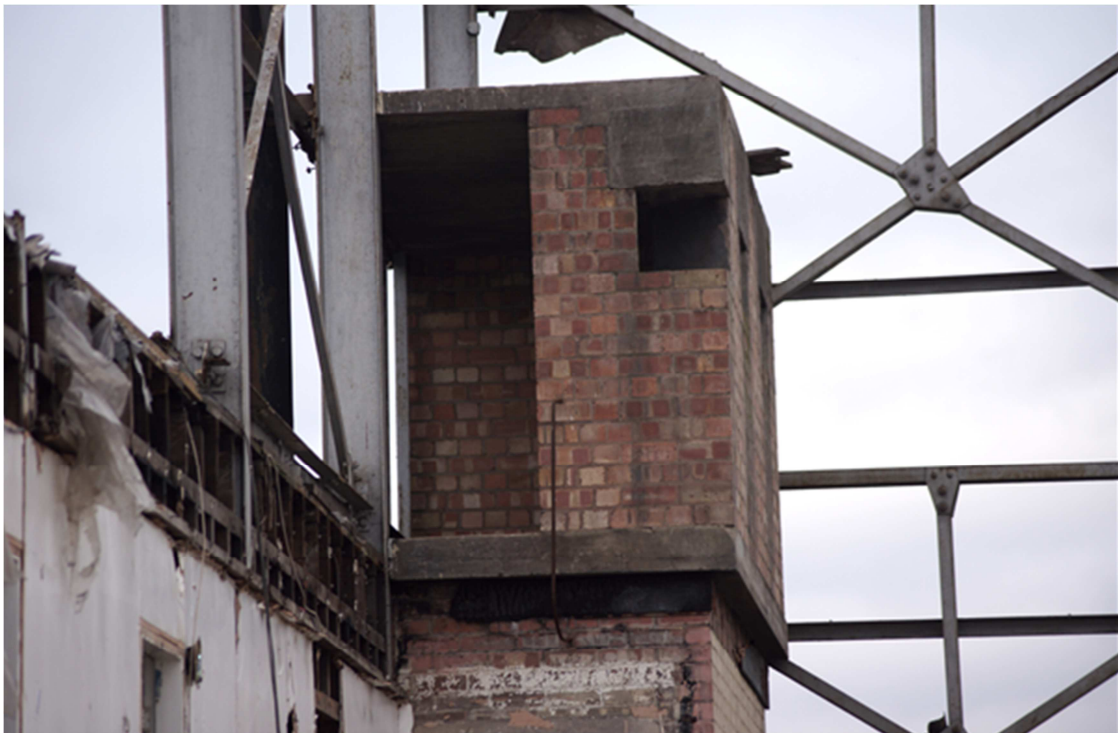
*Figure 11: View from the hangar's interior showing entrance side (south) elevation. [Paul Francis 05-12-2017]*

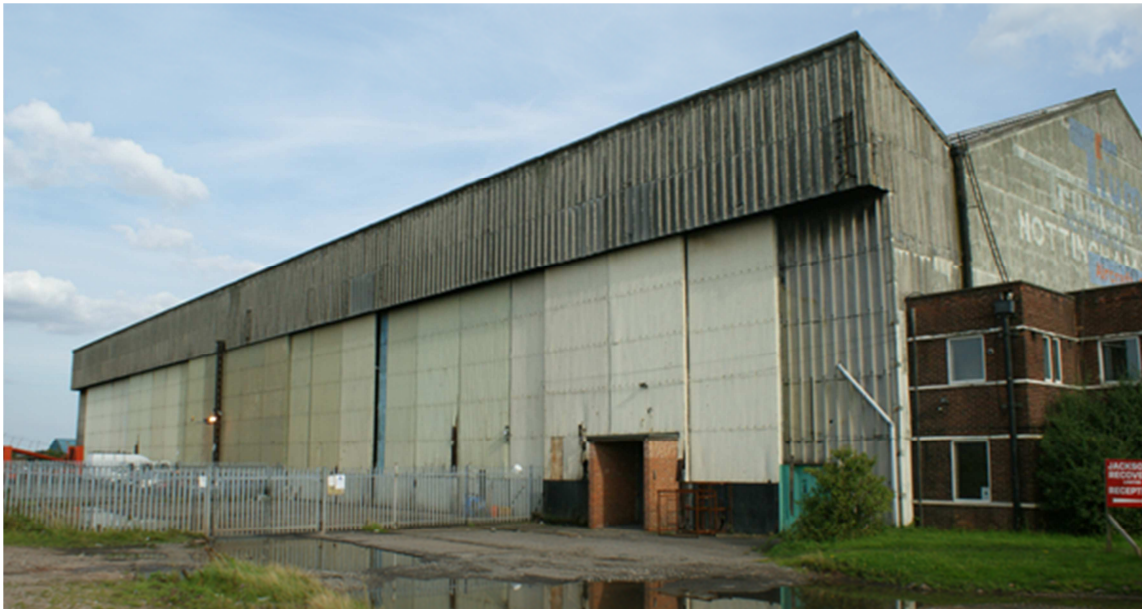
*Figure 26: Main hangar, airfield elevation (Bldg.43). Note the roof access ladder positioned close to the fire watcher's shelter (which is hidden behind the wall cladding). [Paul Francis 07-08- 2009]*
