Rooswijk, Protected Wreck Site, Goodwin Sands Conservation of copper alloy artefacts from the Dutch East Indiaman the Rooswijk

Research Report Series 036-2018

**ROOSWIJK
PROTECTED WRECK SITE
GOODWIN SANDS**

**CONSERVATION OF COPPER ALLOY ARTEFACTS FROM
THE DUTCH EAST INDIAMAN THE ROOSWIJK**

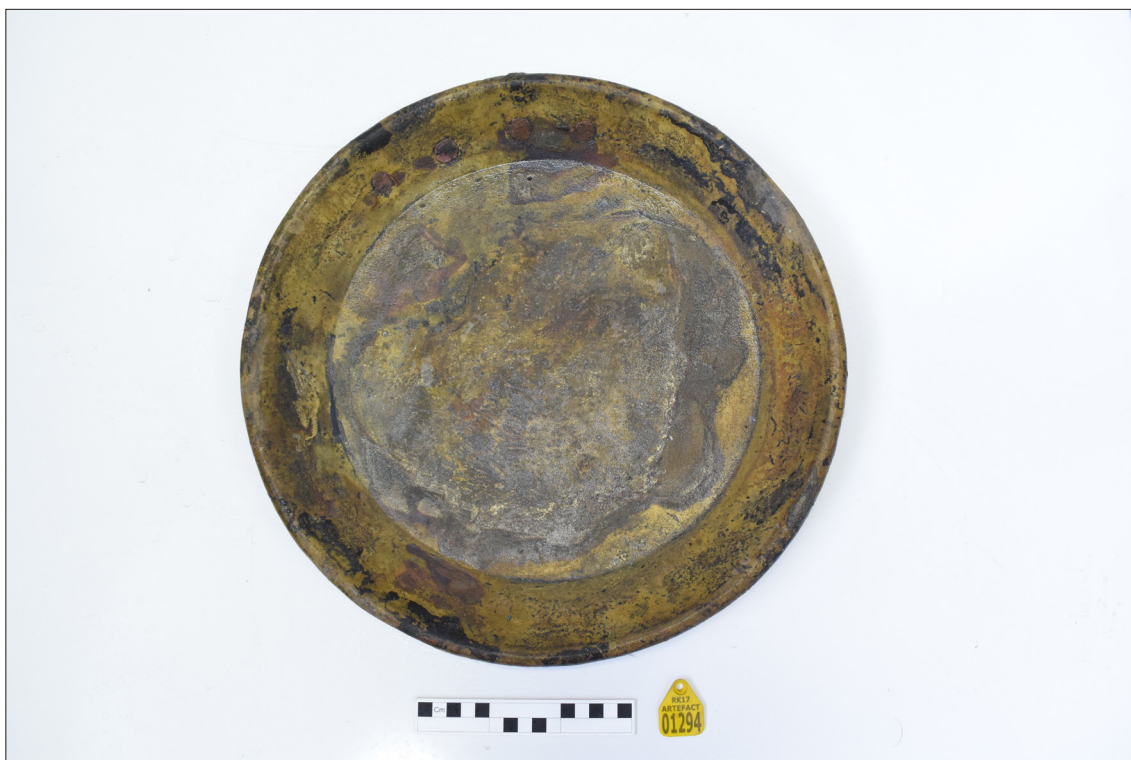
The material composition of the pan was studied using pXRF in four different areas following cleaning (Fig 15 and 16. The copper alloy of the pan itself was analysed on two different places: on the base of the pan and on the rim. The analysis gave a clear result showing a copper alloy of approximately 66wt% Cu, 27wt% Zn, 2.3wt% Pb with traces of As and Ni. This composition is commonly referred to as brass. The rivets, as will be shown next, were on the other hand made from copper.

Fig 15: Top view obverse side of object RK17 A01294 after corrosion removal.

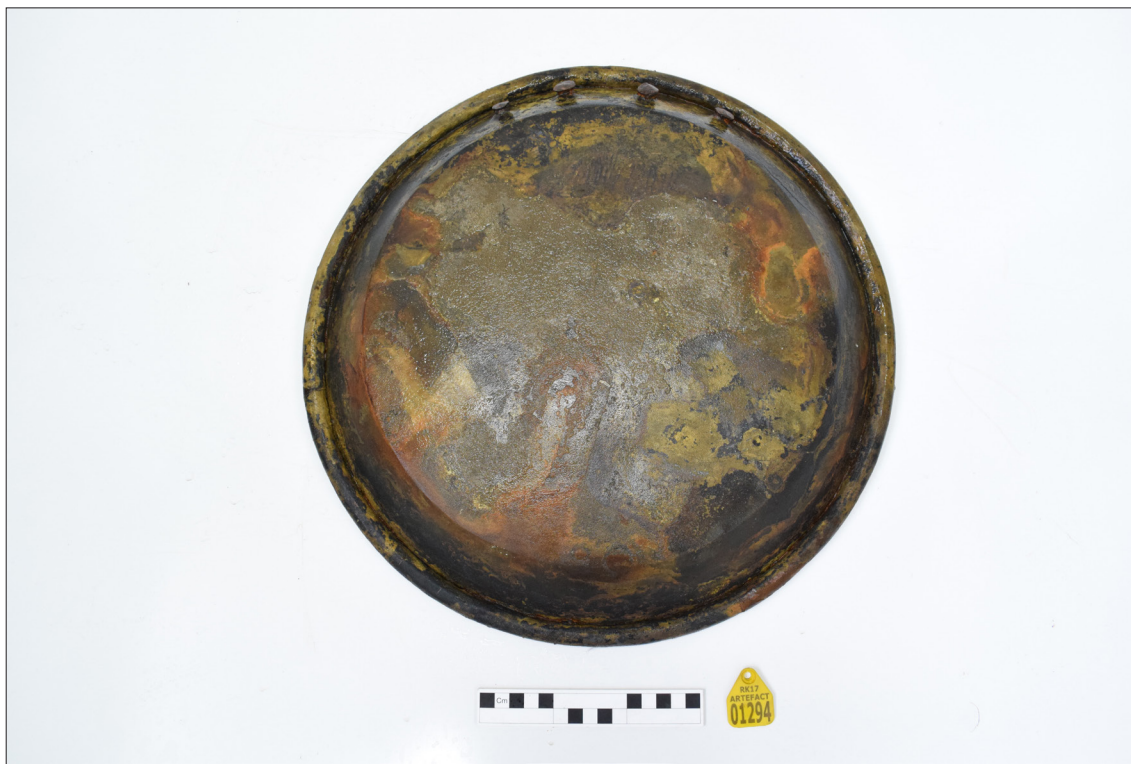
Fig 16: Top view of reverse side of object RK17 A01294 after corrosion removal.

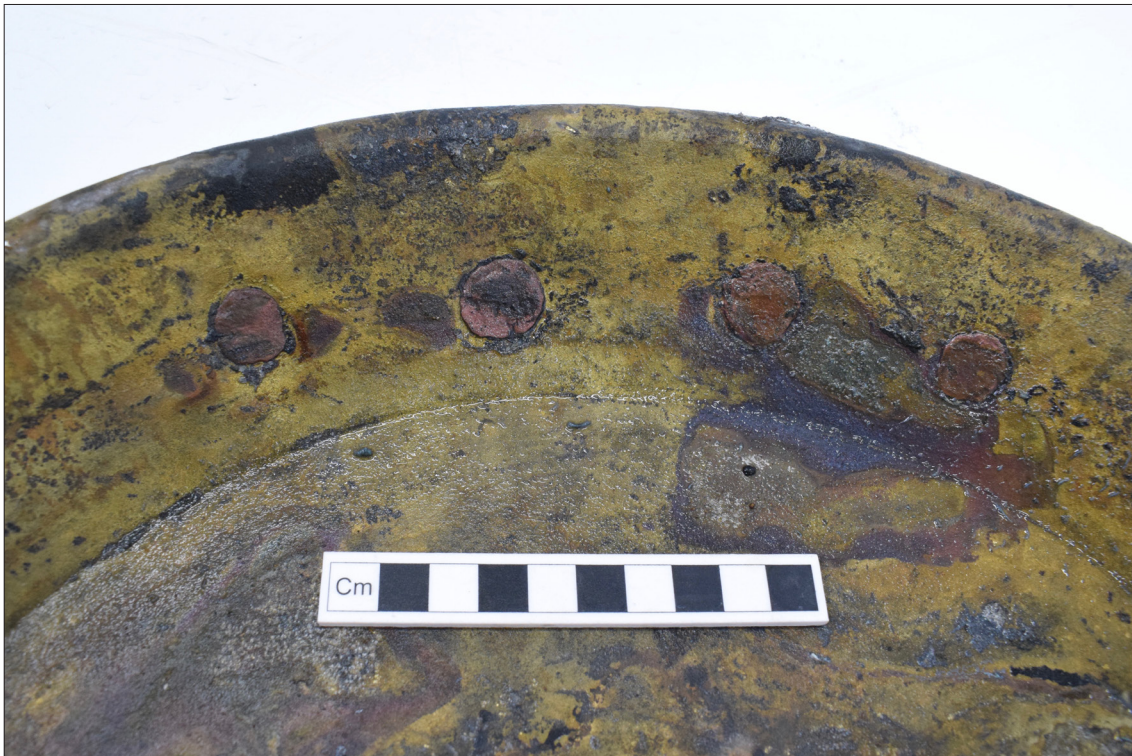
Fig 17: Object RK17 A01294 after corrosion removal showing rivets on the inside of rim.

Corrosion layers and sediment were cleaned from the surface of the dish using a pneumatic air-scribe. The main corrosion products on the surface of the object seemed to be concreted iron corrosion together with sediment. Although the origin of the iron corrosion product could not be determined it was clear that the original surface lay underneath. In one area the surface of the object could be seen underneath the corrosion layer and this was used to guide the cleaning of the object. The external markers like stones and shells confirmed this. The features that were seen earlier on the X-radiograph were found to be copper rivets (see above). On the inside of the pan the rivets are flattened, but on the outside they protrude from the surface of the object (Fig 17 and 18). The square rivets stick out about 1 cm and end in a flat head. Possibly they would have held an iron handle in place, which would also explain the concreted iron covering the object. In most areas the corrosion did not adhere to the surface of the object much, but near the rivets the iron corrosion was somewhat more solid. Despite this it was not possible to conserve this potential iron component as it was mineralized in such a manner that no remains could be kept in place.

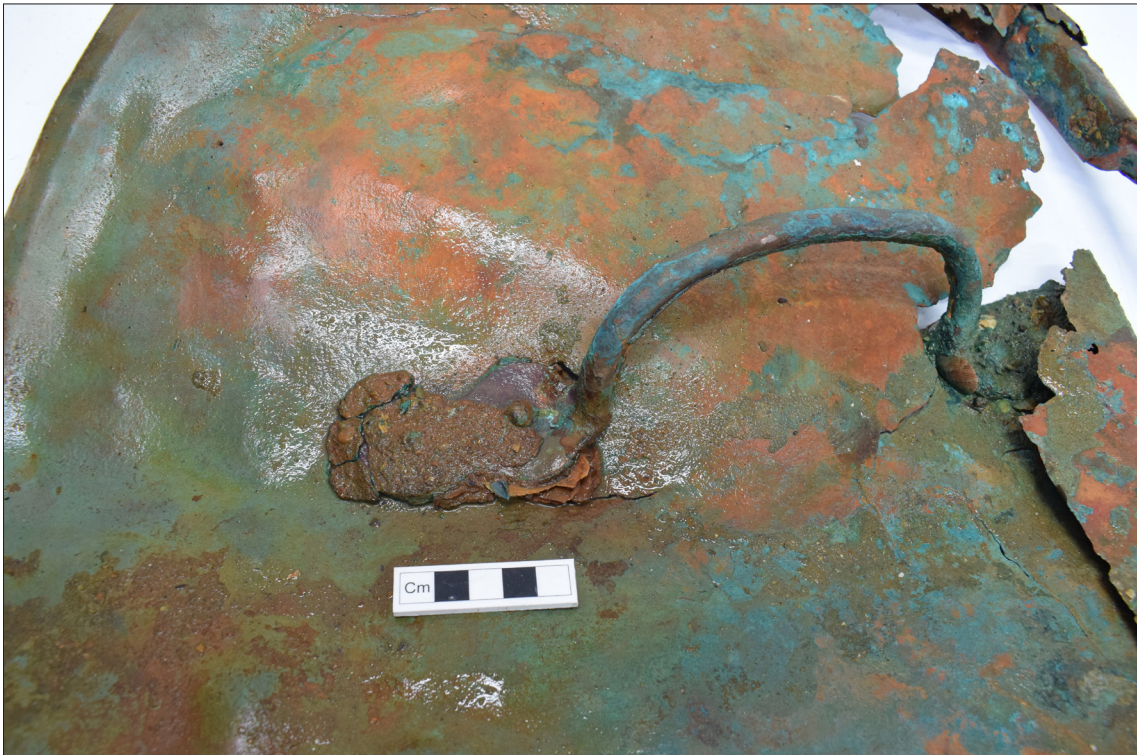
One of the artefacts from the Rooswijk is a large lid. The lid consists of a round sheet metal that has been folded over a round metal hoop. The hoop was created from a metal strip made into a circle and riveted together at the ends (Fig 19). On top of the lid, a handle likely also to be attached to the lid with rivets was obscured by layers of concreted sediment (Fig 20).

Fig 20: Object RK17 A01073 before conservation showing riveted handle and corrosion layers obscuring mechanism.
