Archaeological Services in Relation to Marine Designation

UB 78, off Folkestone, Kent

Archaeological Report

Ref: 83803.40
January 2015

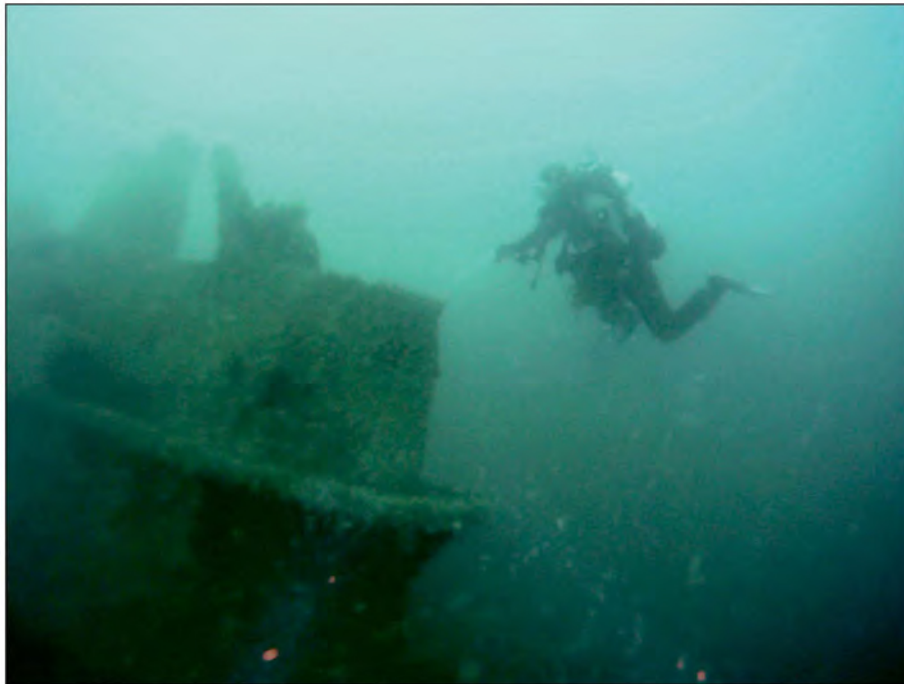
Plate 1: Video still of aft end of conning tower

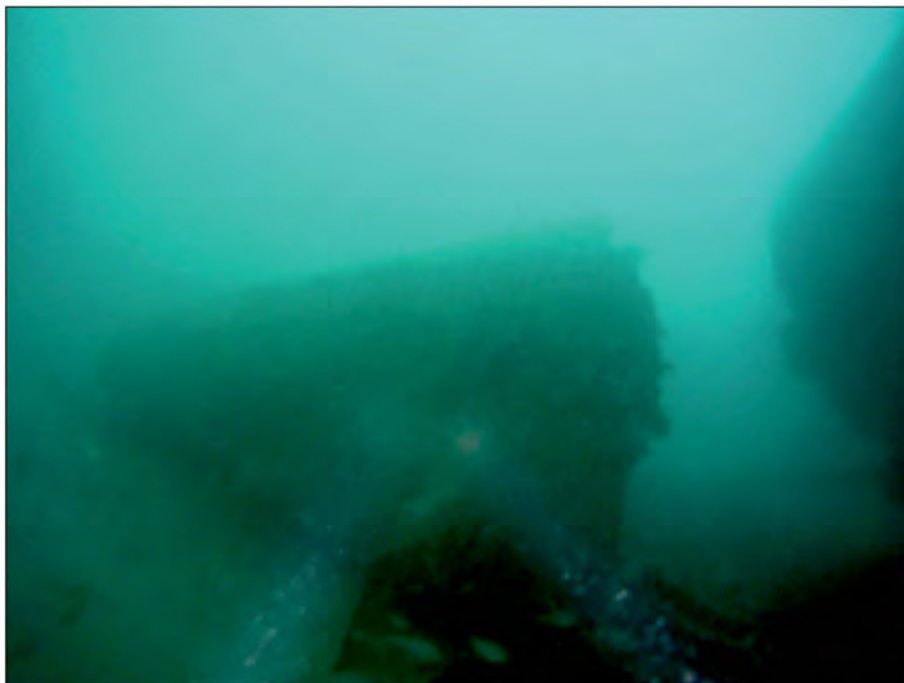
- 4.4.26 About 2m starboard of the aft end of the main section is the small stern section (**Plate 2**). This comprises the casing aft of the rudders. The aft torpedo tube door is missing and the opening mechanism levers are damaged. The casing behind the door is distorted, with the plating pushed outwards. Within can be seen what appears to be part of the aft torpedo tube, although it is not clear whether the flanged end is present. The aft torpedo tube would have extended well forward of the surviving section and therefore only a small part of it can have survived.

- 4.4.28 The stern section appears to be smaller than comparison of the batch plans with the position of the fracture on the main section would suggest. It therefore appears that some of the aft torpedo room is missing, presumably destroyed by the explosion.

Plate 2: Video still of detached stern section looking aft (main section to the right)

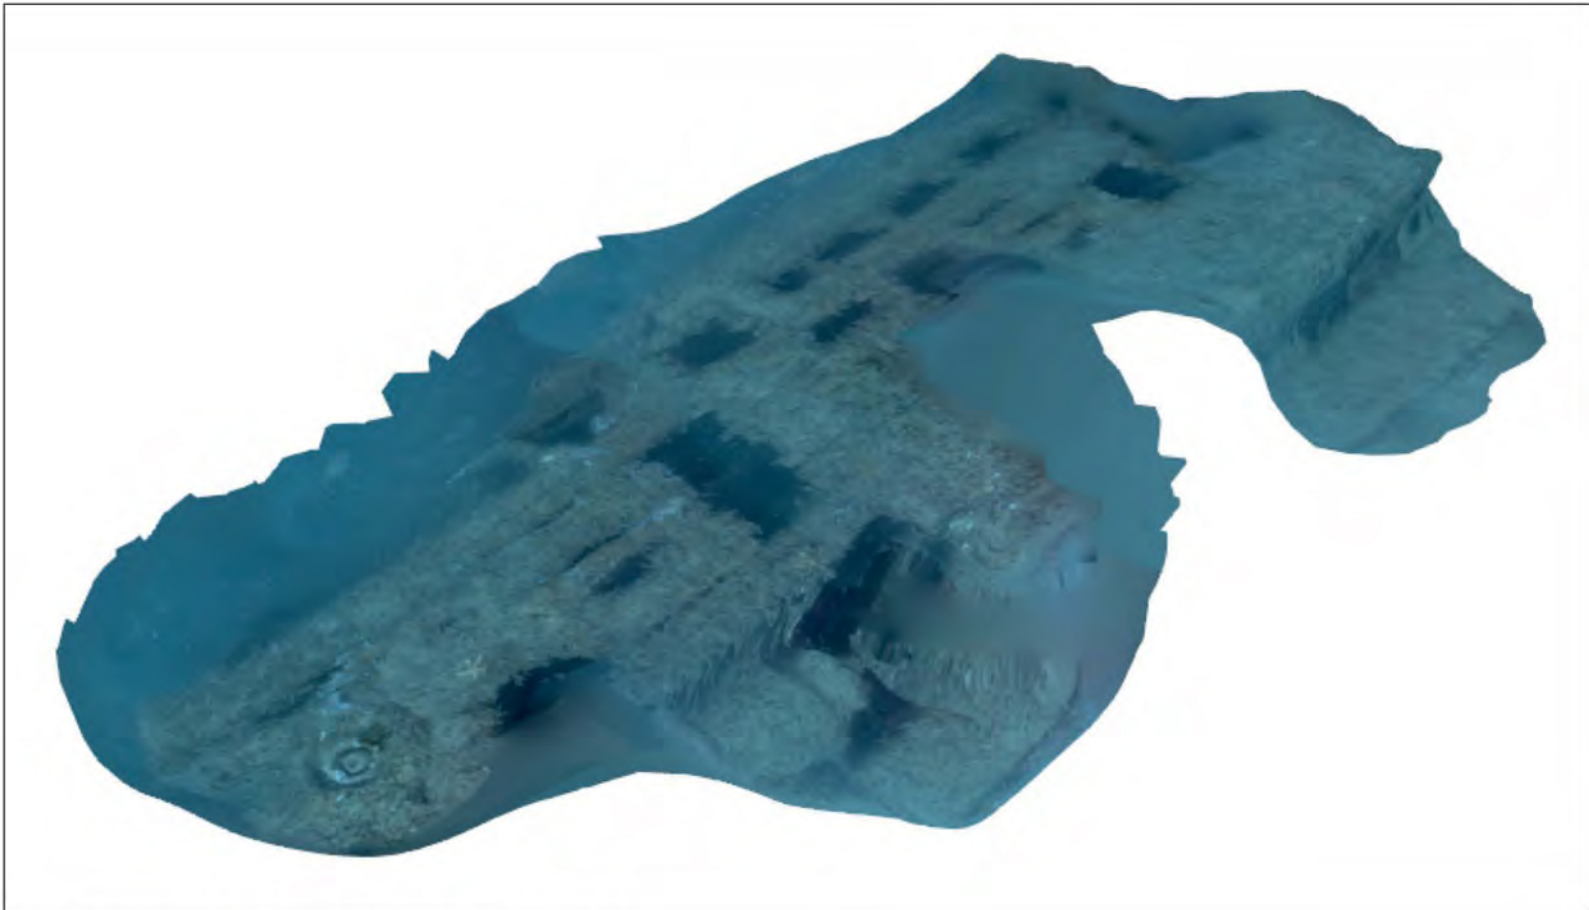
- 4.4.12 Forward of the tower the deck casing is *in situ* (**Plate 3**), with only small sections of planking missing. The casing consists of thin wooden deck planks supported by longitudinal steel angle beams with free flooding slots on either side, with transverse angle beam supports. Heavy marine turf has colonised the planking, the surfaces of which appear to be moderately eroded. There is a small amount of unidentified debris lying on the deck. The deck railings are not present and may have been dismantled at the time of loss.

- 4.4.16 Further forward there is a small base ring set into the deck with a squared central shaft that does not protrude (**Plate 3**, to the left). This appears to be the deck base plate of the capstan, together with the top of its spindle. The capstan head itself is missing. This motorised capstan is connected by a transmission arm to a windlass further forward which

Plate 3: Photogrammetry model of part of *UB 78*'s foredeck
