THE BELL FRAME AT ST MARY'S CHURCH, ATTLEBOROUGH, NORFOLK

An historical analysis

By
Richard Bond

Research & Analysis Team
Reports and Papers B/014/2004
2004

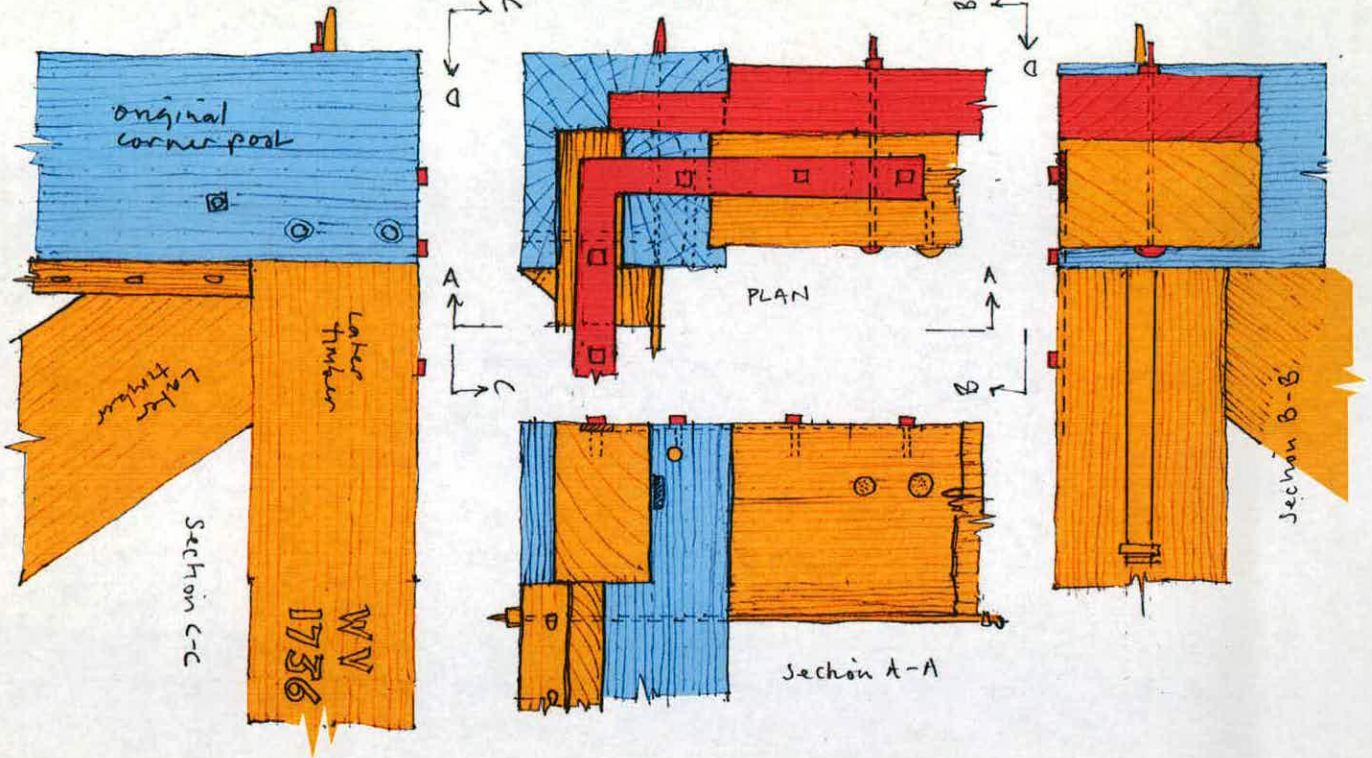
Figure 23 Detail at A. Series of sketch plan and elevational views showing the assembly of the upper part of the bellframe at the north-west corner. The original drawing has been coloured to show the phasing of the timbers

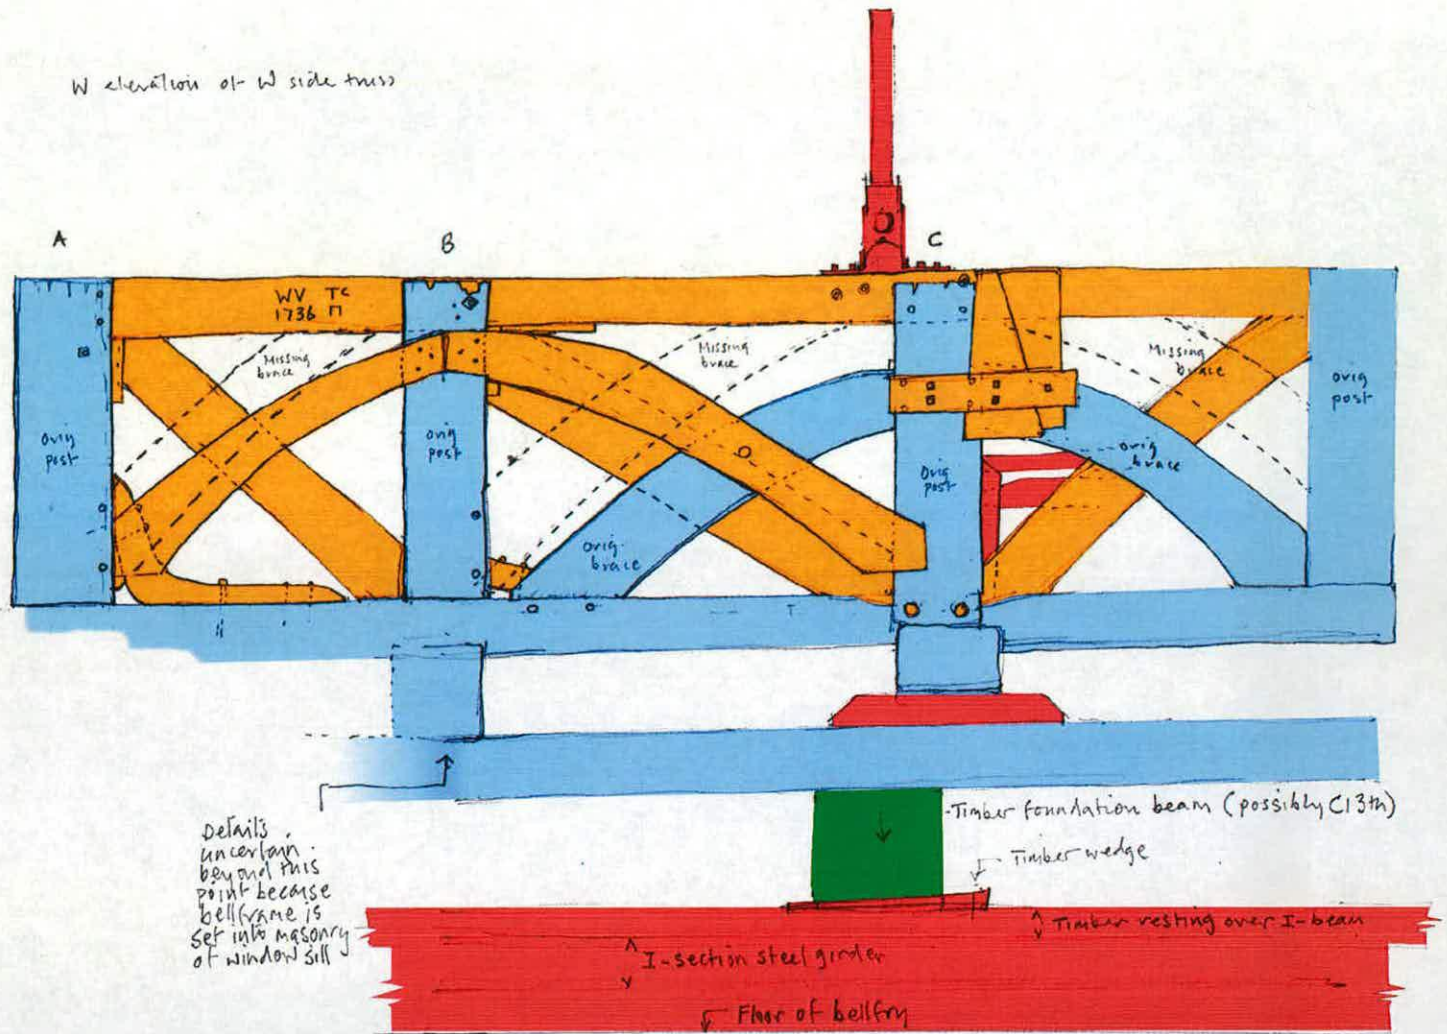
Figure 24 West (external) elevation of west side of bellframe.
The original sketch has been coloured to show the phasing of the timbers

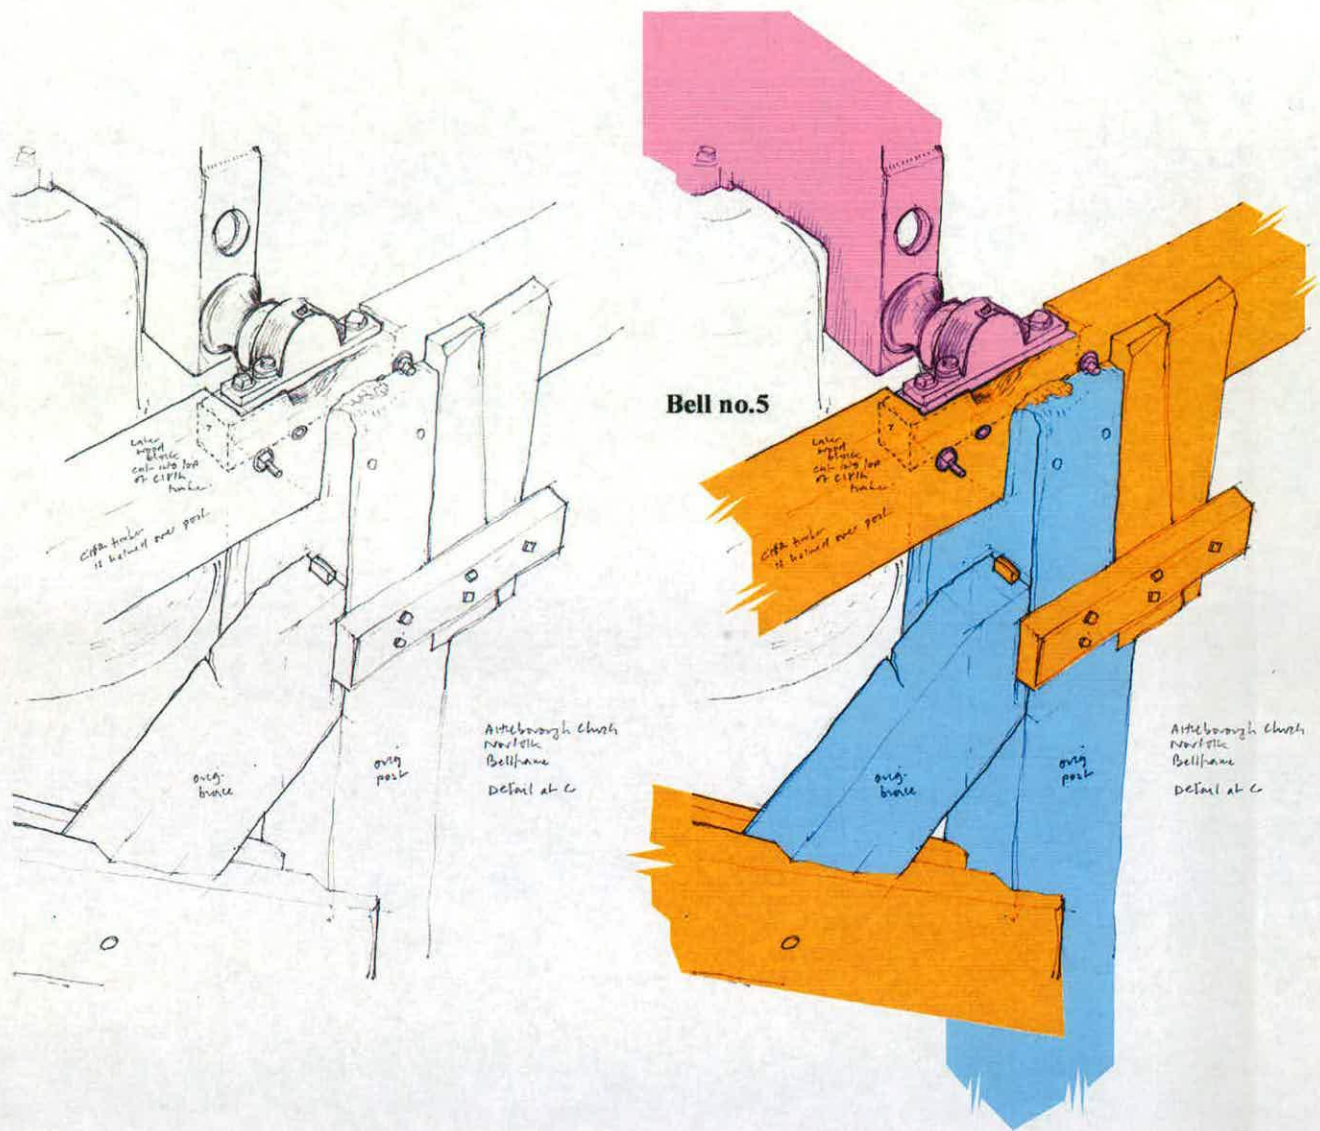
Figure 26 Detail at C.
Original sketch on left; edited sketch showing phasing of timbers on right.
No.5 bell. Inscribed date of 1581; recast in 1926

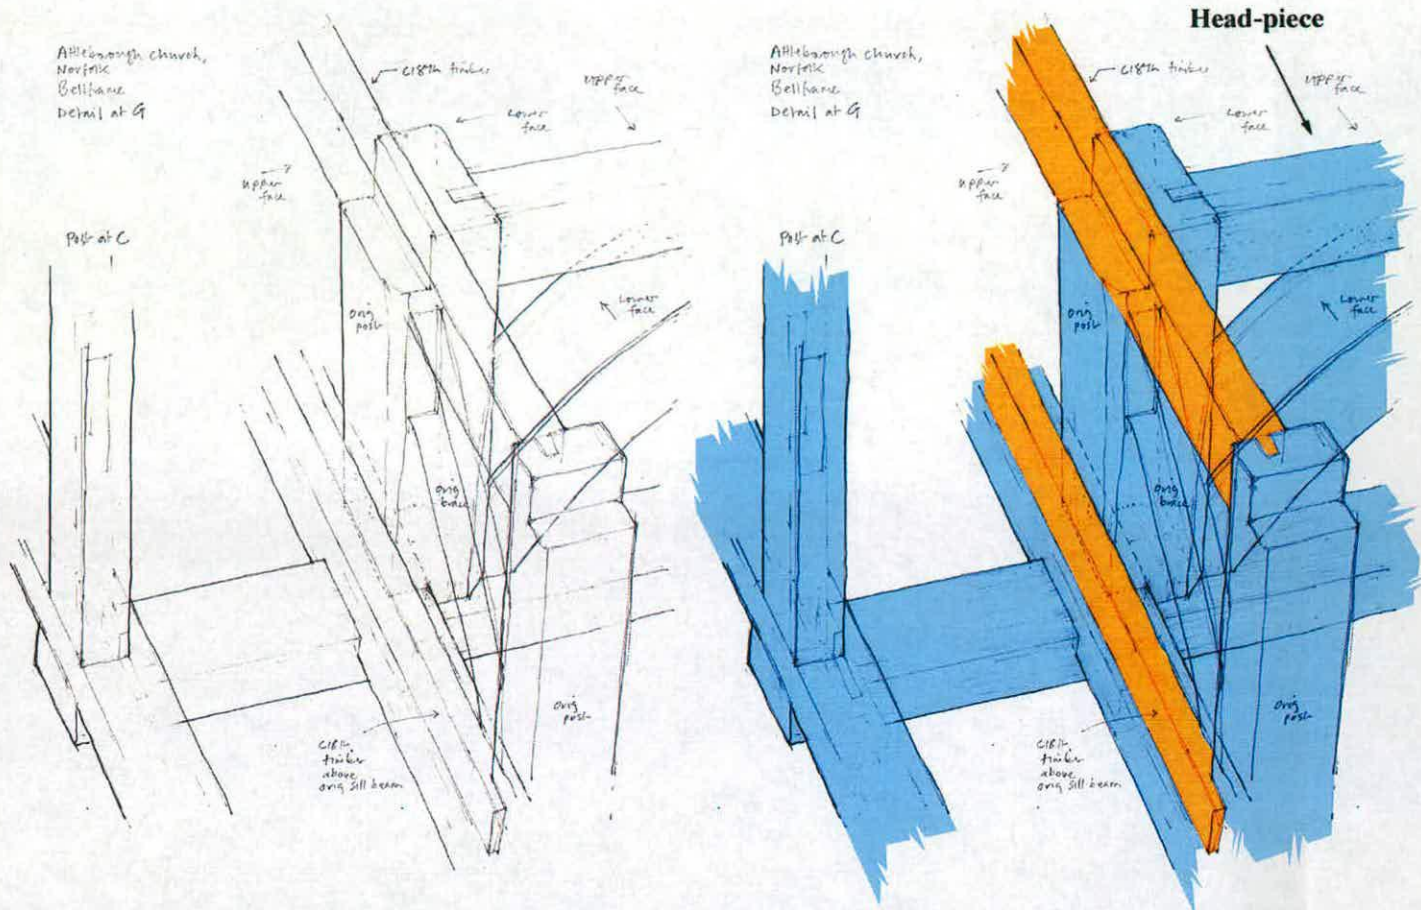
Figure 27 Detail at G.
Original sketch on left; edited sketch showing phasing of timbers on right.
Head-piece is probably an early C16th timber reset in early C18th or c. 1909

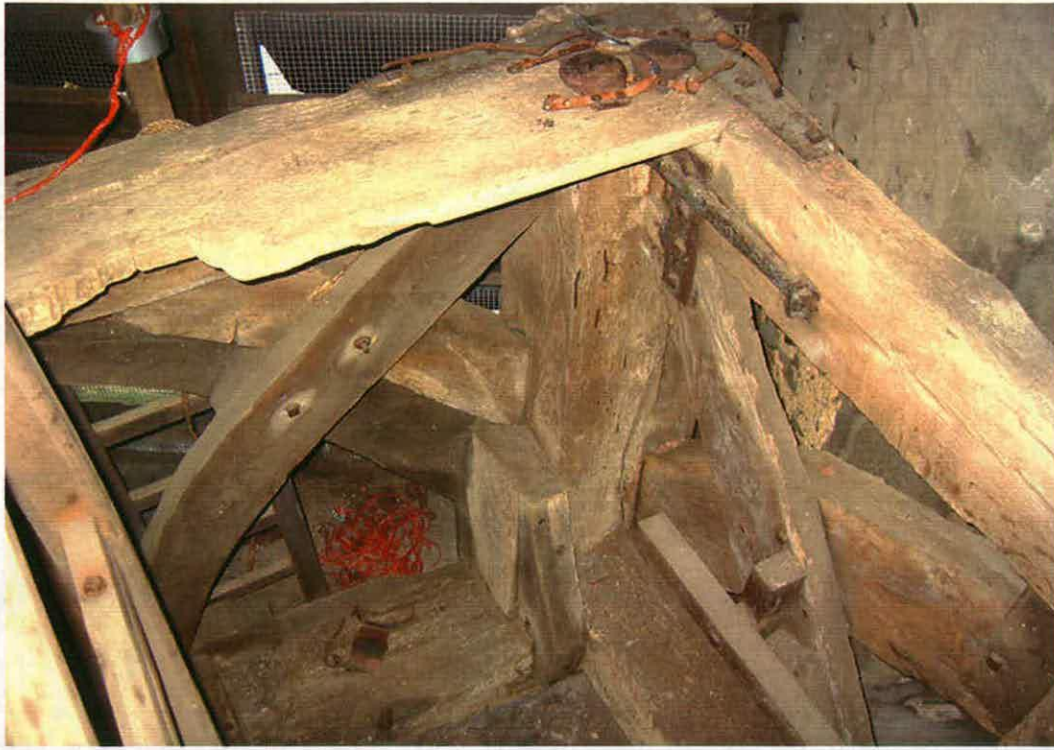
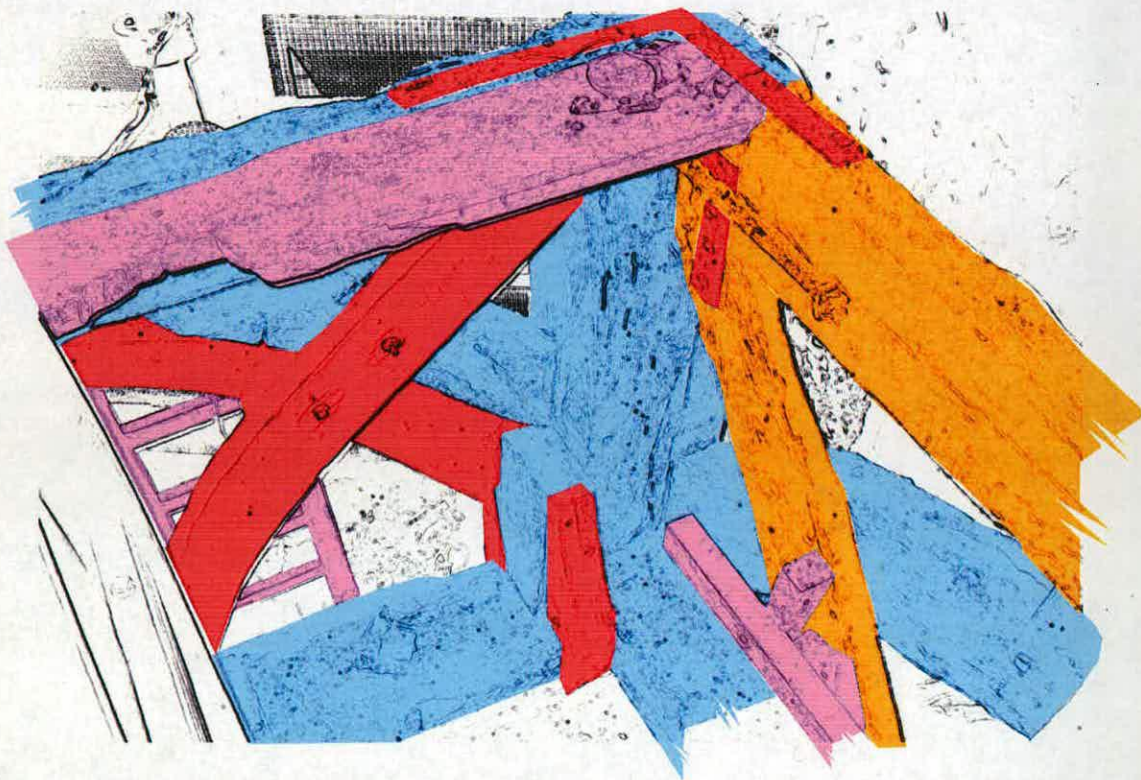
Figure 28 Detail at D.

**Original photo above; edited photo showing phasing of timbers below.
The head-piece of the south side frame is probably an early C16th timber
reset in the early C18th or c.1909**

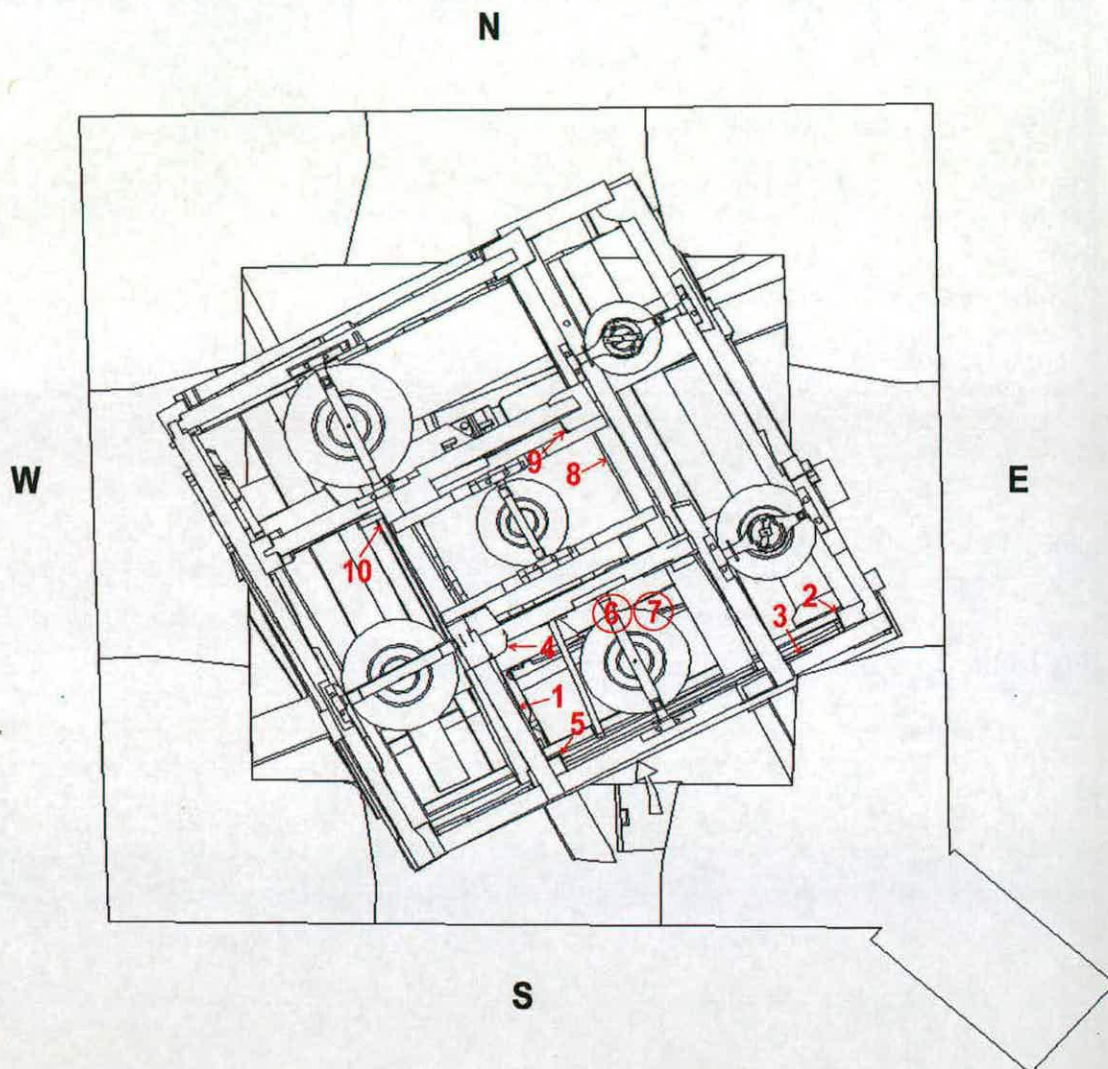
It is possible that the bottom two foundation beams supporting the present bellframe are reused timbers and previously supported an earlier bellframe that was contemporary with the thirteenth-century belfry and spire. Samples were taken from the beams during the recent tree-ring dating project; however the timbers failed to date.

- ⑥ South lower foundation beam (possibly C13th)
- ⑦ Bearer above sample no.6
