Blackbeck Gunpowder Works,
Cumbria:
an archaeological
and architectural survey

SURVEY REPORT

Archaeological Investigation Report Series AI/32/2004

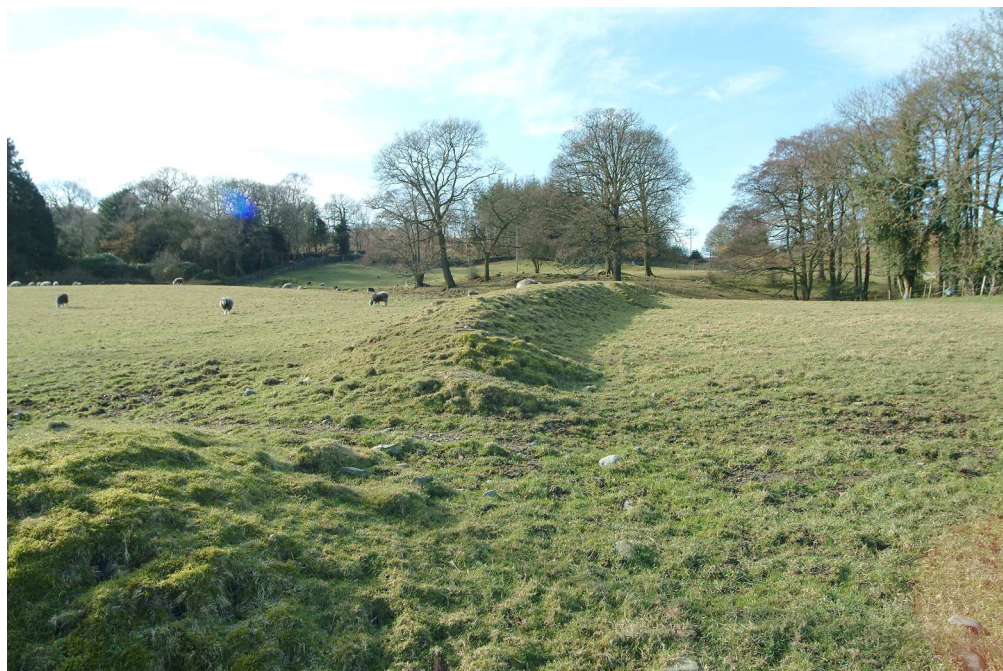
Figure 11.
*Upper part of flue
(west of the farm
track) from the boiler
house. Looking west.
(NMR: DP003389)*

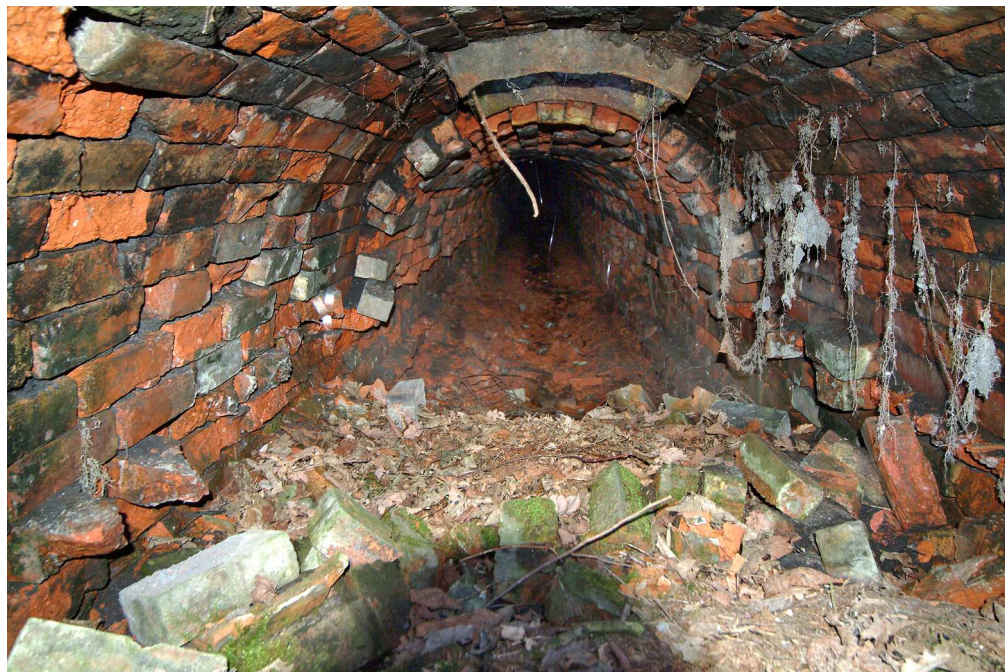
Figure 12.
Internal view of east end
of boiler house flue,
looking west. (NMR:
DP003402)

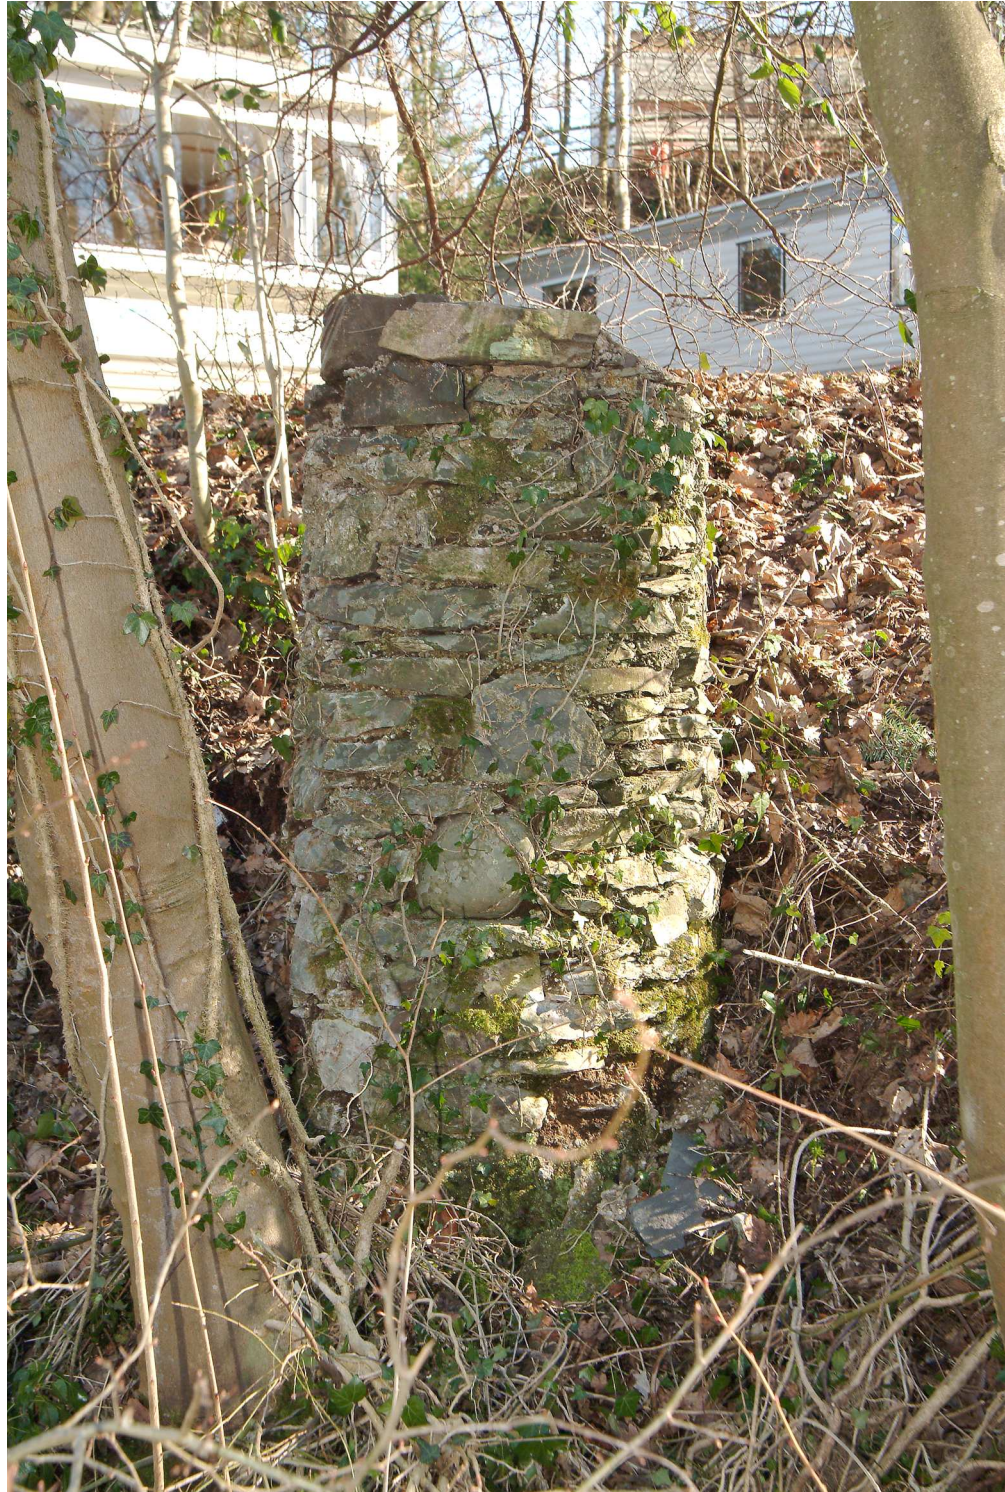
Figure 13.
Northernmost surviving pillar which supported the steam pipes to the little engine house, looking south. (NMR: DP003406)

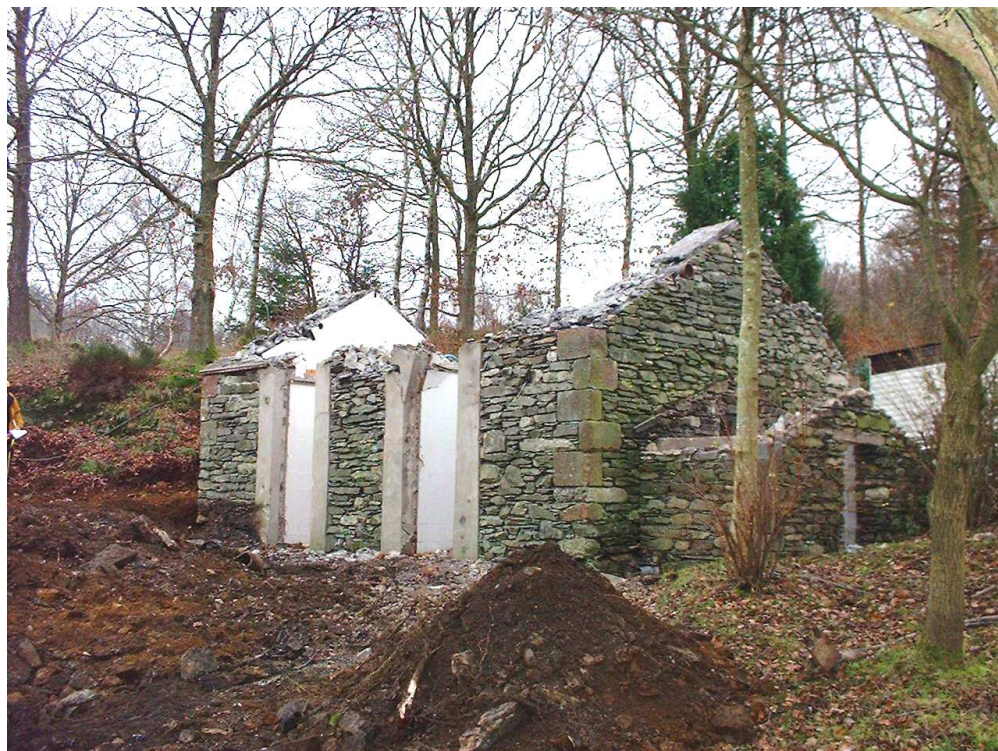
Figure 14.
*The oil engine house
near the corning house
in process of demolition,
looking north west.
(Abby Hunt,
November 2003)*

This building no longer survives, but at the start of the EH survey in November 2003 it was in the process of being demolished, apparently because its slated roof had become unsafe (Mike Thwaites *pers comm*). Rectangular in plan, and one storey high with gabled end walls, it stood on a platform cut into land which rose in a westerly direction above the tramway spur. It was built of coursed rubble with dressed sandstone quoins and measured 7.2m by 5.25m. Two doorways pierced the long southern wall while the north wall contained another doorway off-centre towards the east. Since the openings were plaster lined, it was unclear which were original. Just below the apex, each gable end had two brown circular ceramic pipes which ventilated the building, a feature found in other gunpowder buildings on the site (saltpetre house plus store and stable). The east gable wall had a small window which was blocked by a rectangular outshot built of coursed rubble with slate block quoins which had been erected sometime after 1974 (Ordnance Survey 1976). Externally this outshot measured 3.35m by 1.5m and was set 0.7m and 0.9m in from the south-east and north-east corners respectively of the engine house. It was entered through a low doorway in its east wall. Inside the probable engine house all that was visible were the remains of modern sinks and toilet pans. Following demolition of the building the platform has been extensively graded and altered to make way for caravan pitches. The site of this building lay outside the area surveyed at large-scale by EH so does not appear on figure 66.

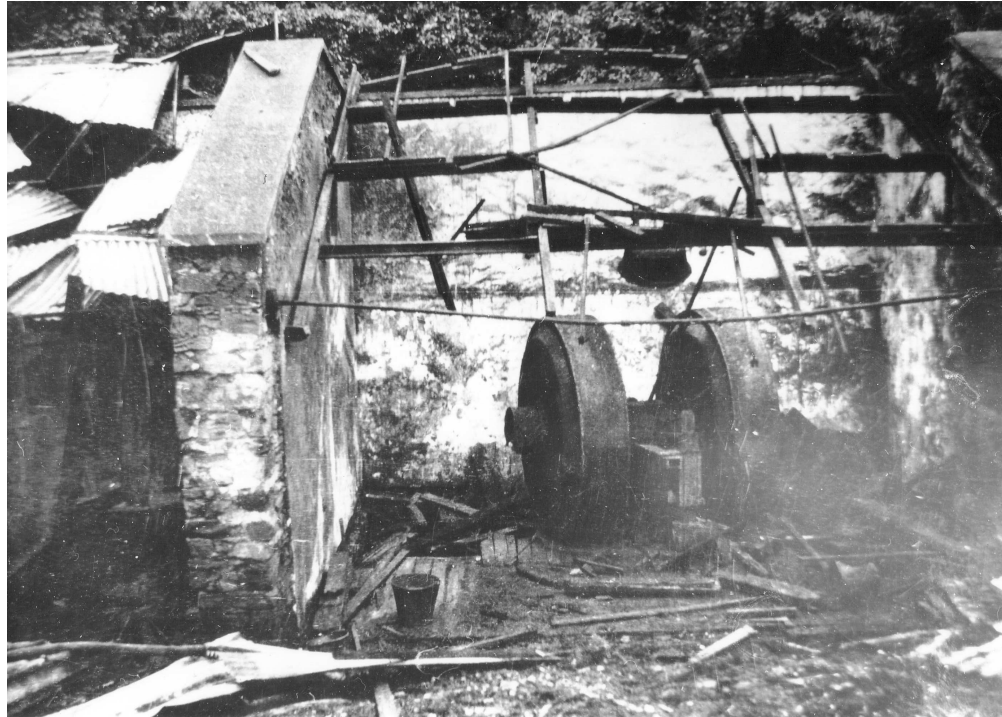
Figure 25.
Mill chamber 2 and its
edge runner mill after
the explosion in
September 1928,
looking east. (NMR:
Patterson Collection)

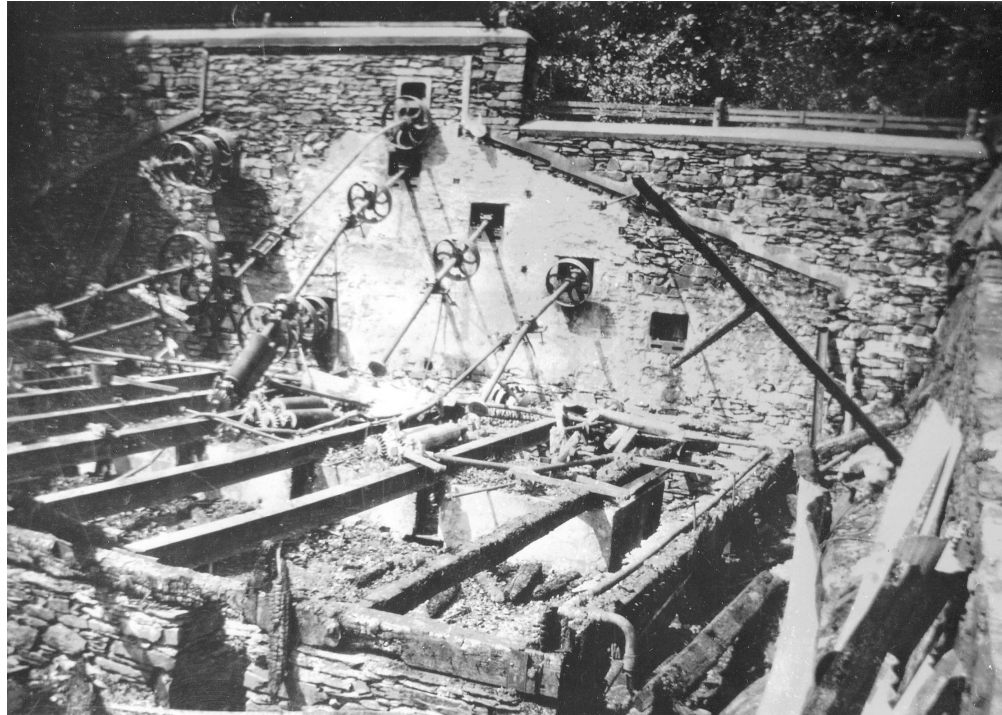
Figure 29.
*The charred ruins of
 the corning house
 after the fire in June
 1929. (NMR:
 Patterson Collection)*

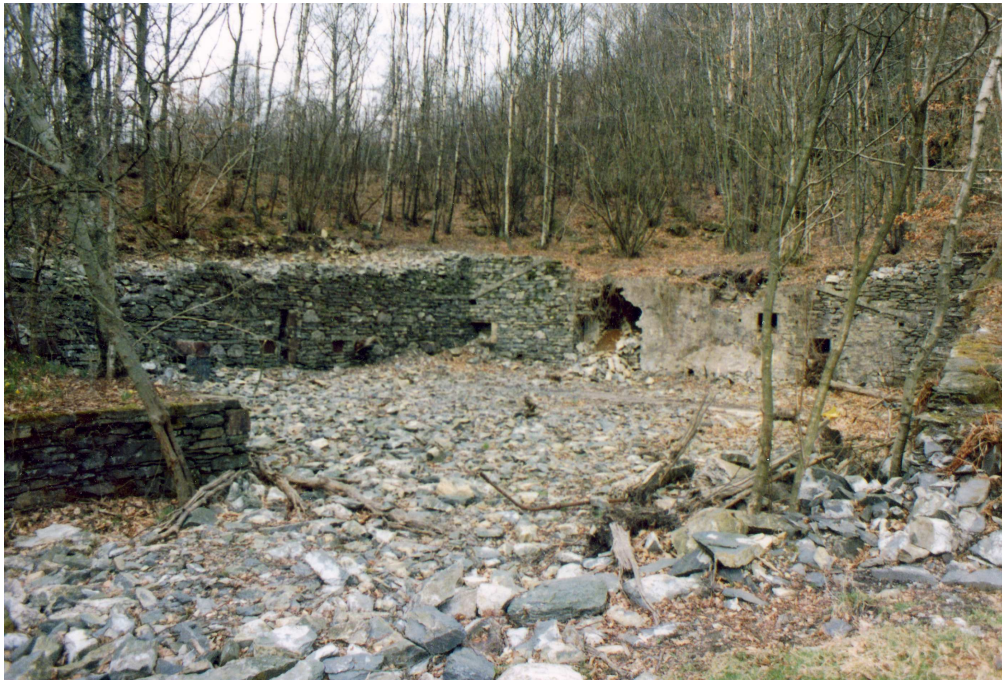
Figure 30.
*The remains of the
 corning house
 (destroyed by the
 June 1929 fire) in
 April 1979. (NMR:
 Patterson Collection)*

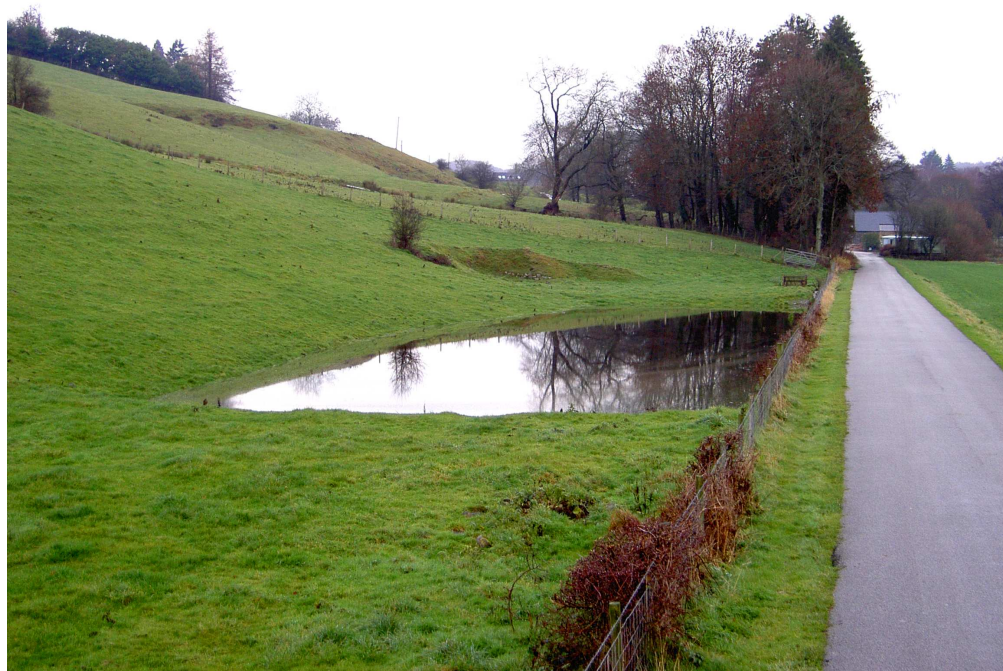
Figure 36.
Standing water between the sites of cartridge houses Nos 4 and 3; the latter is visible in the middle distance and the site of the store magazine is marked by the clump of tall trees on right. Taken from the south. (Abby Hunt, December 2003)

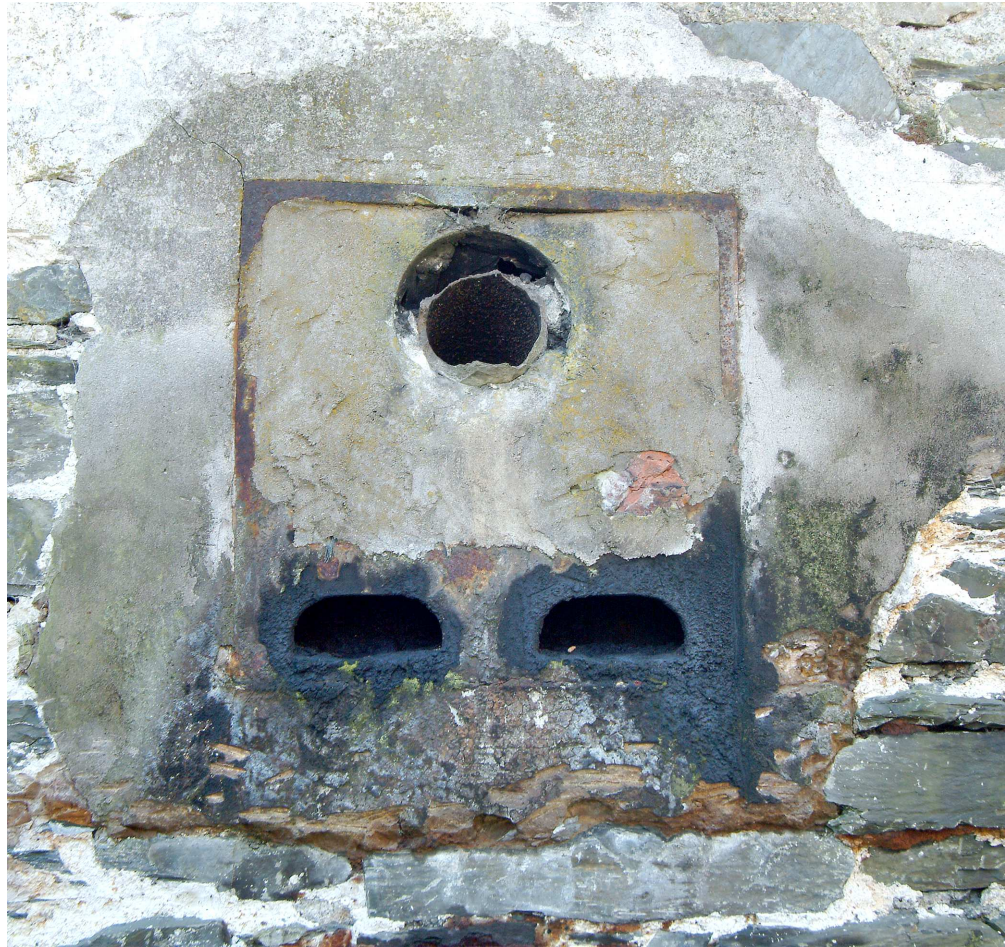
Figure 43.
*Wall box in outer face
of north wall of
building range
immediately south of
former incorporating
mills. Broken pipe
from later reuse is
visible in upper hole.
(NMR: DP003397)*
