THE HERMITAGE,
17 UPPER SUTTON LANE,
LB HOUNSLOW

A LATE-MEDIEVAL TIMBER-FRAMED
HALL HOUSE AT HESTON

Richard Bond & Mike Dunn

Reports and Papers B/024/2003
2003

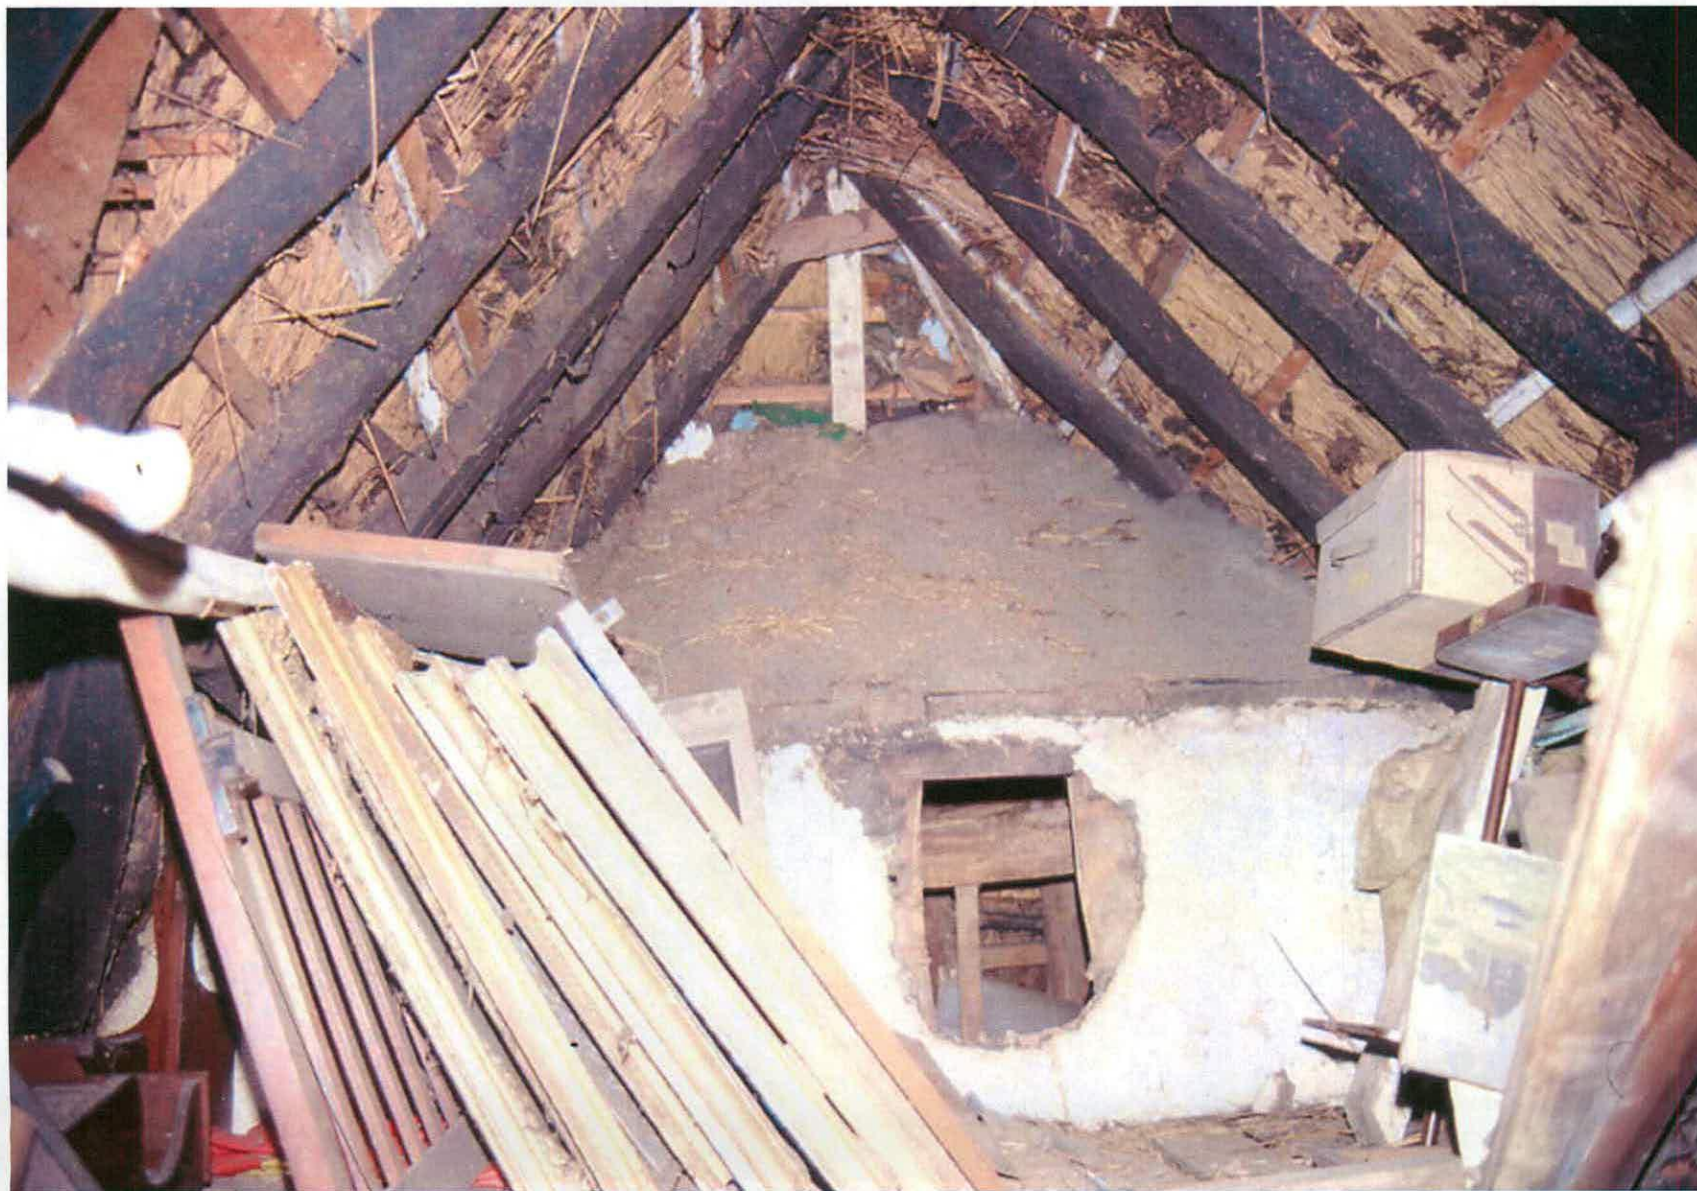
Figure 17 Interior of roof space looking west, showing smoke-blackened roof timbers and sloping ceiling over solar chamber. Photo taken in 1995

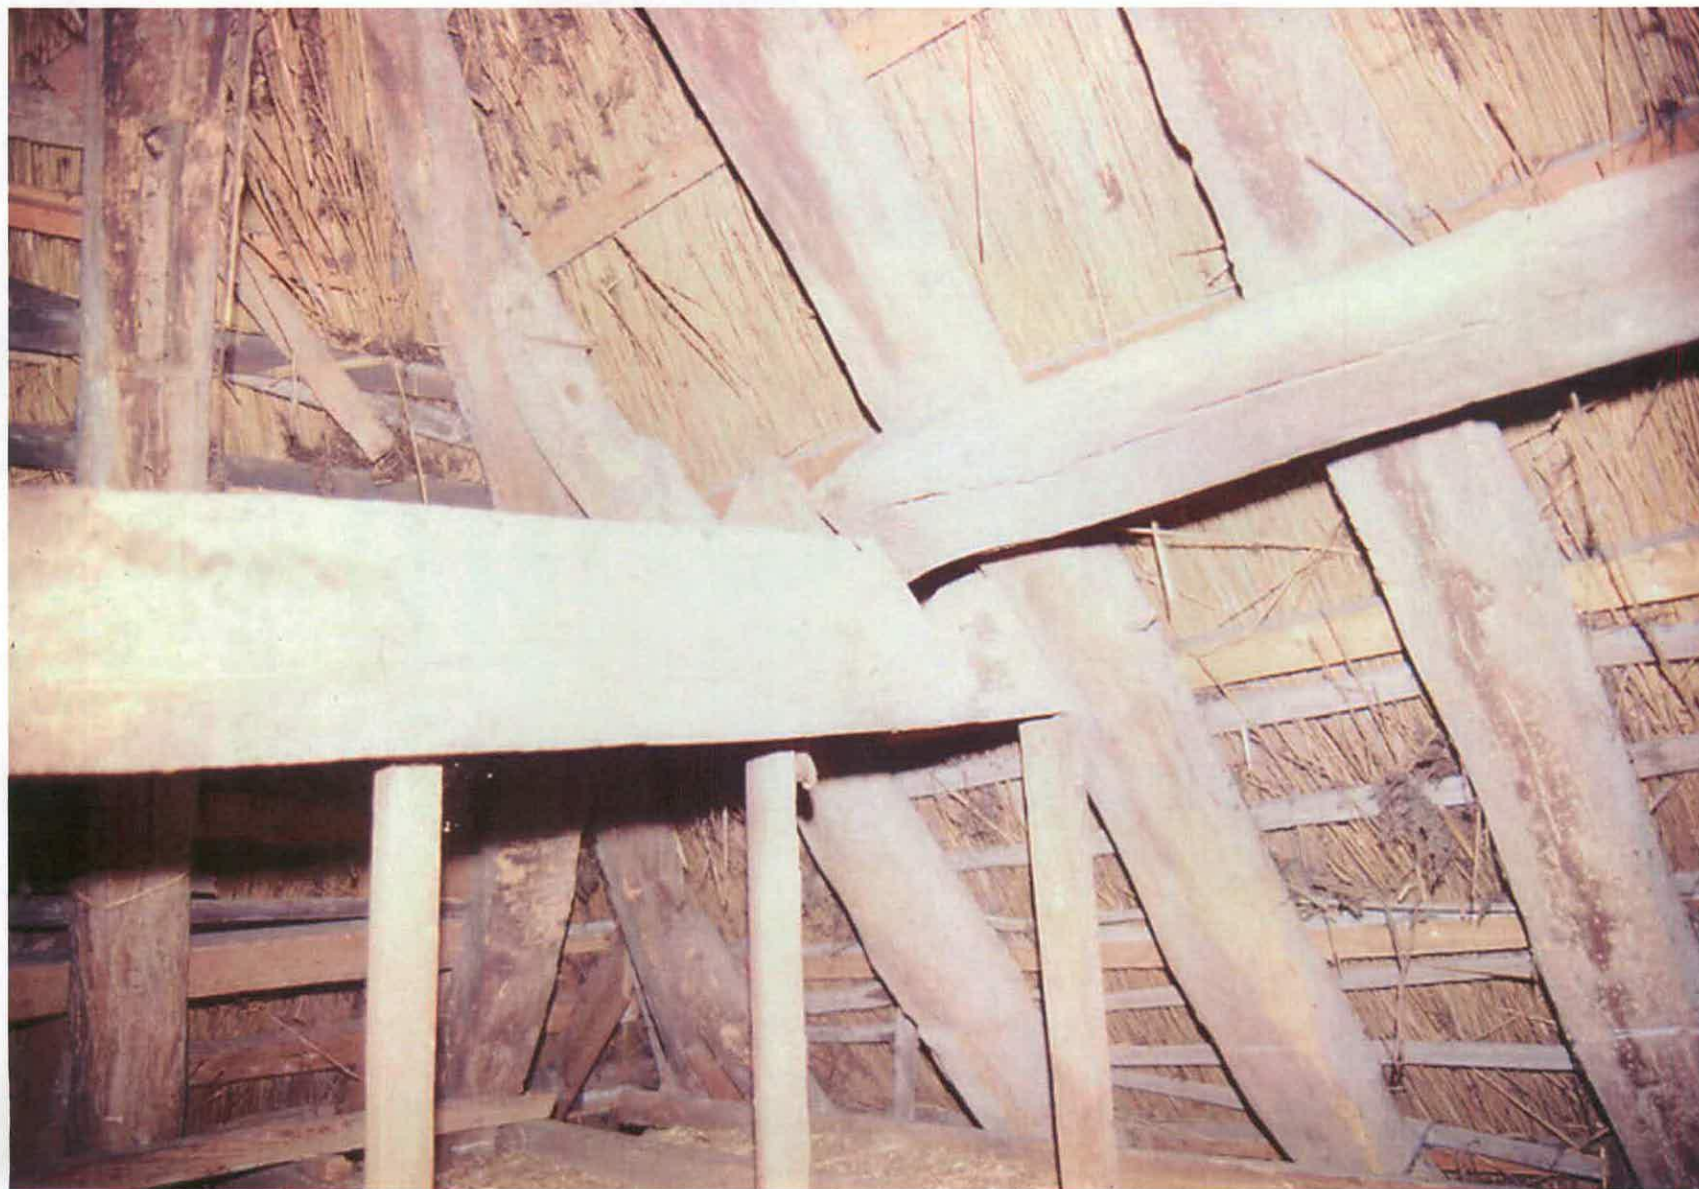
Figure 18 Interior of roof space over west (solar) chamber. Note the absence of smoke-blackening on the original roof timbers. Photo taken in 1995

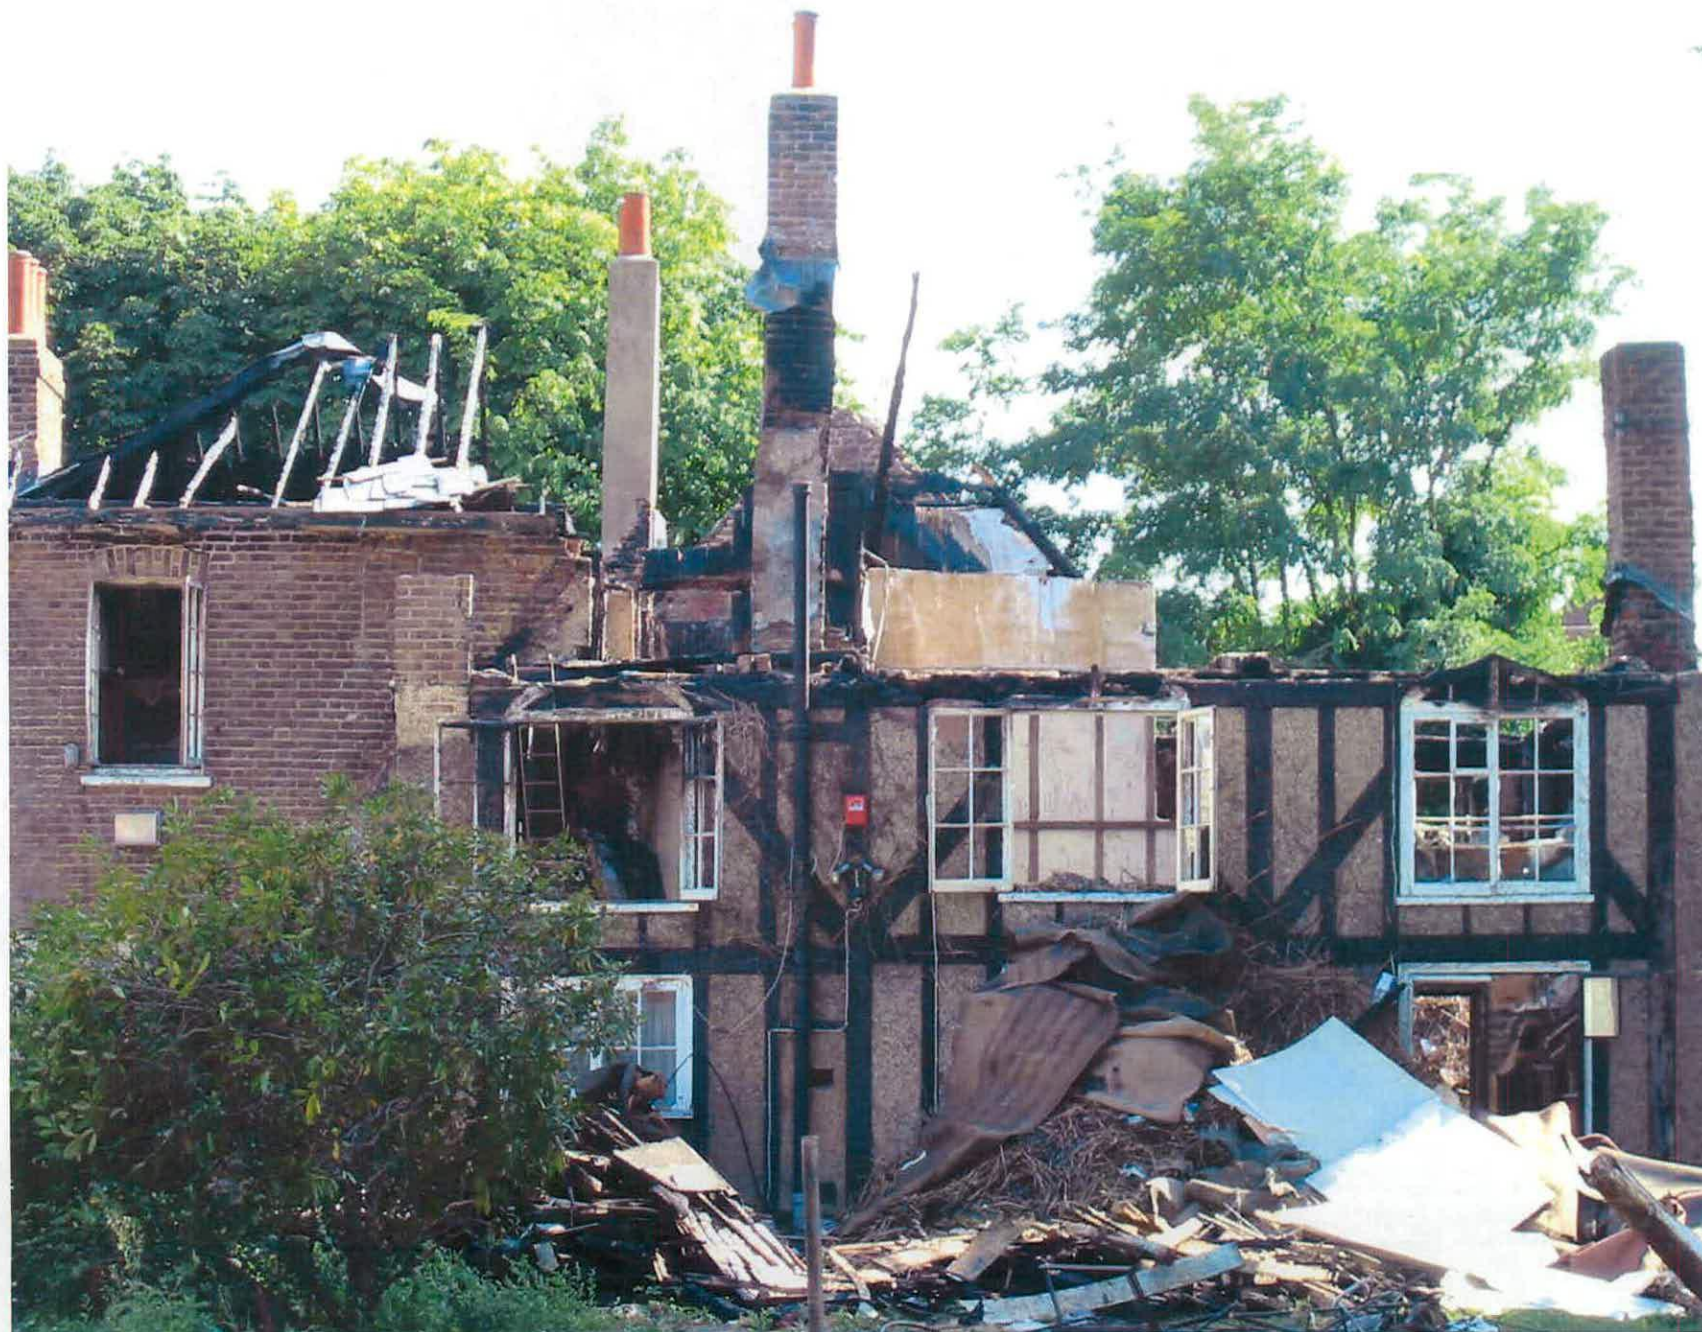
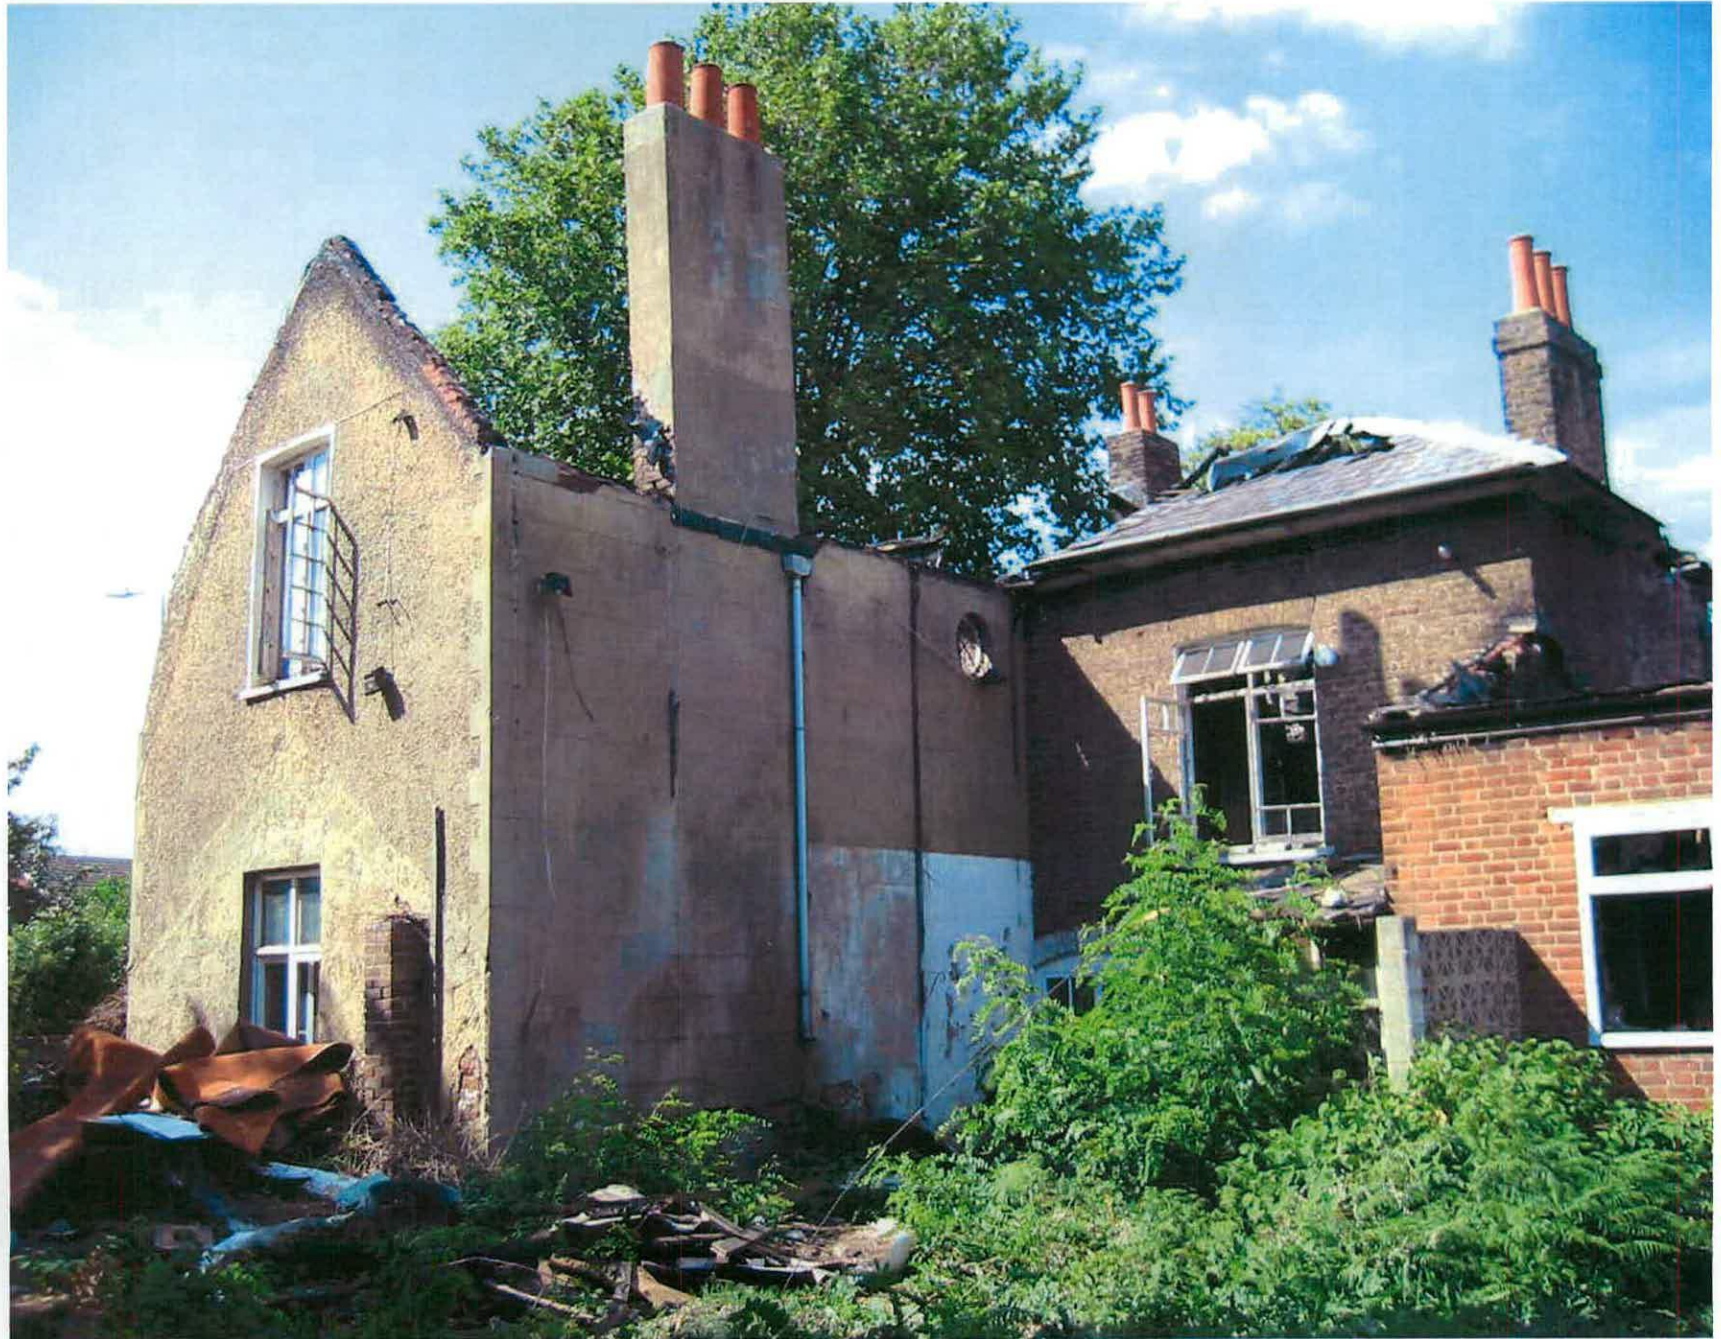
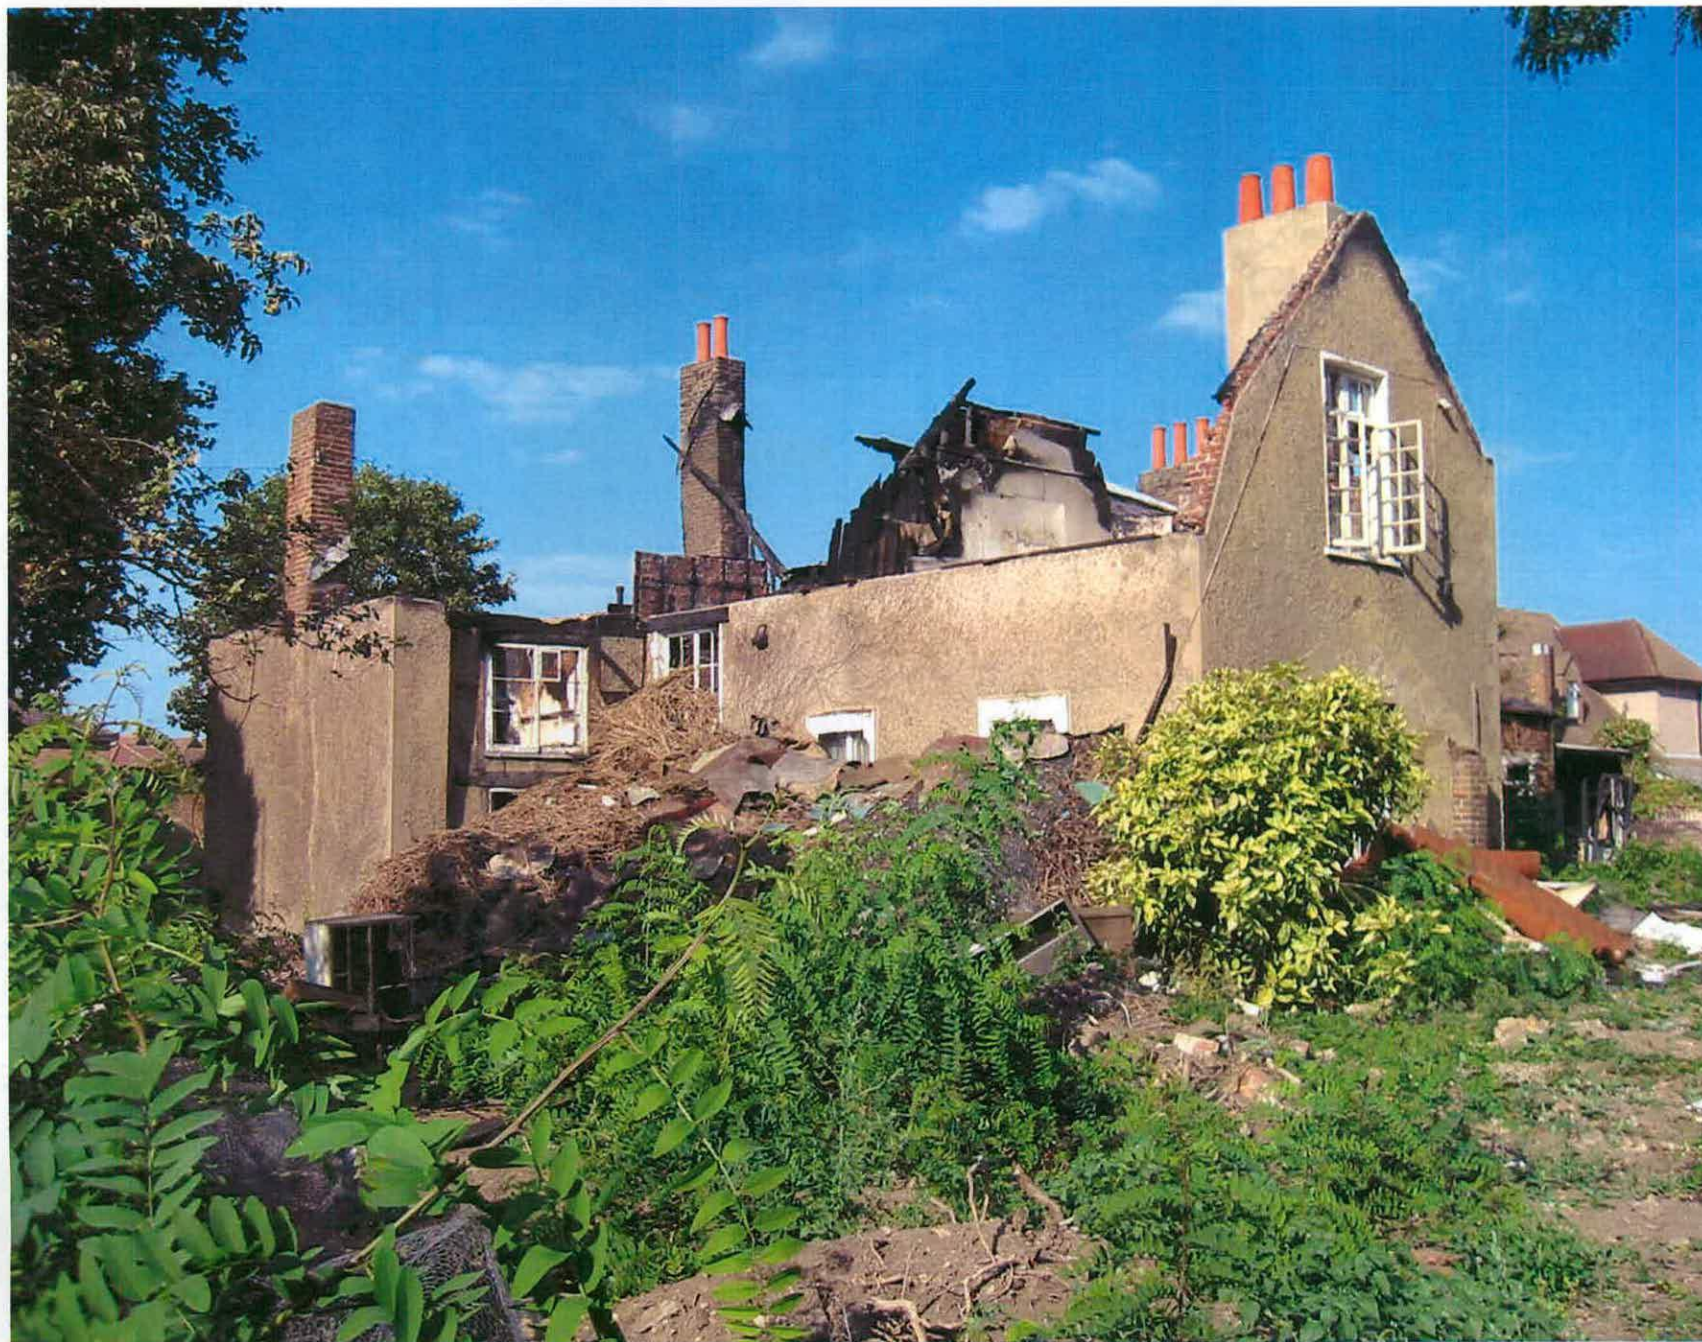
In June 2003 a fire at the house destroyed the whole of the roof of the medieval wing and the roofs of a late seventeenth or early eighteenth century south wing and early nineteenth century extension (*figs 19, 20 & 21*). The other buildings on the site, a group of mainly single-storey outbuildings of nineteenth century date, remained undamaged. Following the fire, the burnt roof timbers were removed from the building and stacked up in the garden in front of the house. Although one of the upper rooms had lost its floor (probably of eighteenth century date) and some of the timbers were badly charred in certain areas, the timber frame in general survived in a reasonably intact condition up to wall plate level (*figs 23 & 23*). Indeed it is somewhat ironic that the fire, whilst destroying the roof of the medieval house, led to the uncovering of many hitherto hidden features, including evidence of the position of doors and windows (*figs 25 & 26*).

Figure 19 View of front (N) elevation of house following the fire in June 2003

Figure 20 View of house from south-east following the fire in June 2003

Figure 21 View of house from south-west following the fire in June 2003

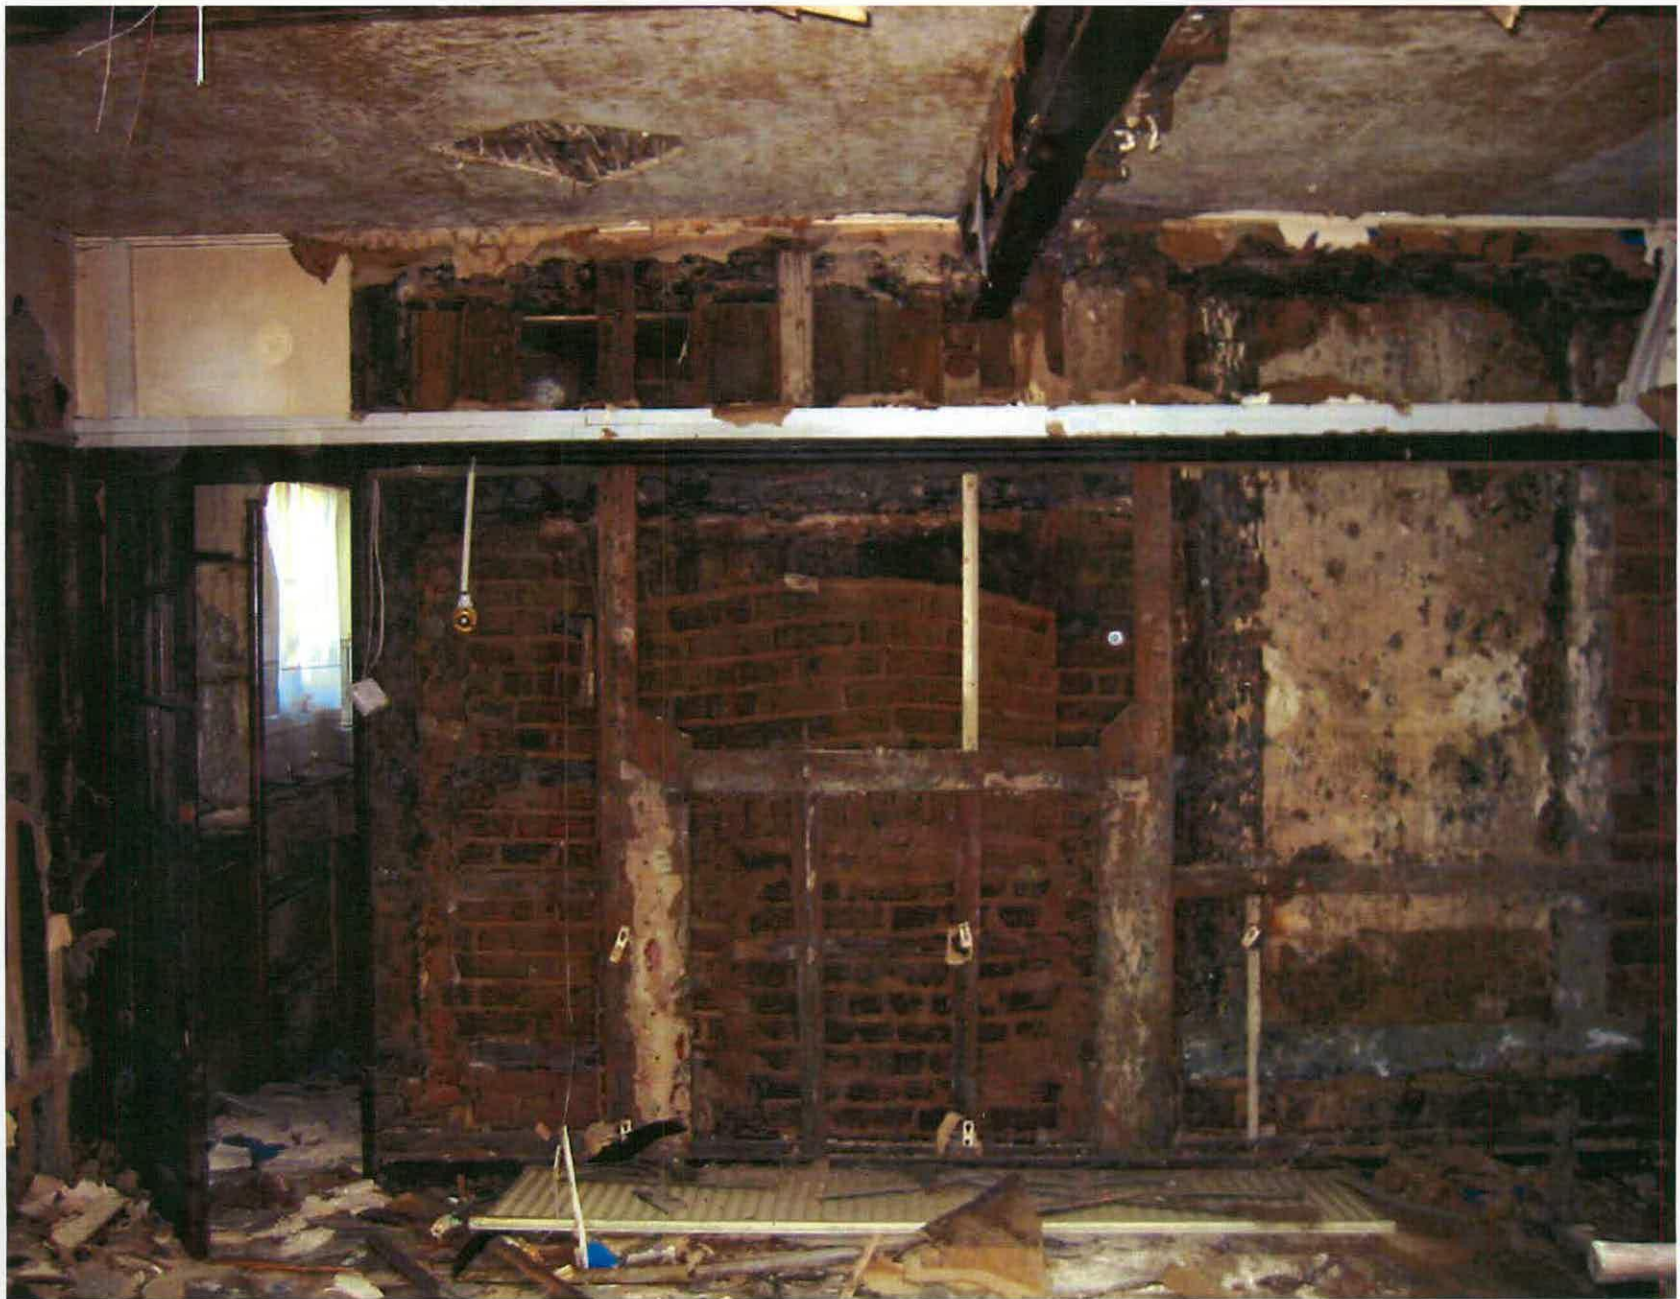
Figure 22 View of central (hall) bay looking east following the fire in June 2003

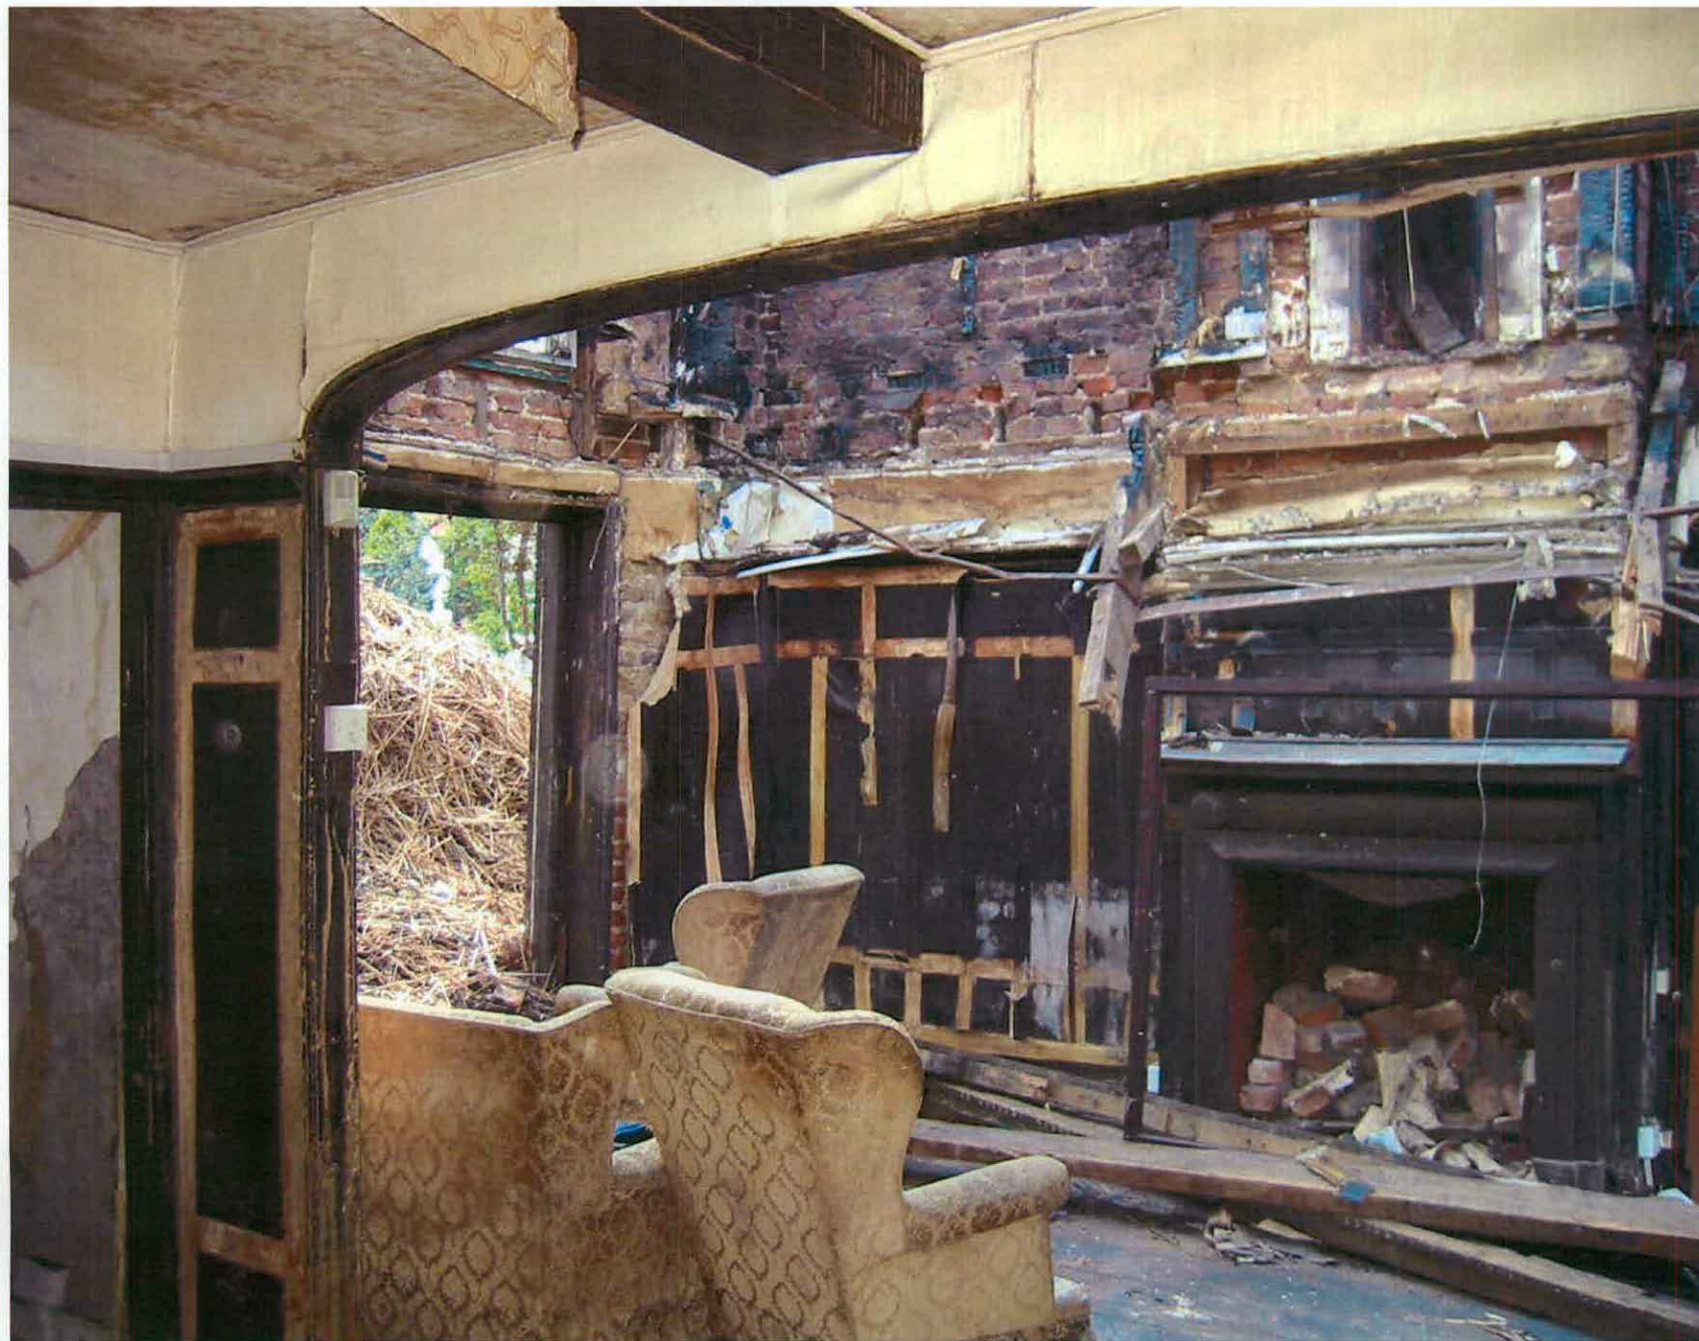
Figure 23 View looking south-eastwards from central (hall) bay into west bay following the fire in June 2003

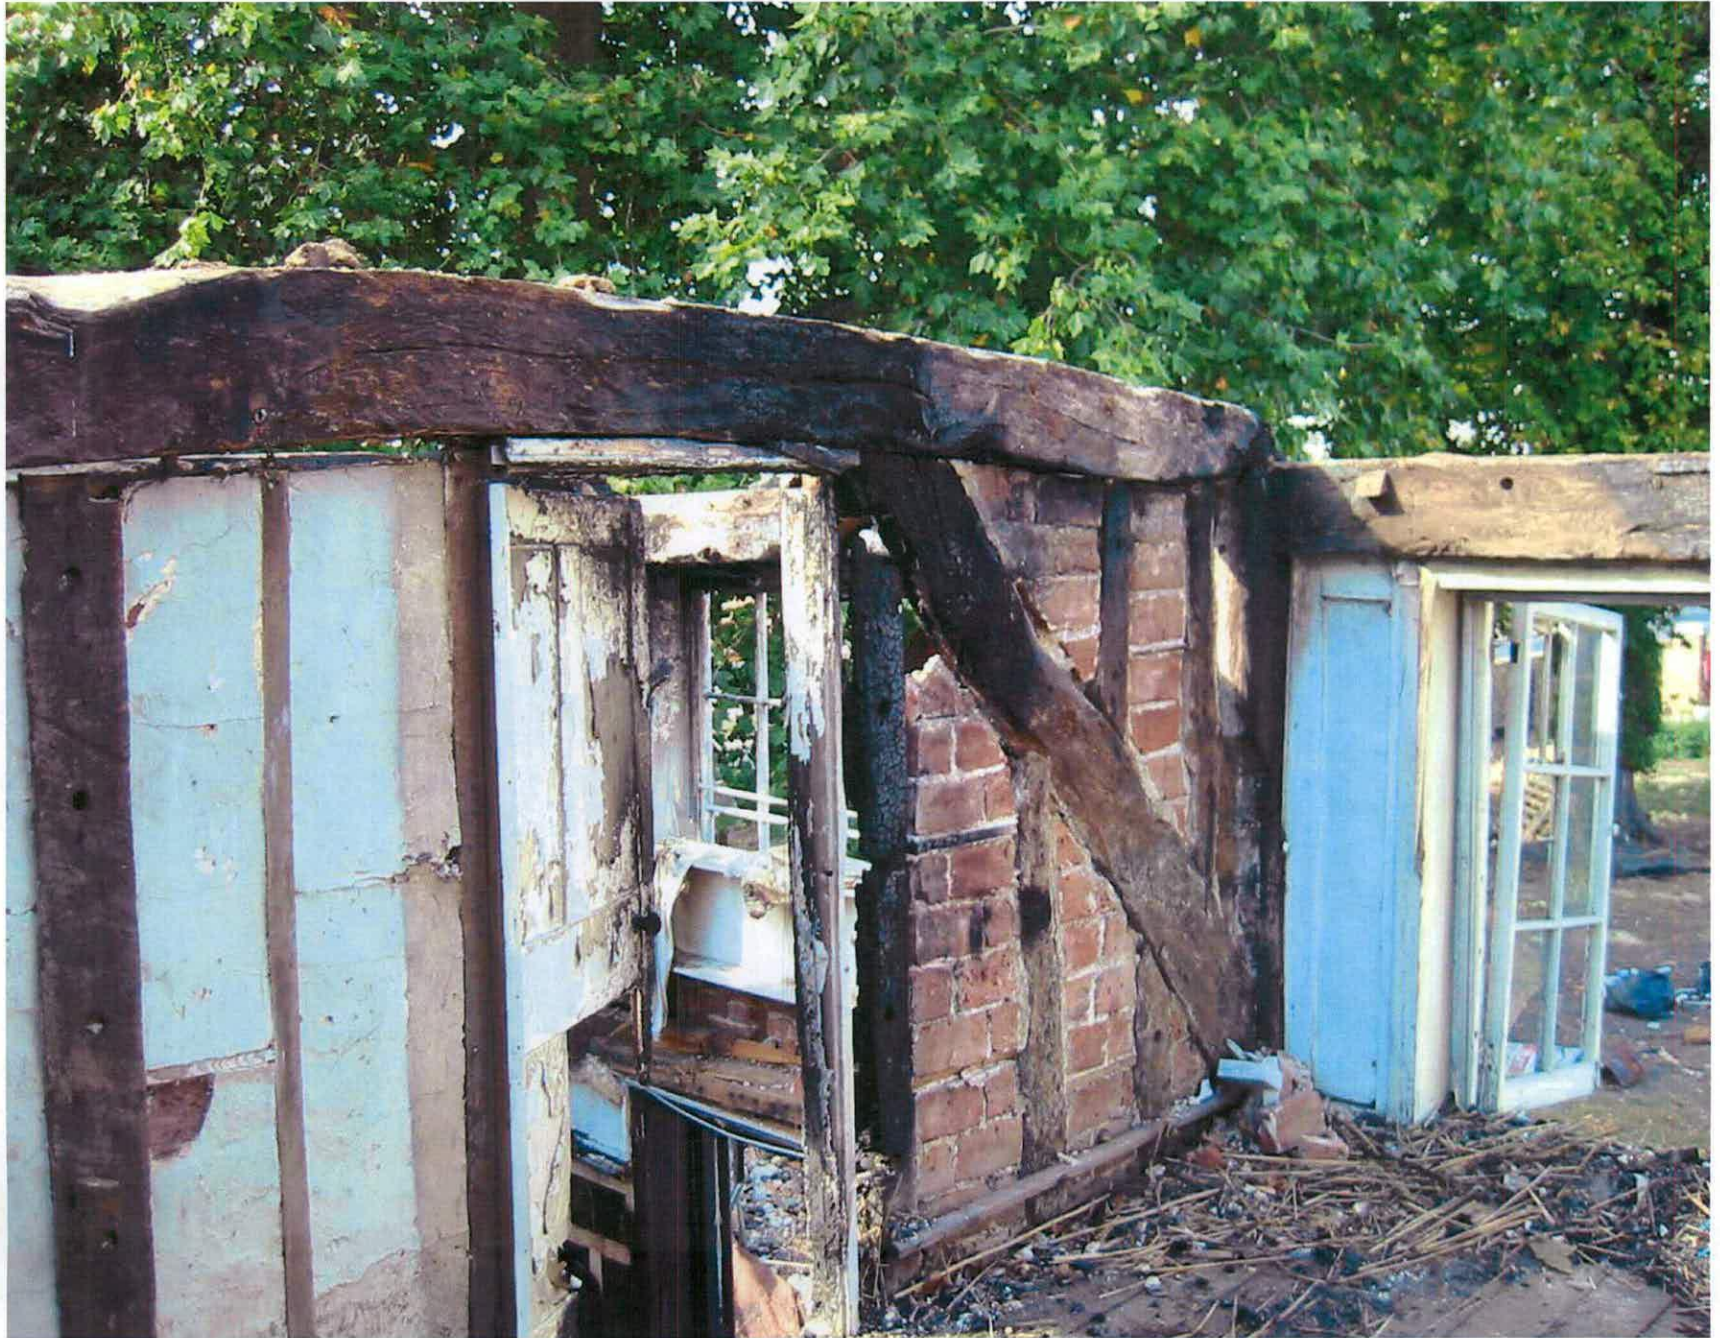
Figure 24 Framing of upper part of west intermediate cross frame following the fire in June 2003

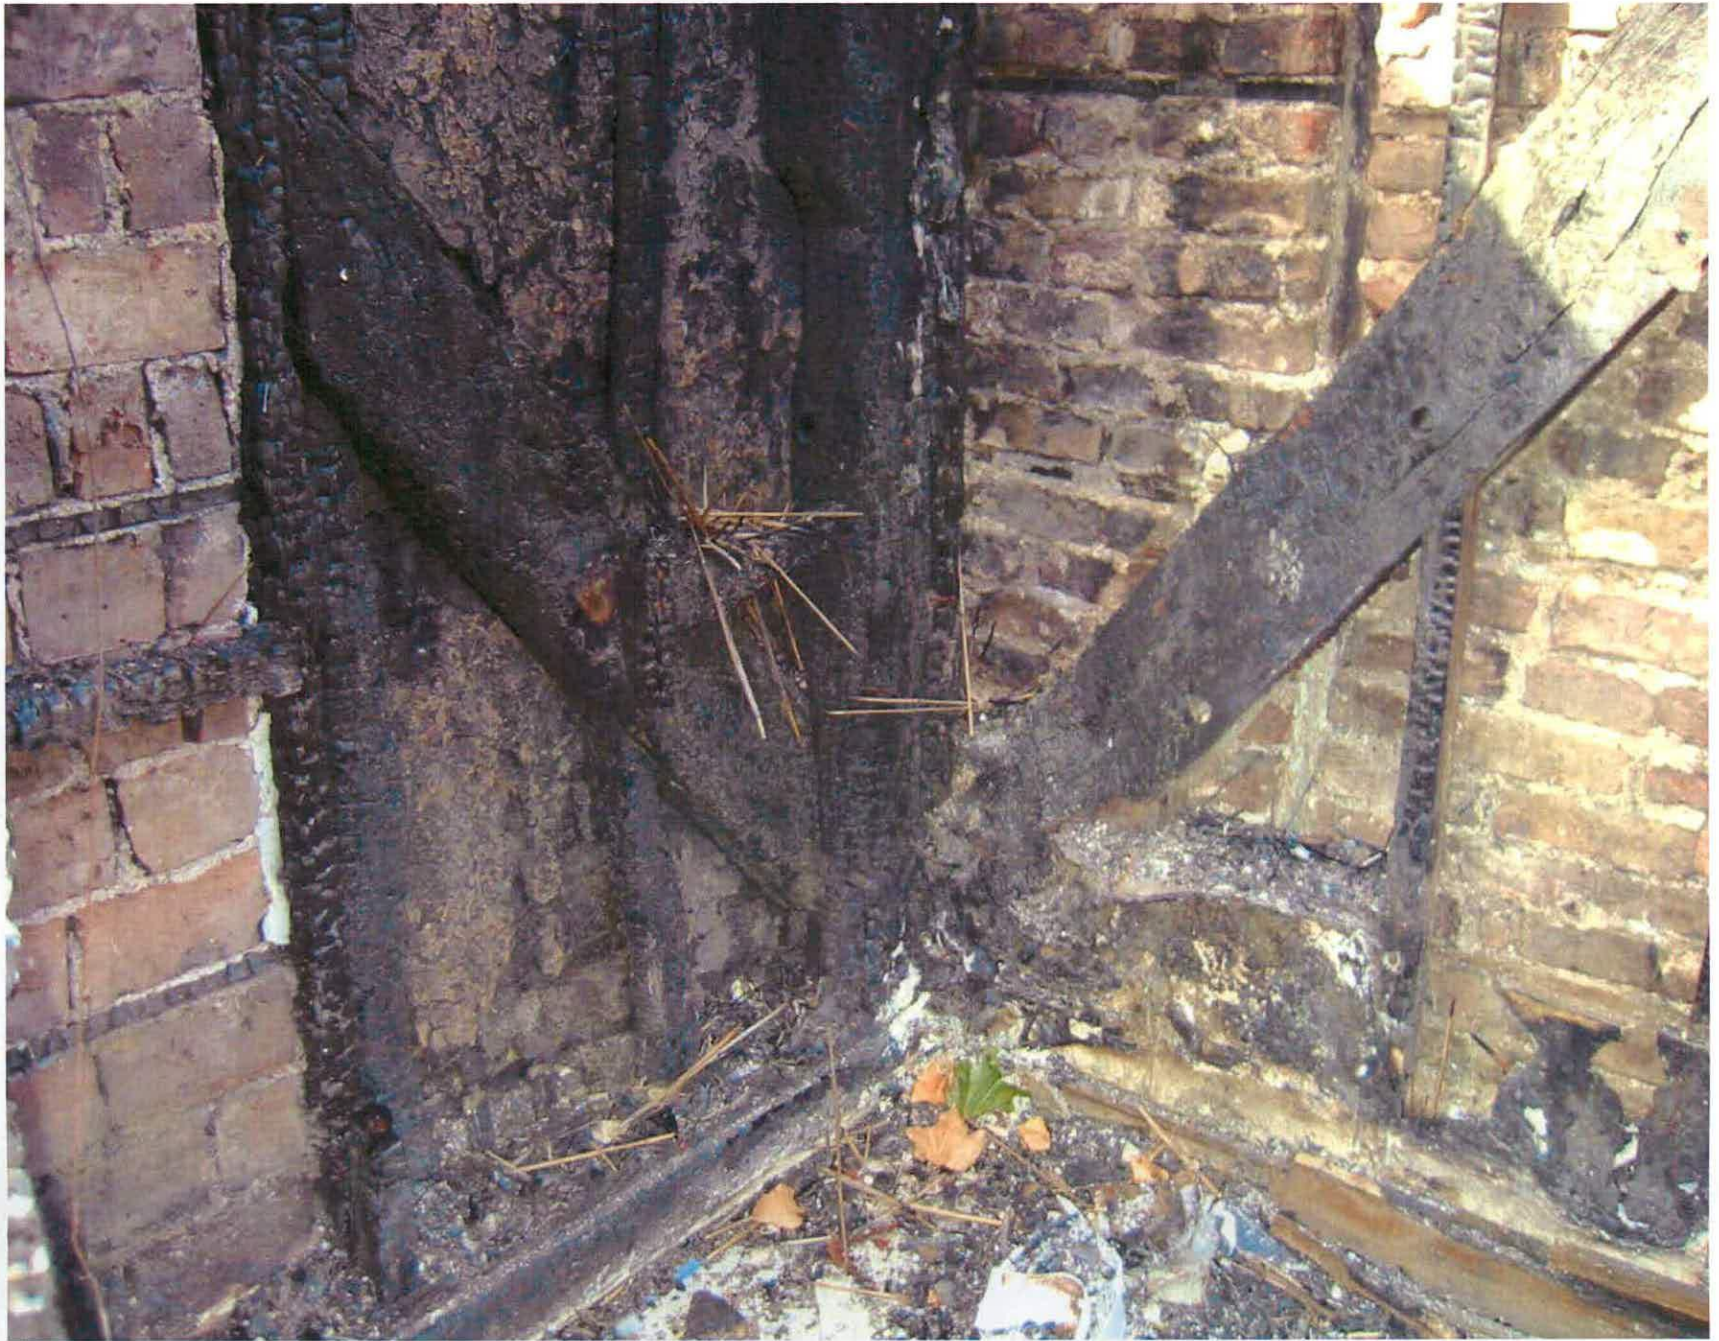
Figure 25 Exposed timber frame at first floor in north-west corner of east bay

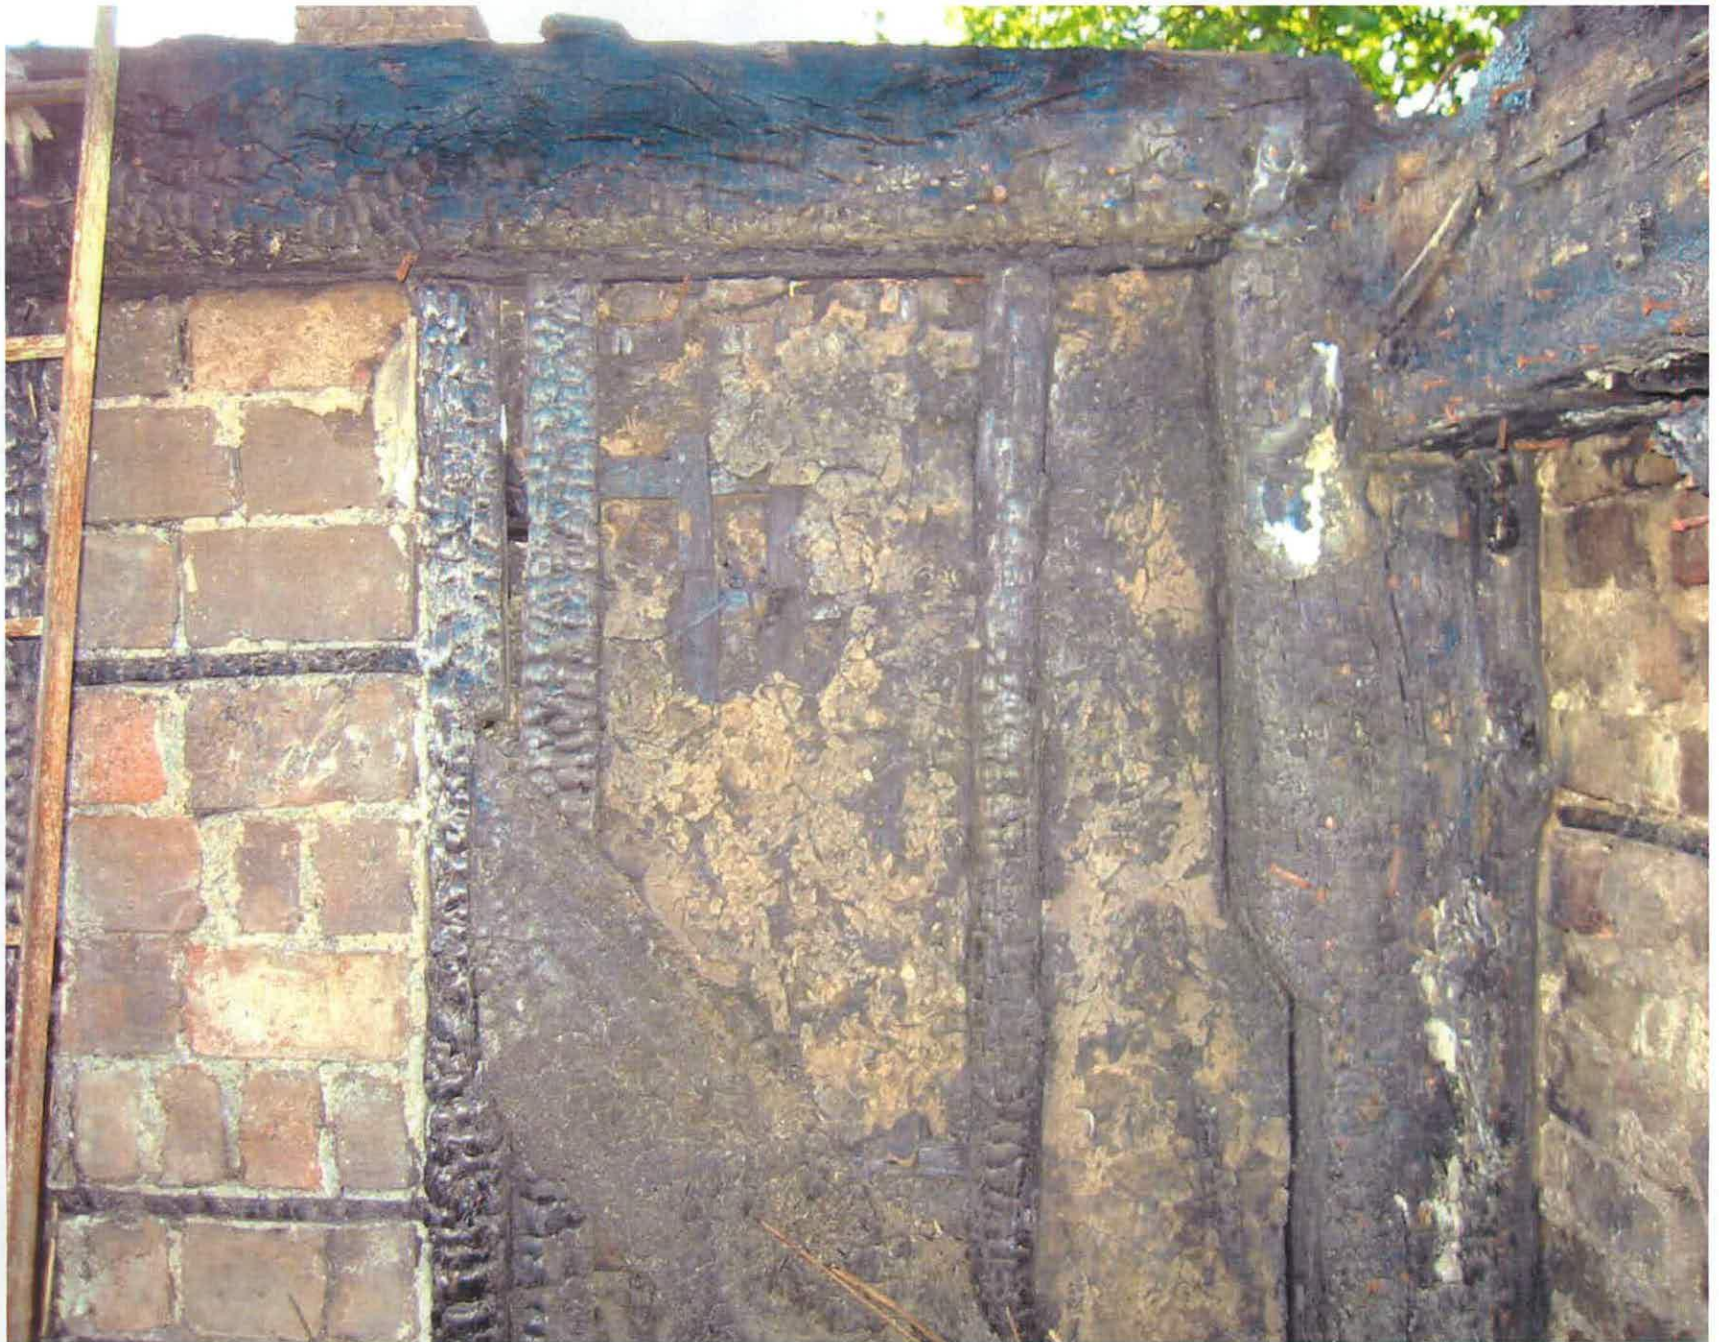
Figure 26 Original late-medieval infilling of timber frame at north end of east intermediate cross frame
