St PAUL'S CHURCH DEPTFORD LEWISHAM

Glazing and window ferramenta

Reports and Papers 72

2002

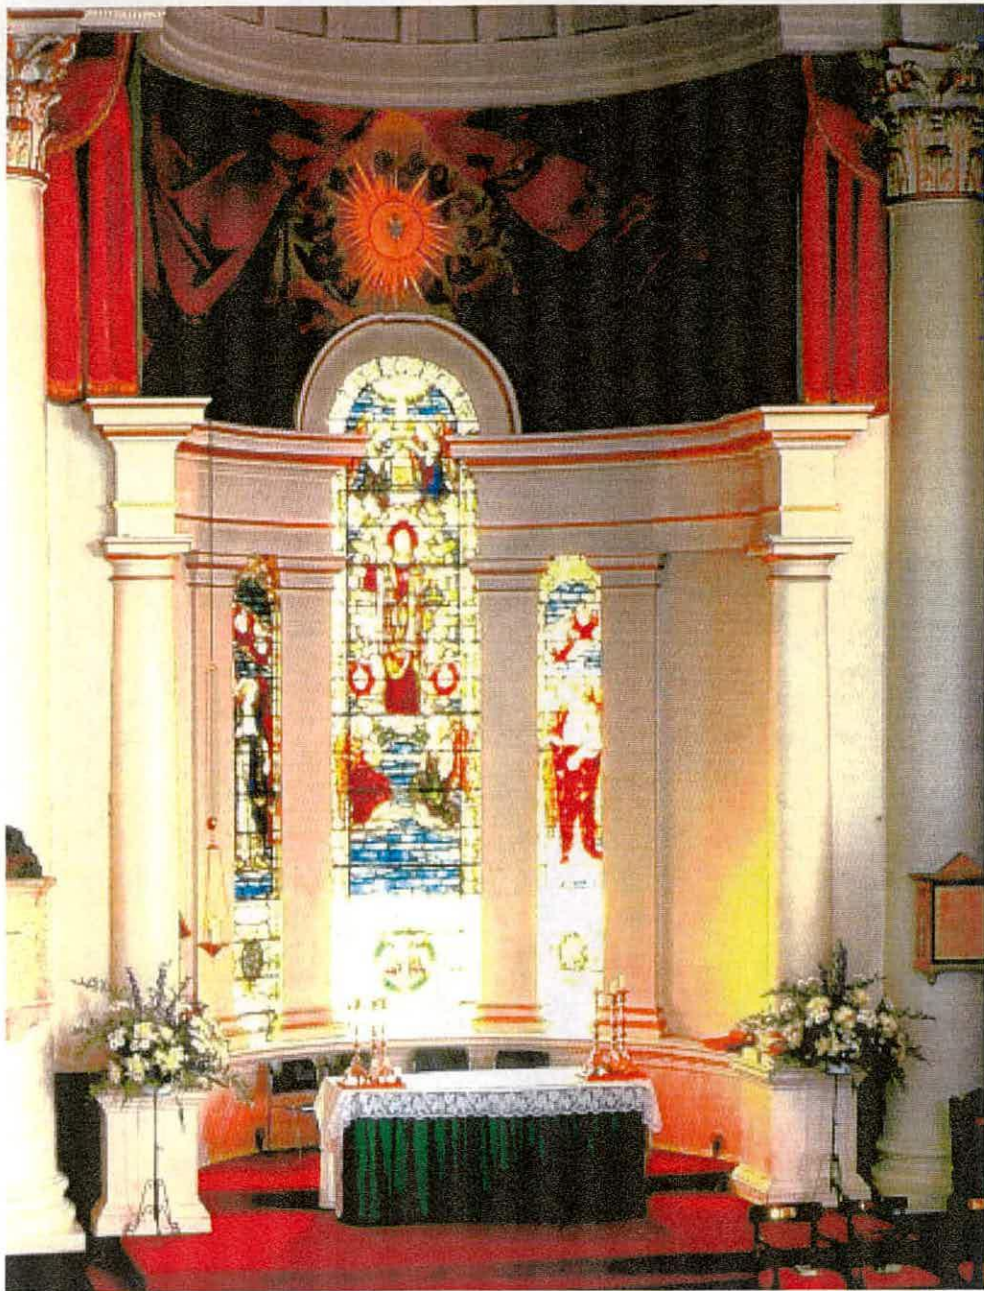
In 1913, the Collins painted glass east window was removed from the east window and replaced by a stained glass window supplied by James Powell & Sons, Fig. 7.¹² This was a fully leaded window supported on a framework very close to the inner face of the apsidal wall, Fig. 31 and Fig. 32. Like the Collins window before it, the figurative content required good site-lines from within the church. Externally, however, it was set a long way from the outer wall face and the window openings would have appeared cavernous, Fig. 33. The inner set of columns, originally designed to be seen from inside the church only, now formed part of the exterior elevation. The original ferramenta, which remained *in-situ*, would have offered a degree of security. The removal of the centre sections of six of the lower horizontal bars may have occurred when either this or the Collins window was installed.

Fig. 7, the chancel photographed before the fire of May 2000 (photograph supplied by Roy Tindle).

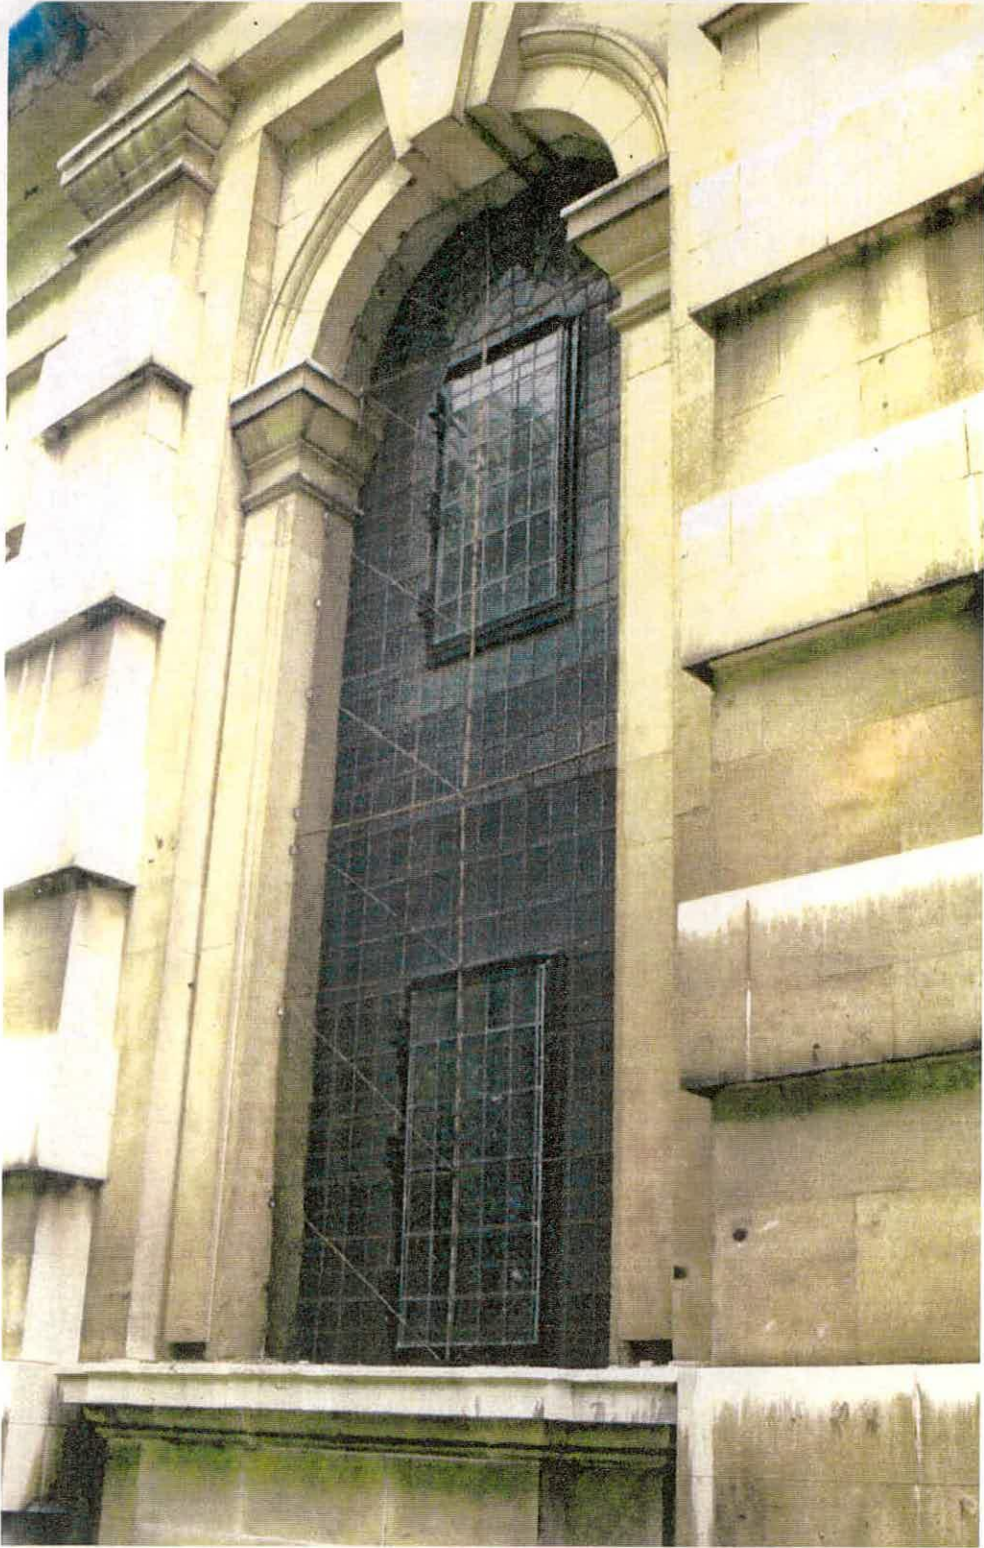
Access to the windows for study is currently restricted by various security measures. The visually intrusive wire mesh security grilles, designed to prevent unlawful access, also hinder observation, Fig. 11, and the east window is currently boarded with plywood. Because of the problems of access, the dimensions included in this report are approximate, especially for the east window. Naturally, there is variation in the section of wrought iron and accurate measurement is now made difficult by successive layers of paint and corrosion. The dimensions cited here are therefore for interpretation only and should not be used for the specification of repair without checks on site.

Fig. 11, a standard window, east of the north door, June 2002.

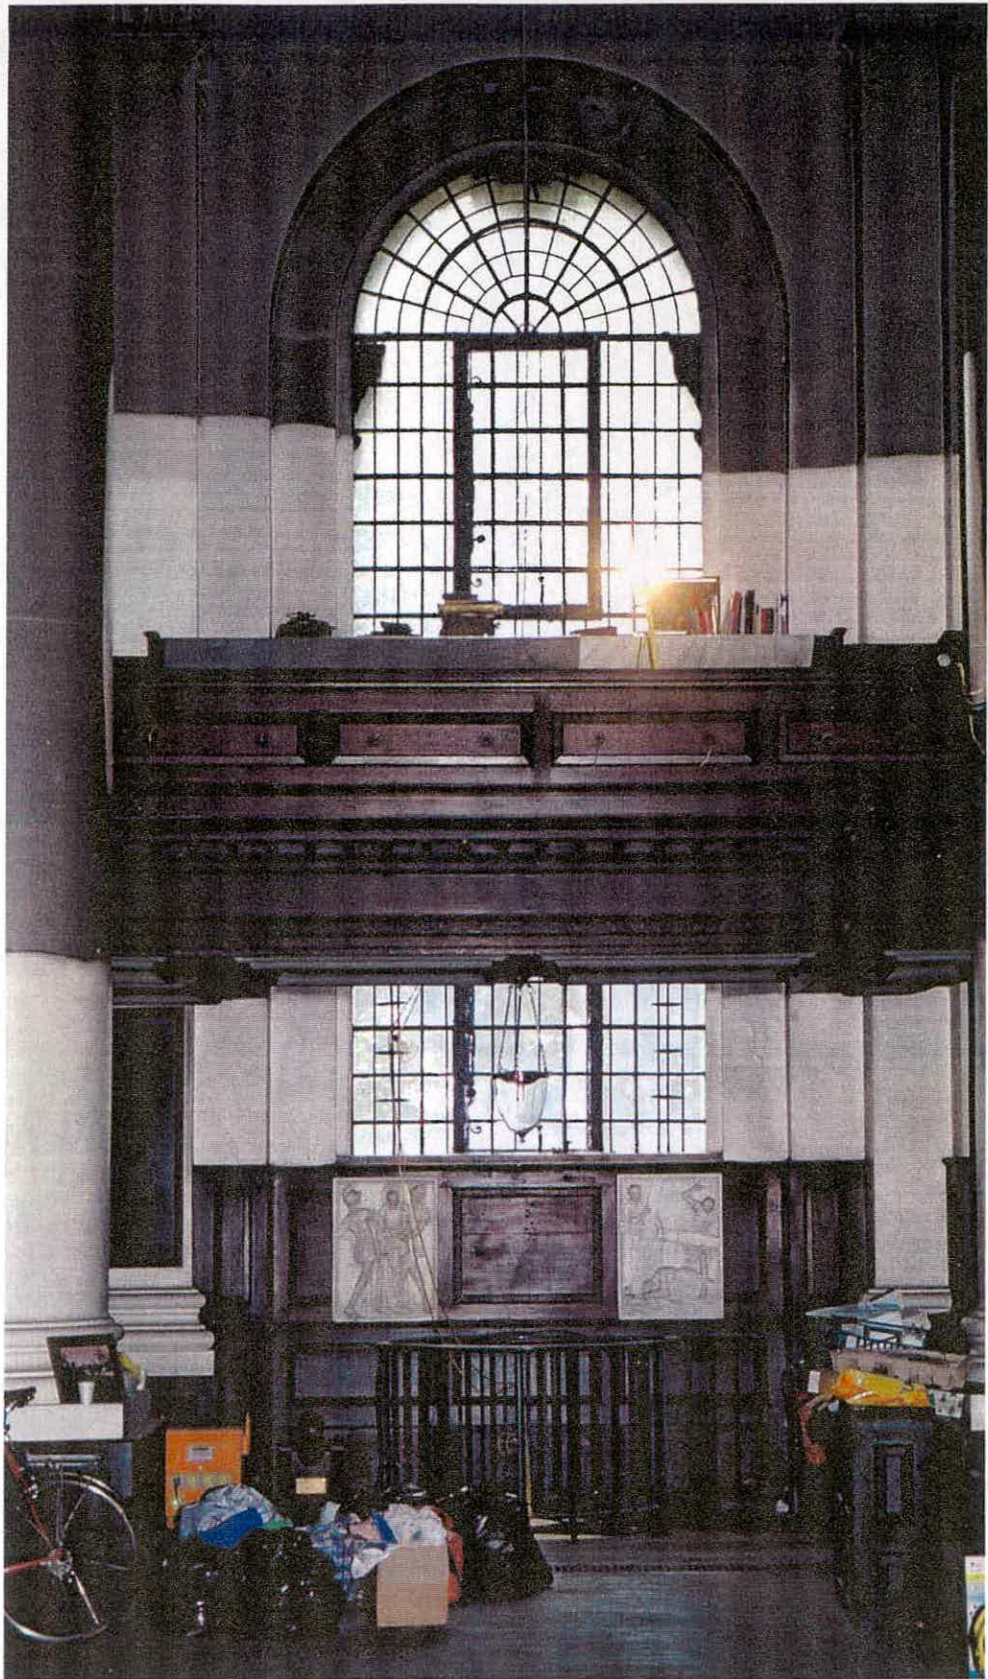
Inside each window, the slight masonry rebate, in which the frame of iron glazing bars is set, is the depth of the frame itself. Immediately inside this frame, is a second rebate of *c* 70mm, Fig. 12.

Fig. 12, one of the standard windows in the south wall. The bands of dark and light show where the smoke blackening caused by the fire of May 2002 has been partially removed by washing, June 2002.

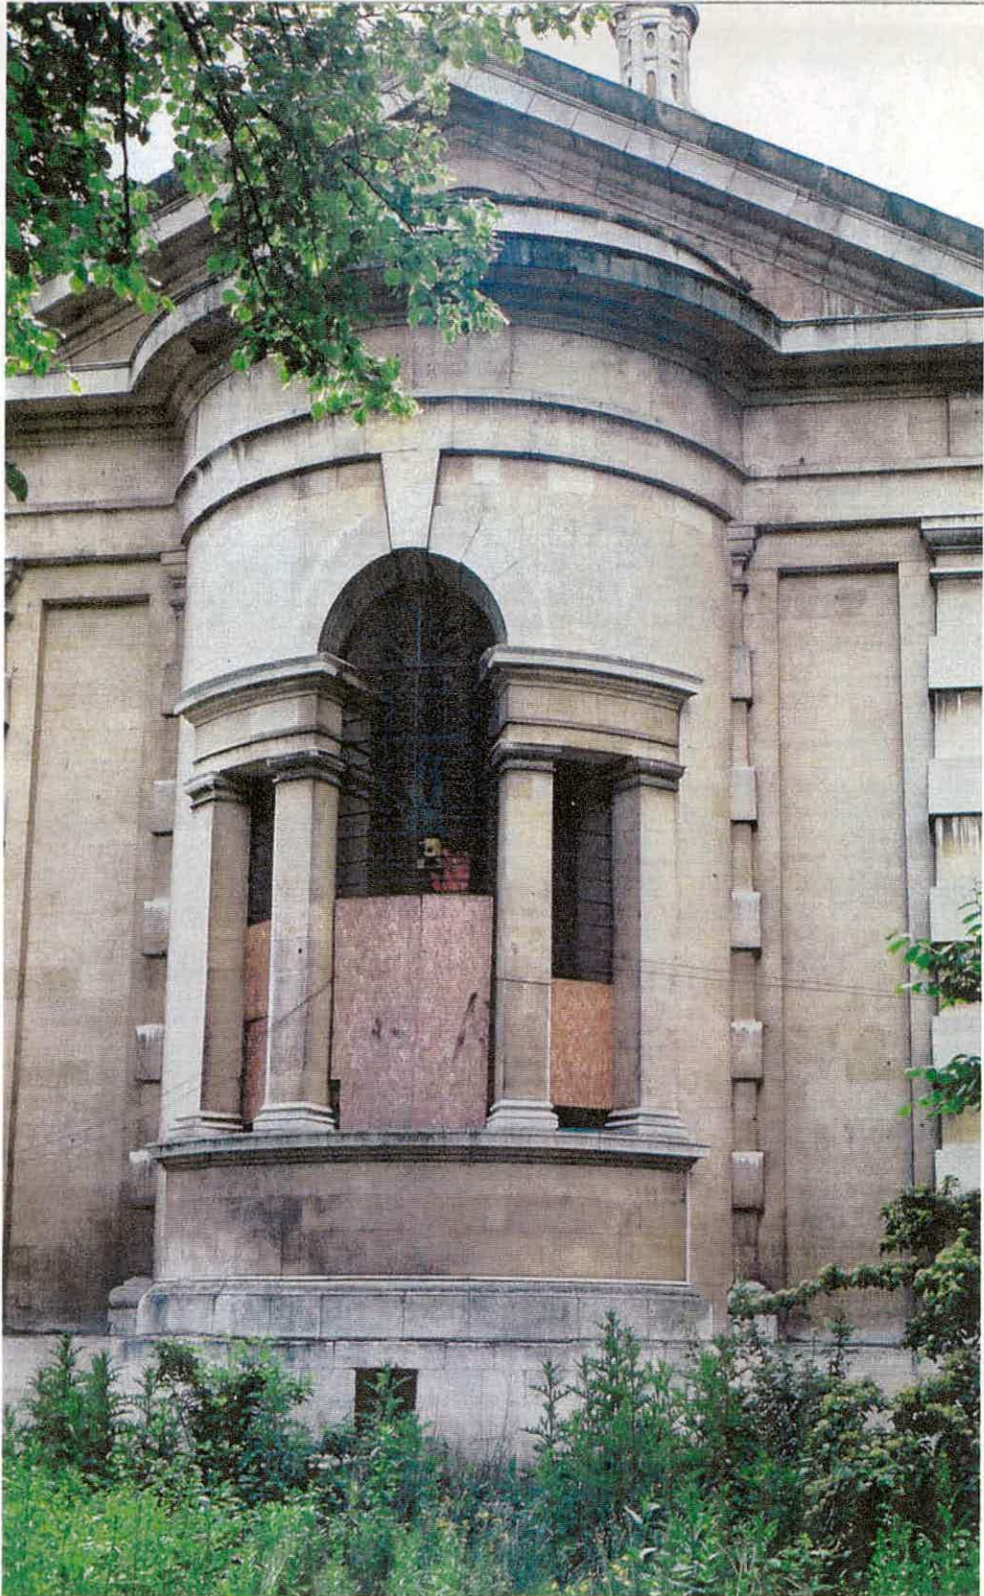
The east wall of the apse is pierced by a Venetian window; a round-headed light flanked by two smaller rectangular lights, Fig. 13. Because the window forms the backdrop to the altar, it is elaborated with more architectural detail than the standard windows in the aisles, Fig. 7. The reveal of each light is treated as a square Tuscan column with a base and capital, although the column shafts are straight with no entasis. The thickness of the wall requires that there are two sets of columns, one on the outside and one on the inside. The two sets are visibly articulated in the reveals, Fig. 14 and Fig. 15. The fully developed Tuscan entablature above the columns is divided in two by the central round headed light. Internally, it appears there was a change of design, when the entablature was extended in timber along the curving apse wall above additional pilasters to meet the three-quarter columns set on the returns at the entry to the apse, all in timber. The additional timber was added in 1722 before Henry Turner was commissioned to paint the interior in 1724.¹⁰

Fig. 13, the east window as it appears after the fire, June 2002.

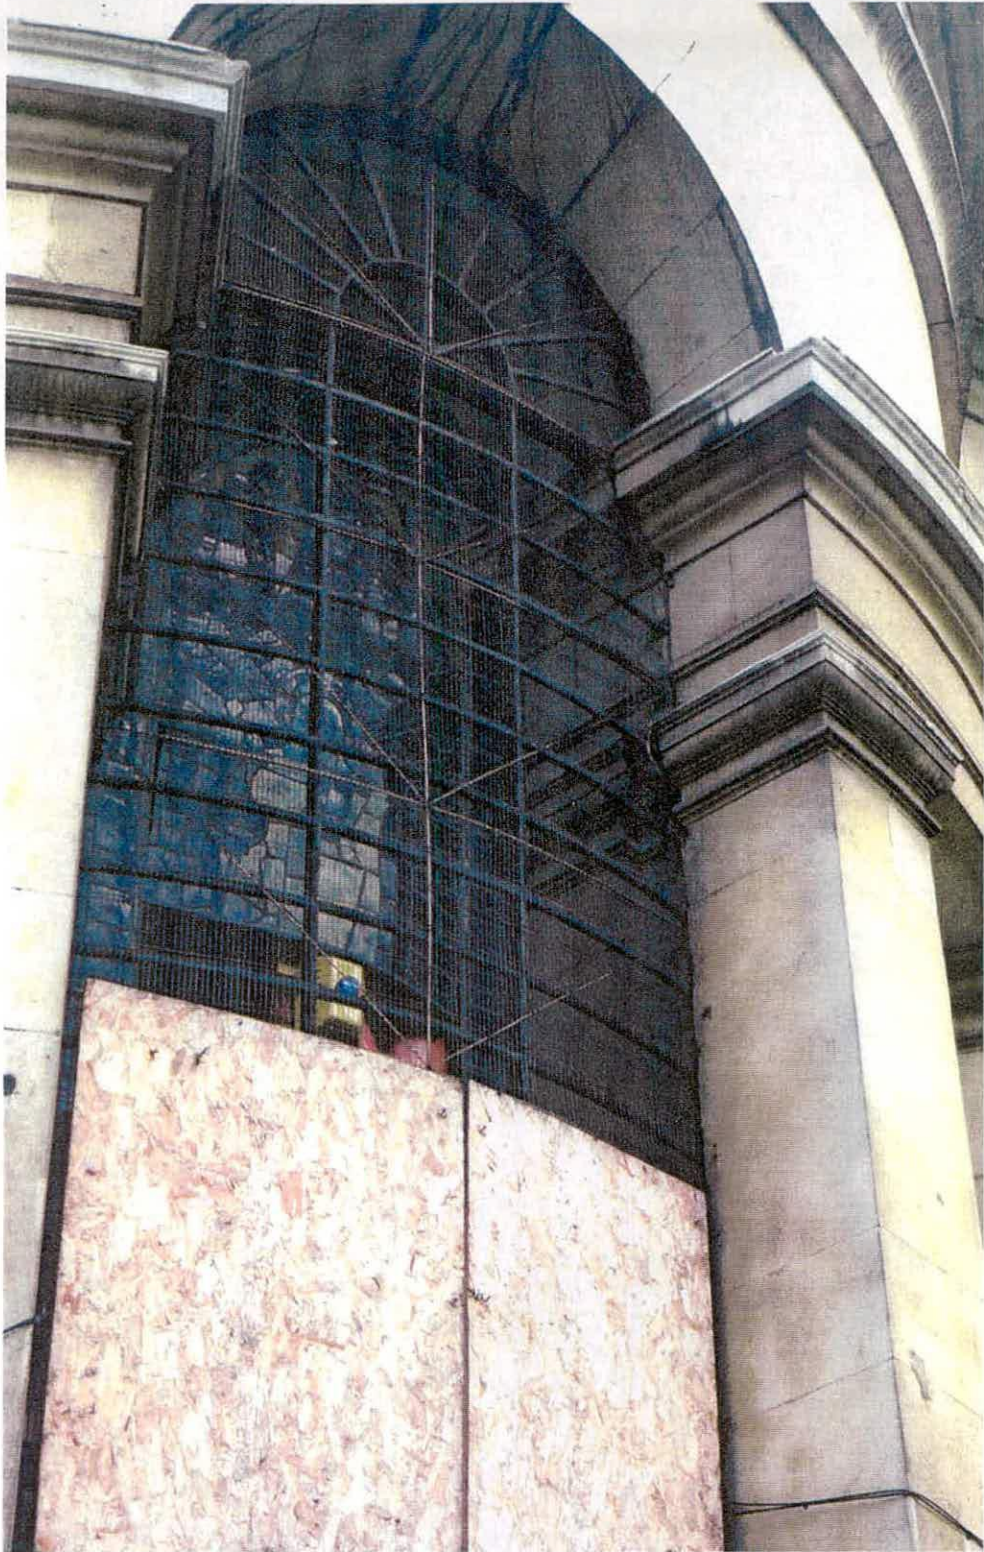
The original ferramenta in the east window survives *in-situ* although it is now located outside the present glazing, Fig. 14. It is set just inside the outer set of pilasters. Unlike the ferramenta in the standard windows, the original ironwork in each of the three lights that make up the east window, with the exception of the head of the centre light, was installed without enclosing frames, Fig. 17. Instead, the horizontals are set in rectangular sockets cut into the masonry window reveals, Fig. 14. Thus, although the head was probably pre-fabricated, the rest was probably assembled *in-situ*.

Fig. 14, a detail of the east window, showing the original ferramenta outside the plane of the later glazing and the rebate between the inner and outer columns, June 2002.

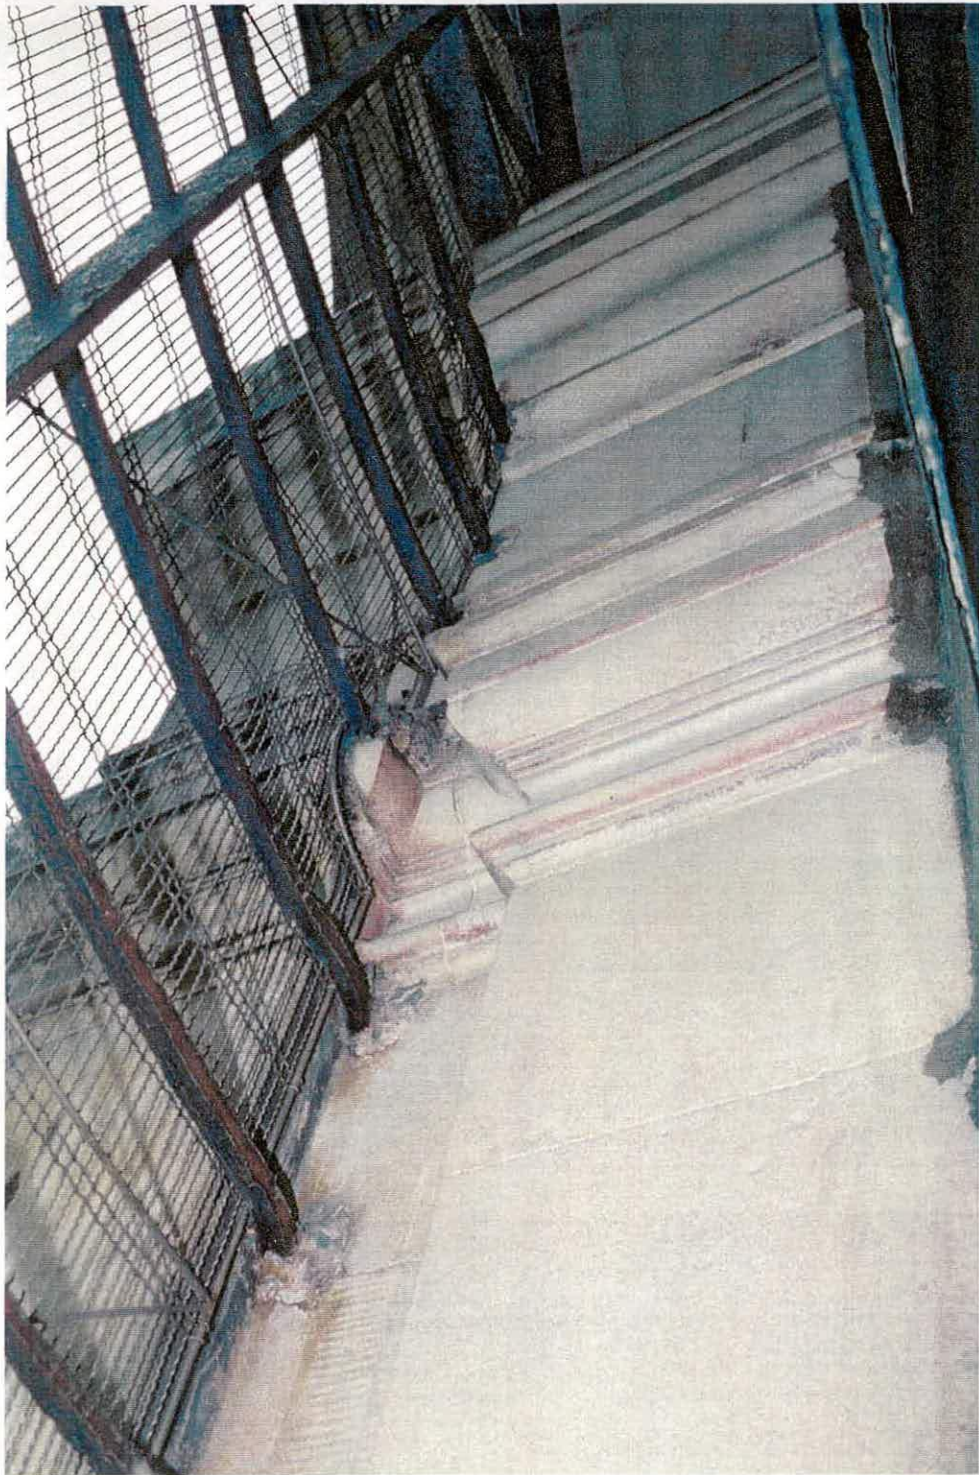
Fig. 15, the south jamb of the east window, showing how the original ferramenta is set in sockets cut into the masonry just behind the outer column, June 2002.

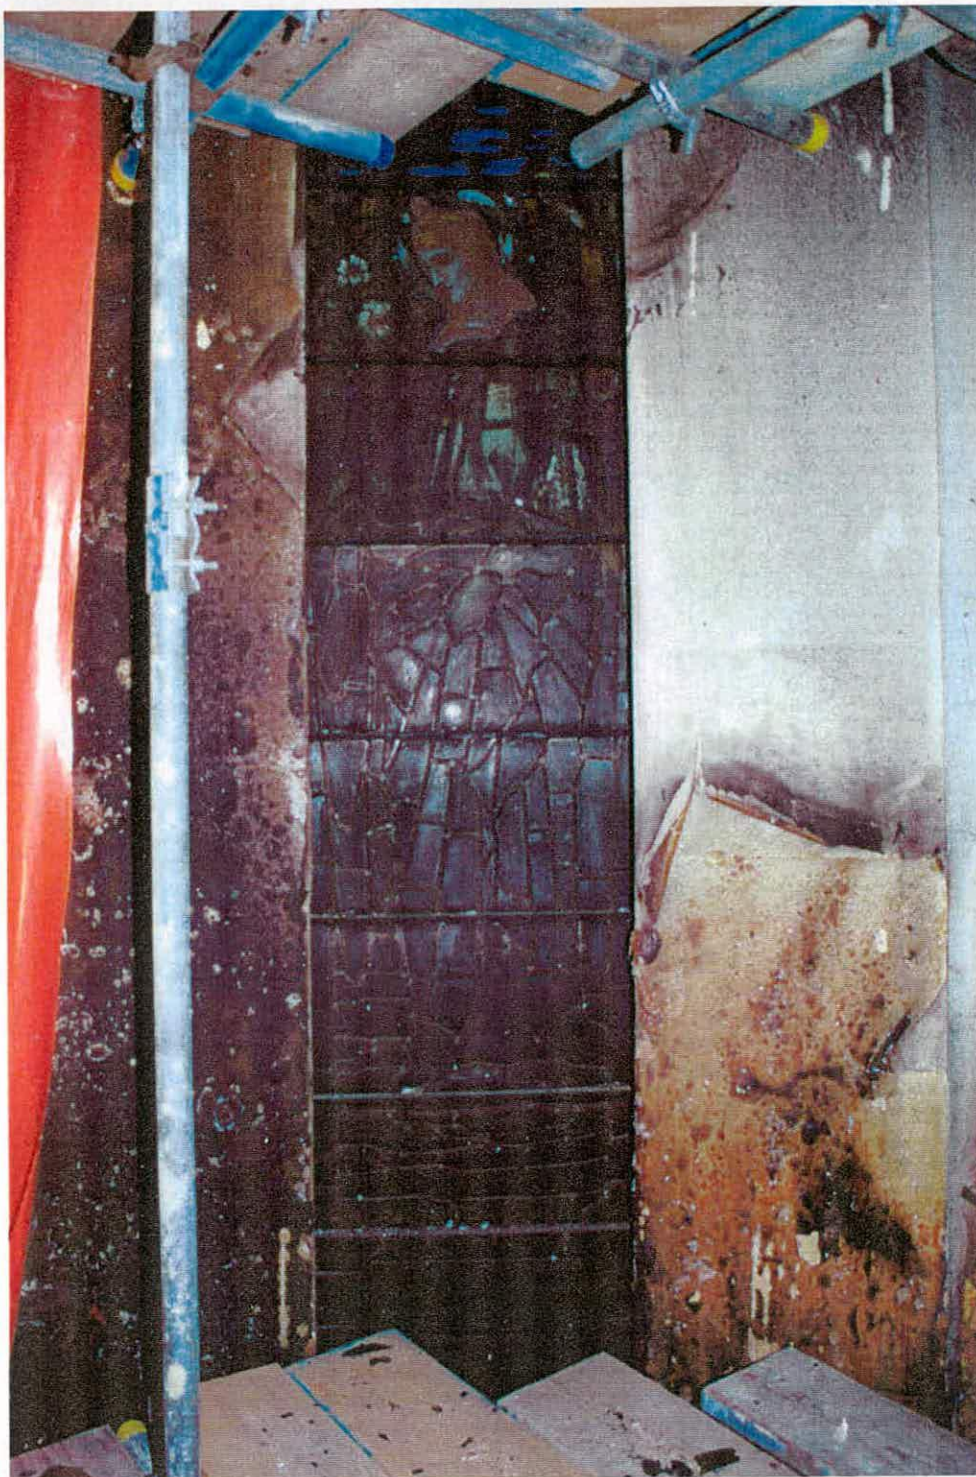
Fig. 31, the southern light in the east window, the figure of St Gabriel, after the fire of May 2000. The heat lifted the paint on the adjacent wall surface but left the glazing intact.

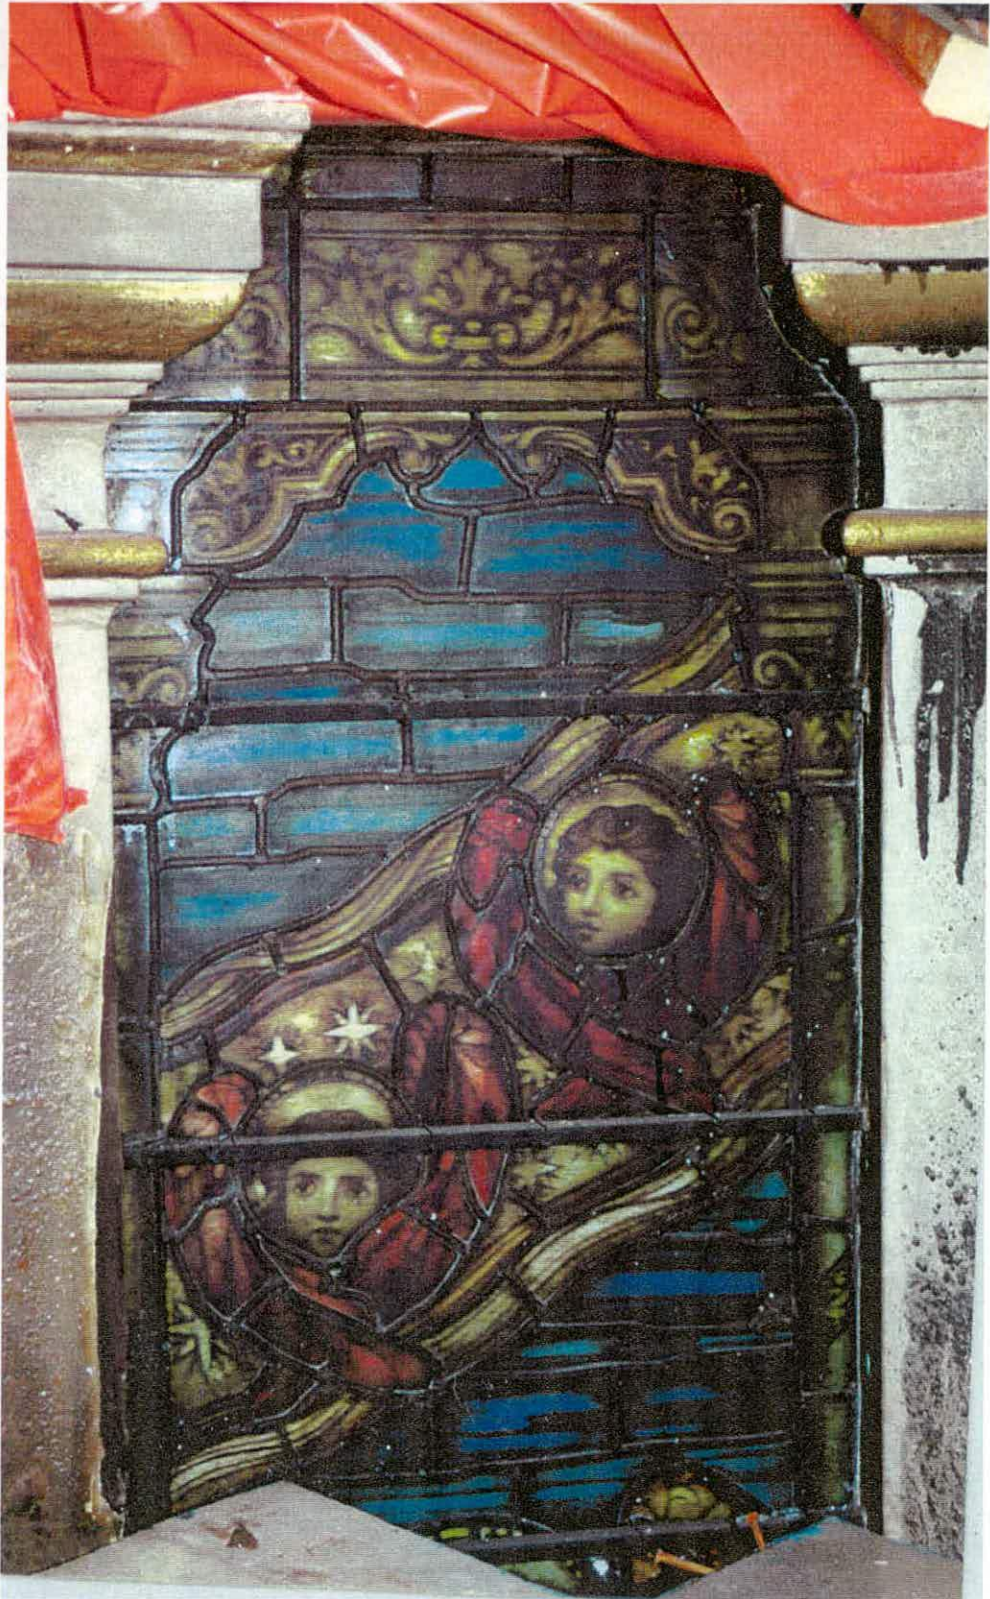
Fig. 32, a detail of the head of the southern light in the east window, with angel heads above the figure of St Gabriel.

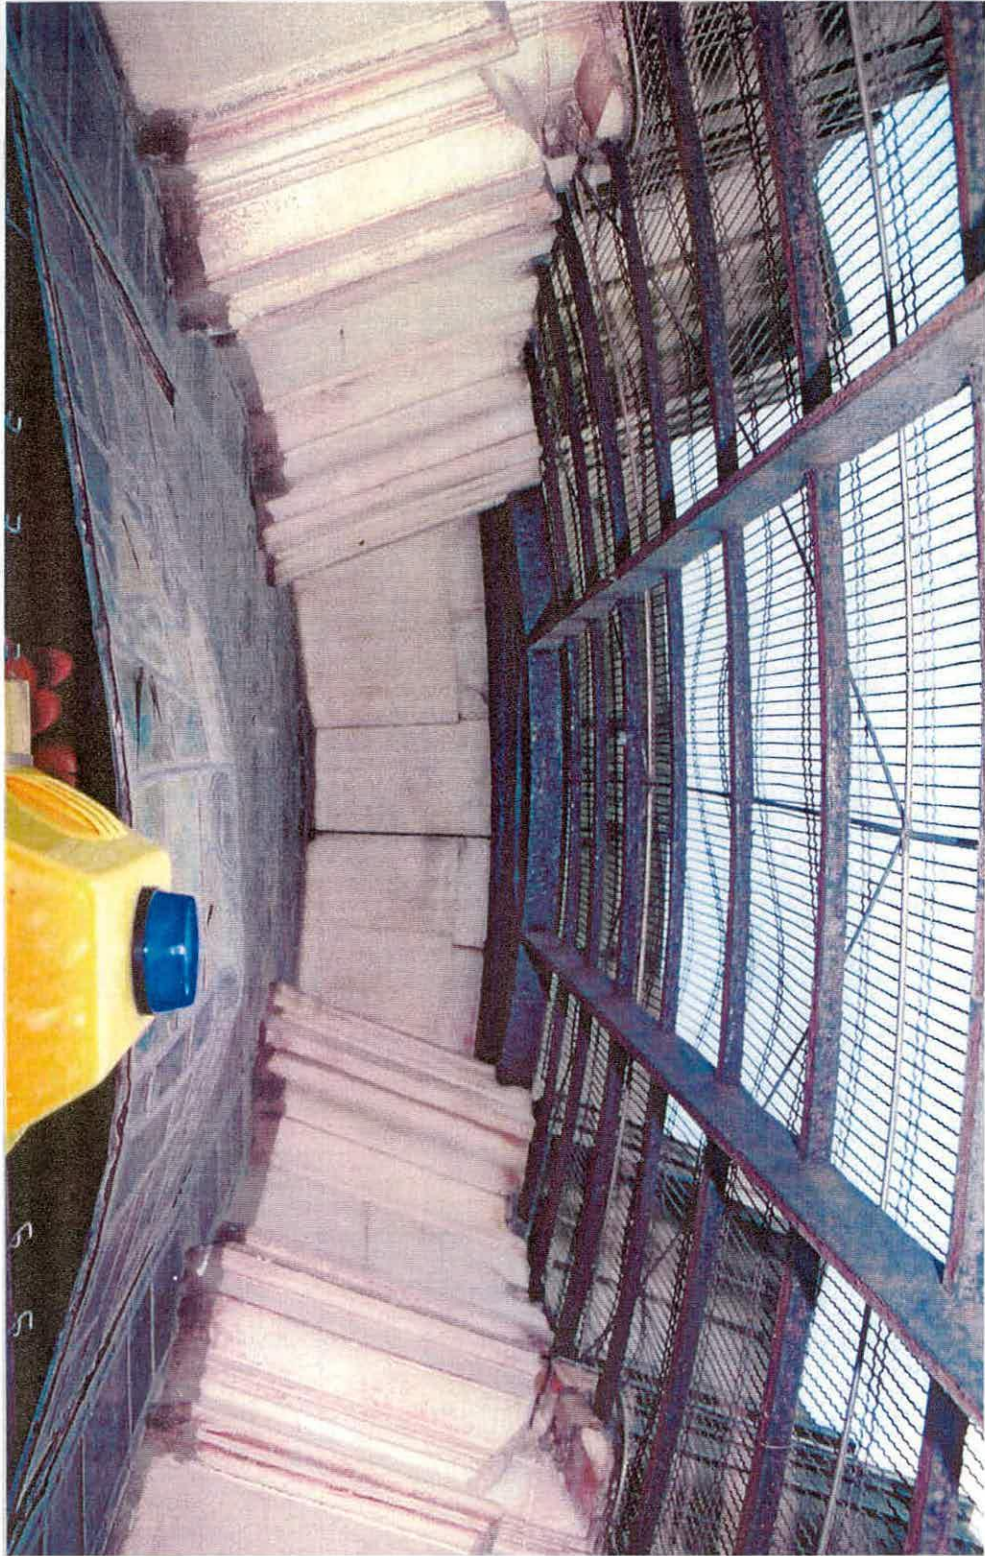
The heart of the fire in May 2000 appears to have been centred on the altar: those parts of the east window nearest to it suffered the most. The lower part of the centre window was totally destroyed. The upper two thirds remains *in-situ* but is severely buckled, Fig. 34. The two side windows remain intact. Any repair would, however, require complete removal of the centre window and replacement of all the lead.

Fig. 34, the space between the original ferramenta and the Powell glazing in the centre light in the east window, looking upwards, June 2002. The buckling of the lower part of the surviving Powell glass is apparent in the glazing detached from the wire ties visible at the left-hand edge of the photograph.
