Church House Farm, Wellington, Herefordshire : Historic Building Assessment

Research Report Series 050-2019

**CHURCH HOUSE FARM
WELLINGTON
HEREFORDSHIRE**

HISTORIC BUILDING ASSESSMENT

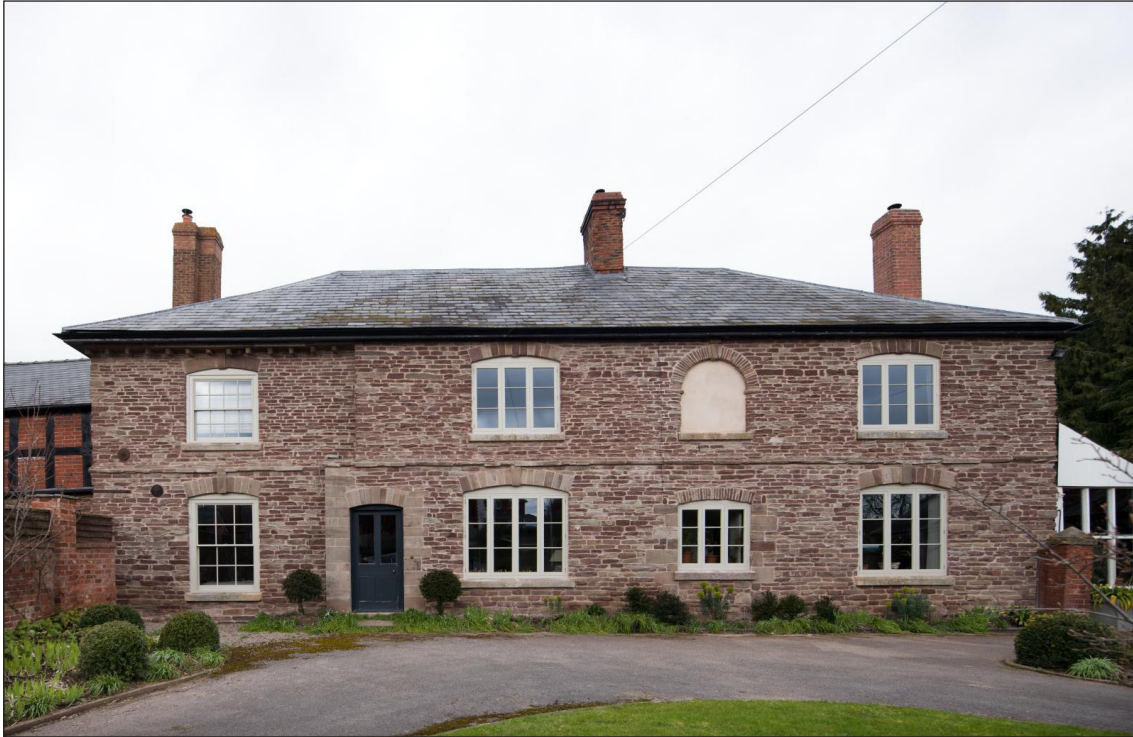
Figure 1 South elevation of Church House Farm (DP221705)

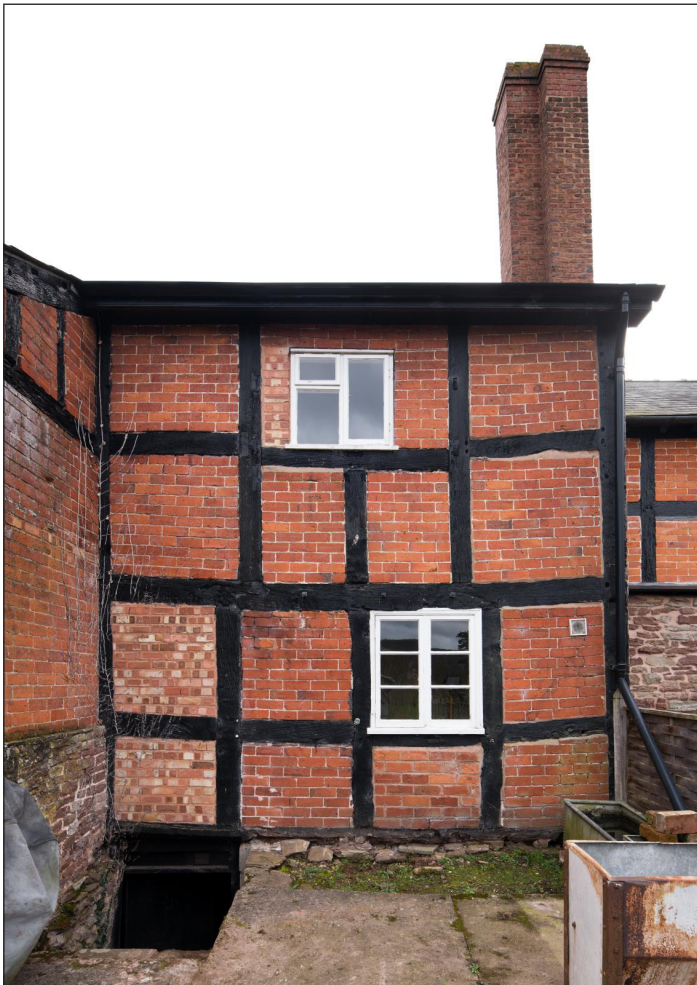
The main farmhouse of Church House Farm sits on the eastern edge of the farm complex. It is orientated on a northeast to southwest alignment, with the main front facing slightly east of south. For the purposes of this report however it is presumed to be orientated on a west to east alignment with the main façade facing south. The farmhouse now presents a relatively uniform façade of coursed sandstone, which belies the complexity of its development (Figure 1). The main elements of this are the early cross wing which forms the western portion of the house, and the main range which occupies the centre and east (Figure 2). This can be better appreciated from the rear of the house, where the timber framing of the cross wing is still visible (Figure 3).

Figure 3 North elevation of cross wing (DP221702)

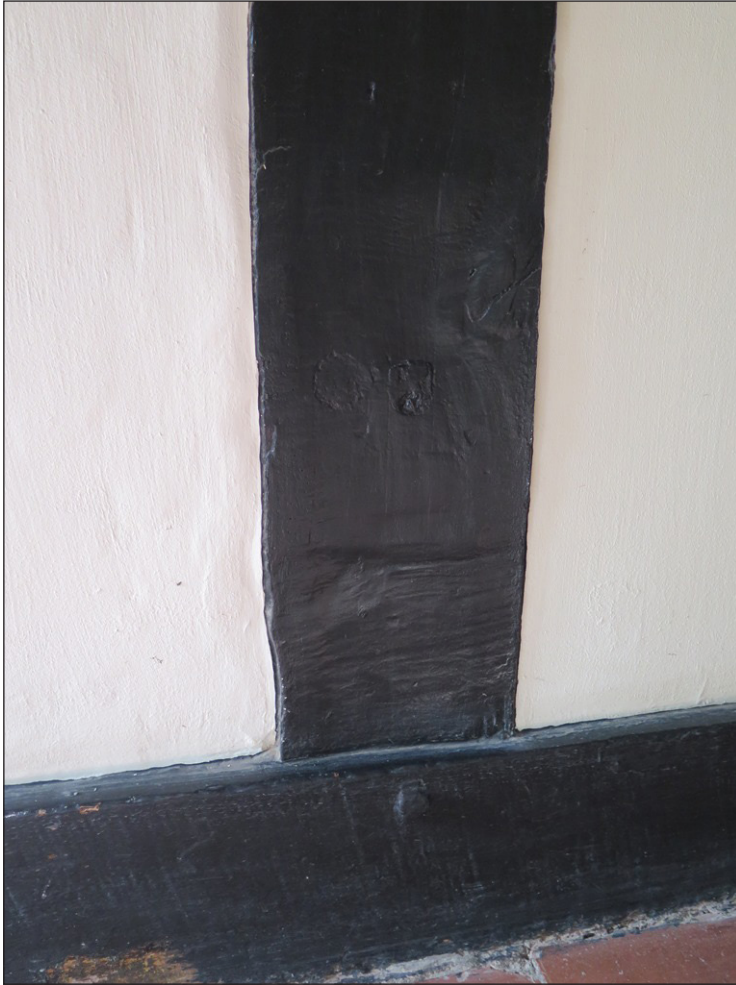
Figure 4 Detail of studs in east elevation of cross wing, showing the residual peg holes for a high-end bench arrangement. Photo Stuart Mee

on each stud indicate the position of a bench, which would have served the high-end of the earlier hall (Figure 4; see phase one above). At first-floor level the pattern of panels largely mirrors that at ground-floor level, including the slightly irregular position of studs in the bays with doorways. However, there is no evidence for original doorways in the east elevation at first-floor level.

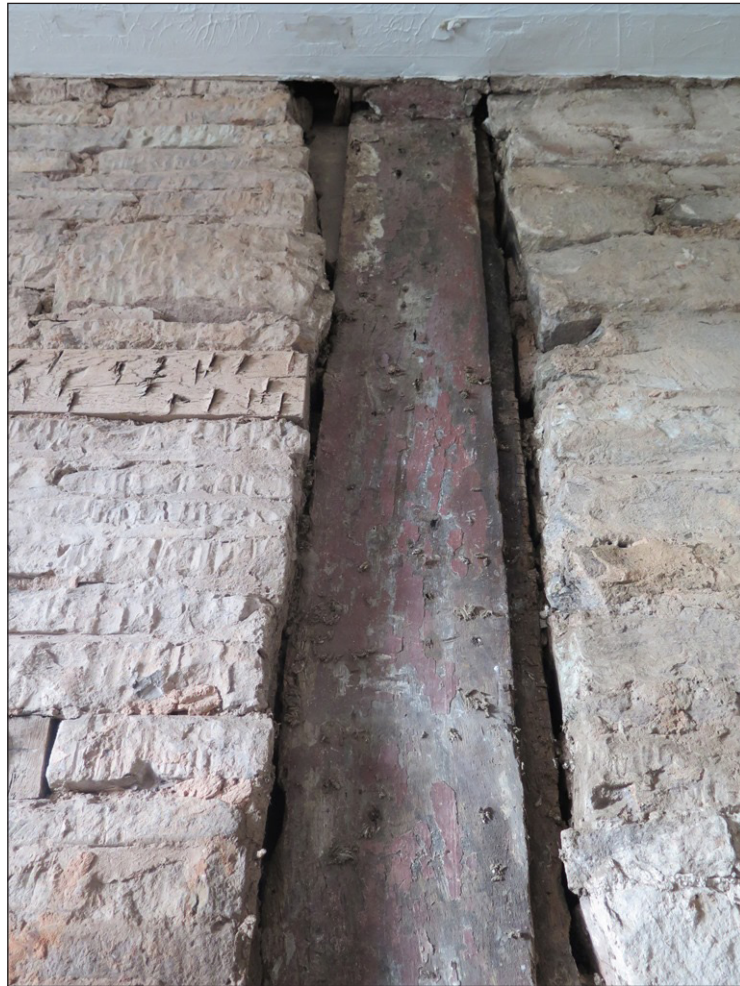
Figure 5 Central post in west elevation of cross wing showing rebate on its northern side.
Photo Stuart Mee

the rebate on the southern post suggesting that the window had an internal shutter arrangement.

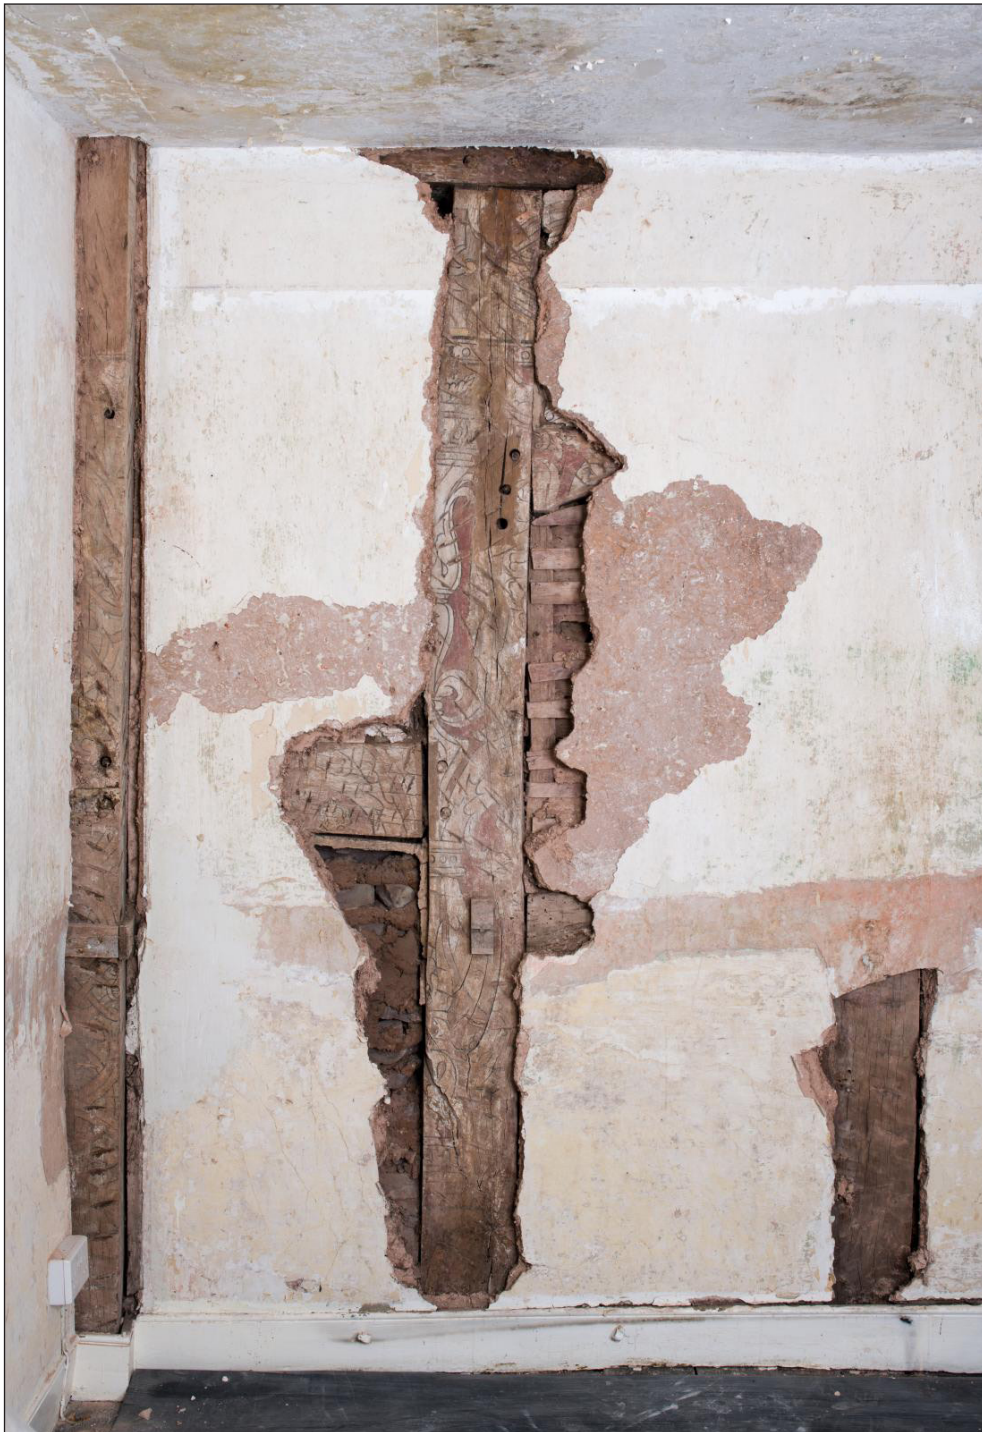
Figure 6 Exposed studwork of the west elevation of the cross wing at first-floor level with part of the doorhead for the garderobe visible on the northern side of the stud (DP221684)

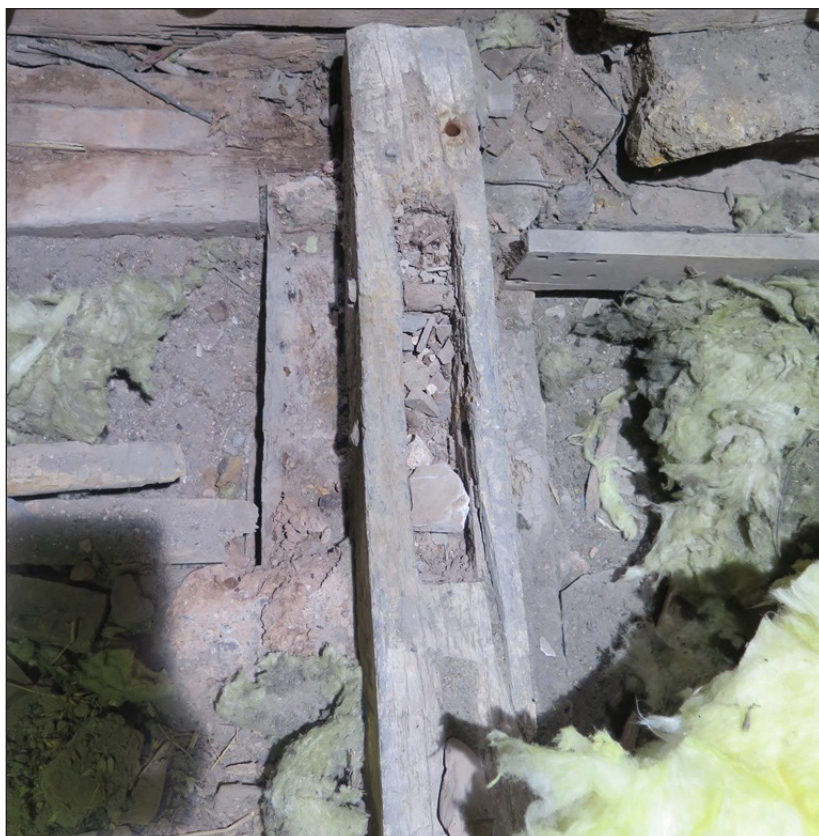
Figure 7 Tie beam of the original roof over the cross wing still in situ. Photo Stuart Mee

At roof level, much of the original structure has been removed. It appears that the tie beams survive *in situ* however (Figure 7). The joists supporting the ceiling at first-floor level appear to be integral to the tie beams, suggesting that as constructed the first-floor room was ceiled rather than open to the roof. There is also a fragment of surviving flooring, formed of mortar mixed with small stones, and laid on laths. This may be original to the wing, allowing at least part of the roof space to be used for accommodation or storage. Further investigation of the surviving elements of the roof structure may well reveal more detail of this arrangement, and the original form of the roof.

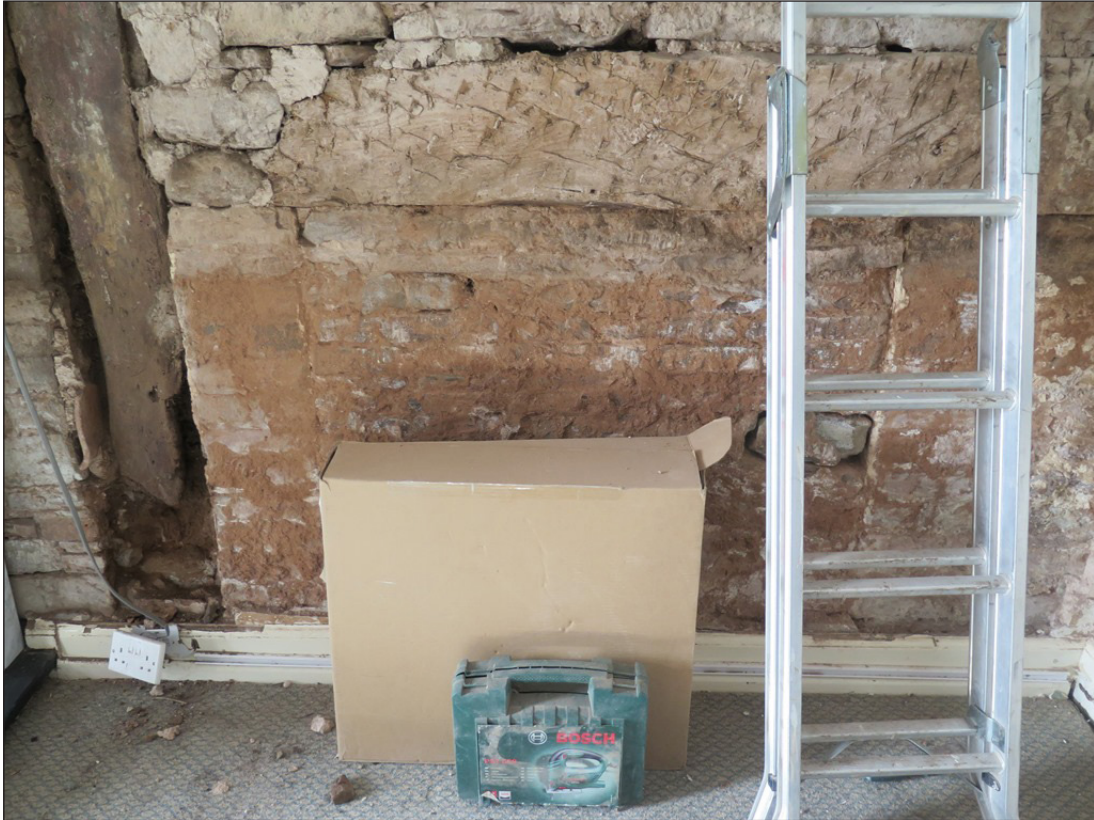
Possibly the first of these alterations was the insertion of the ground-floor fireplace into the northern central bay of the west elevation (Figure 8). This replaced the oriel window which had previously been in this location. The fireplace stack is formed of stone, and projects beyond the timber framing of the wing externally, although much of this is now concealed by the later barn structure built against this elevation. Internally the stack is largely flush with the earlier timber-framed wall. The fireplace jambs are formed of rubble stone, and the lintel is of wood, and apparently undecorated, although it is possible that it has been cut back or

Figure 8 Inserted fireplace in the west elevation of the cross wing, with later blocking. Photo Stuart Mee

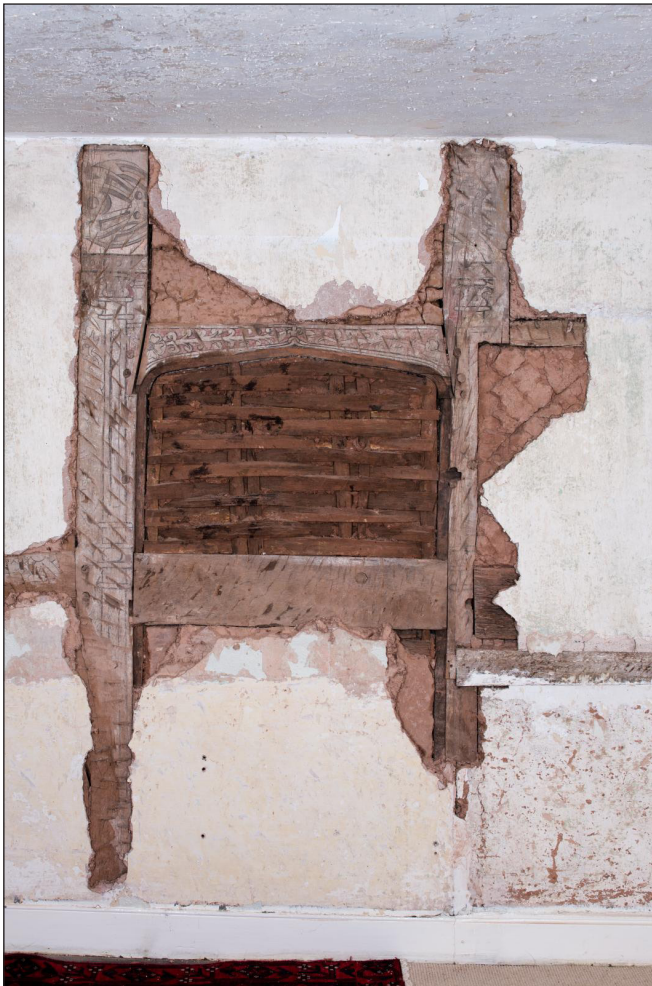
Figure 9 Doorway in the inserted cross wall between the northern and southern rooms at first-floor level (DP221674)

At ground-floor level the position of a doorway between the northern and southern rooms is indicated by the peg holes for a doorhead in the central western bay. At first-floor level the doorhead of the original doorway survives in the central eastern bay (Figure 9). This is of a similar four-centred form as that of the original doorheads to the garderobe suggesting that the cross wall was inserted not long after the original construction of the wing. The first-floor doorway is also located

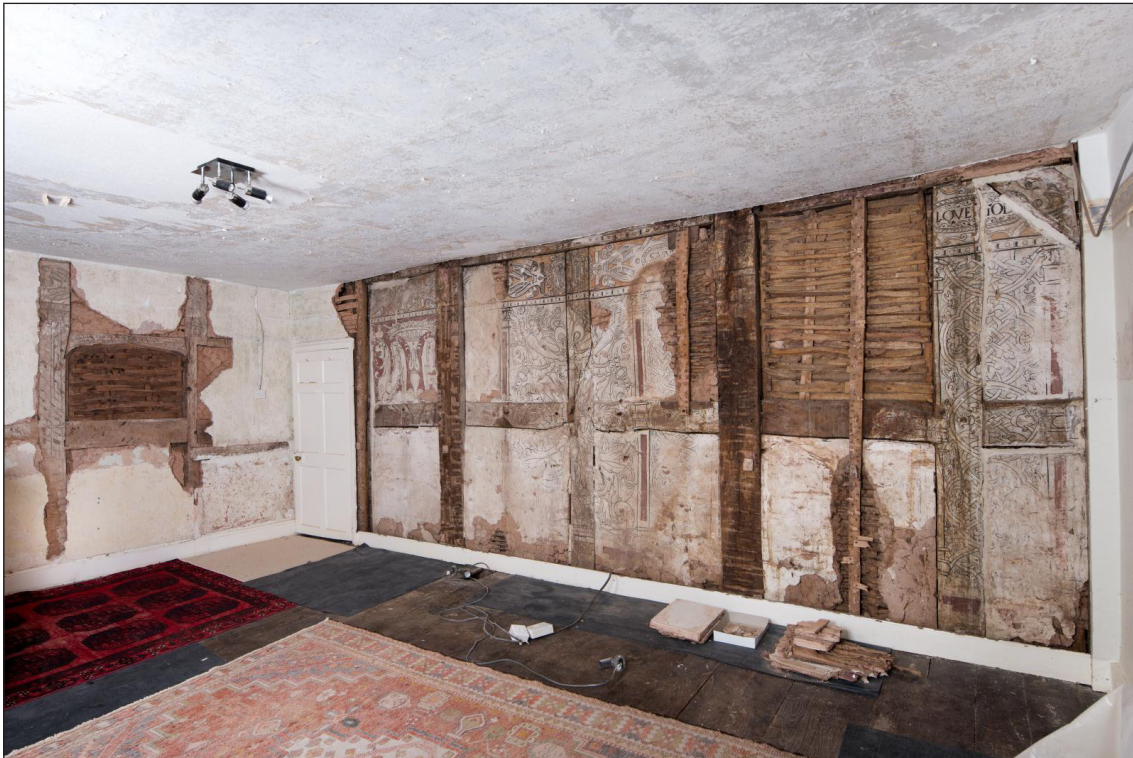
Figure 10 Main room in the first floor of the cross wing, showing exposed parts of decorative scheme (DP221673)

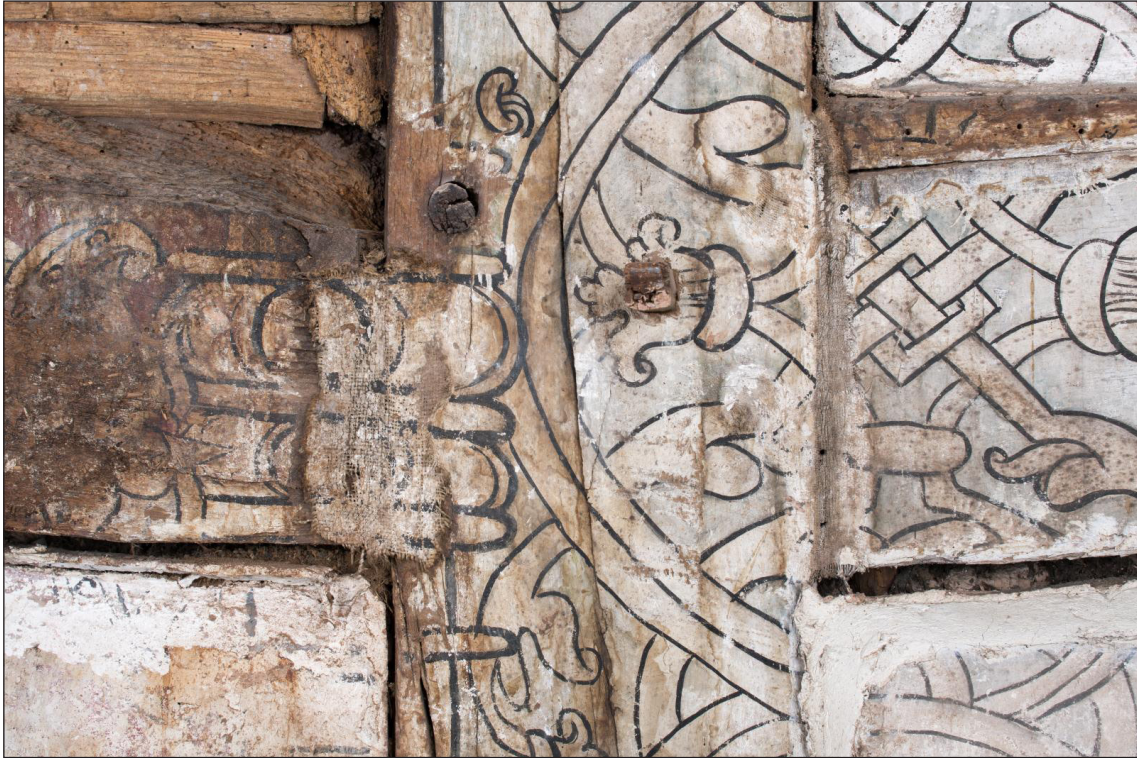
Figure 11 Detail of junction in timber frame, showing detail of small patch of cloth used to cover the joint on the left-hand side (DP221695)

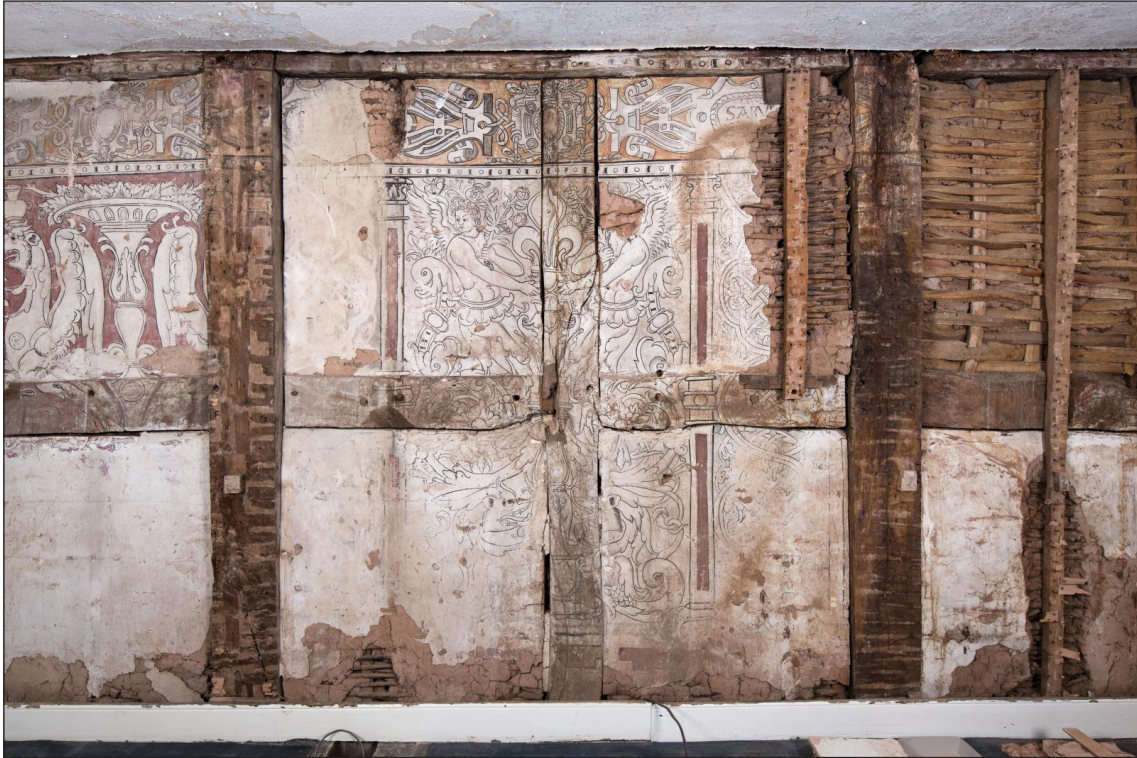
The east elevation of the room appears at present to have the best survival with most of the wattle and daub infill panels surviving as well as the decoration on the majority of the posts, studs and rails (Figure 12). It also seems likely to have been the main focal point of the decorative scheme. The elevation appears to have been divided into seven panels of varying sizes, symmetrically arranged with a large central panel. The panels are divided by columns with decorative heads reminiscent of Corinthian capitals. The central panel is occupied by a large figurative scene,

Figure 12 East elevation of cross wing showing the centre of the decorative scheme (DP221697)

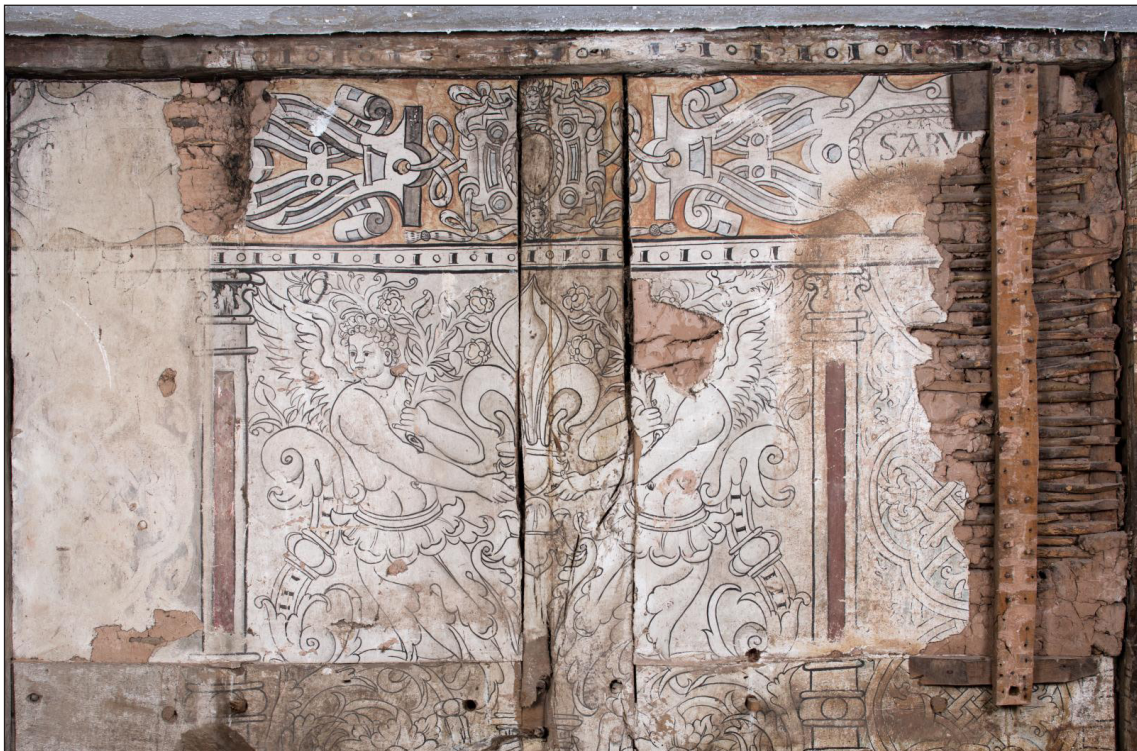
largely created from simple black lines on the pale background of the plasterwork (Figure 13). This has two large winged cherubs, who are holding what appear to be stems of flowers, possibly roses, in one hand and with the other supporting a large, centrally placed fleur-de-lys which they appear to be about to place on a central candelabrum. Flanking the candelabrum is a pair of winged grotesque creatures. To either side of this central panel appear to have been a pair of narrower panels with a geometric interlaced pattern, although the left-hand panel appears only as a slight shadowing on the plasterwork due to some later over painting. The right hand panel however survives in a slightly better state and comprises a pattern of intersecting circles and squares set on a pale green background. Many of the lines finish in shapes suggestive of foliage.

Figure 13 Detail of the central panel of the decorative scheme (DP221690)

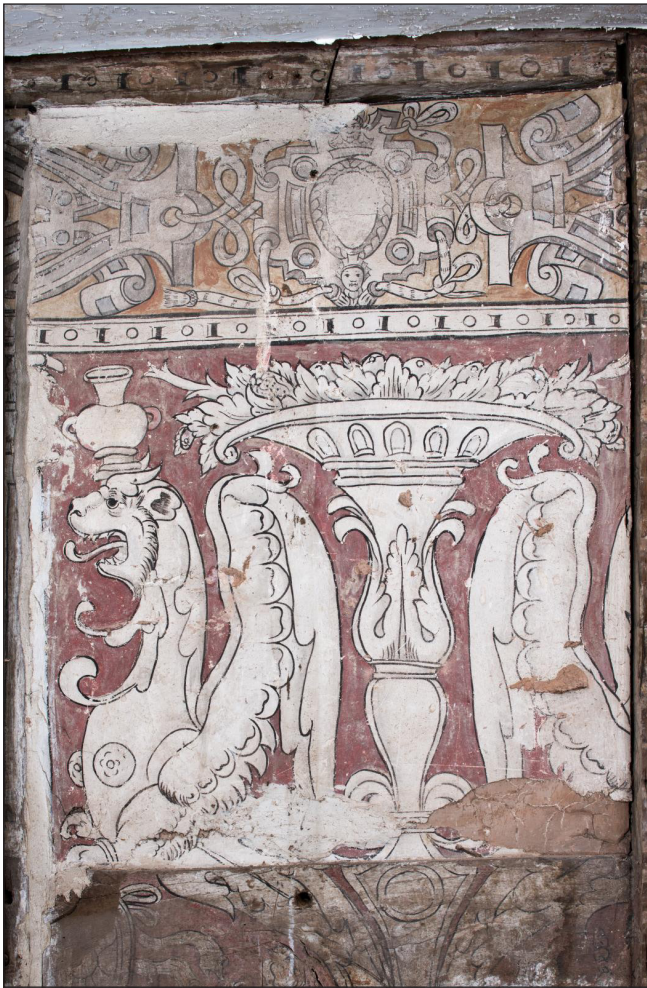
Figure 14 Detail of east elevation, northernmost surviving panel (DP221688)

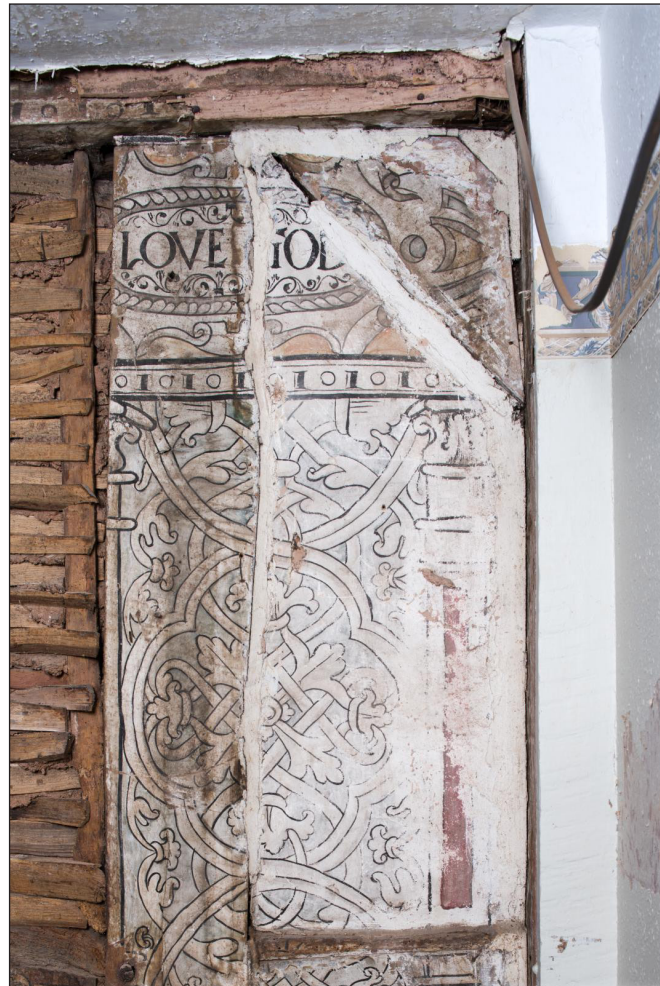
Figure 15 Detail of east elevation, southern panel (DP221693)

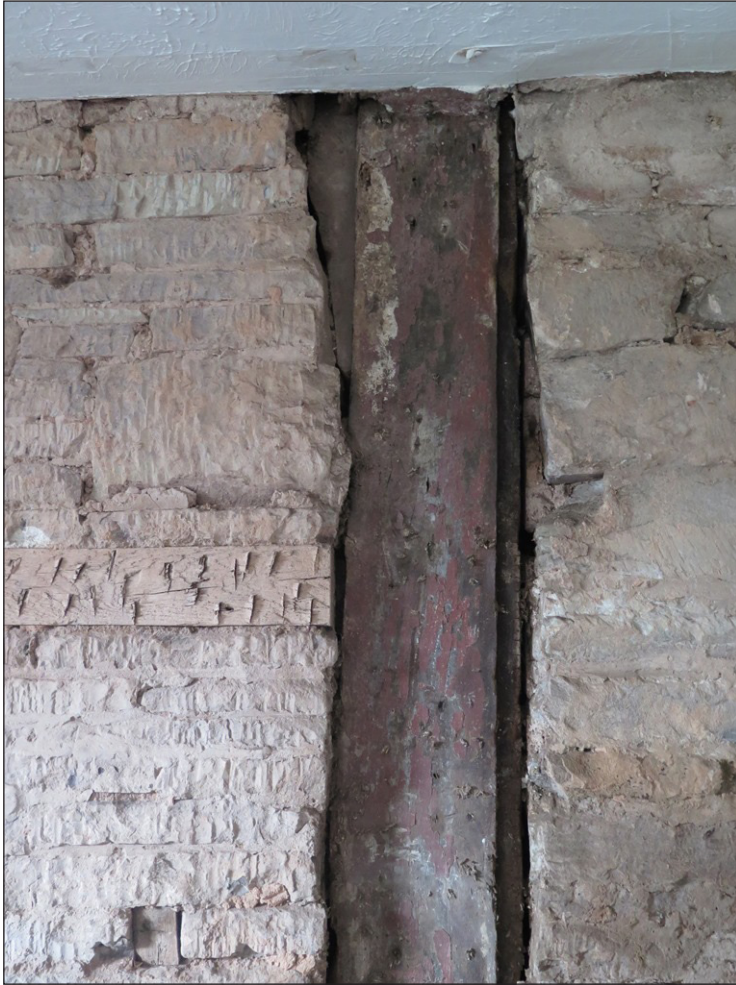
Figure 16 Detail of stud in west elevation of cross wing showing surviving fragments of dark red paint. Photo Stuart Mee

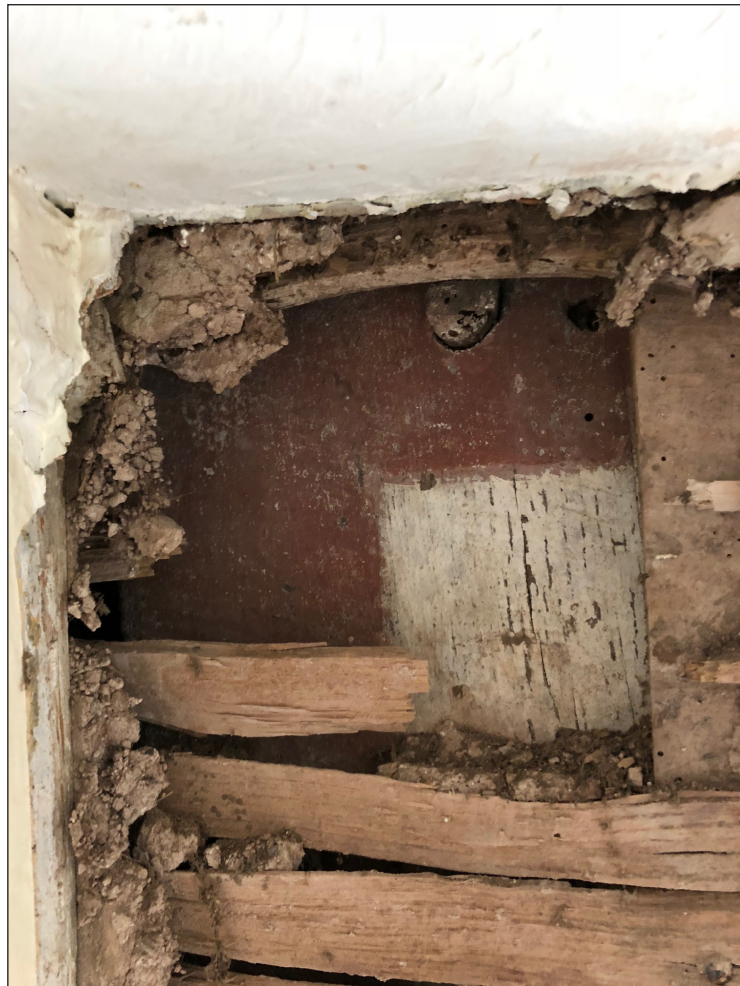
Figure 18 Detail of surviving section of decorative plaster ceiling. Photo Stuart Mee

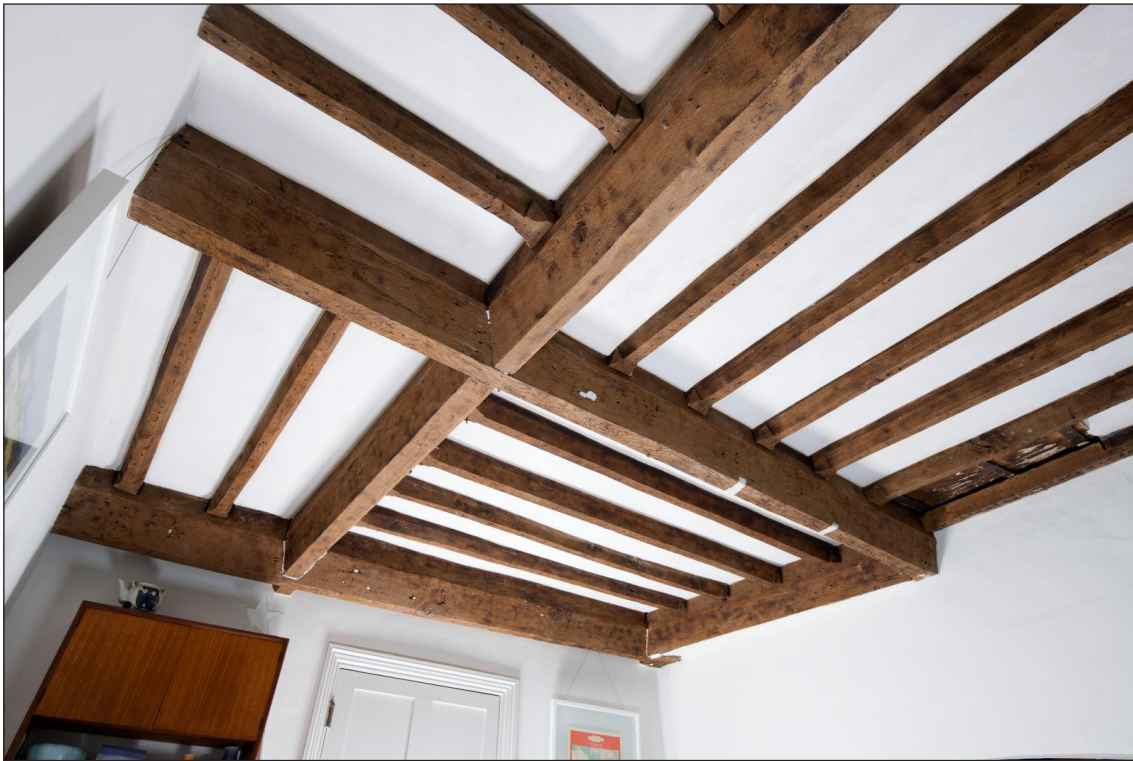
Figure 19 Counter change ceiling inserted into the original hall, and retained in subsequent rebuildings of the range (DP221699)

Another major phase of modification to the building was the construction of the counter-change ceiling which now sits to the east of the cross wing (Figure 19). It is presumed that this was inserted into the earlier open hall, and retained when that hall was demolished at a later stage (James 2019; see Appendix One). The ceiling abuts the cross wing, but does not appear to be contemporary, because, as James has noted, it is not in any way structurally attached to the cross wing. Counter-change ceilings are known from the late 16th and early 17th century, and given this it seems likely that the insertion of the floor was part of the significant upgrading of the building in the late 16th century.

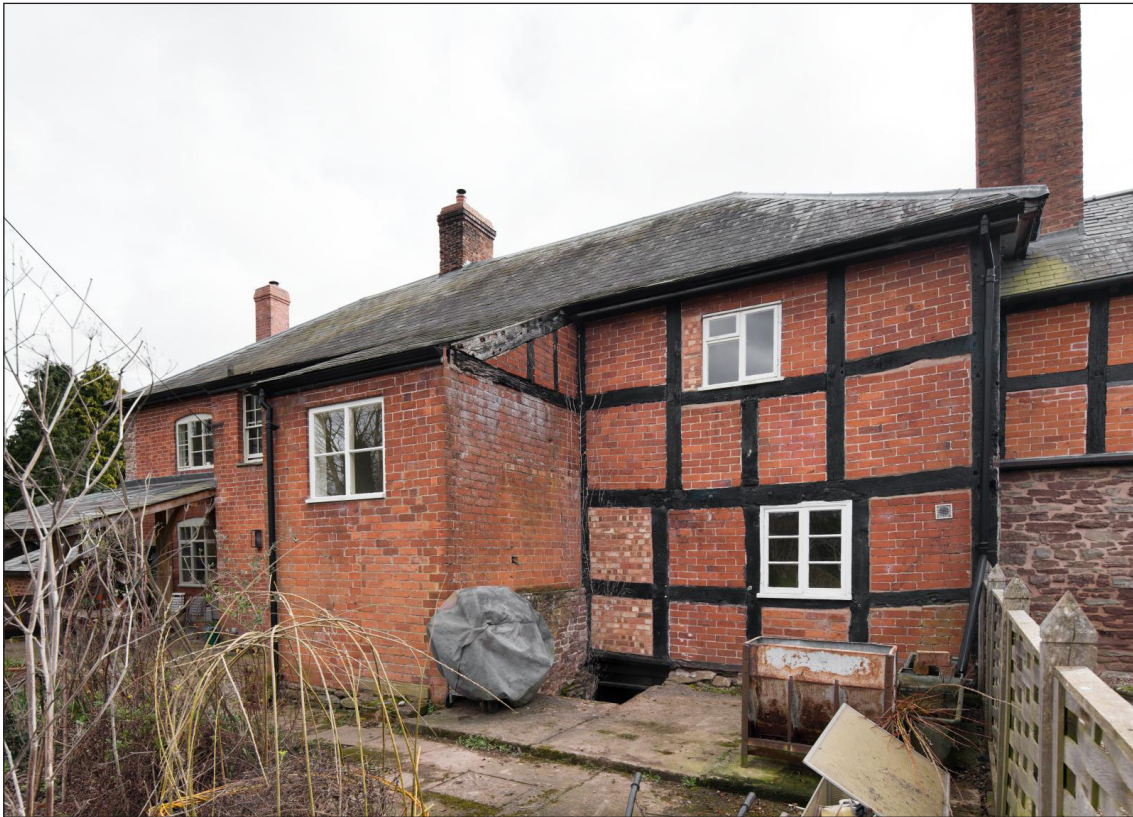
Figure 20 North elevation, showing stair turret, mostly reconstructed in the 19th or 20th century but with an early stone base (DP221701)

The first floor was accessed via the principal stair located in an outshut to the northwest of the hall range (see Figure 20). It is possible that this reflected an earlier stair position (see phase three above) but in its current configuration it appears predominantly to belong to this phase. A subsidiary service stair rises from the northeast corner of the hall range, although it is not clear when it was inserted and it may be a later feature.

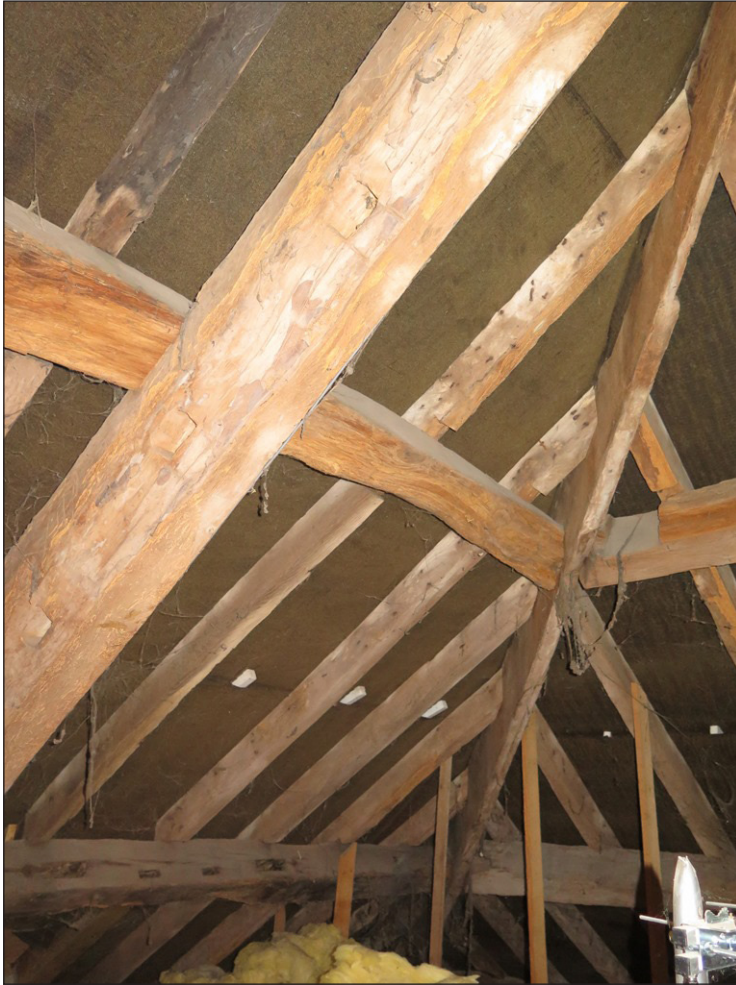
Figure 21 Detail of roof structure, showing reused timber elements, some with charring. Photo Stuart Mee.

James has suggested that confirmation of the existence of this reconstruction phase is found in the roof structure, where the later roof reuses a significant amount of timber of the 16th and 17th centuries. Some of this timber is charred, but the pattern of charring suggests this occurred prior to its reuse in the current roof configuration (Figure 21). James has postulated that this charring relates to a fire which may have been the reason for the reconstruction of the building in a later phase. Further investigation of the roof may confirm more of the original form of the re-used timbers and provide support for this theory.

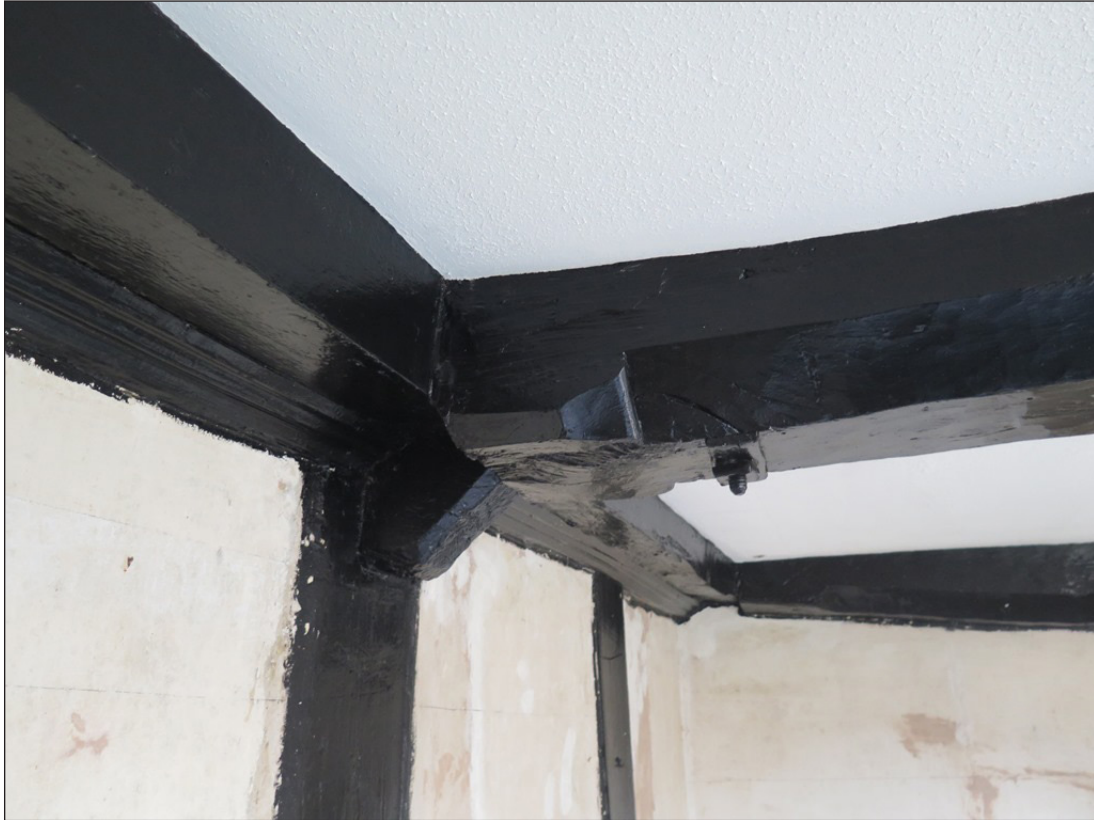
Figure 22 Detail of reused 17th century beam in the southwest room of the hall range. Photo Stuart Mee.

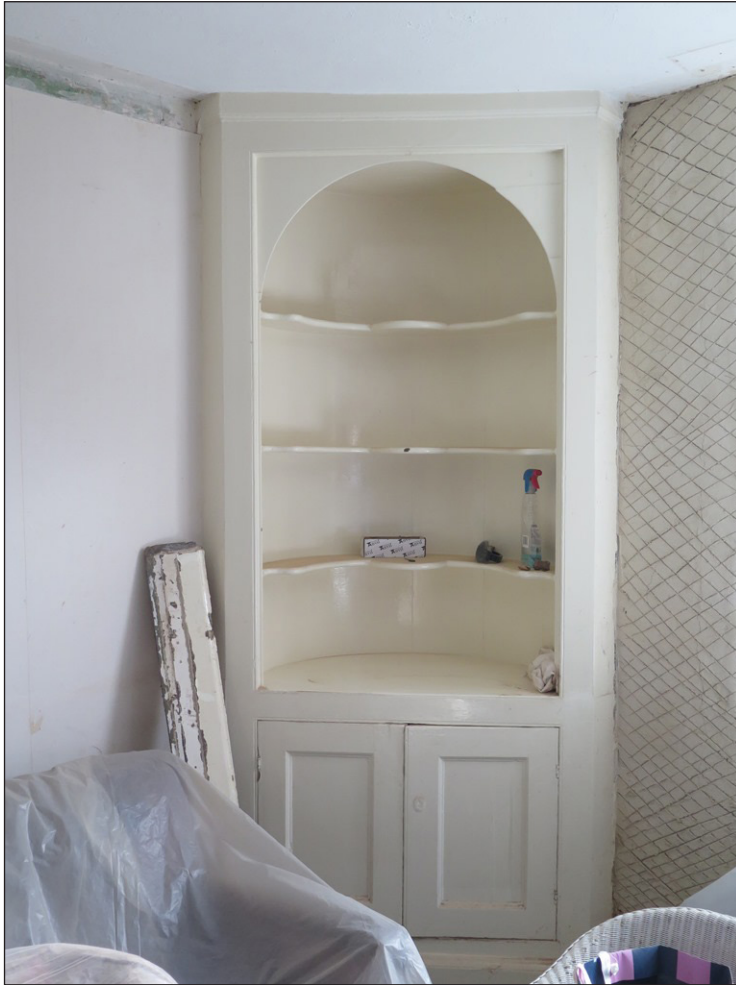
Figure 23 Fitted corner cupboard in ground-floor room of cross wing. Photo Stuart Mee

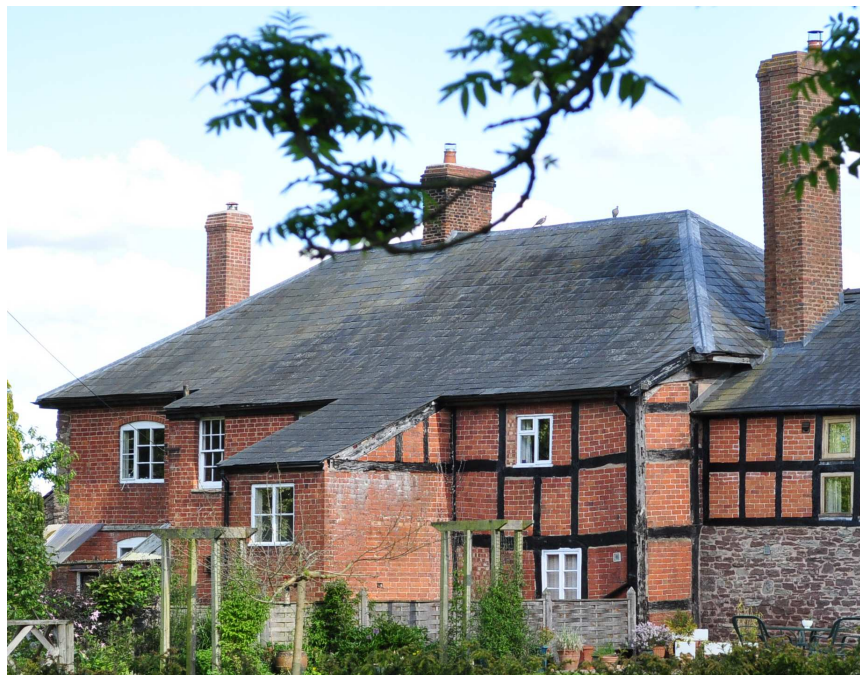
Fig.5. The rear elevation of Church House Farm seen from the north-west.

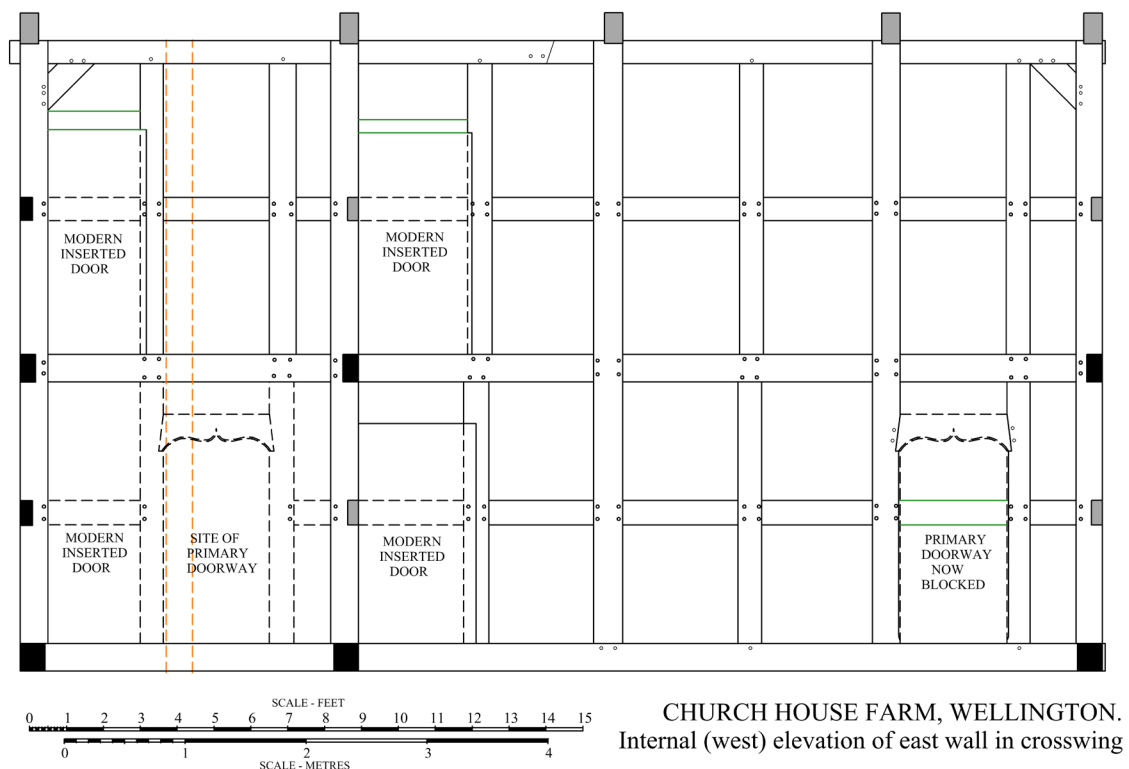
The west sidewall of the wing also retains some of the primary timber framing although two fireplaces (one blocked) on the ground floor and one on the first floor and their associated stacks of brick and stone have displaced some of the timber framing. On the ground floor the present fireplace in the west wall approximately central to the room, as is that on the first floor. However, the blocked fireplace on the ground floor, which has an arched brick support in the cellar for the lost (?) hearth stone, is adjacent to the cross-frame – indicating that it predates it. (Figure 8) Above the site of this blocked fireplace, at first-floor level there are, on the exterior face of the framing (recently exposed), mortices that suggest it was the site of an oriel window in the side wall of the crosswing. This would also conflict with the site of the cross-frame.

Fig.6. The surviving timber-framed east wall of the crosswing (west elevation).

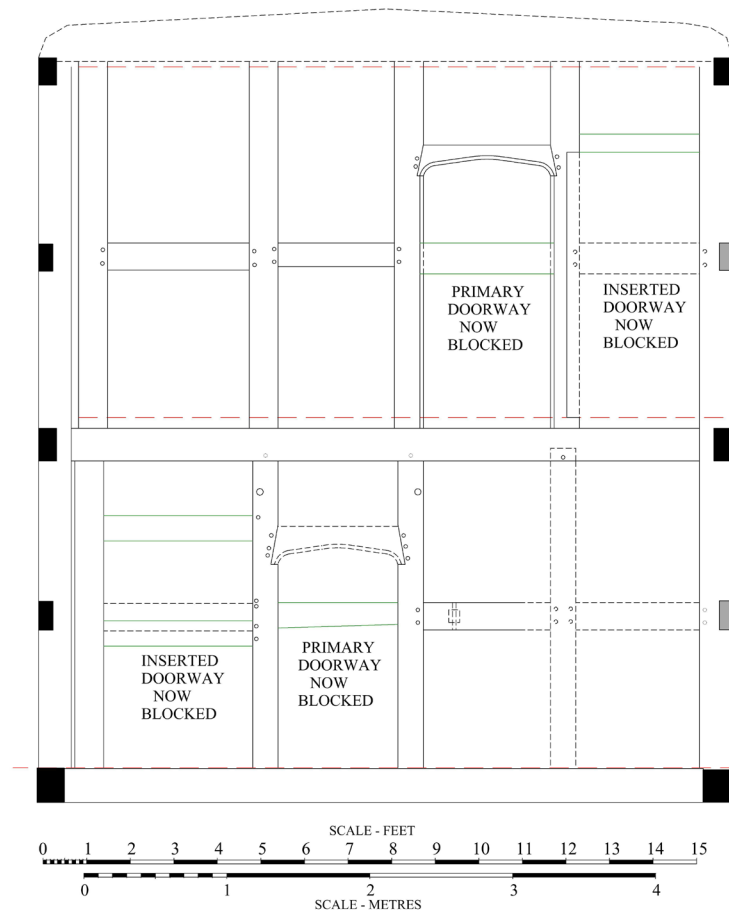
There was a primary doorway in the cross-frame (partition) on both the ground and first floors linking the two rooms at both levels. Figure 7. It is highly likely that the smaller, north room contained a staircase. One doorhead, a nominally four-centred Tudor arch, survives on the first floor. It will be noted that the posts on the left end (west) of the frame are set alongside the wall post. This is further evidence to indicate that the partition is likely to be a later insertion.

Fig. 7. The cross-frame in the crosswing (south elevation).

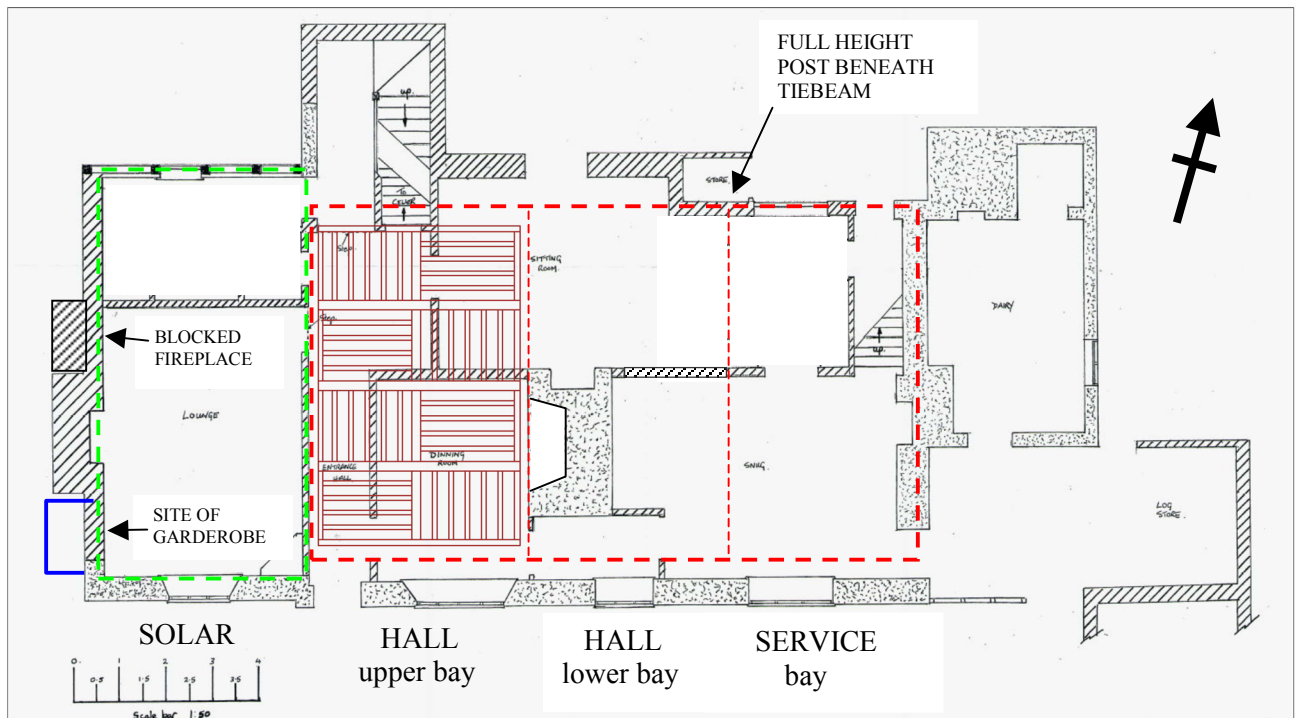
Fig.8. A modified recent ground-plan with the probable layout of the three bays of the lost hall range indicated in red dashed lines. The inserted counter-change ceiling is shown in red with the two lost panels restored. The crosswing is shown outlined in green dashes. The crosswing partition is of timber framing and timber framing survives in the north and east walls and much of the west wall of the wing.
