Church House Farm, Wellington, Herefordshire : Historic Building Assessment

Research Report Series 050-2019

**CHURCH HOUSE FARM
WELLINGTON
HEREFORDSHIRE**

HISTORIC BUILDING ASSESSMENT

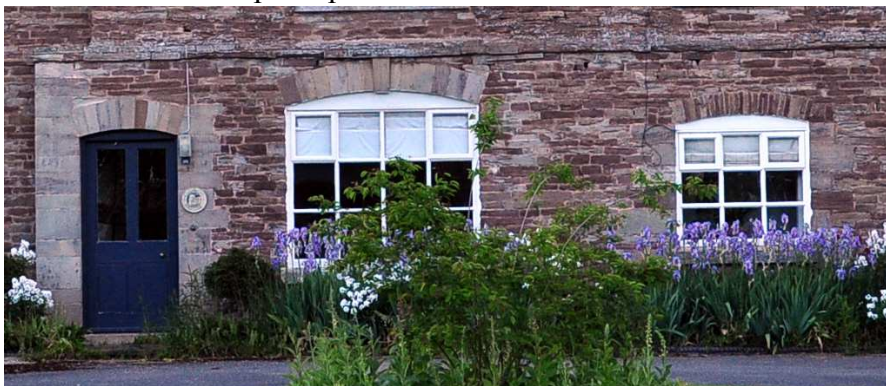
Fig.9. The south elevation showing the blocked doorway on the right and the later new position for the principal doorway on the left.

keystone. There is no evidence in the adjacent stonework to suggest that the present, inferior arched-lintel is a repair, so it may be that the doorway had a hood of some sort that was supported on timbers set into the wall at each end of the arch where there are infilled holes of appropriate size. A door hood would have masked the inferior lintel.
