Abbey Farm Barn Snape Suffolk

Record Drawings
Schedule of Repairs and
Repair Details

for English Heritage
Mr & Mrs H. S. Raynor

March 2001

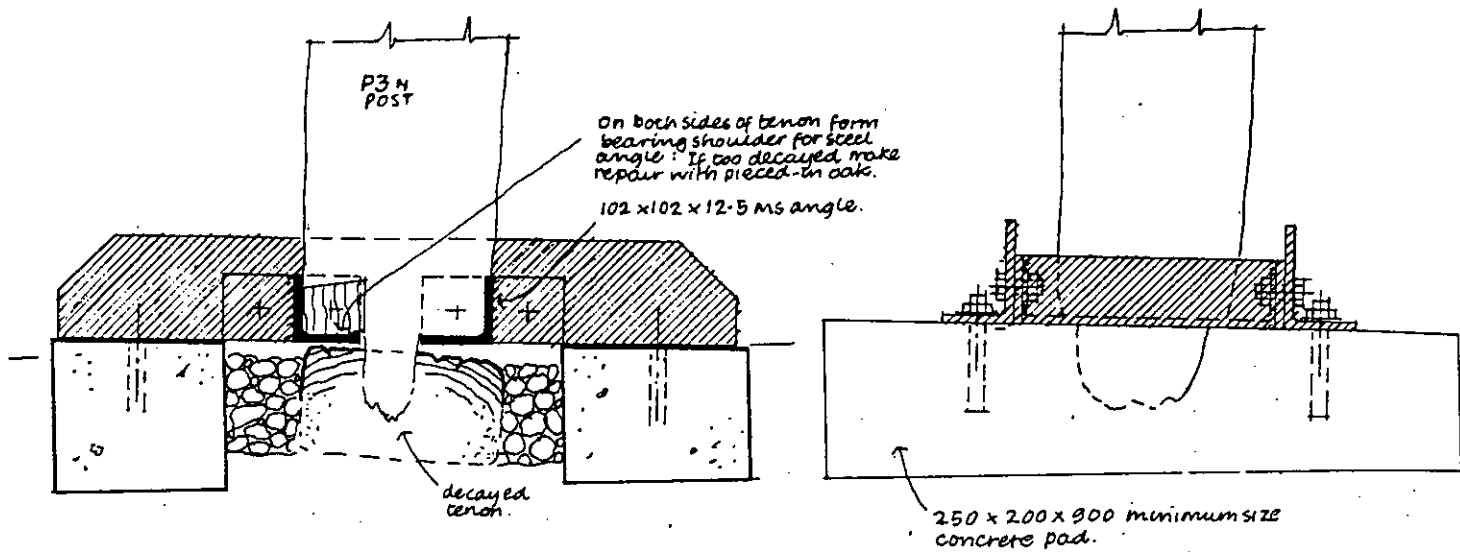
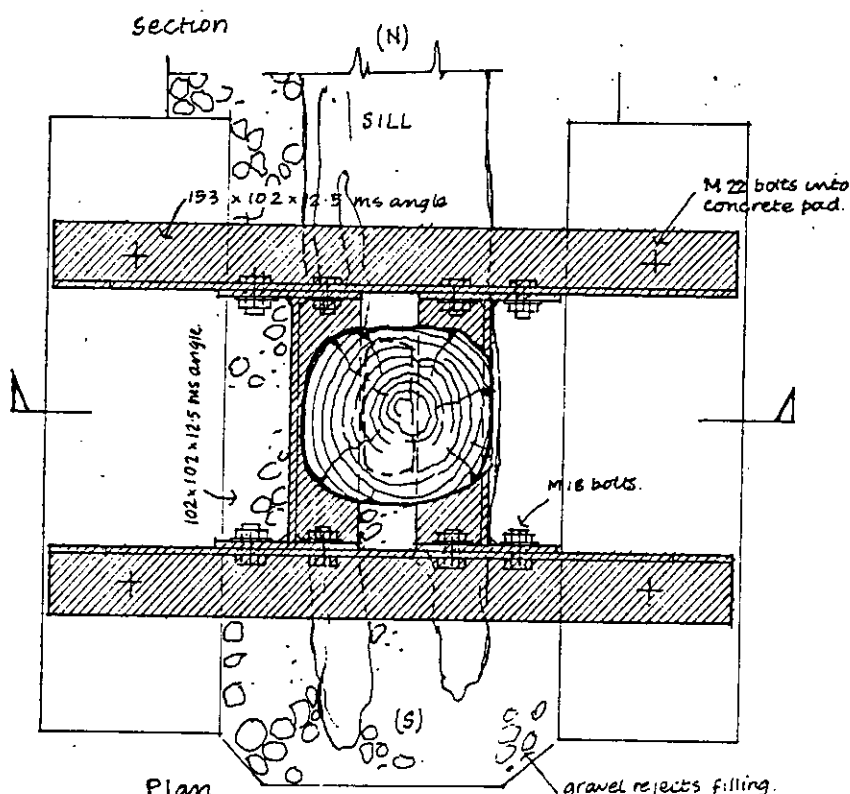
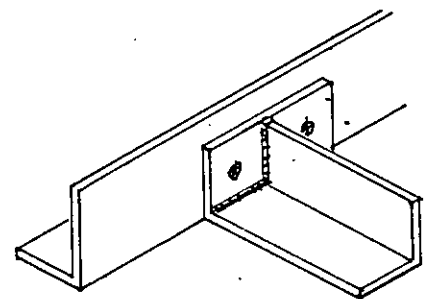
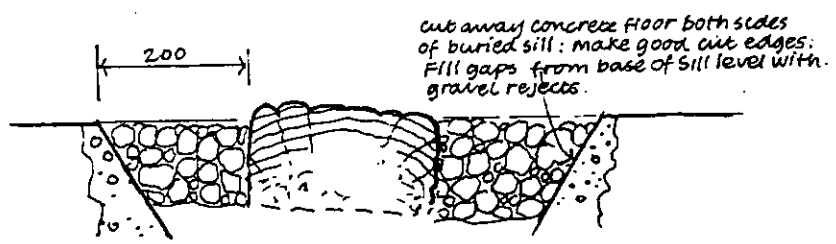
Figure 16 Repairs to sill P3

The foot of the Arcade Post rests on what is probably a surviving primary sill, which has decayed and is partly buried into the concrete floor. There was a need to provide a better foundation and anchorage for the post without removal of the sill or disturbance of archaeological evidence below it.

Steel Cradle support over decayed sill to Arcade Post P3N
scale 1:10.

- Archaeologist to survey buried Sill below P3 N, before any excavation by contractor.
- Before installation of Cradle, prop area plate on both sides of Post, and support self weight of Post.
- Decayed and infested friable timber to be treated with Rotafix Consolidation Resin, slow set.

A steel cradle has been devised spanning over the sill onto two concrete pads. A back filling of cobbles set in weak lime mortar around the sill acts as a breathing fill.

7.2	Arcade Post P1n: installation of steel 'T' plate at foot of post: refer drg. no. ABS 1.34	158.00
7.3	Arcade Post P3n: installation of steel cradle support over decayed sill plate and repair to foot of post: refer drg. no. ABS 1.33	758.00

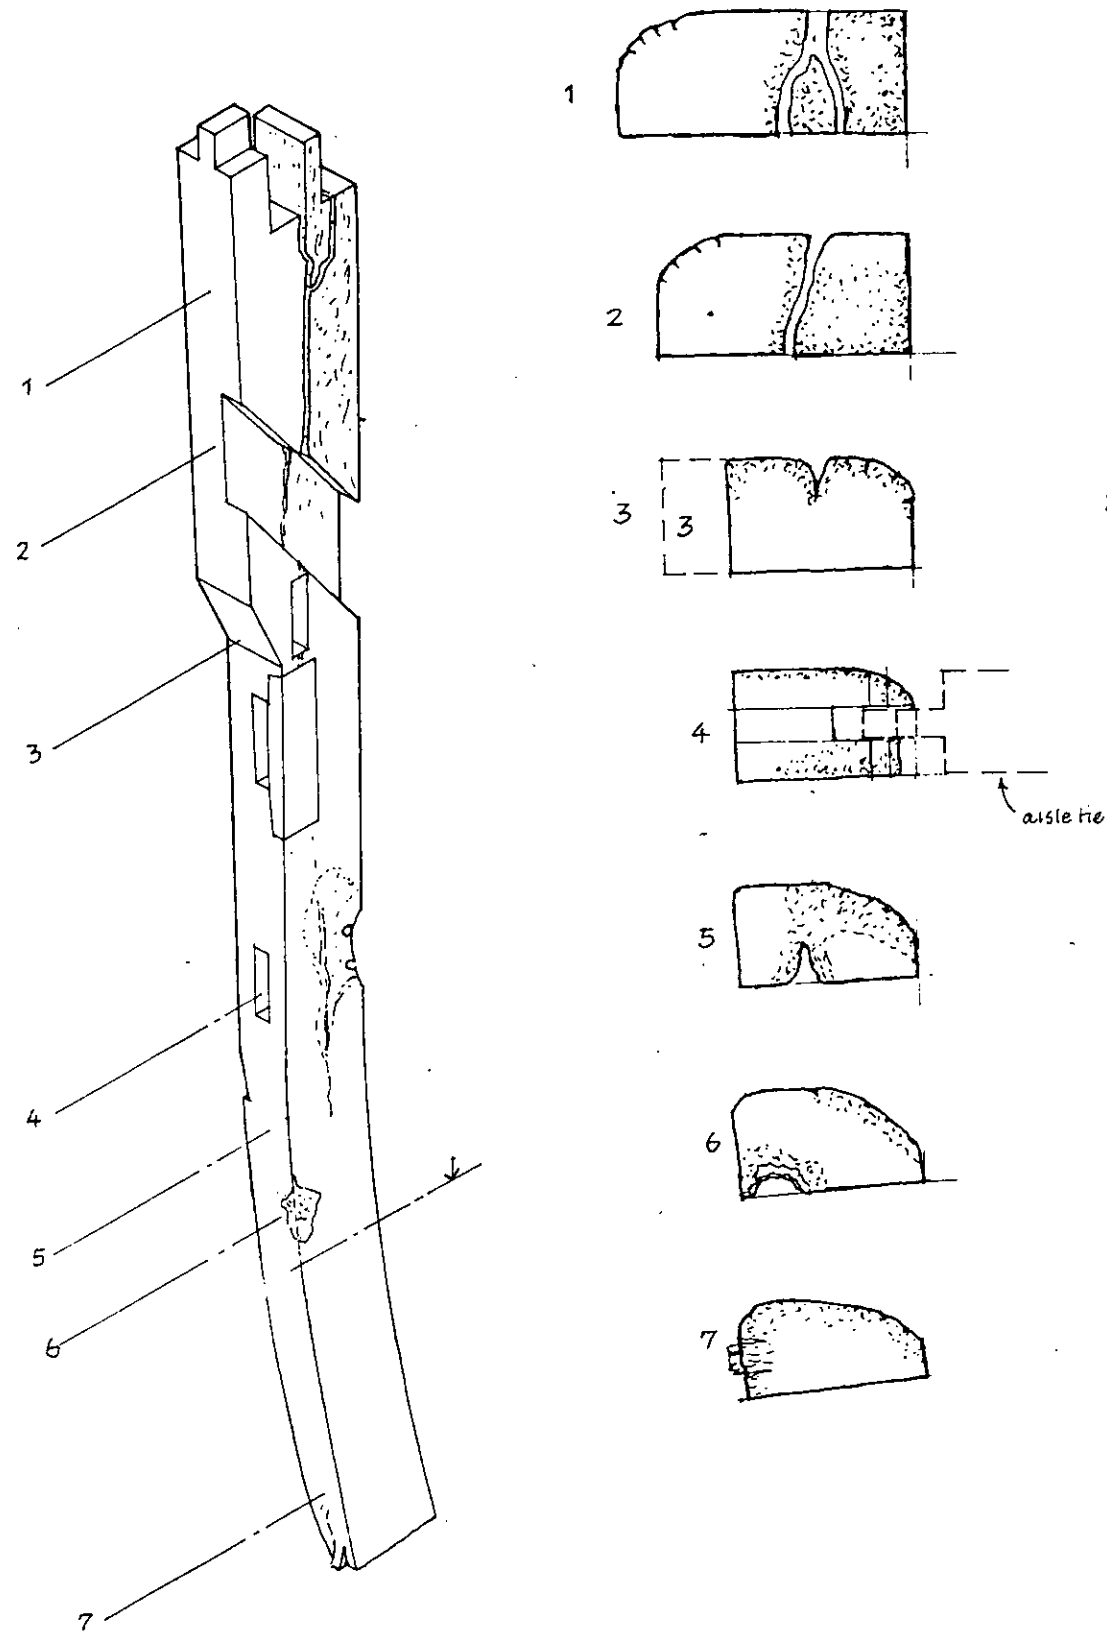
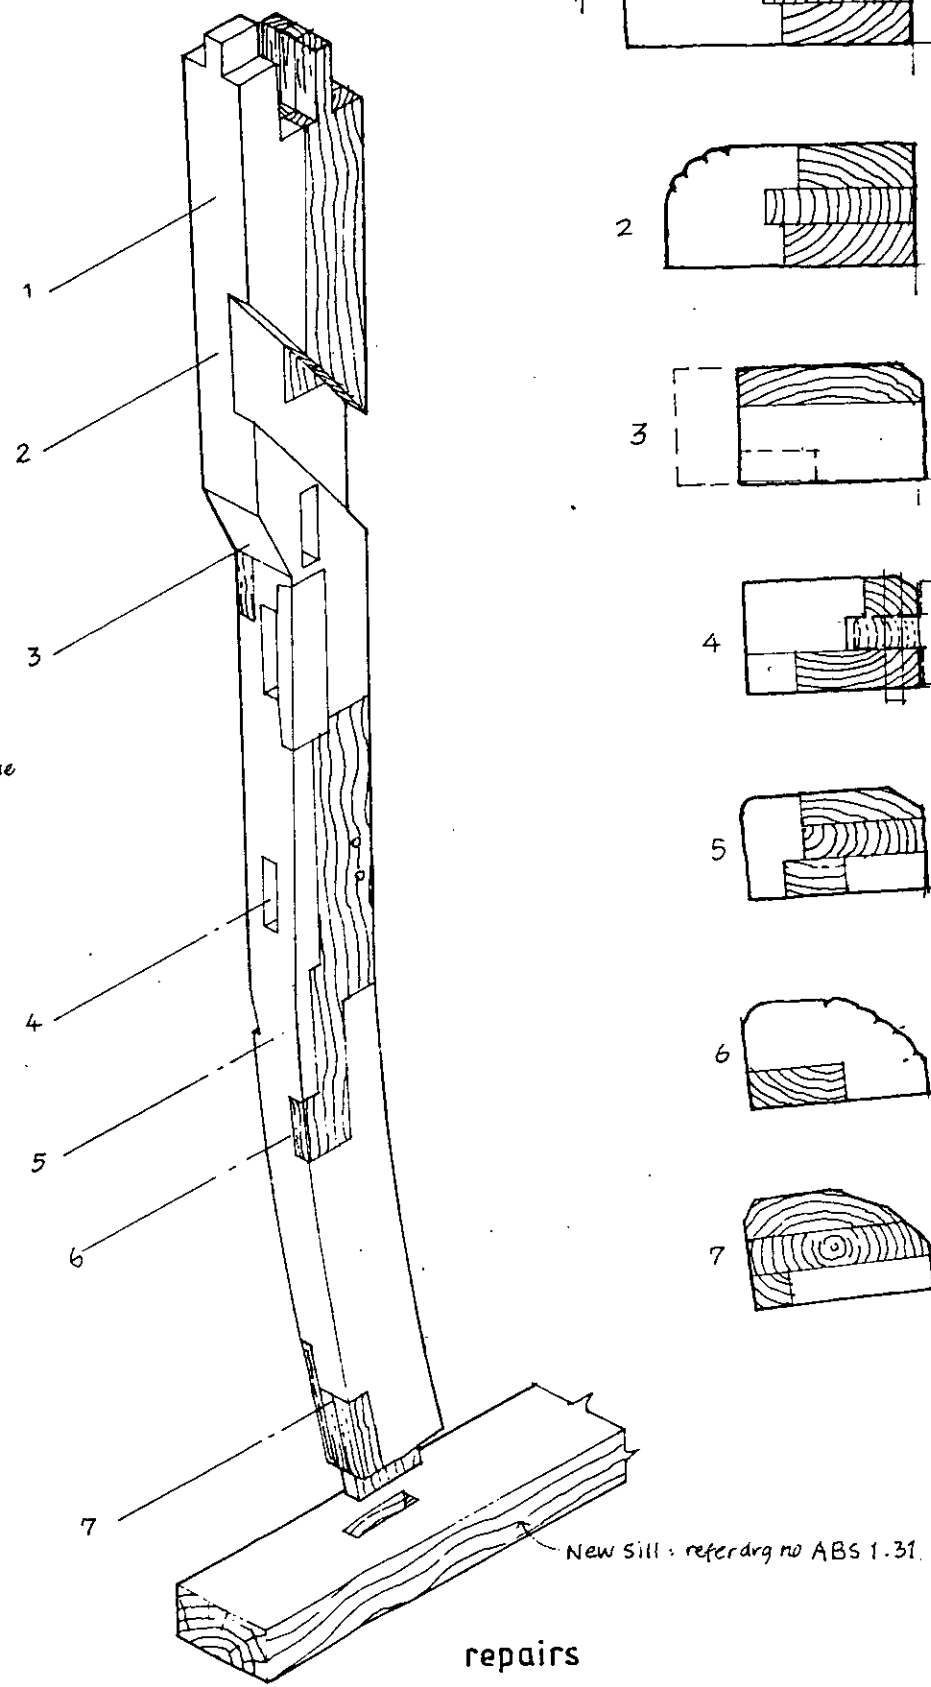
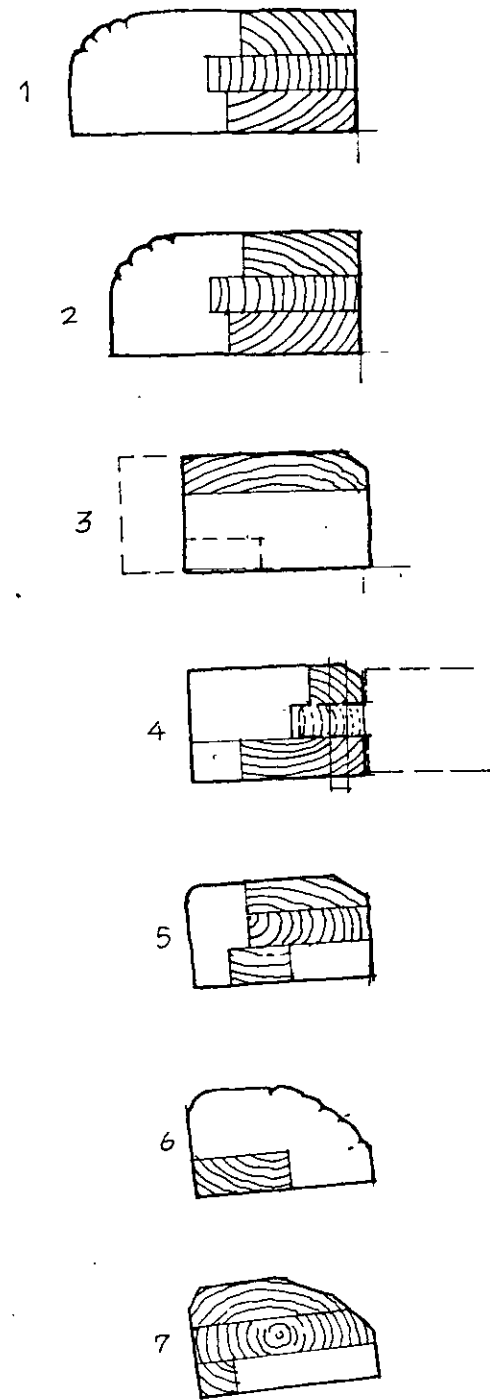
Figure 26 Repairs to arcade post P6 N (superseded detail)

The repairs to Arcade Post P6n, illustrated in Fig 32, also presented problems. This was an important part of the primary structure and had an example of a passing brace and aisle assembly attached to it. The original specification called for complex timber repairs in a laminated form. After the builder started work, it became apparent that the post was in an extremely fragile condition, with a fracture at aisle tie level. It was also disintegrating where there was a vertical shake at the jowl head.

1. All steel is to be galvanised; prime with one coat of calcium plumbate before fixing.
2. Arcade Post P6N: This post is in a decayed and very fragile condition. Fix temporary light steel banding round the Jowl head of the post before attempting any repair work.
3. After fixing steel the Arcade Post to be treated with 'Rotafix' Consolidating Resin - Slow Set.

- Read with proposals for Adjustment of Cross Frame : drg no ABS 1.31.
- Complete adjustment of frame to re-engage joints, before commencing repairs on Post P6N
- Use Rotafix fillers and Adhesives: severely decayed and infested friable timber which is not to be removed, should be treated with Rotafix Consolidating resin slow set

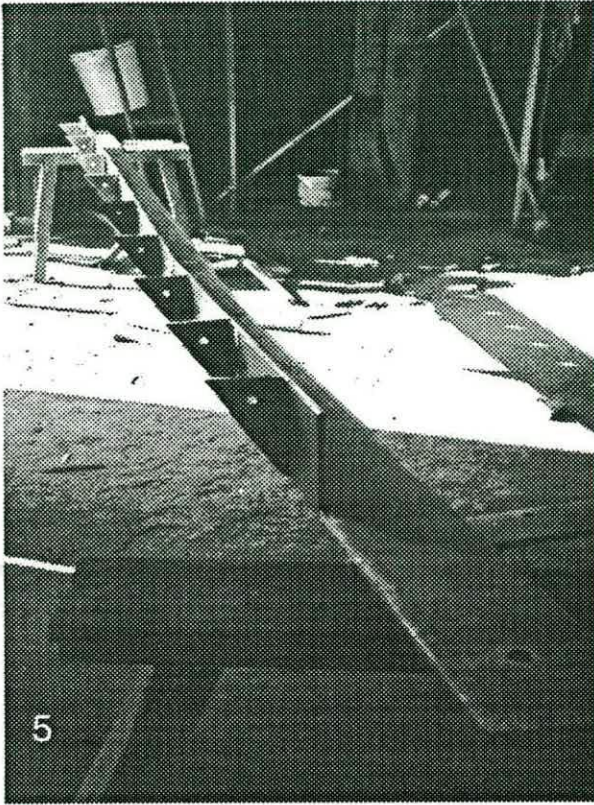
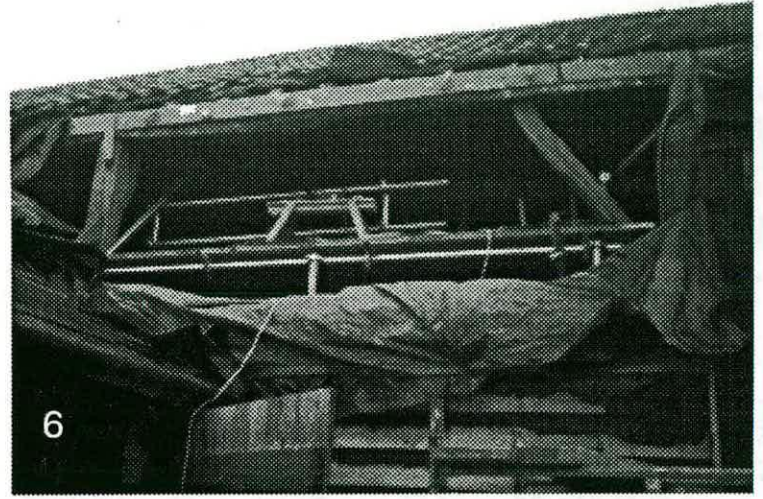
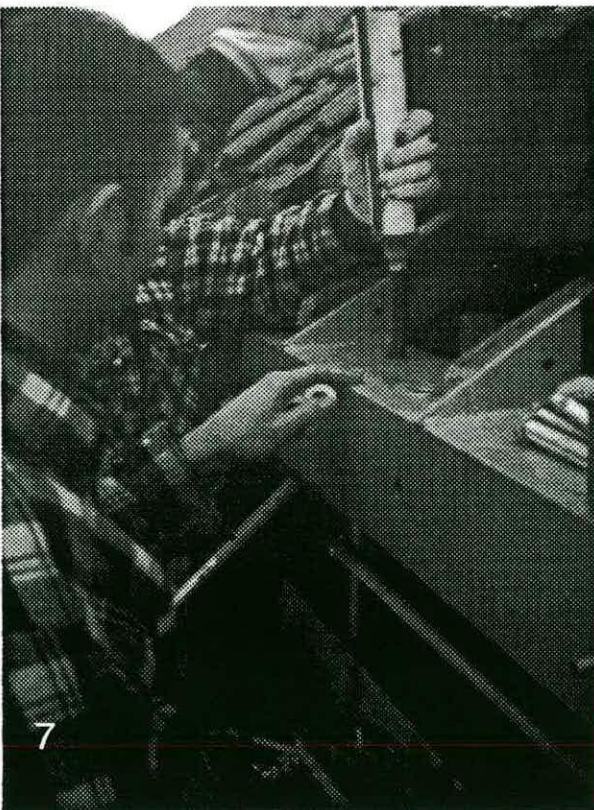
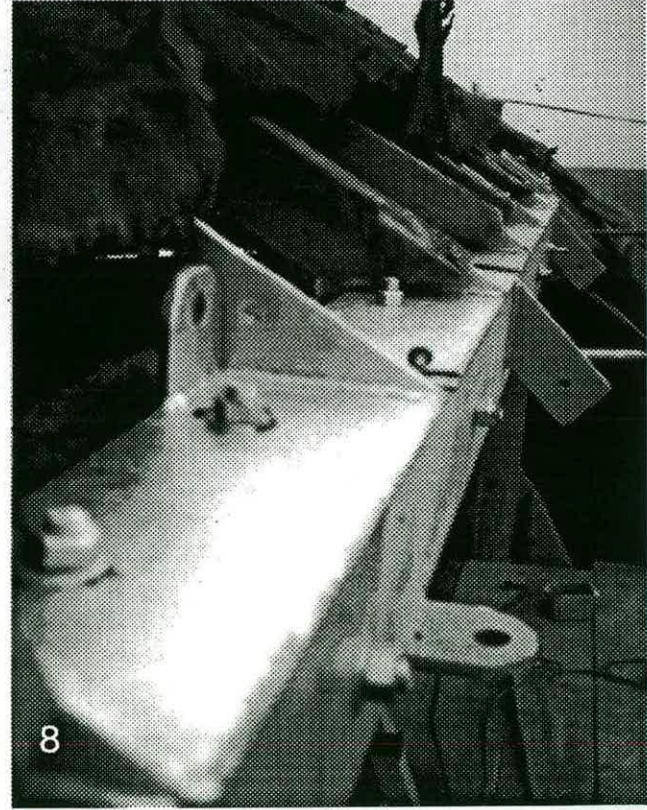
Figure 34 Repair to South aisle wall

5 Fabricated steel before fixing.

6 The steel in position on the outside face of the plate.

8 Steel bolted into position showing lugs for rafter fixing.

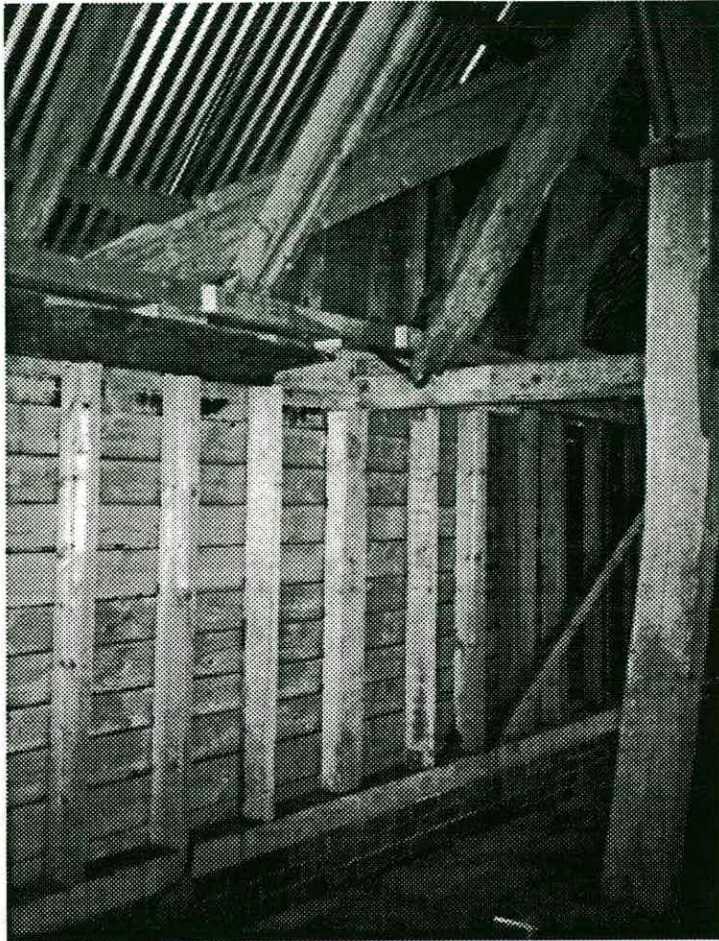
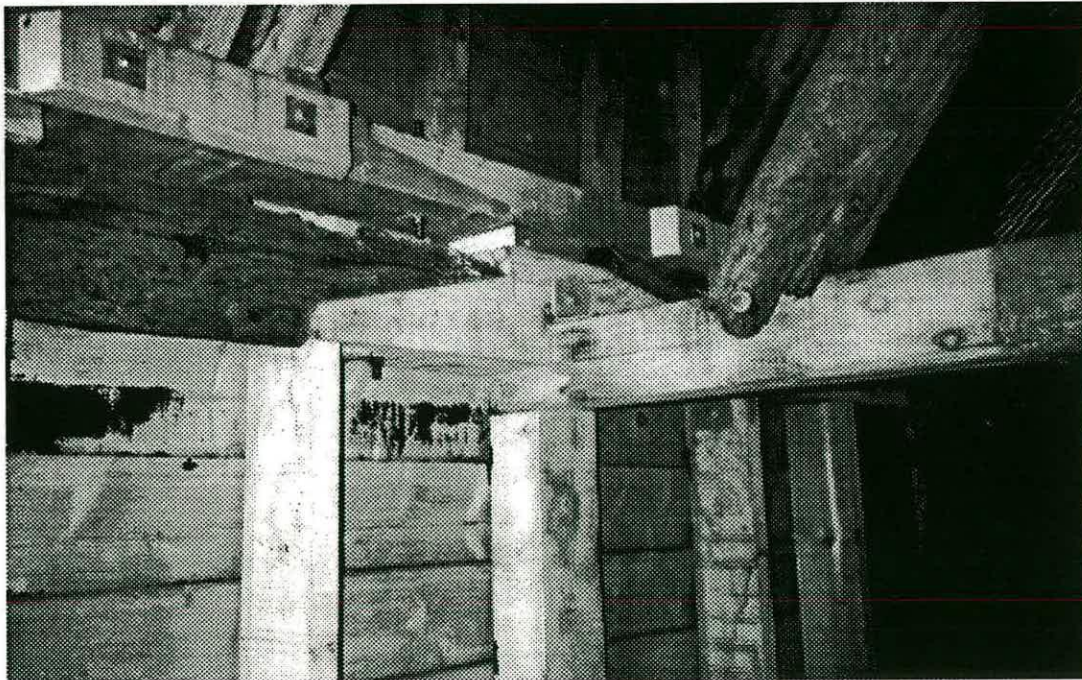
A section of the South Aisle Wall has been reconstructed due to the ravages of recent wet rot and decay. There was no primary fabric here. The construction was mainly in softwood with some surviving old oak.

The repairs by our contractor are a good example of carpentry skills and ingenuity in dealing with an already distorted and haphazard structure.

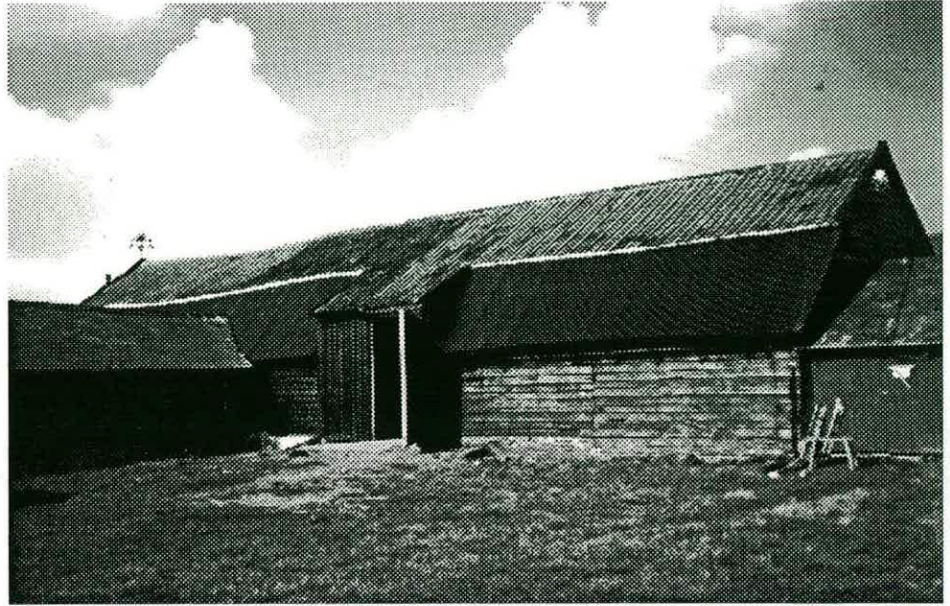
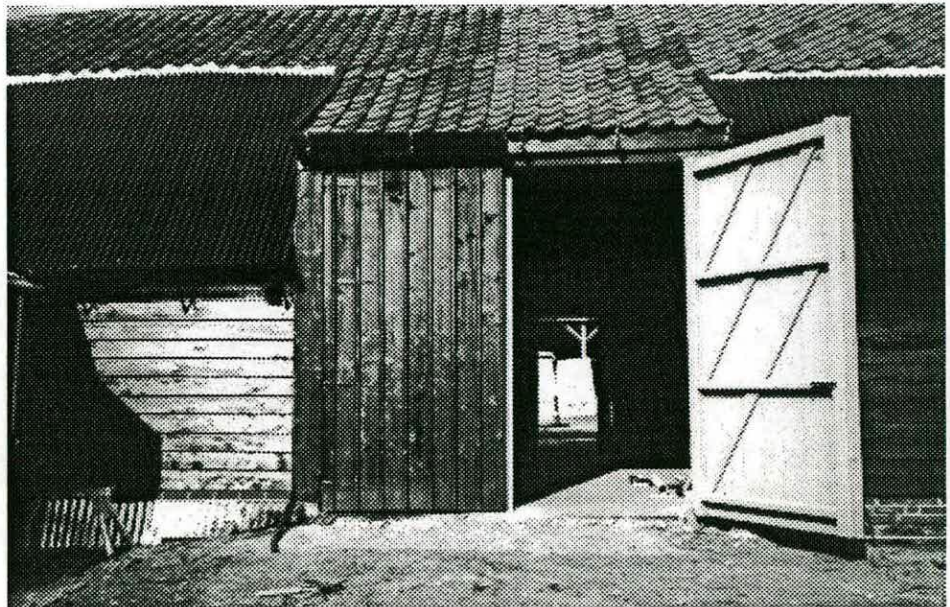
Figure 35 Exterior of the barn from the South

The pantile roof has a much lower pitch than the original roof which would have been consistent with the present aisle pitch.

General repairs have been carried out which includes the renewal of some metal roof sheeting over the aisles, part of the weather board and new barn doors. All external timber has been painted with coal tar.
