46-52 ARCHBISHOP'S PLACE
Brixton
London SW2

*Brief analysis and interpretation
of an early 19th century boundary wall*

Historical Analysis & Research Team
Reports and Papers 34
2000

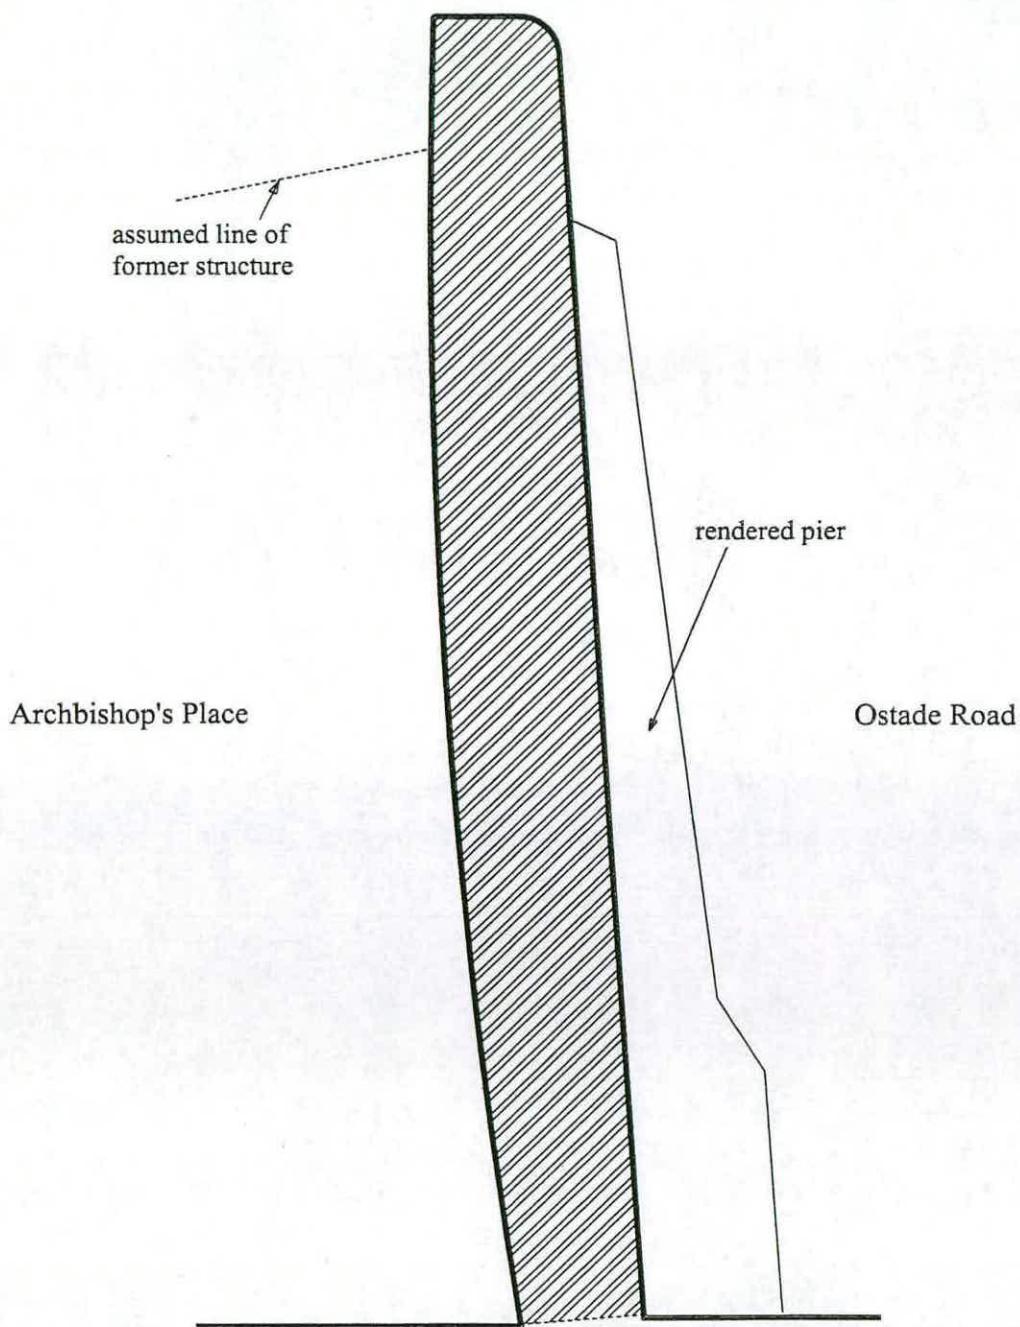
Fig. 15

Section through rear wall of properties

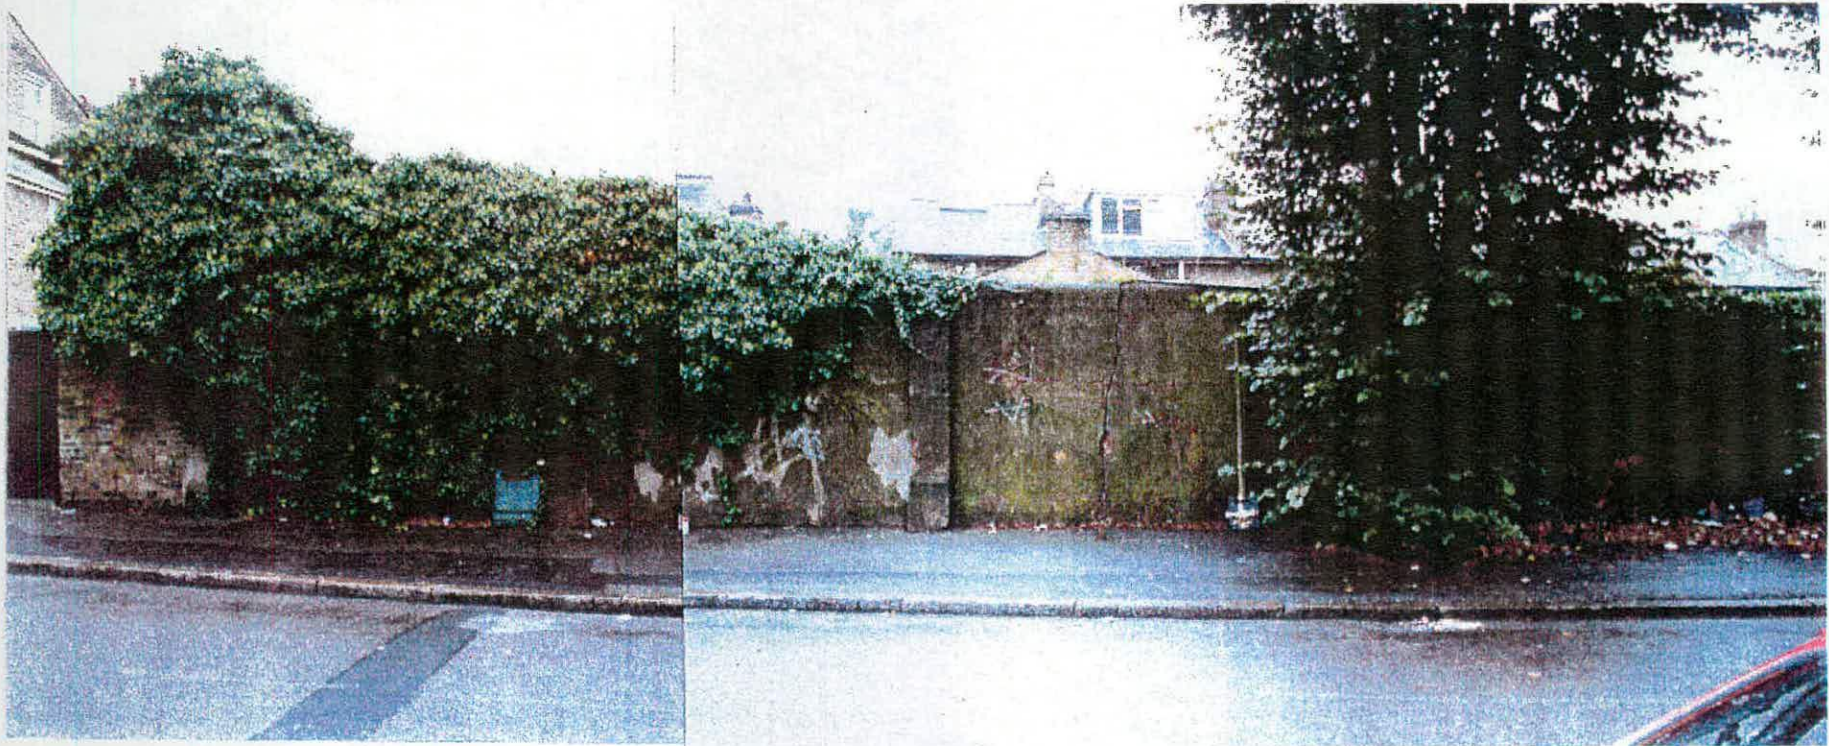
Plate. 1

Part-main front elevation of wall from Ostade Road

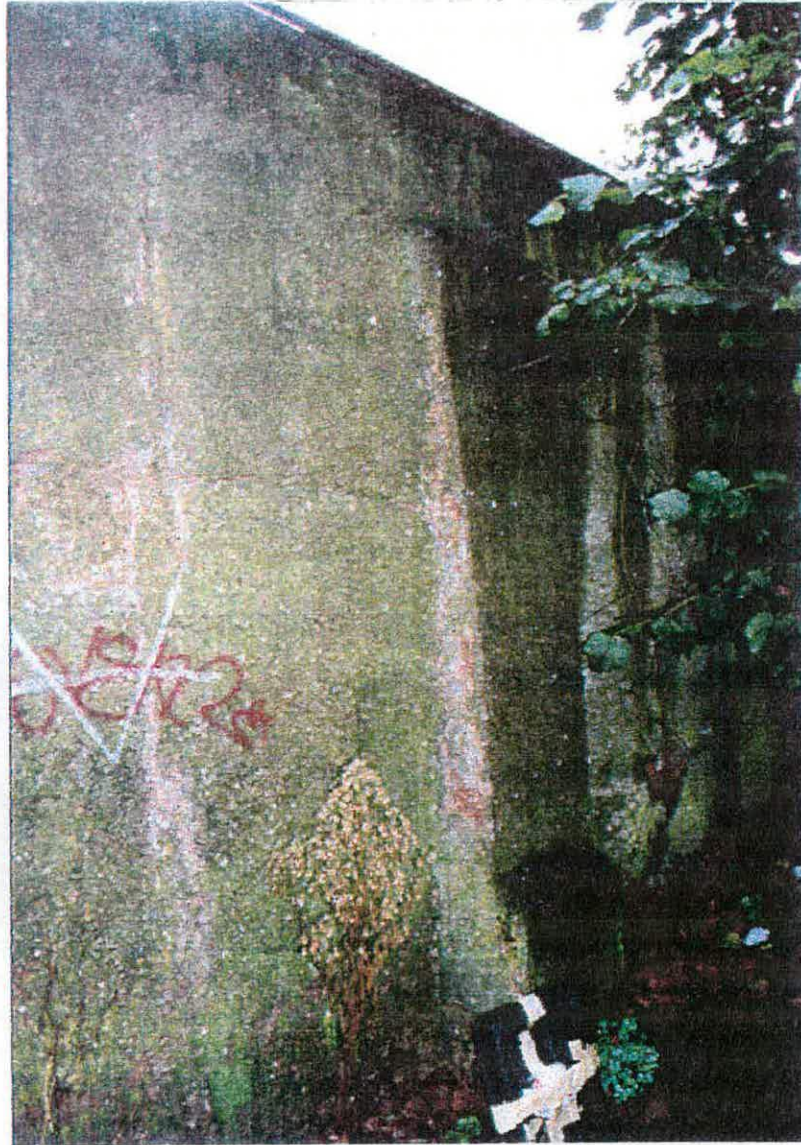
Plate. 2

Part-elevation of wall to Ostade Road showing cast-buttruss arrangement

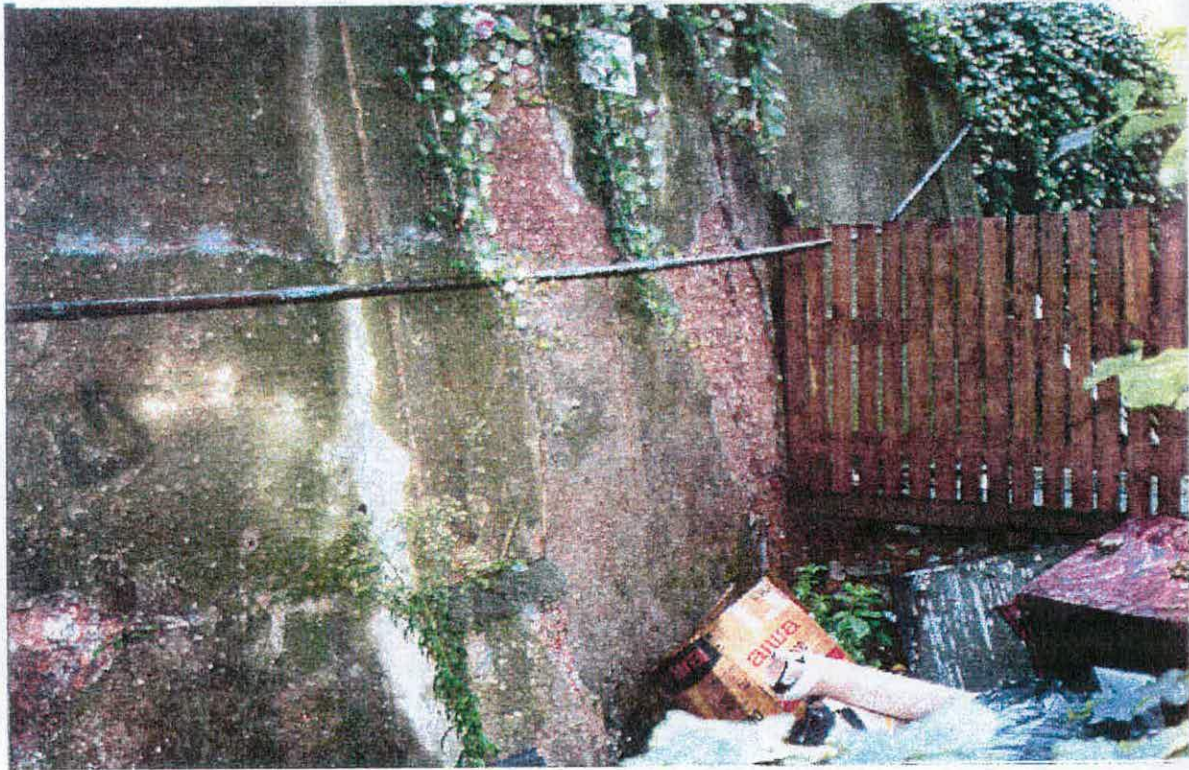
Plate. 3

The wall, including its buttresses, has a tangible westward lean. There are also a number of major fractures evident. Walls of this nature have low tensile strength and will tear readily due to stress caused by local settlement at ground level or around openings. The construction of the brick buttresses on the west face has been attempted to oppose the lean of the wall. However, their construction was of poor quality and they appear not to have been placed exactly where they were required or adequately bonded. The lack of a suitable foundation has also exacerbated the condition.

Ostade Road elevation showing horizontal breaks in the external render where movement has occurred on original construction lines

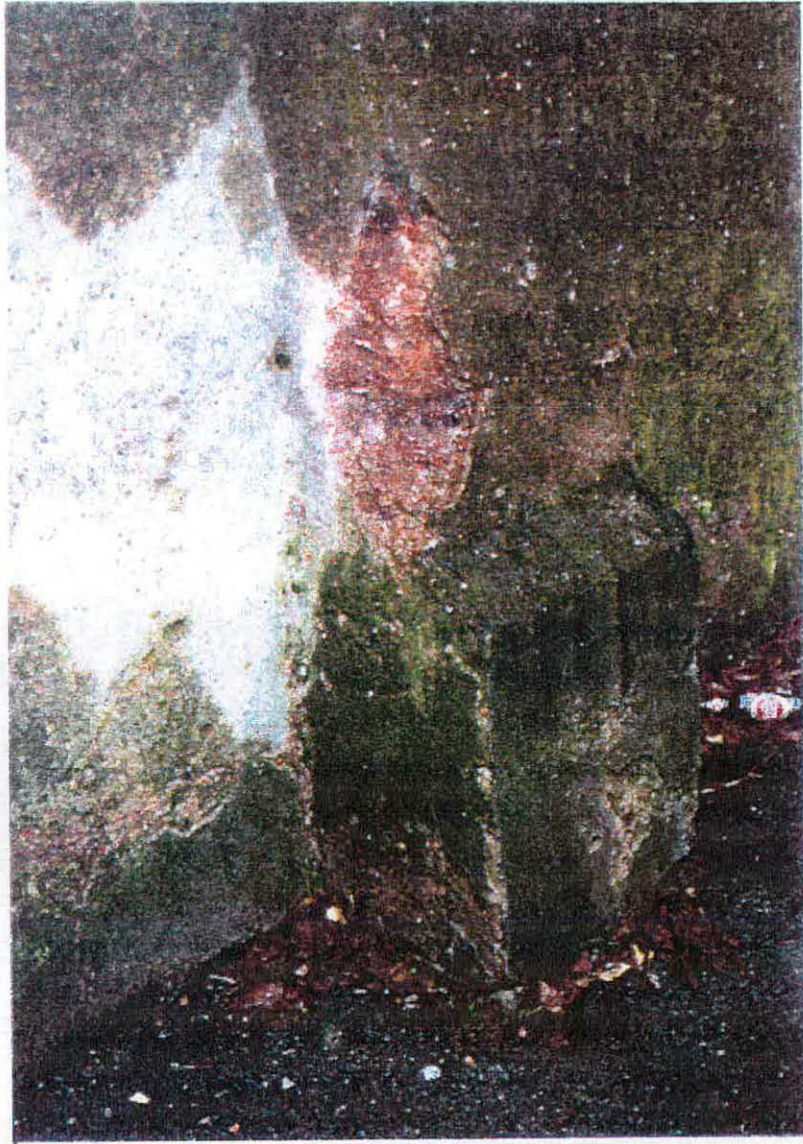
Plate. 4

Ostade Road elevation, detail at base of buttress

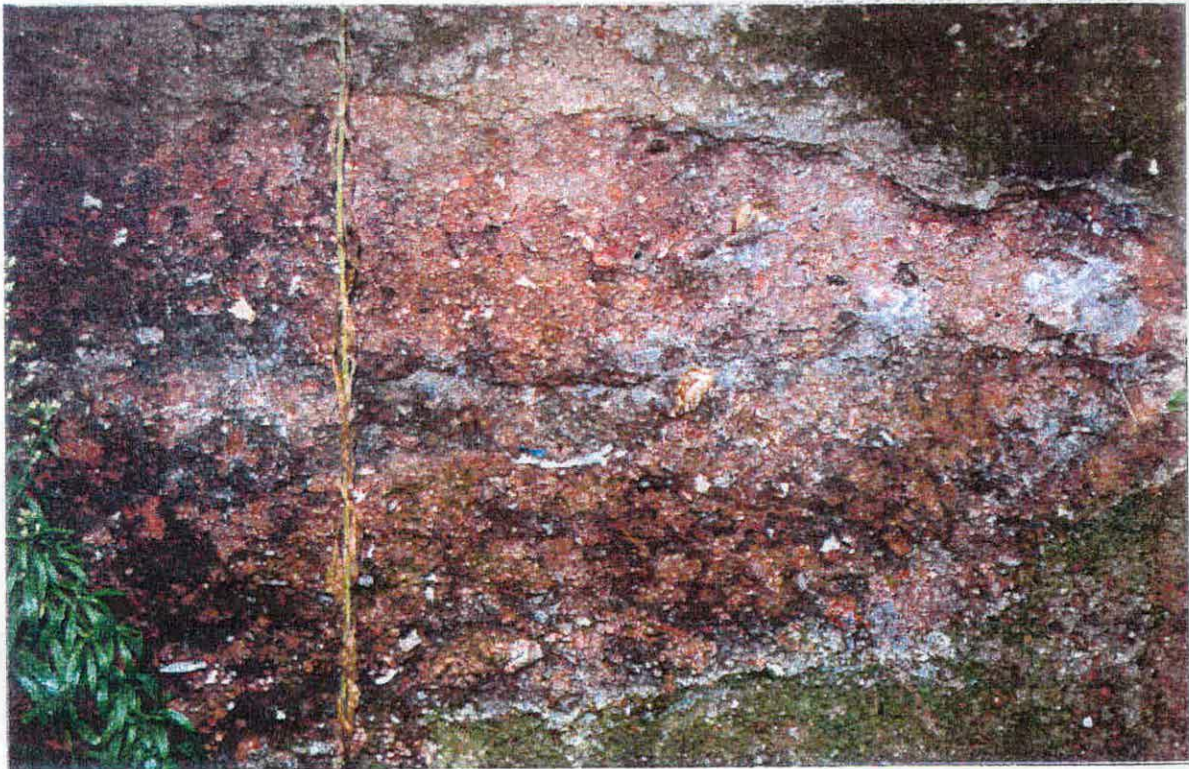
Plate. 5

Ostade Road elevation, original horizontal construction joint exposed due to failure of covering render

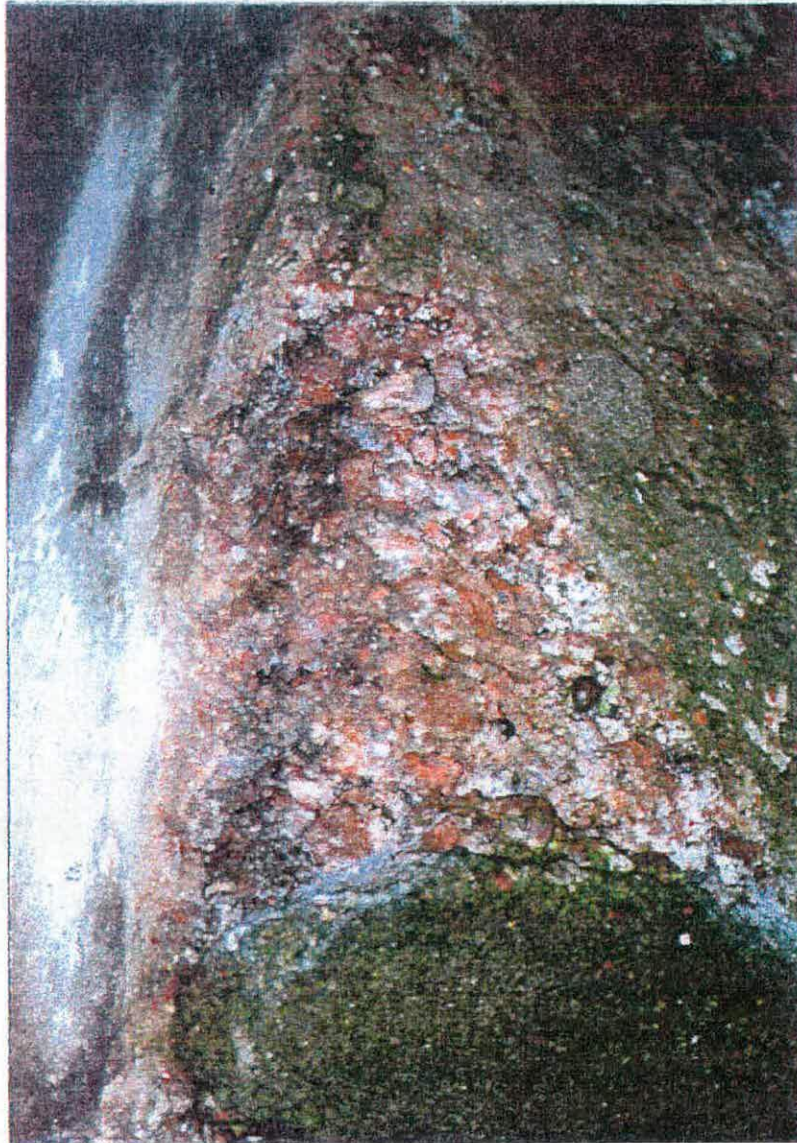
Plate. 6

Close site inspection of the exposed substrate confirmed that the wall is in fact of multi-material construction and consists of a 'concrete' mortar mix containing mainly gravel, pieces of brick and tile and chalk forming a hard monolithic mass. No traditional binding medium, such as hair or straw, was found.

Multi-material construction of wall consisting of a 'concrete' mortar mix containing mainly gravel, pieces of brick and tile and chalk forming a hard monolithic mass. No traditional binding medium, such as hair or straw, was found.

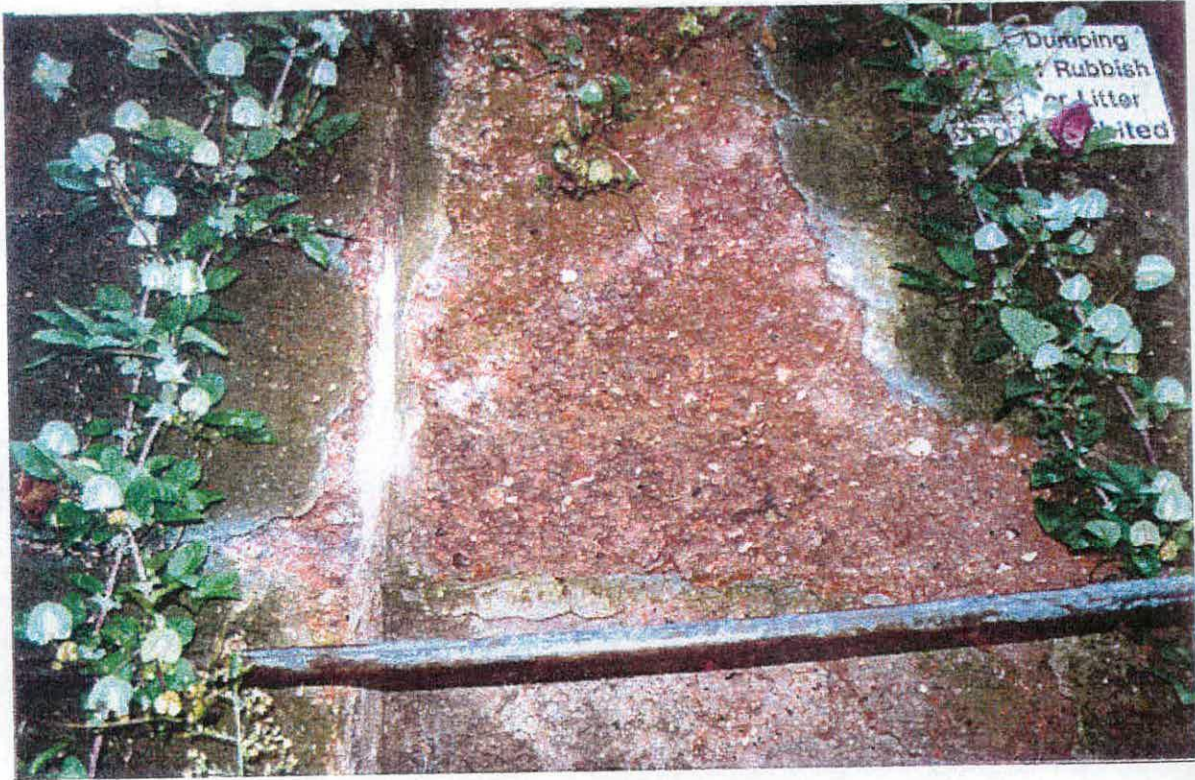
Plate. 7

The external rendering has broken away in a number of areas. This loss of cover and evidence for patch repairs of varying materials, suggest that the existing covering may in fact be detrimental to the surviving substrate, trapping moisture and encouraging the breakdown of the surface.

Failure of external rendering in a number of places has left the substrate exposed and liable to decay.

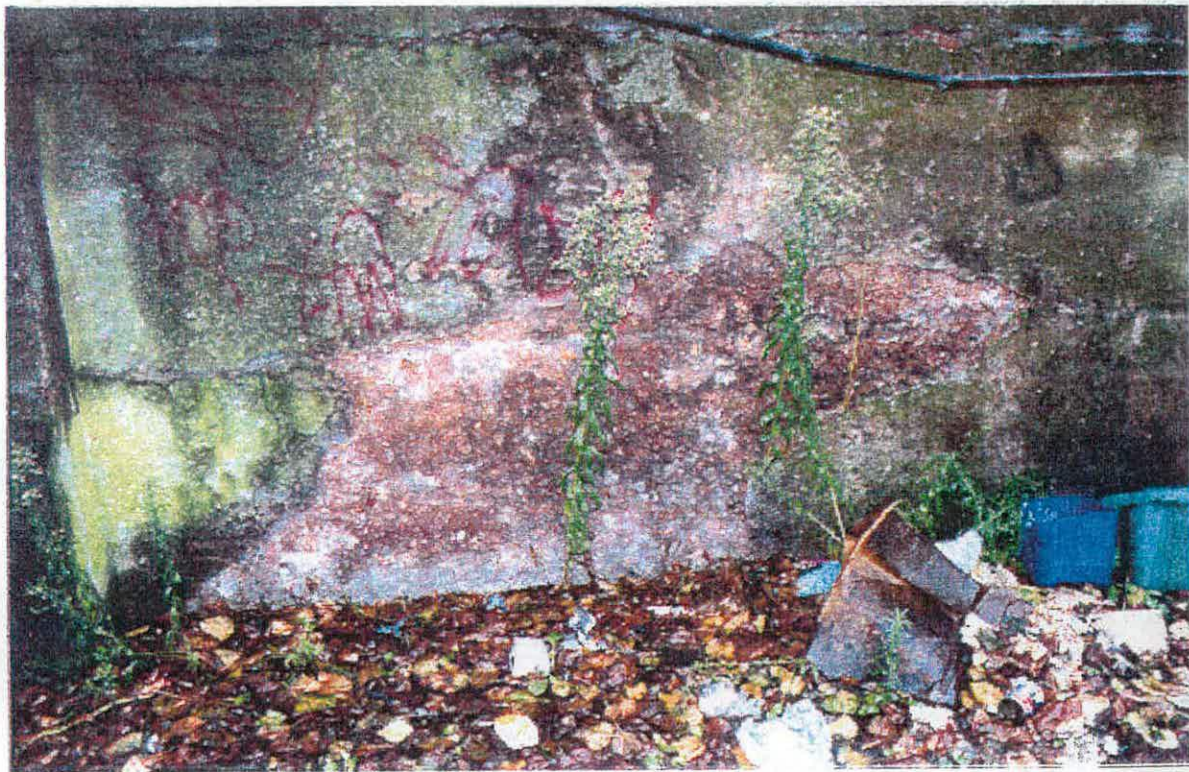
Plate. 8

Although the techniques adopted for construction appear to be similar, there was no evidence from the material used and method adopted for construction to suggest that this wall was of cob construction. Walls of this nature were typically constructed from a brick (or stone) foundation (commonly called 'pinning') and would have been capped by a coping (possibly of thatch or more likely tile). No evidence was found for any of these features and in fact it would appear that the wall may not have any founding and has been simply 'cast' from the ground.

Original horizontal construction joint exposed due to failure of covering render at base of wall. It would appear that the wall may not have any founding and has been simply 'cast' from the ground.
