PALACE HOUSE MANSION

PALACE STREET, NEWMARKET, SUFFOLK

*Report Outlining the Analysis and Interpretation of a
Late Seventeenth-Century, Solid-Frame,
Counterbalanced, Sash Window*

Reports and Papers 15

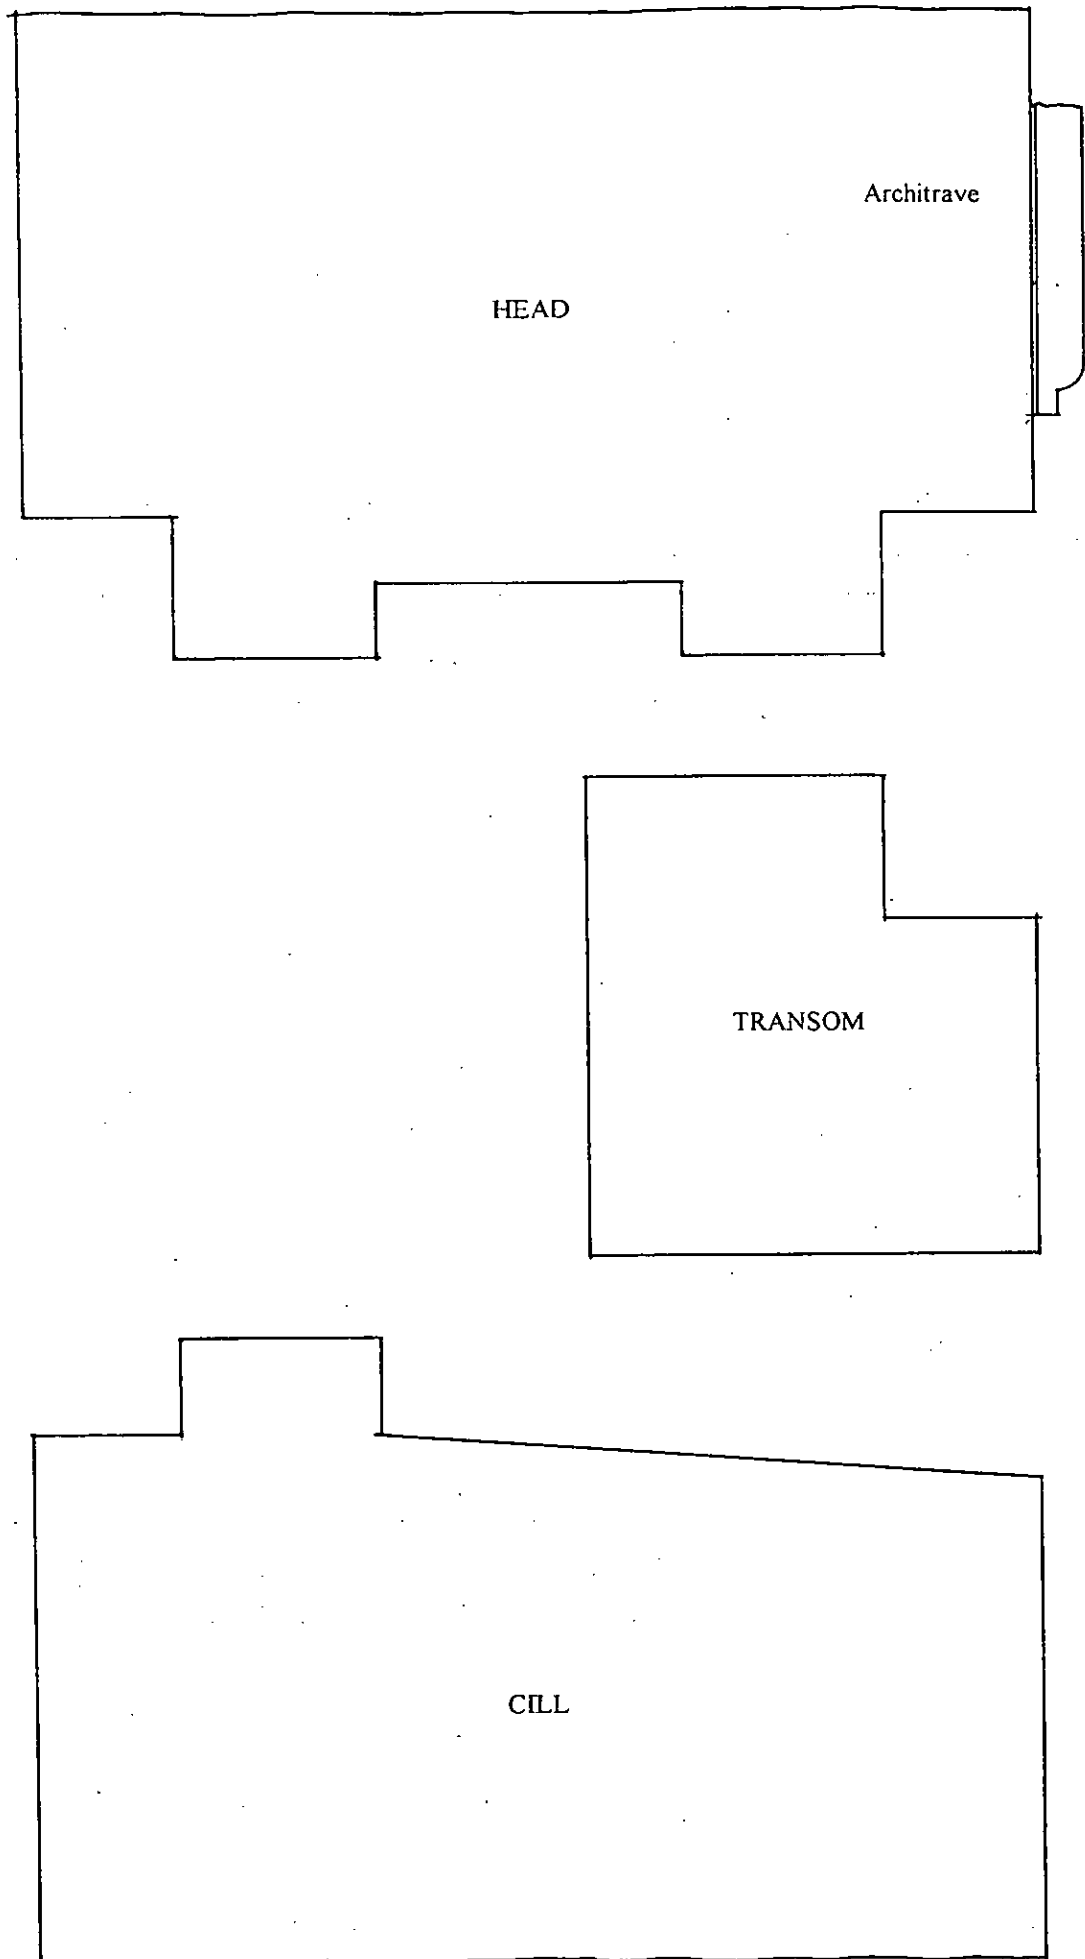
Fig. 1
Full-size frame sections

The frame head, 127 x 87mm (5"x 3.5"), also has the central, staggered 'U' shaped guide run from the solid (*Fig. 1*). The exposed cill, 127 x 83mm (5"x 3.25"), was prepared with a slight bevel which gave a weathered upper surface and an upstand, married to the jamb guides, to retain the lower rail of the sash and offer protection from wind-blown rain. The transoms, 63 x 57mm (2.5"x 2.25"), have a simple rebate, 19 x 19mm (0.75"x 0.75"), cut in their upper external face to receive the glazed lights.

A thin cover architrave survives, nailed to the internal face of the head of the frame, although the upper part has been hewn away. Formerly 76mm (3") in width, it would appear to be contemporary and have the same painted application as survives on the framing. A band, 76mm (3") wide, bereft of paint and set 19mm (0.75") from the sash-guide face, suggest that it covered the internal face of the frame jambs and concealed the weight and pulley wheel access pockets. It also appears to have been placed to cover the internal face of the cill. The surviving moulding, merely 6mm (0.25") in thickness, has a rather plain and somewhat unusual form with an ovolo and fillet at its termination (*Fig. 1*).

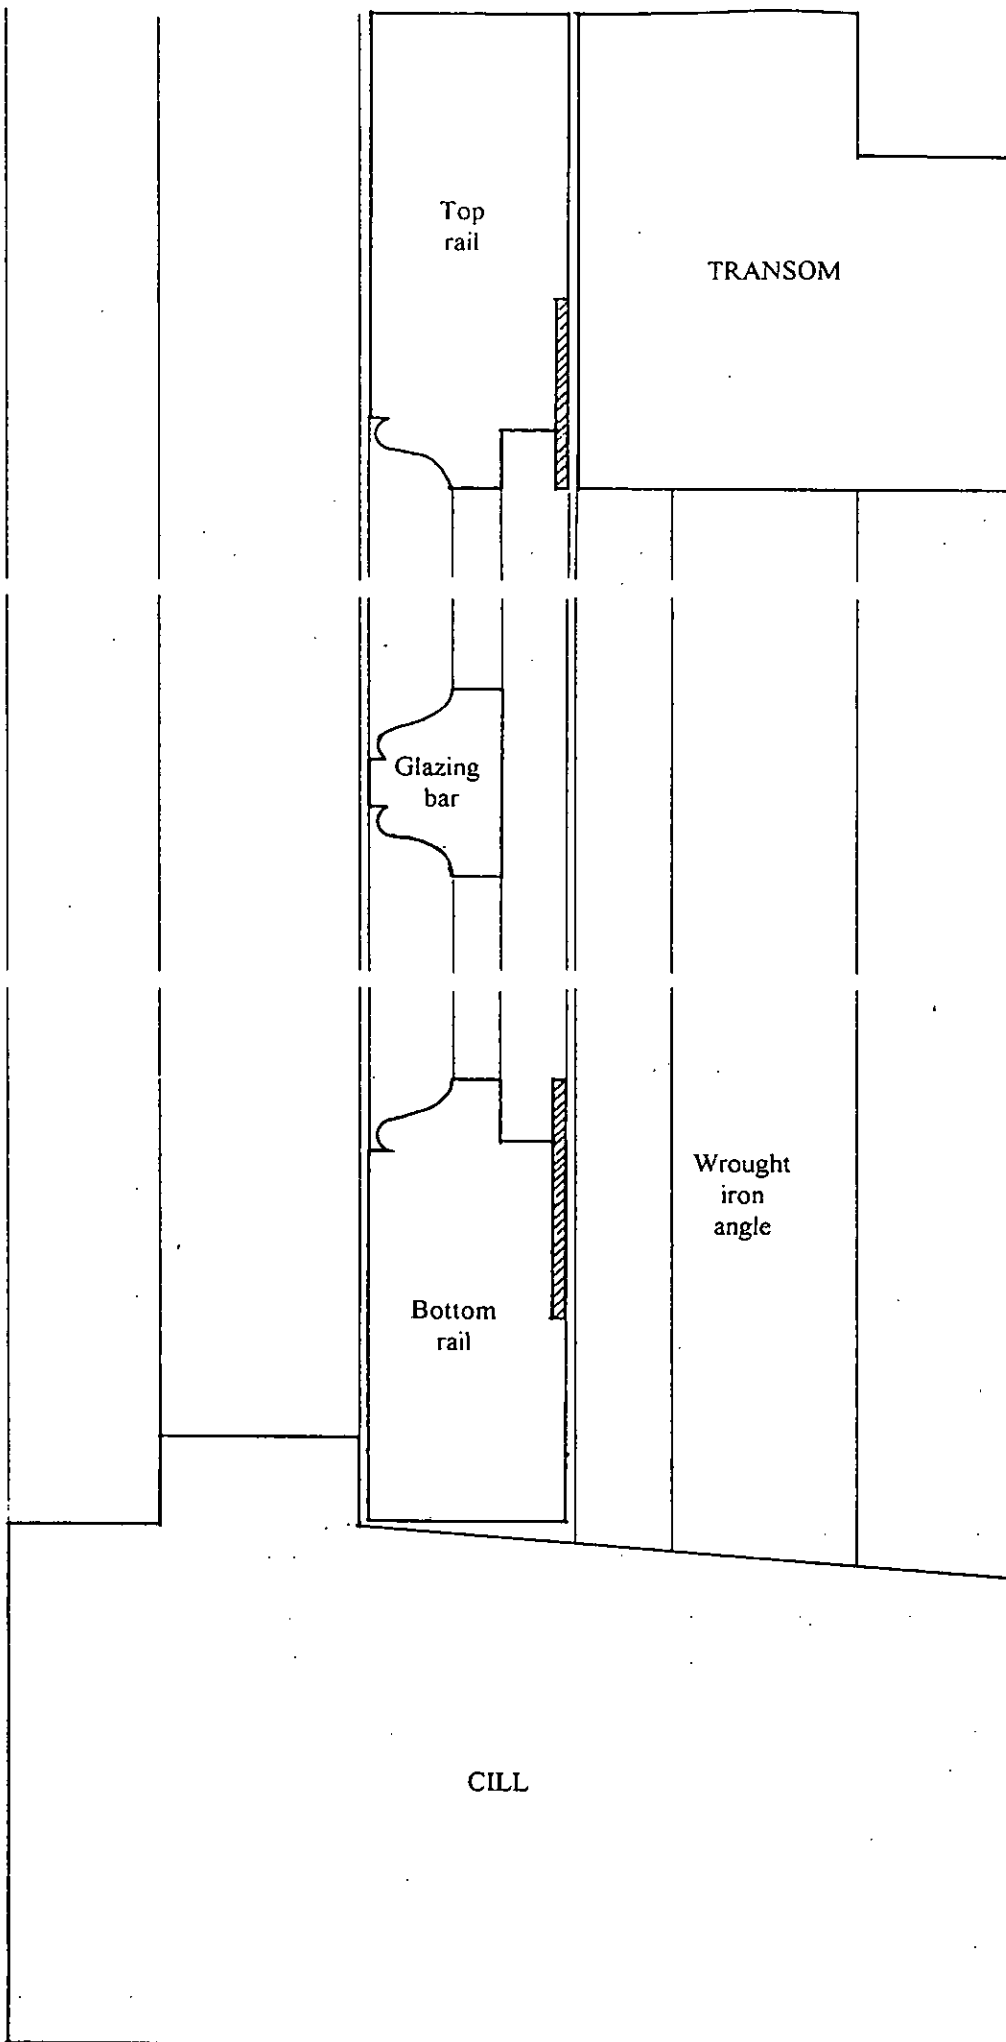
Fig.3
Full size sash/frame sections.

Both the top and bottom rails of the surviving sash frame were cut from solid timber (*Fig.3*), 25 x 63 x 546mm (1"x 2.5"x 1'9.5"). The stiles are similar (*Fig.4*), 25 x 44 x 1360mm (1"x 1.75"x 4' 5.5") only having planted, profiled timber guides, with overall dimensions 25 x 19 x 1360mm (1"x 0.75"x 4' 5.5"). Four equally spaced, horizontal timber glazing bars are mitred and tenoned into the stiles and secured with small timber dowels. All members have a simple quirk ogee bead run along the internal edge and the adjacent face rebated 8mm (0.3125") to receive the leaded glass panel.

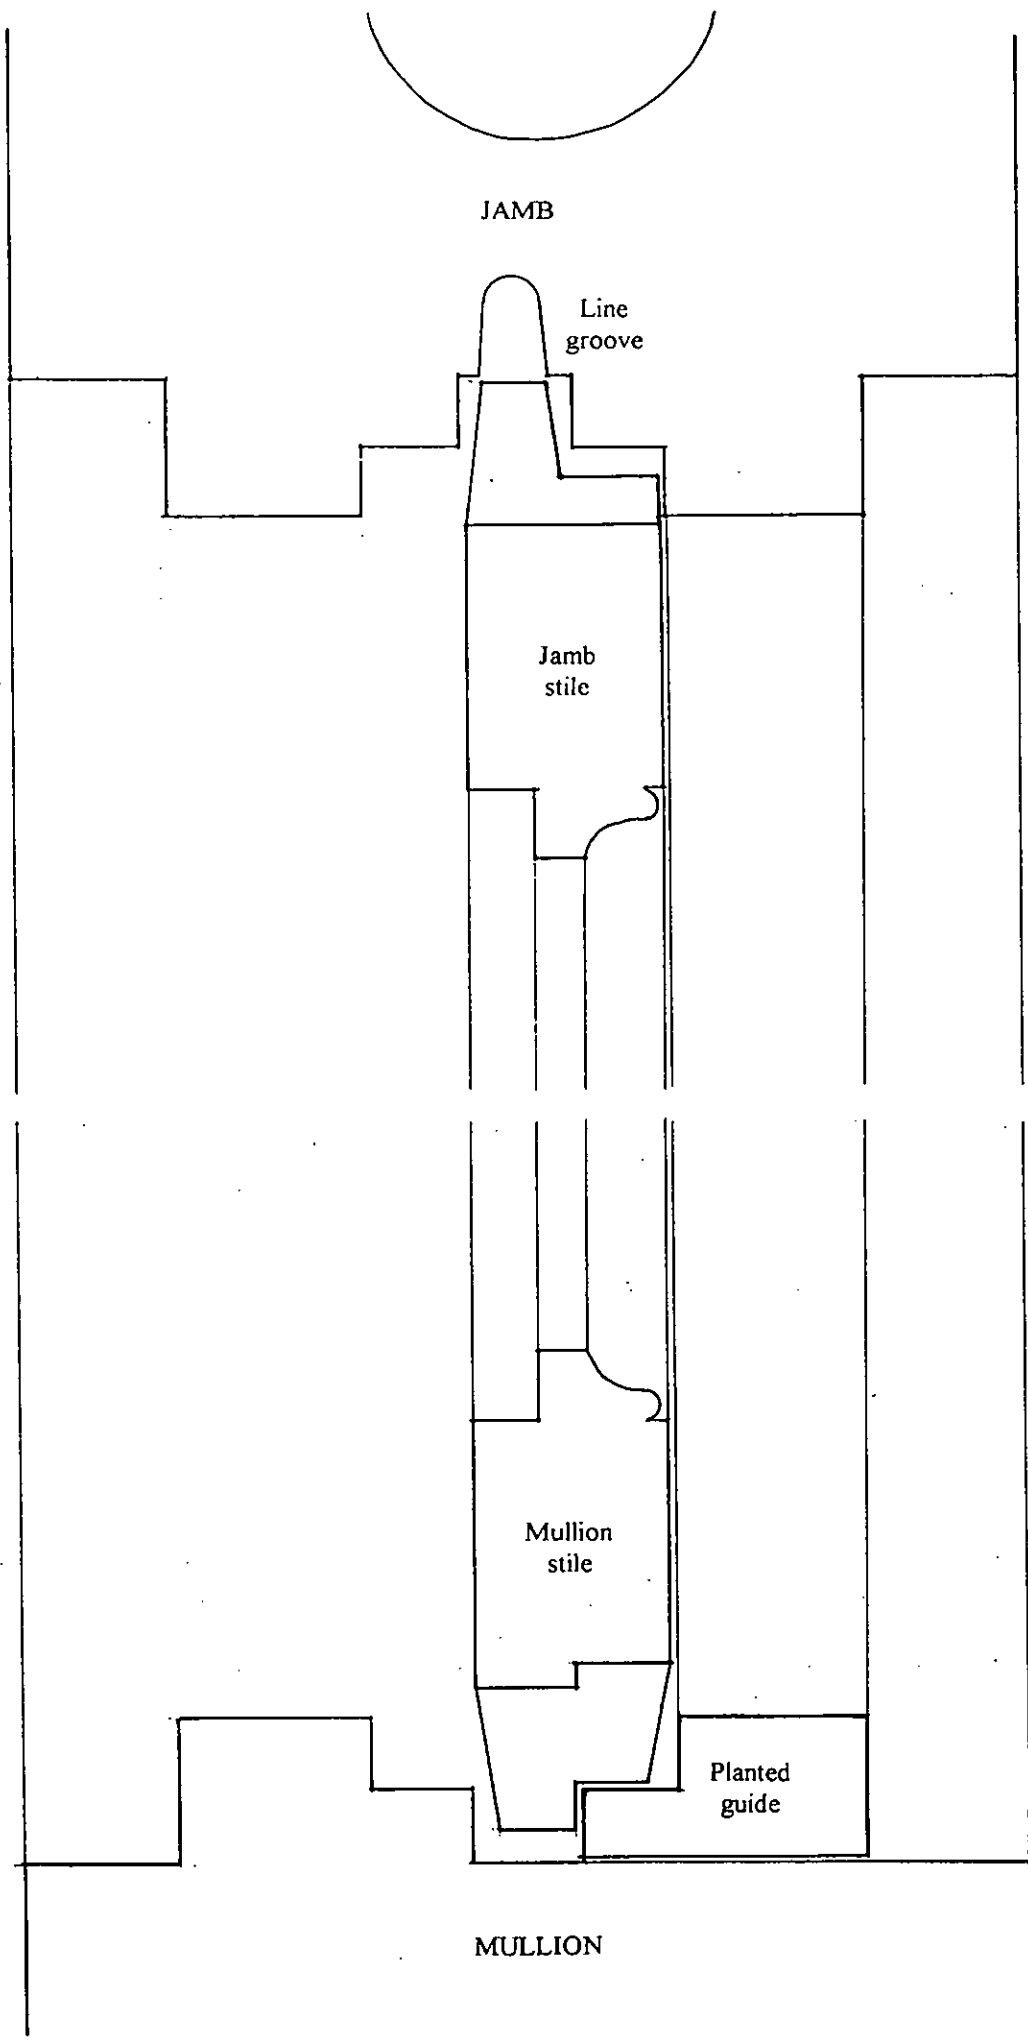
Fig. 4
Full size sash/frame sections.

The planted timber guides to the stiles are unnecessarily complicated. They are 'L' shaped and taper into the corresponding guides of the frame members (*Fig.4*). Each guide has a different pattern which is possibly associated with the purpose that they were intended to fulfil - the extended arm of the jamb stile guide to allow surface fixing of the carrying sash line for example.

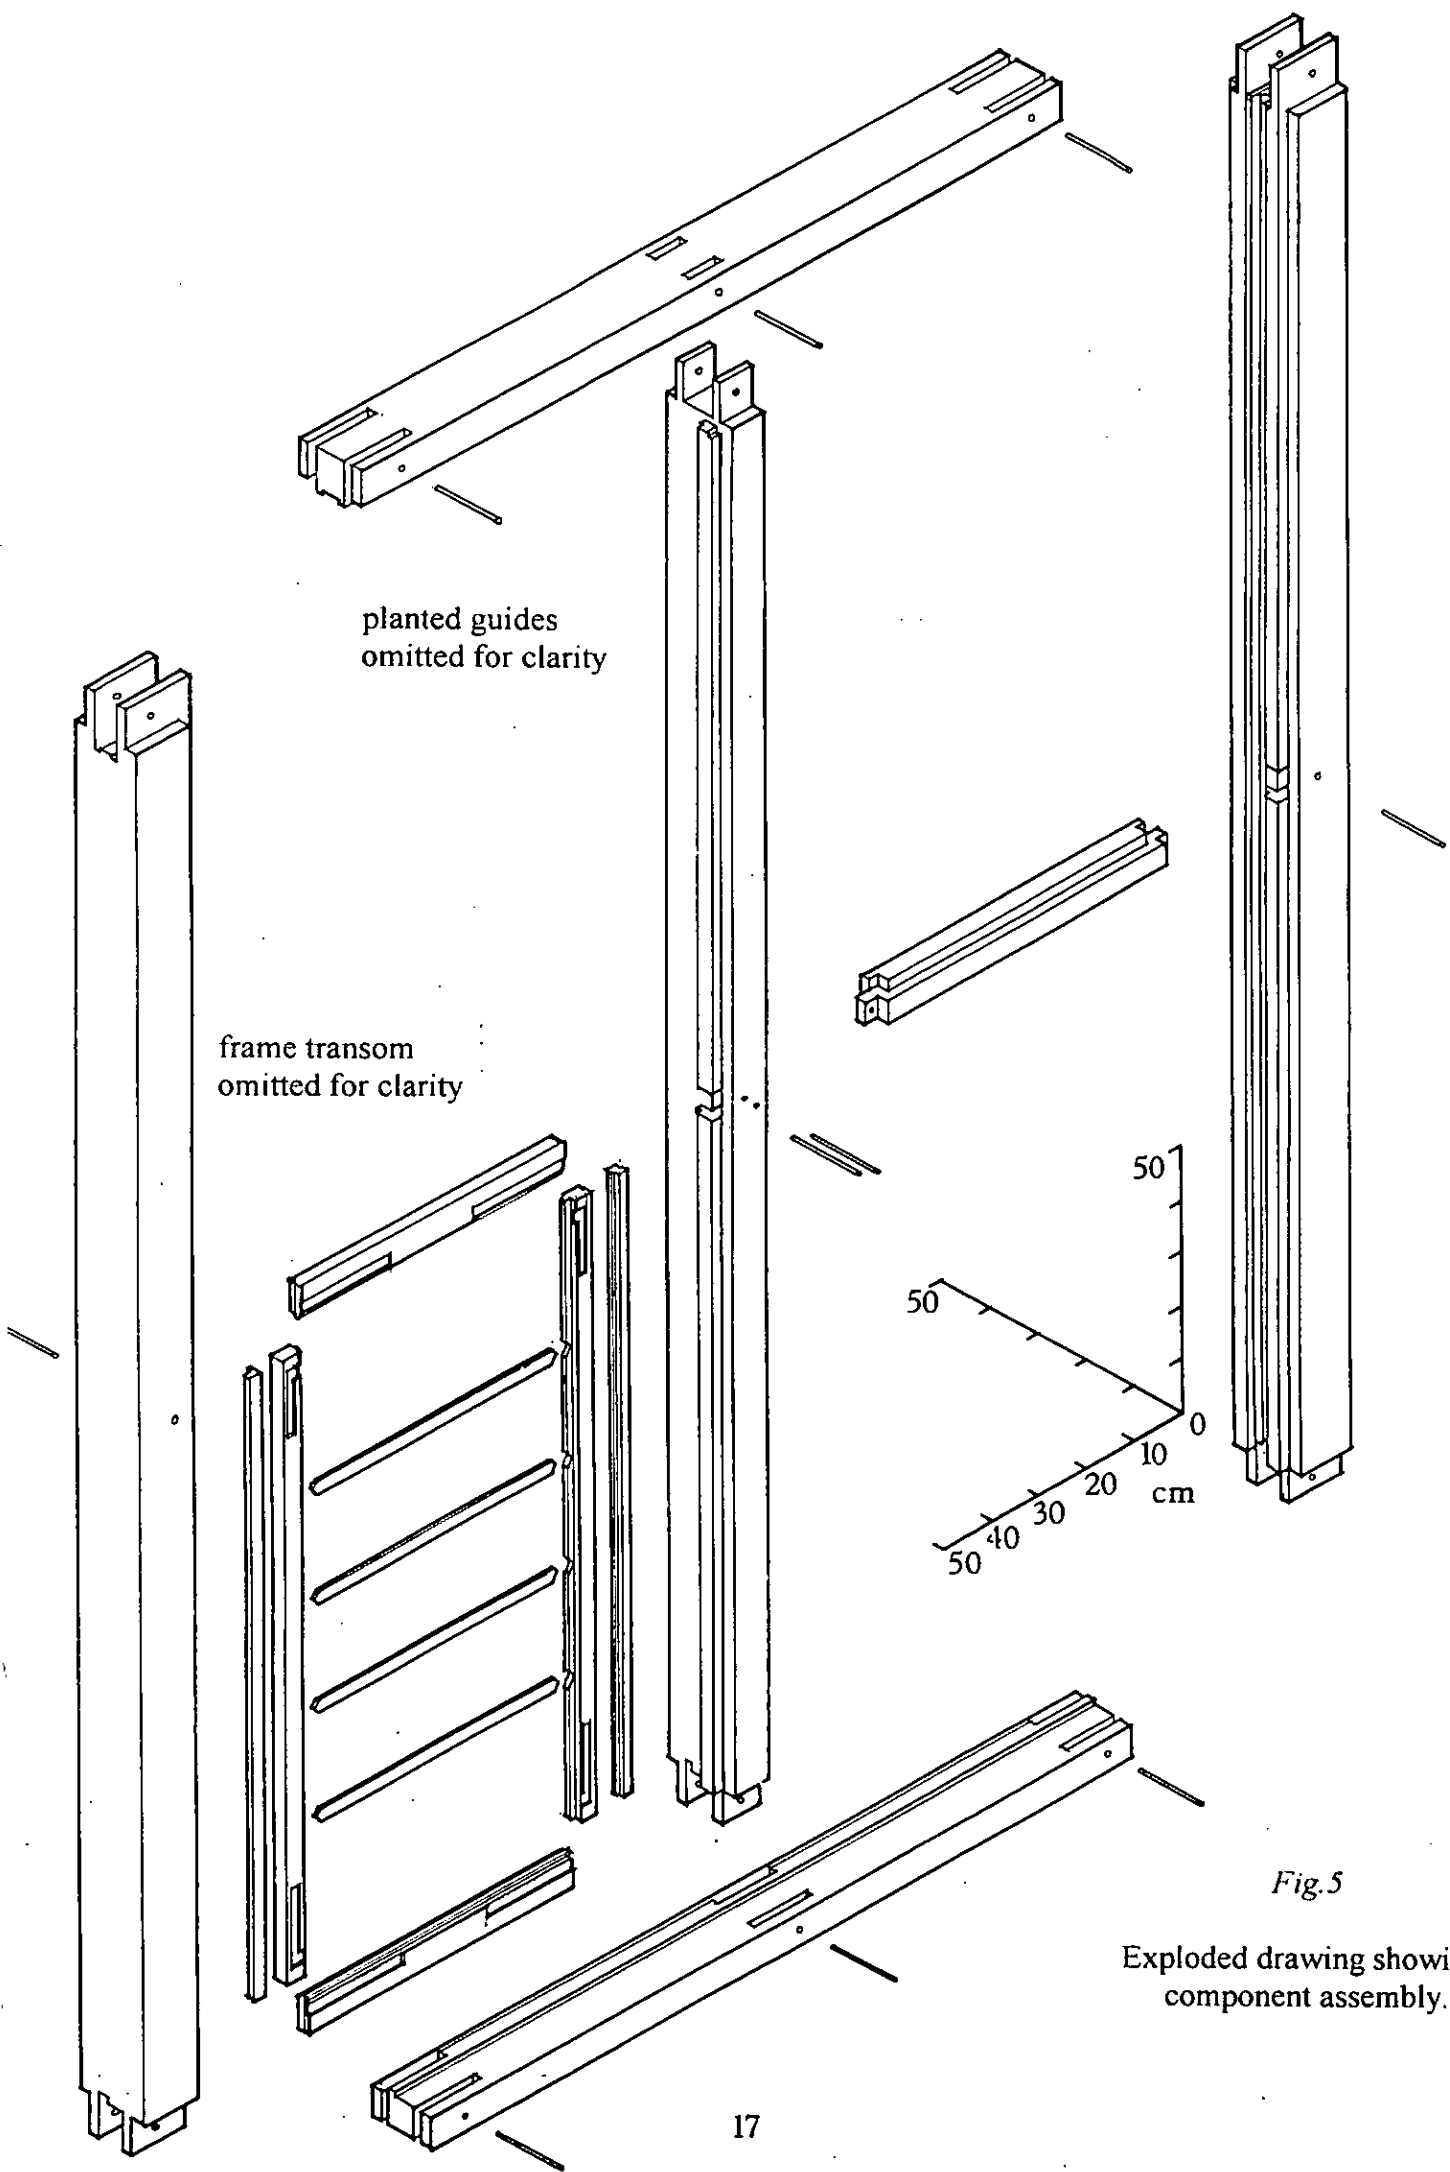
Fig.5

The frame measures 2745 x 1448mm (9'0"x 4'9") overall. It is assembled using traditional mortice and tenon joints with securing timber pegs (*Fig. 5*). No assembly horns survive or appear to have existed and the frame would seem to have been 'squared' to allow uncomplicated accommodation, during construction, within the opening in which it was placed.

Exploded drawing showing
component assembly.

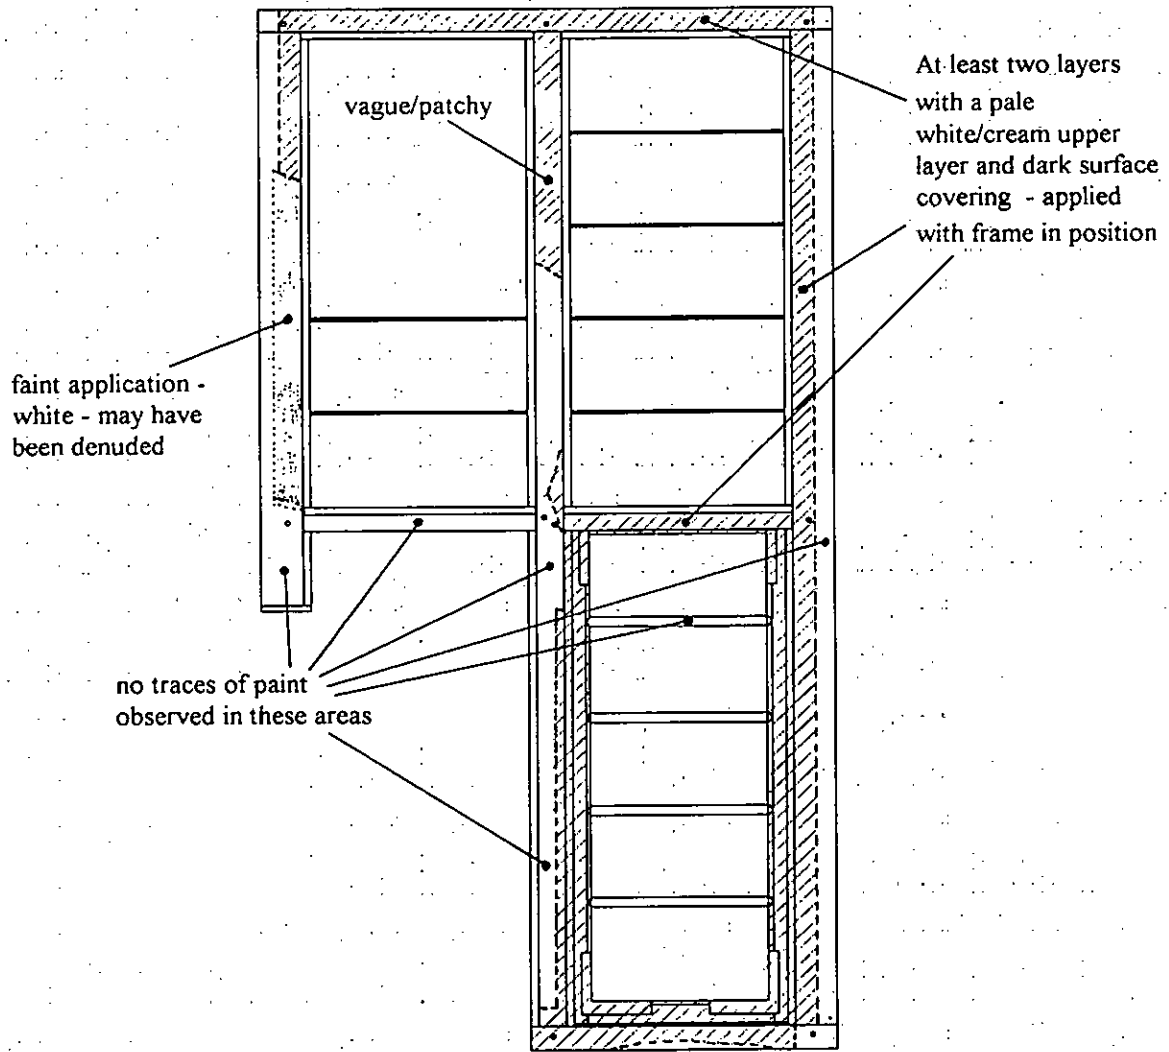
Fig.8

The painted decoration which survives on both external and internal faces of the frame and would appear to date from the pre-staircase period, was analysed by Tobit Curteis in April 1997. The surviving painted outlines offer important information concerning the historical development of the frame (*Figs.8 & 9*).

Extant external elevation (subsequent to removal) - showing areas of surviving polychromy.

Commission further detailed paint research with advice from Helen Hughes, EH Paint Conservation Studios, to establish the broad significance of the decorative sequences. It is important that we fully understand the sequence of layers of paint that have been applied to both internal and external faces of this frame, sash and later filling panels associated with the alterations caused by the creation of the door access. Further examination, by sampling the layers of both the stiles and planted guides to the sash frame, for example, should clarify by sequence matching, whether the planted guides are in fact original to its fabrication.

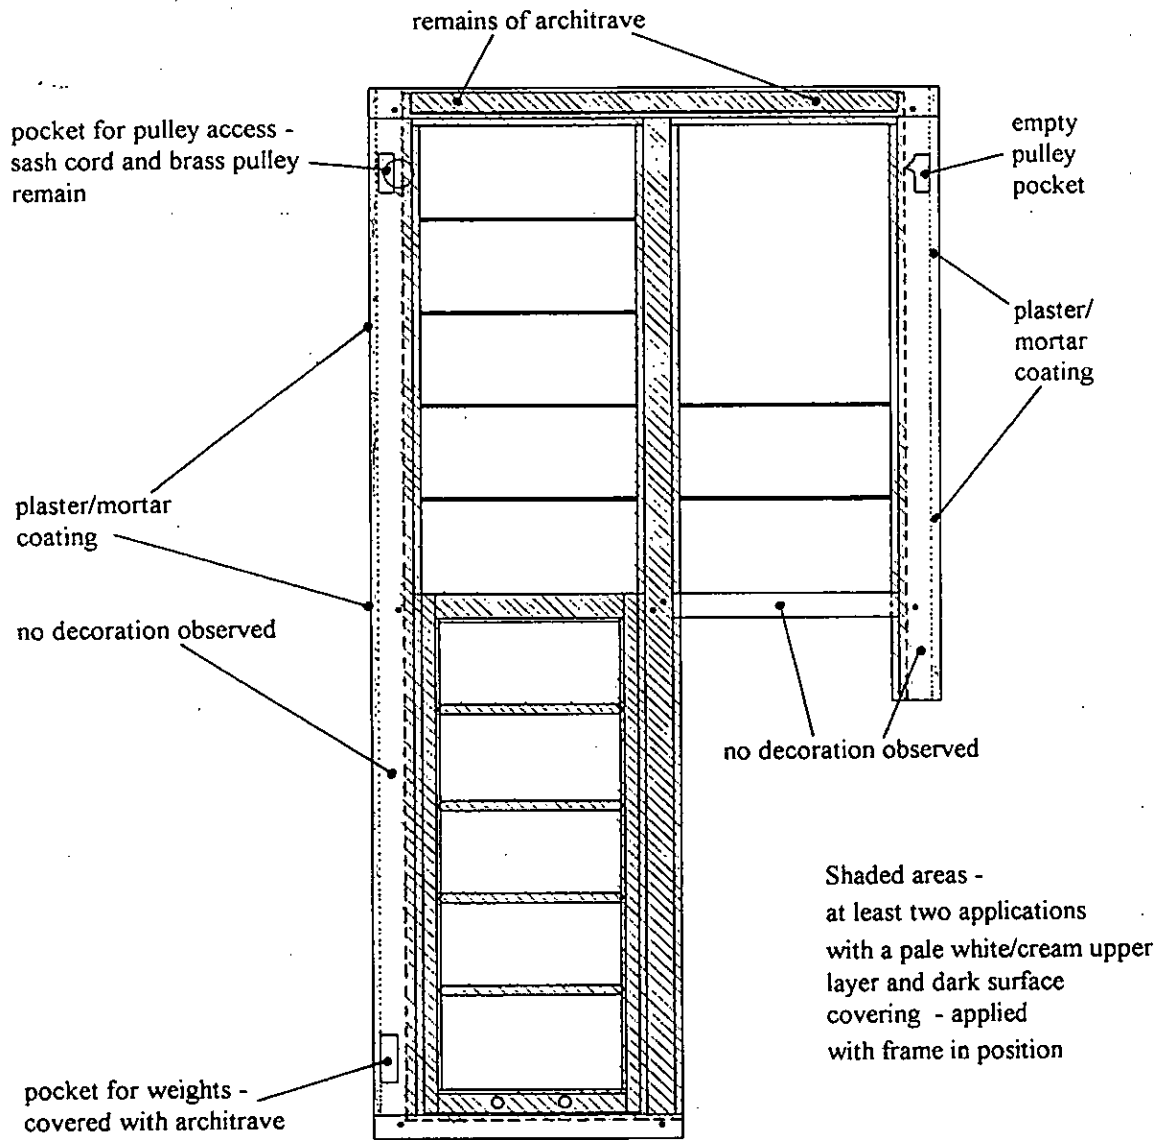
Fig.9

Extant internal elevation (subsequent to removal) - showing areas of surviving polychromy.
