No. 1 WILKES ST – No. 13 FOURNIER ST, SPITALFIELDS, LB TOWER HAMLETS

Report on Building and Other Areas Affected by Proposed Alterations/Refurbishment

APPRAISAL OF HISTORIC FABRIC

June 1996 (1st amendment July 1996)

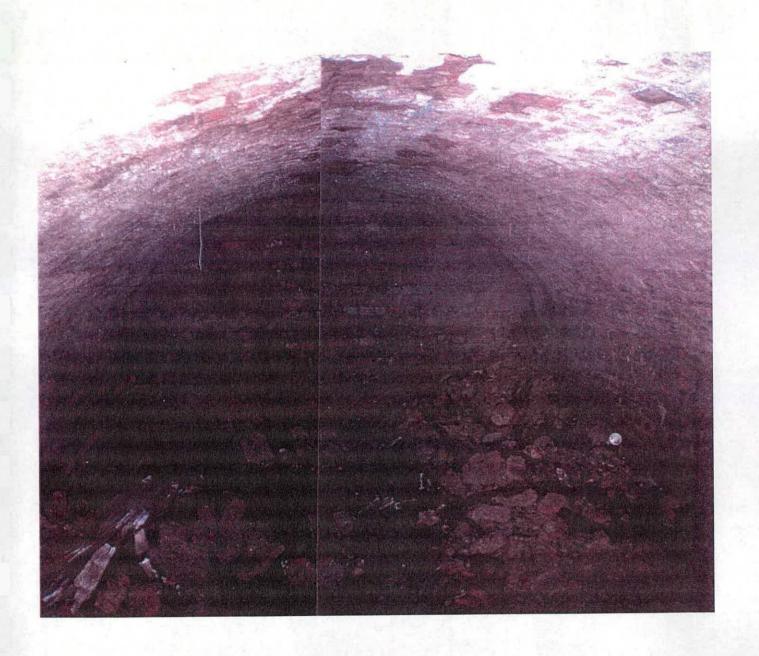
4.1.2 During the initial inspection/analysis the vault was partly filled with building debris and rubbish. This was cleared (July '96) to reveal the lower sections of the vault. However, removal of rubbish/back-fill was halted when certain brick features were uncovered at floor level. A raised brick floor has been partly exposed together with a brick-lined well/sump which appear to be original features.

Plate.7
Brick vault under Wilkes Street, prior to clearing 1996

- 3.4 Once the brick vault has been cleared, further on site analysis of this structure should be undertaken to determine its nature and former use.
- 3.5 Monitoring -

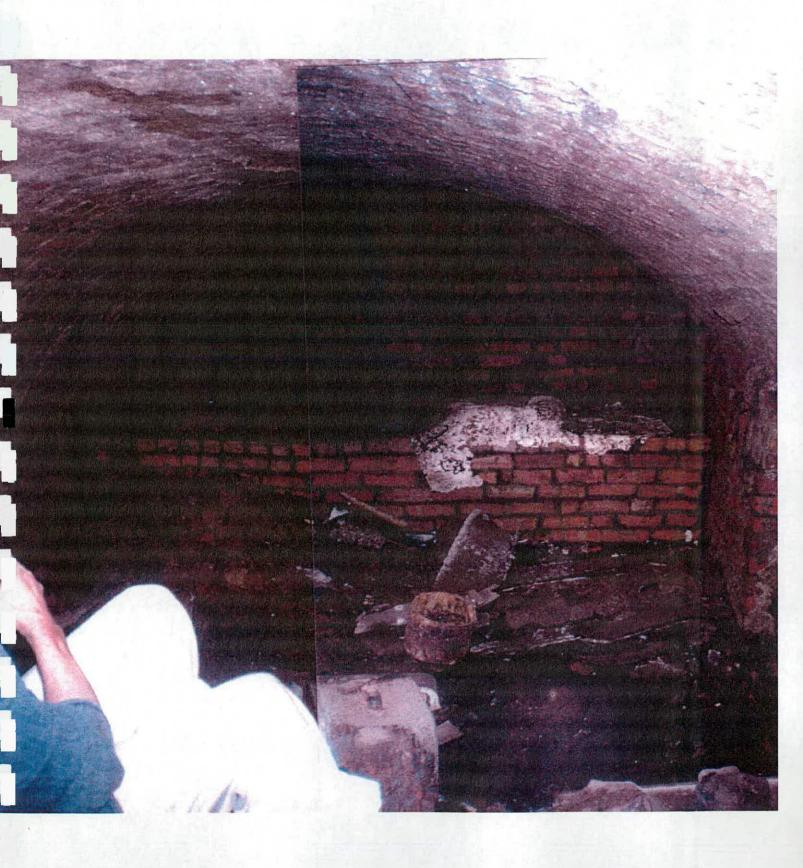
- 4.2.1 The vault, has been substantially built with a good quality stock brick, typical of the period. It has been constructed from the junction with Fournier Street and there is no visible evidence to suggest that it originally extended further than this point. The northern end has been closed along the party wall line with No.3 Wilkes Street. Both end walls are bonded to the brick vaulting and therefore must form part of the original build. A later brick platform has been constructed at the northern end of the vault which appears to conceal a later drain connection to the road sewer.

Plate.8
Brick vault under Wilkes Street, prior to clearing, looking north 1996

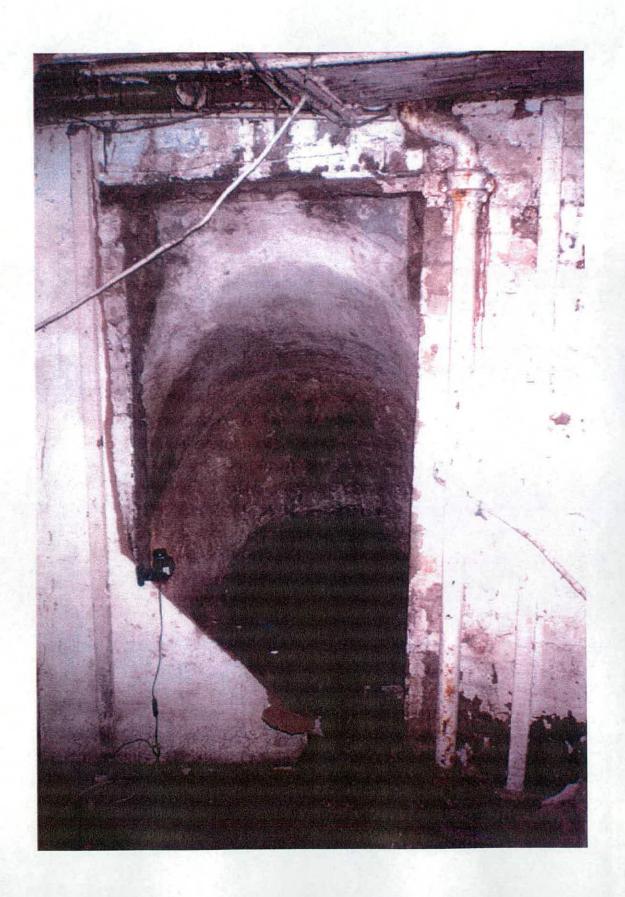
- 4.2.2 The access passage drops steeply to the vault via brick steps. The entrance to the passage has been altered to accommodate a door-frame, now lost. The hacked brickwork has been covered with a lime-based render.

Plate.9
Entrance to brick vault under Wilkes Street, prior to clearing 1996

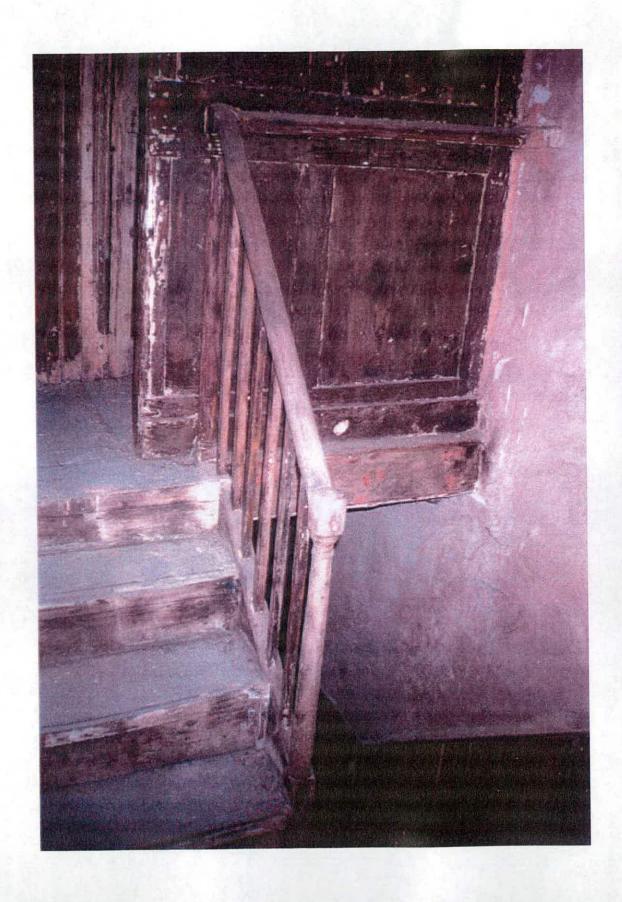
Plate.10
Remains of joinery to upper floor 1996

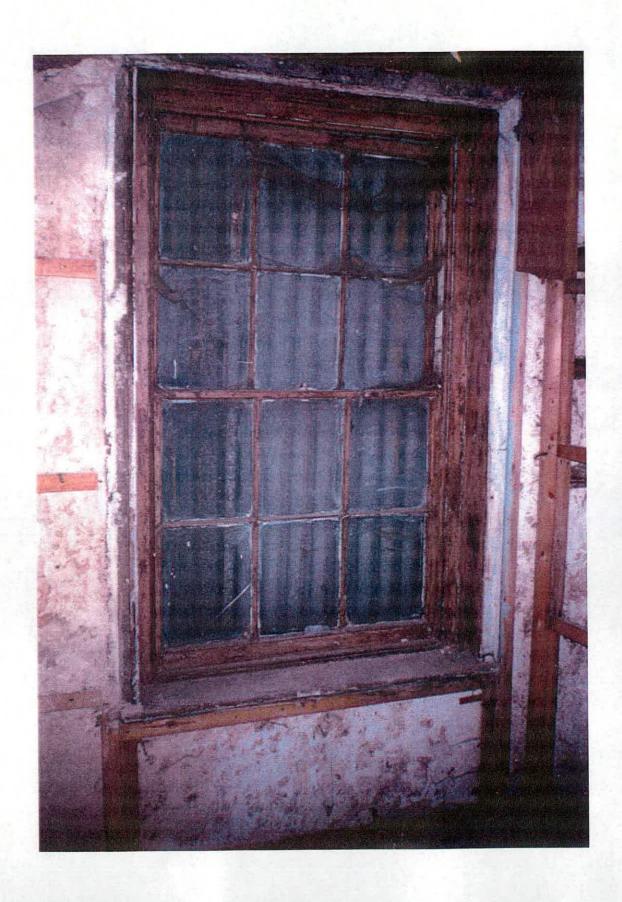
Plate.11 Late 18C window frame 1996
