No. 68 HALE LANE
(MATILDA MARKS SCHOOL)
EDGWARE , LB BARNET

*Report on Building and Other Areas Affected by
Proposed Alterations/Refurbishment*

Historical Analysis & Research Team
Reports and Papers (First Series, 12)
1996

Report on buildings and other areas
affected by proposed alterations/refurbishment.

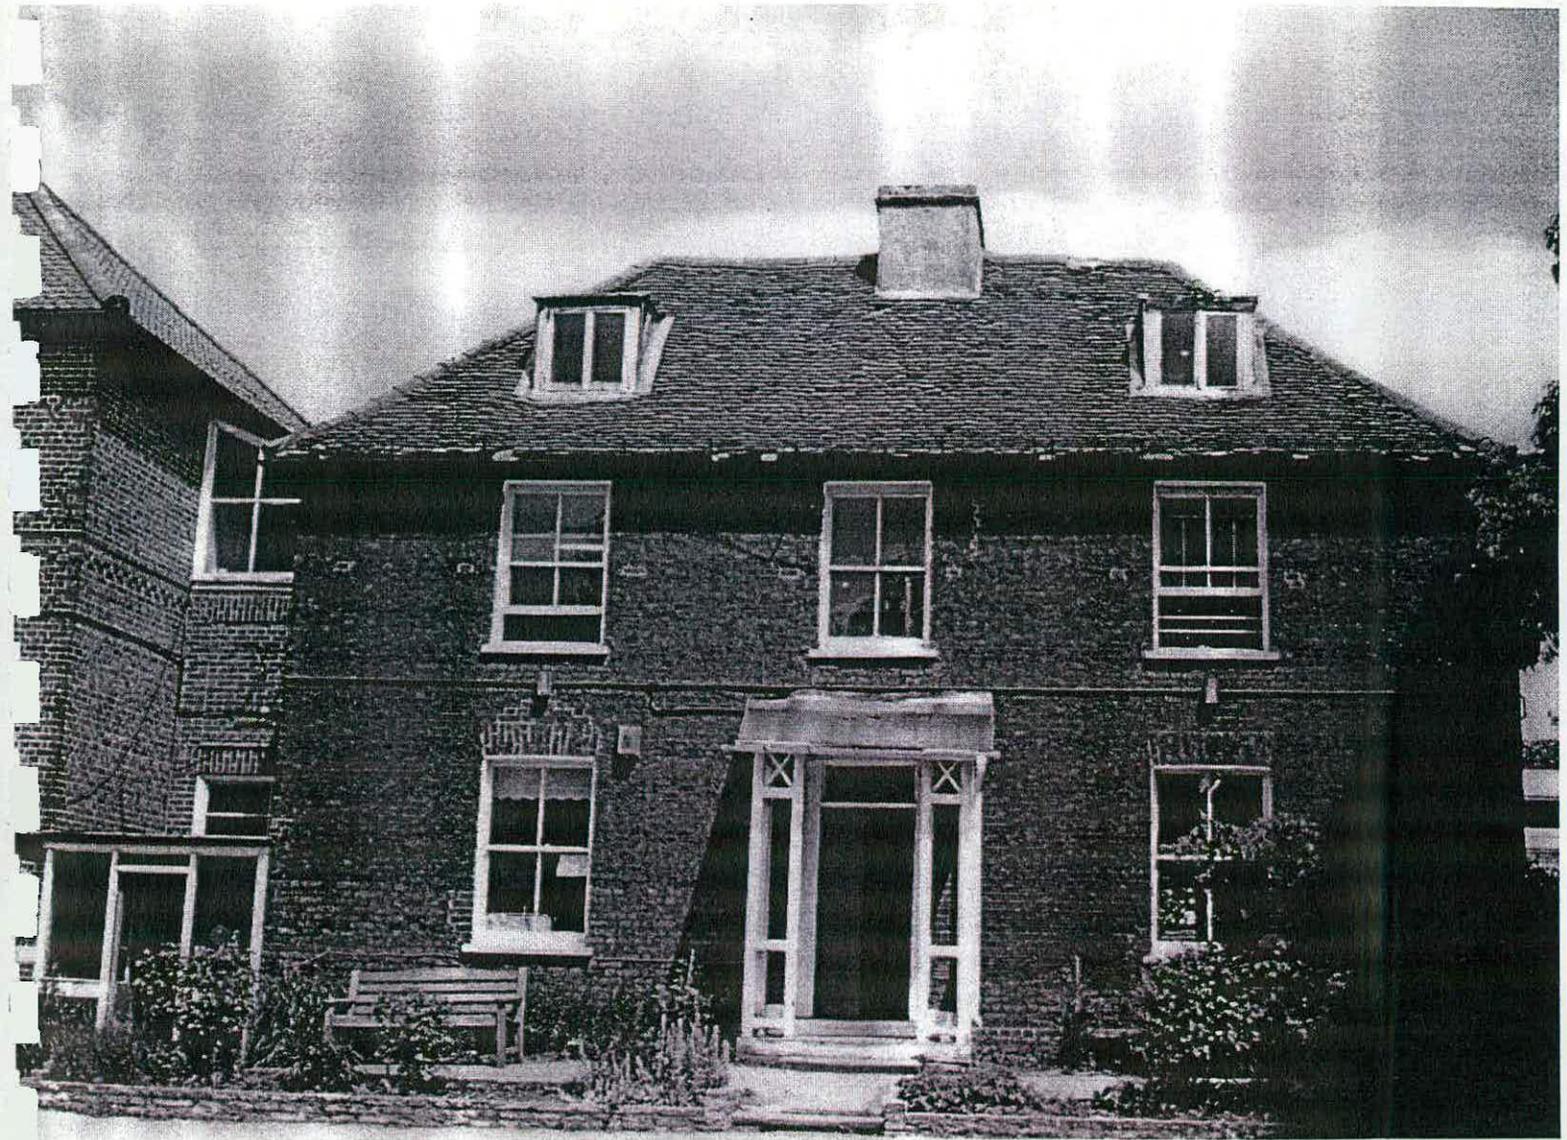
Fig.2

Main front range - elevation to Hale Lane.

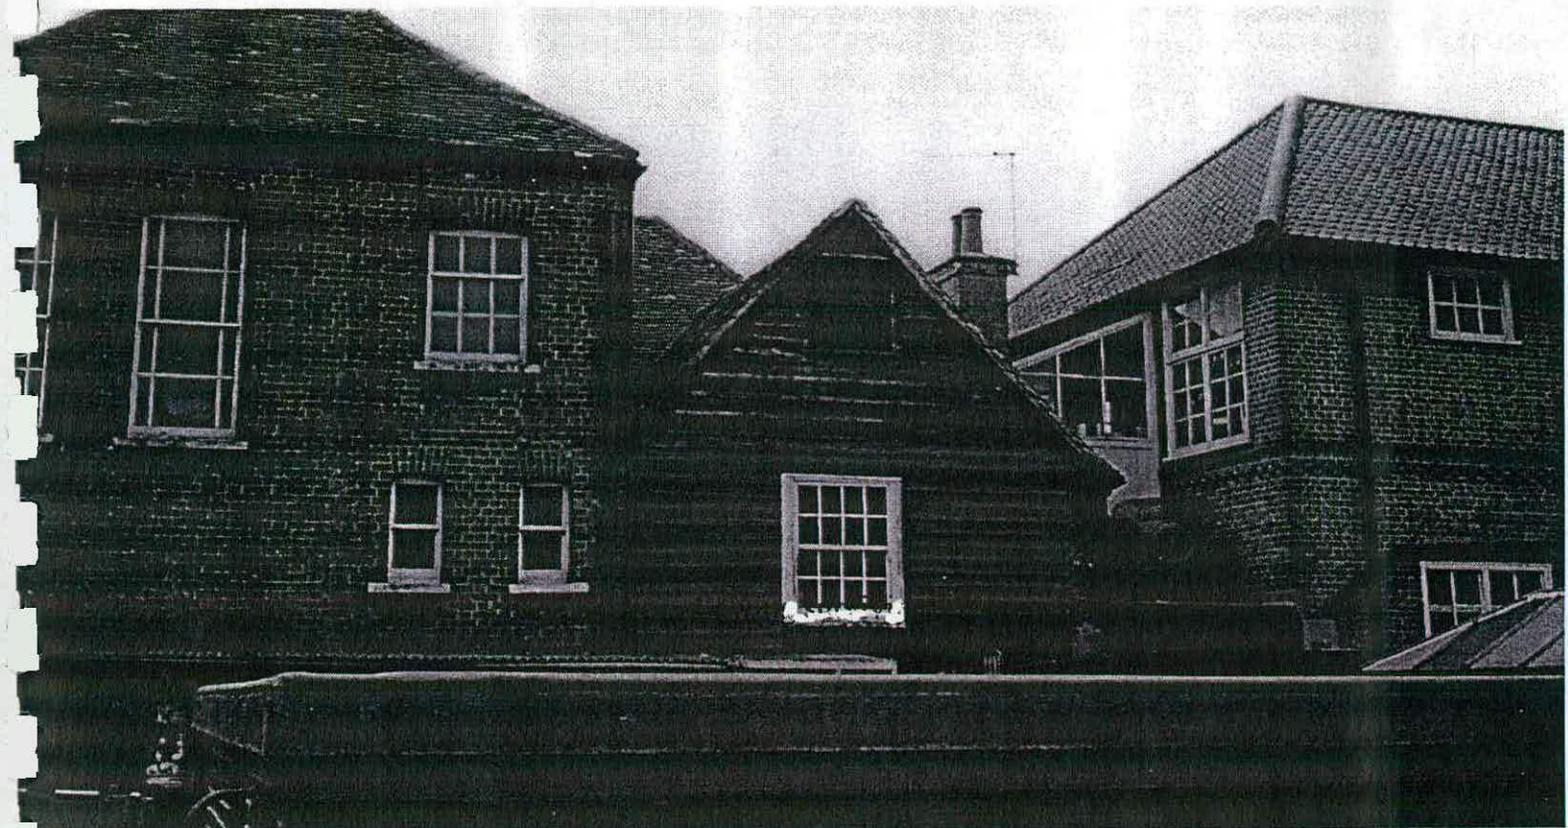
Fig.3

Rear elevation showing surviving 17C range.

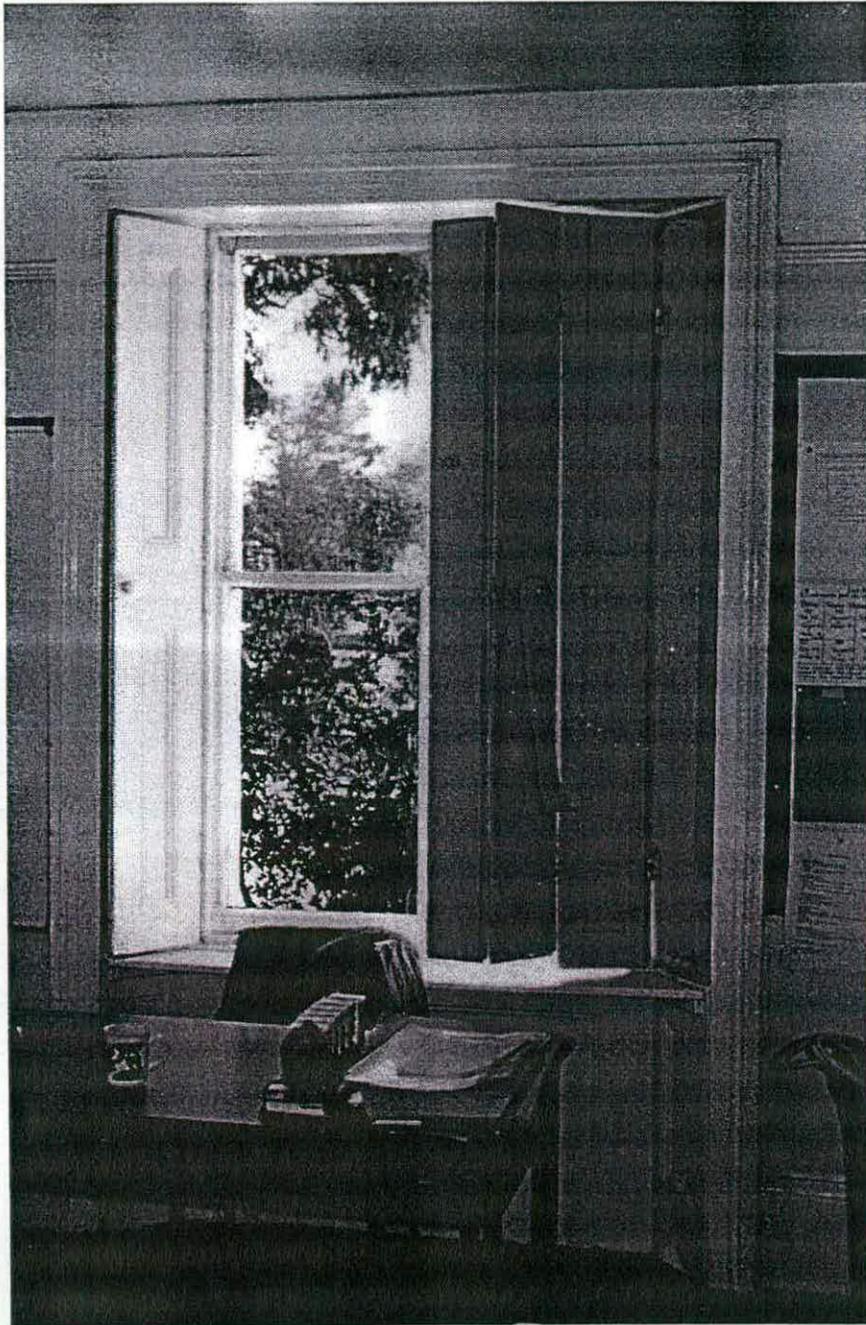
Fig.4

C.19th replacement sliding sashes have been incorporated in all original window frames to both first and ground floors. Window shutters and their housing boxes, where they survive, are original and date from the C.18th.

Internal elevation showing surviving shutters and boxes to main ground floor, counterbalanced sash windows.

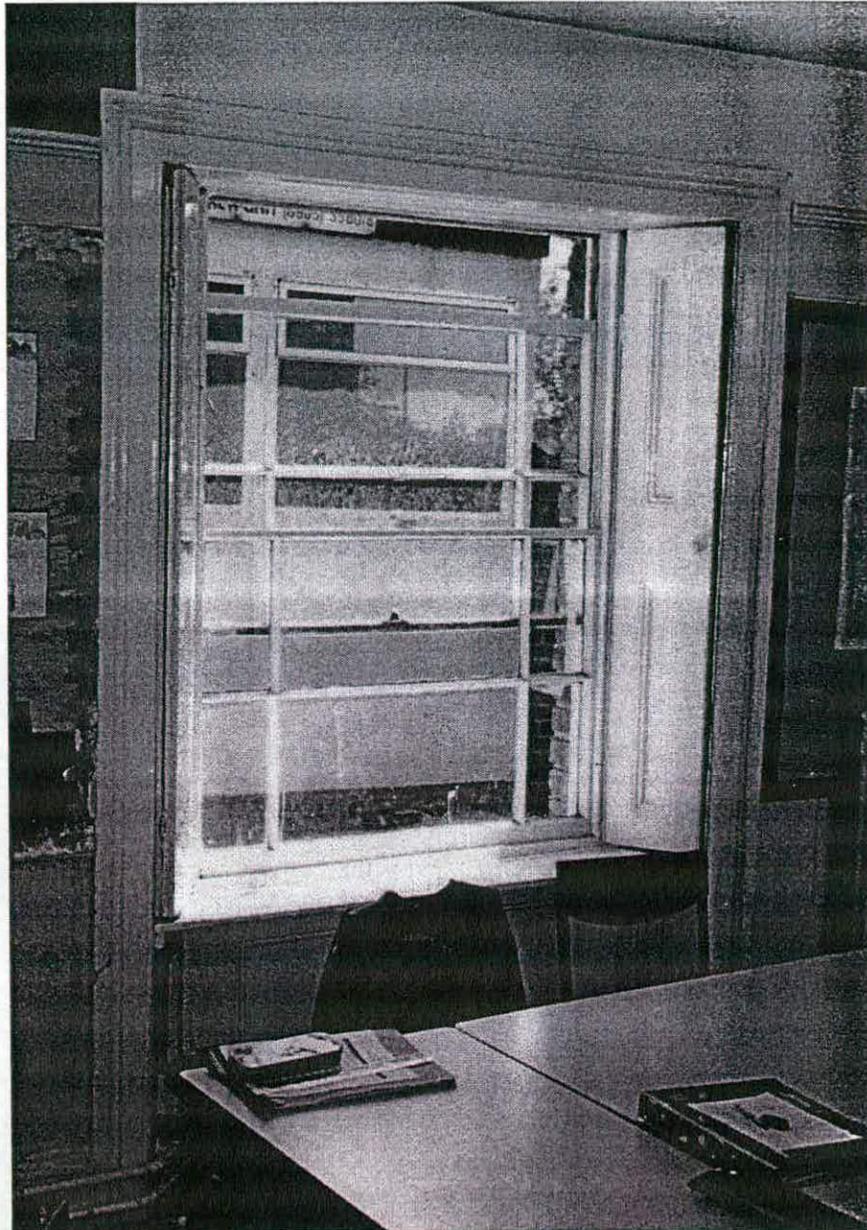
Fig.5

Internal elevation showing surviving shutters, sash boxes and margin-light, counterbalanced sashes to main ground floor, flank wall.

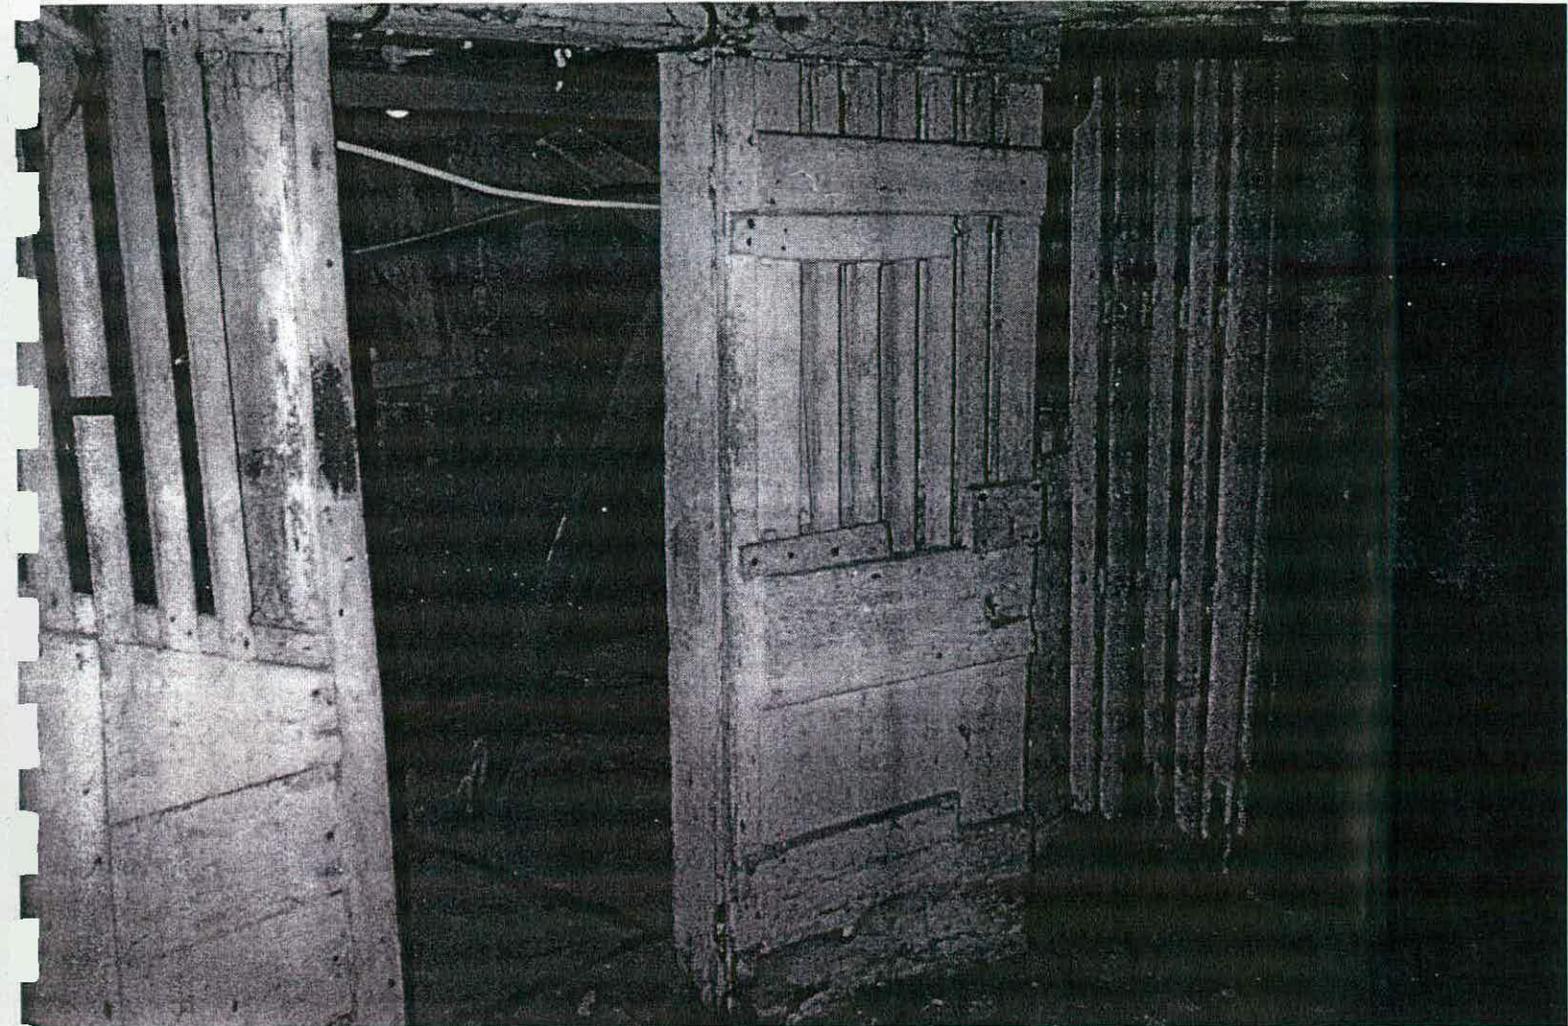
Fig.6

Basement - elevation showing surviving 18C timber screen
dividing area into two cells.

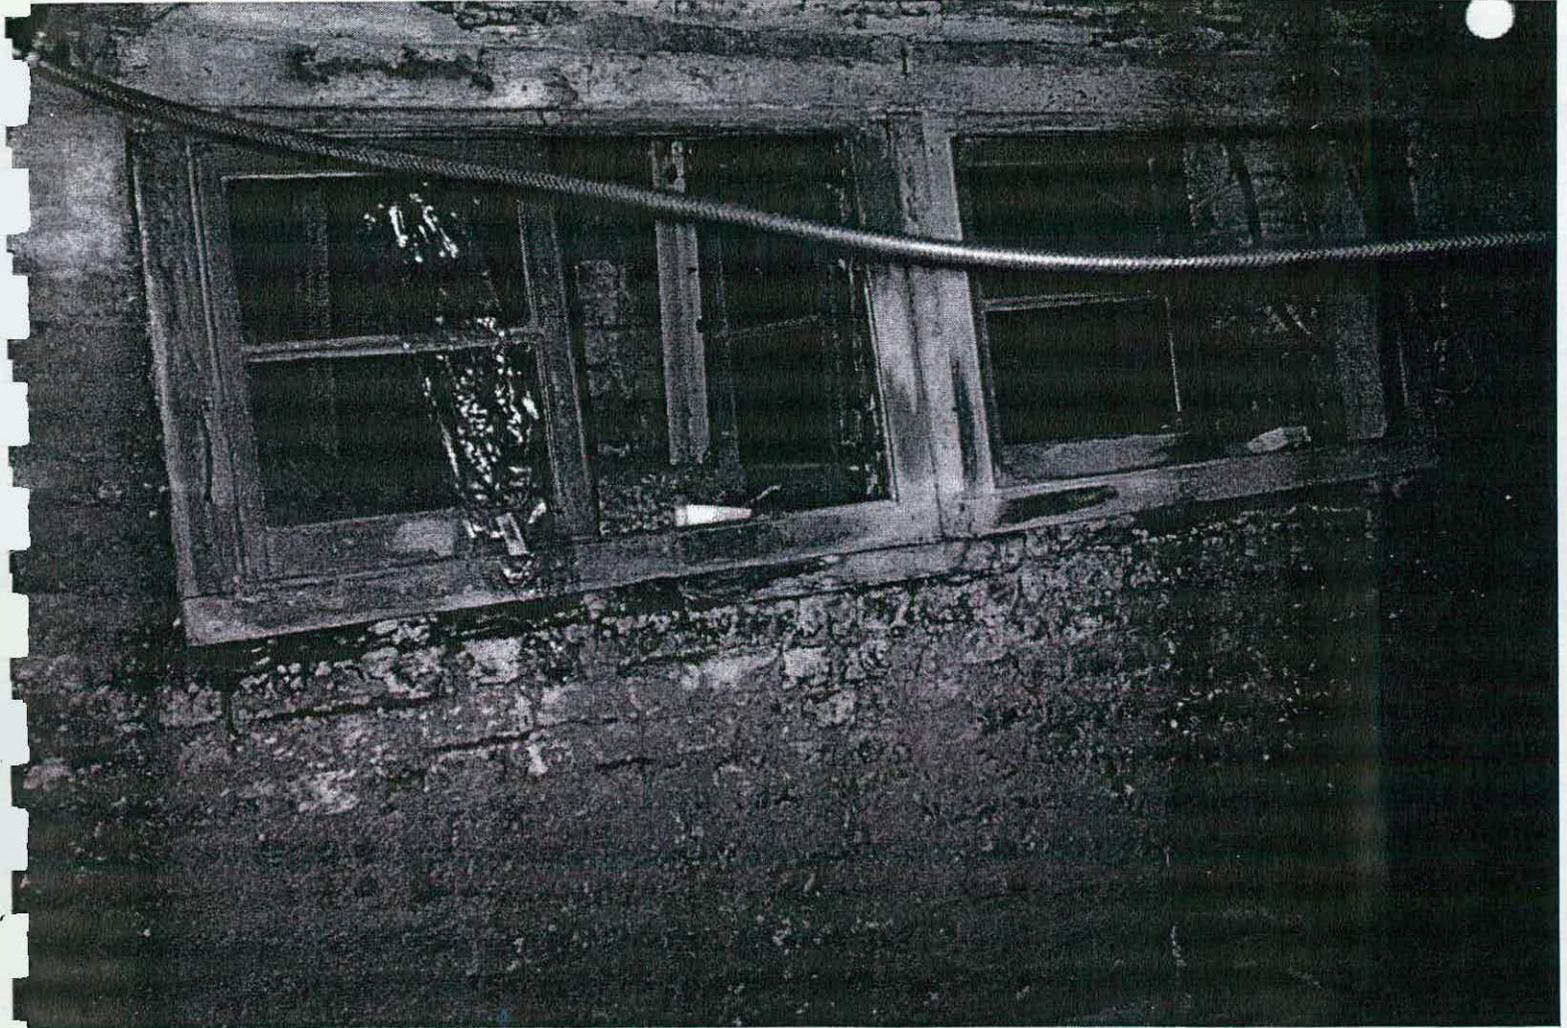
Fig.7

Basement - elevation showing surviving 19C casement window
to east wall.

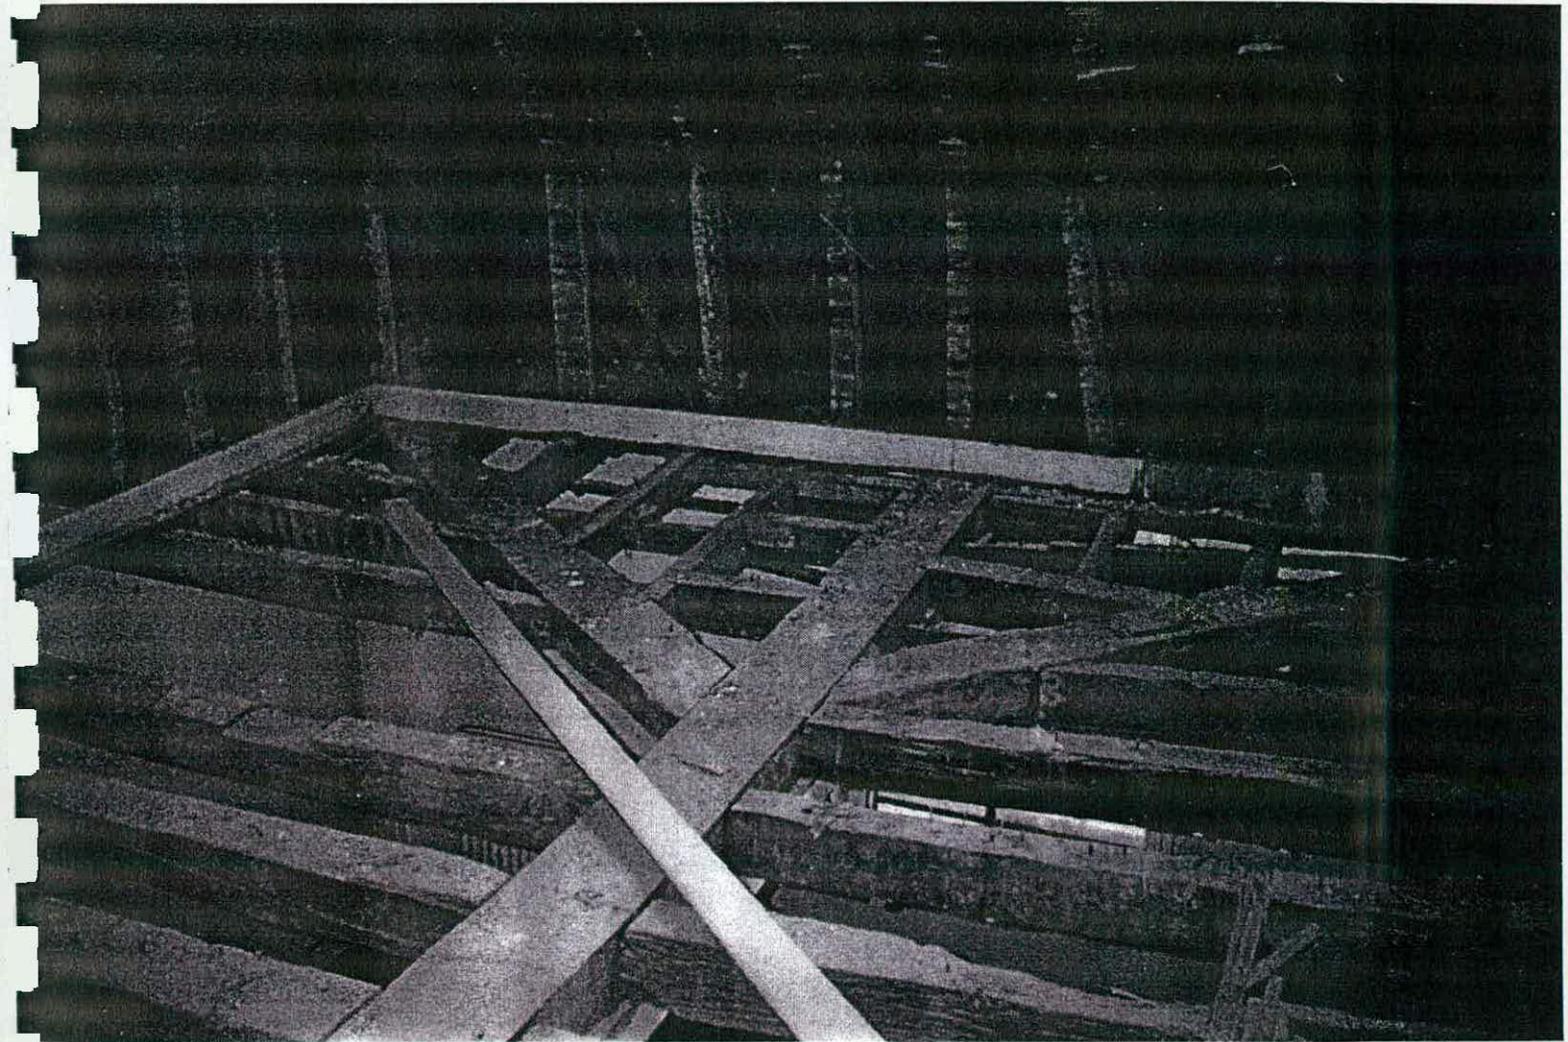
Fig.9

Exposed framed floor structure to main front range showing
dragon-beam arrangement to east.

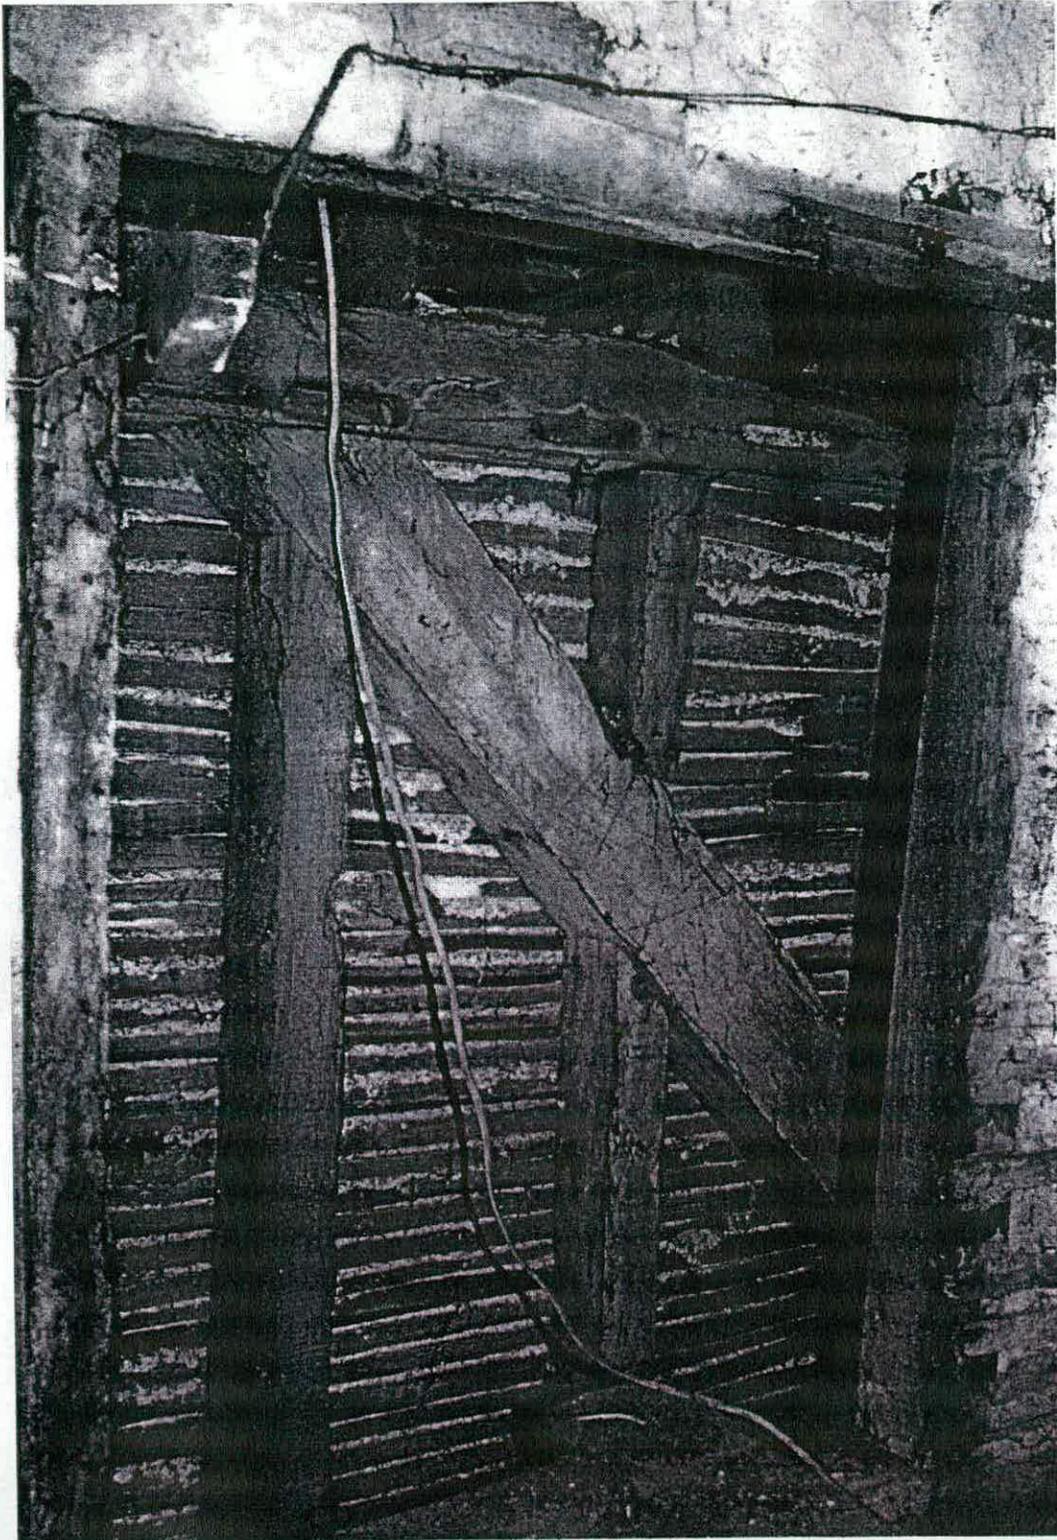
Fig.10

There is no structural integration of timber-framing between this structure and the main front range. The whole assembly is separated from the main building by a small bay (approximately 450mm wide) which is protected by an extension of the extant roof (*Figs. 10 & 11*). The rebuilding of the west wall in brick continues to 'close' this small bay (the east wall was not accessible for inspection). There is also a considerable difference in floor levels between these two ranges for which the only logical explanation would appear to be different construction periods.

Constructional void between main front range and earlier 17C range showing braced framing and re-used timbers.

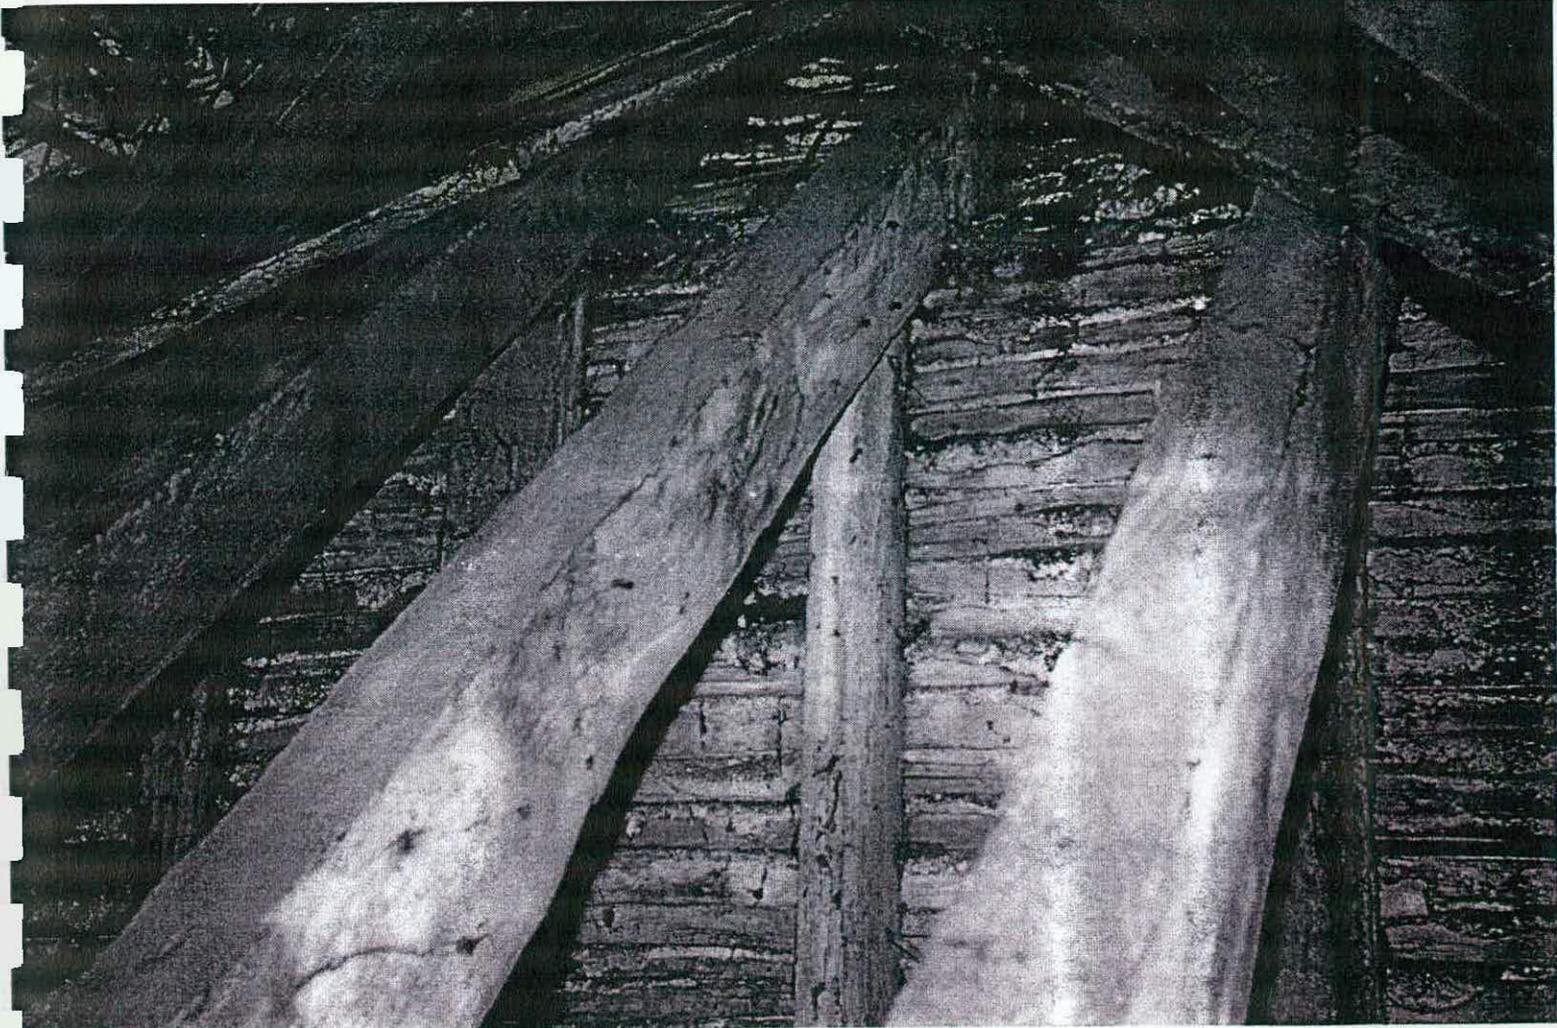
Fig.11

Within the void that exists between this range and the earlier rear range (previously discussed), part of the roof assembly and timber wall framing is exposed. There is no evidence to suggest that any protective covering (battens, tiles, laths, in-filling) has been applied and it therefore appears to have been intentionally left unprotected here. This would confirm that it was constructed against and later than the rear range whose extended roof structure now covers this area.

Constructional void between main front range and earlier 17C range showing rafters to main front range which appear to have been intentionally left unprotected.

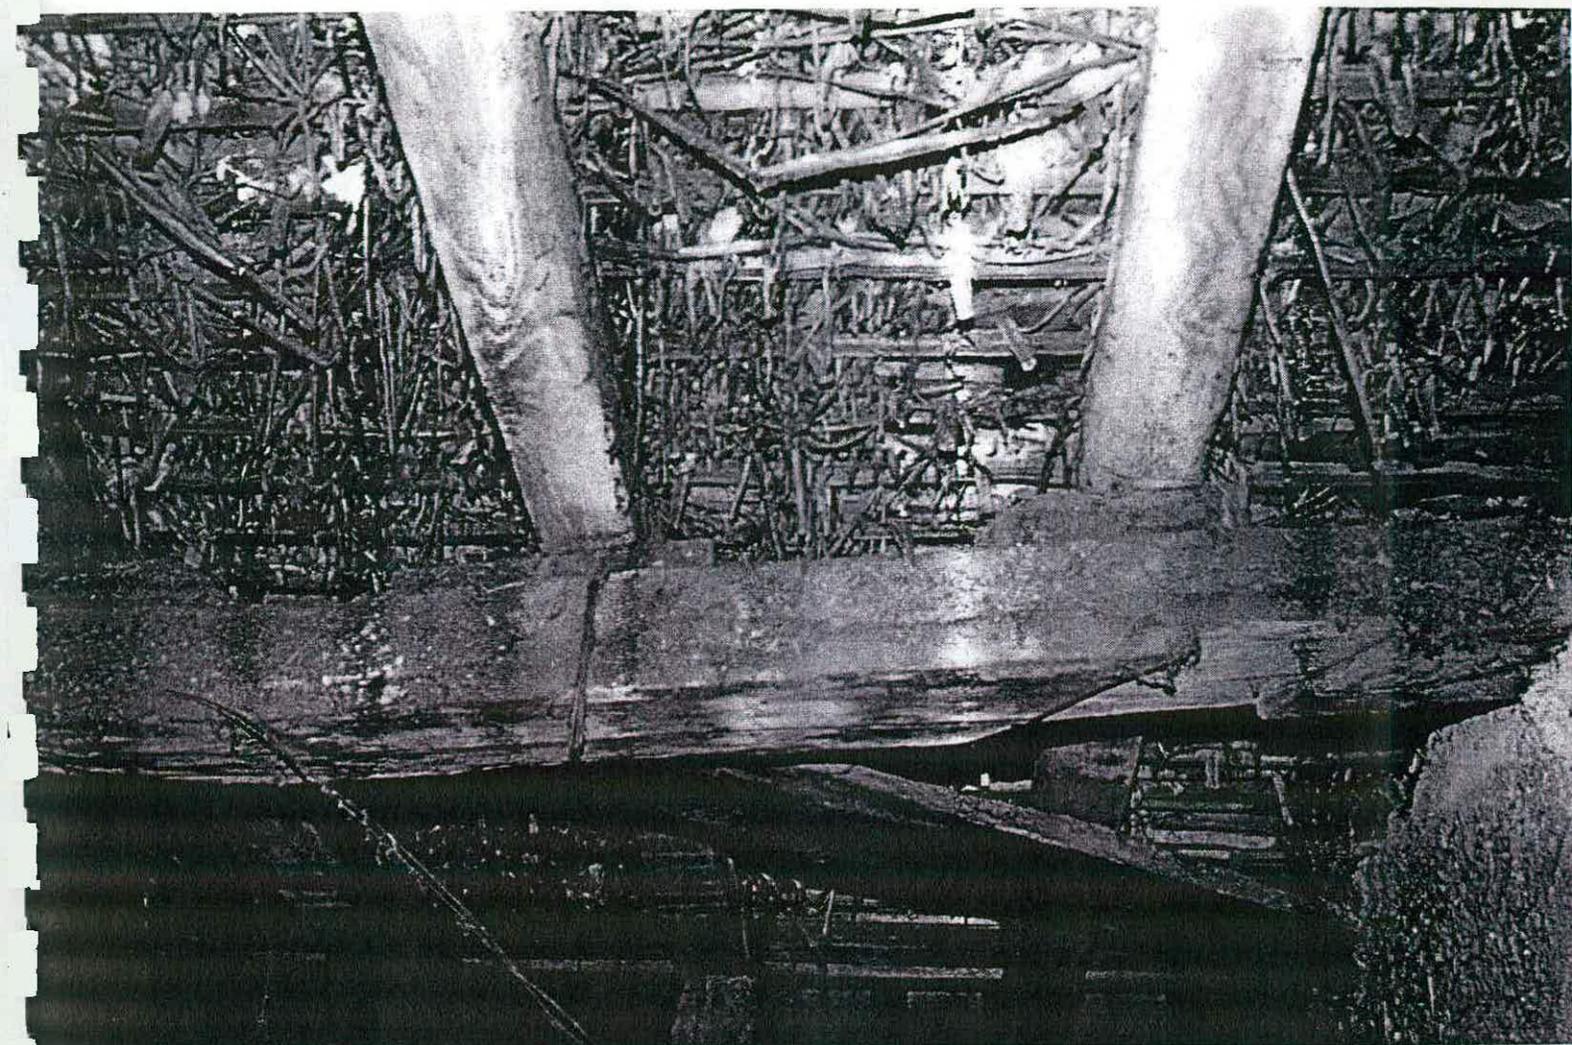
Fig.12

With the exception of the purlins and a number of rafters, the roof construction of this single-bay structure, with nine rafter pairs, survives reasonably well intact. It is of clasped purlin construction with end gable trusses remaining each with principals, tie beam, collar and two vertical struts. The extant connecting purlins are smoke-blackened/charred and of a slender nature (*Fig.12*). They are not original and have illogical brace sockets and mortices which clearly suggest another use. The original clasped purlins were clearly much broader as larger sockets to receive them remain cut into the underside of the principals. The remains of what may possibly be an original purlin survives, scarfed into the extant member at the SW corner.

The roof covering is mainly of hand-made, plain clay peg tiles, which are held in place with timber pegs. Beneath these tiles and dressed over the timber battens is a layer of matted straw, which in some areas has been woven around both pegs and battens. Its purpose is unclear, but it may have been positioned as a form of barrier

to prevent the penetration of driving rain/snow to the internal fabric of the building. Although it would appear to be quite late and possibly C.19th (see 7.2), it is a rare survival within London and few similar examples are known. If wholesale removal of the extant roof covering is proposed, it will almost certainly be completely lost.

Clasped purlin construction of rear 17C range, with smoke-blackened purlins showing brace sockets and mortices from previous use and matted straw blanket woven around both extant pegs and battens.

- i) The straw lining to the roof surfaces
- ii) The plasterwork within the extant roof spaces
- iii) Roof timbers, removed for repair or replacement
- iv) All carpenter's marks revealed during the works
- v) All external surfaces/features where the Works will damage or destroy early fabric
