# NOS 38 and 39 GREAT JAMES STREET, CAMDEN

*An Assessment of the Historic Fabric*

Roger Bowdler and Richard Lea

Historical Analysis & Research Team  
*Reports and Papers (First Series, 3)*  
1996

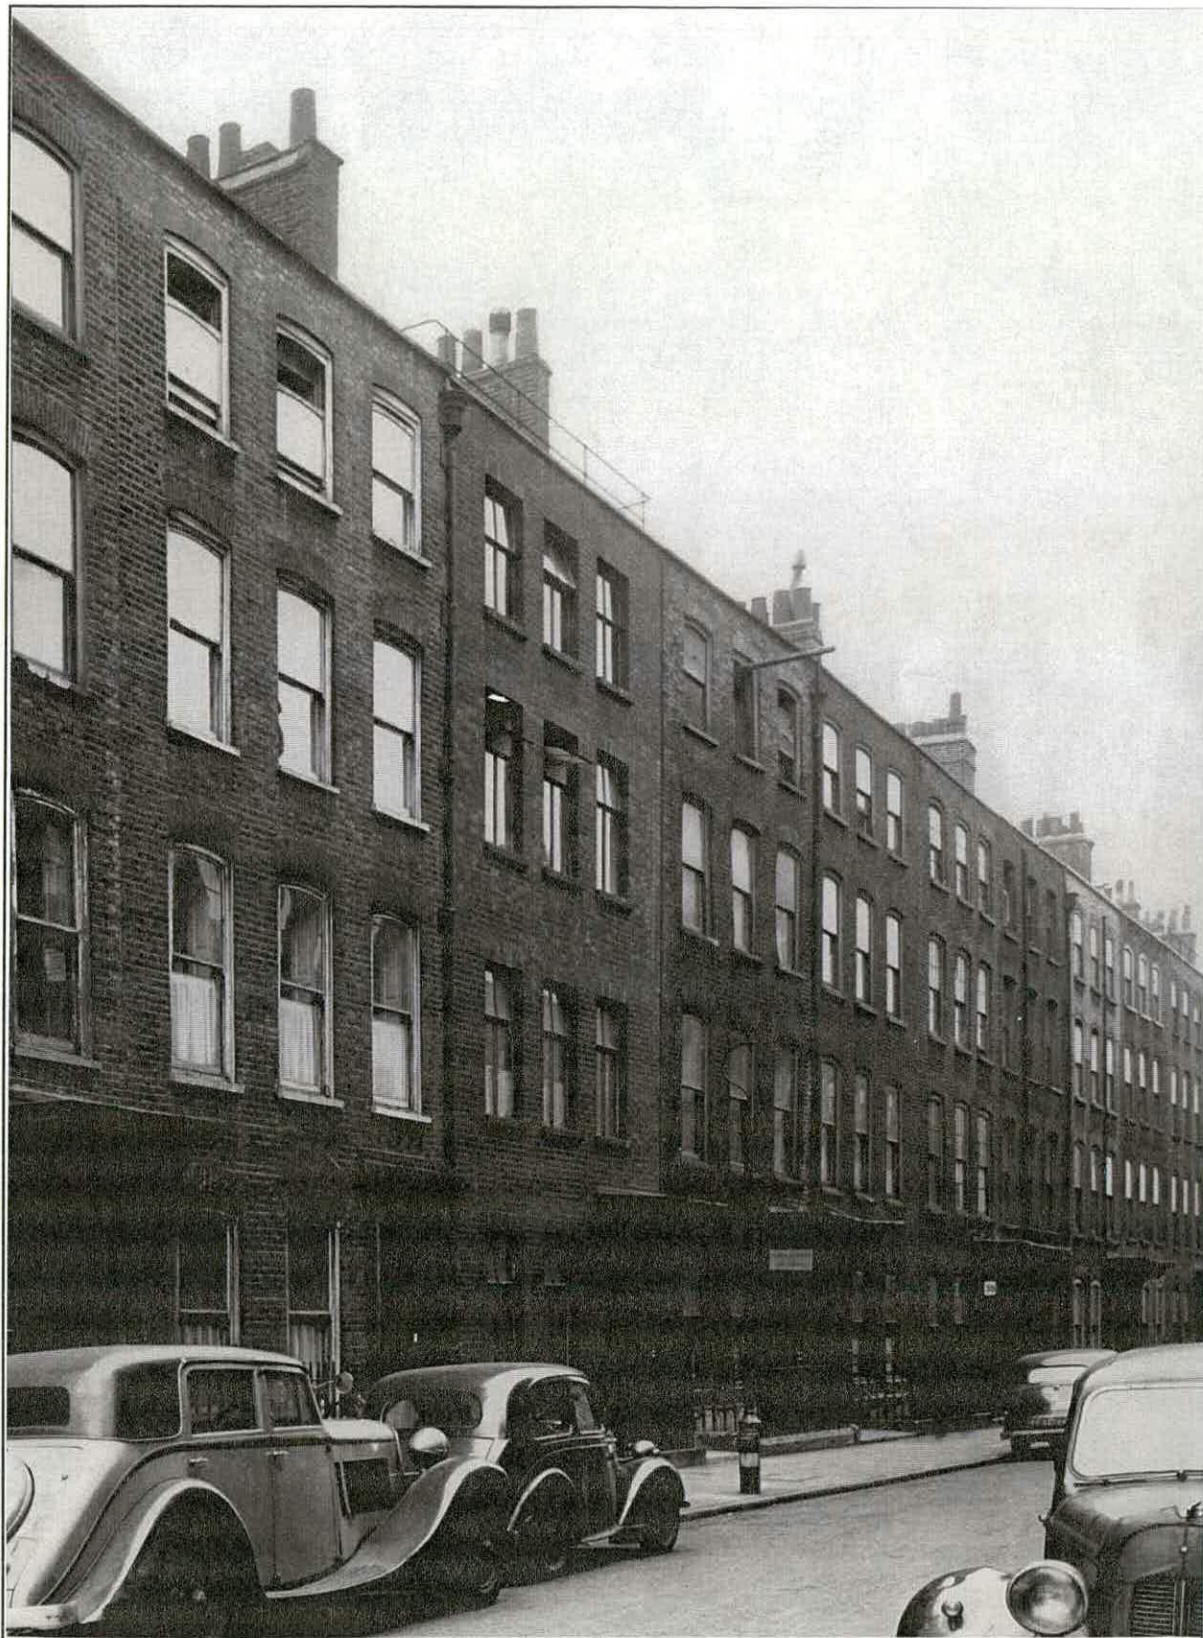
**Figure 1** Nos 38 and 39 looking north-west, photographed in 1946, English Heritage, London and South-east Photographic Collection

- 6.1.1 The facade** The facade has been rebuilt in red brick. The windows have been rebuilt with flat heads in place of the original segmental arches. The original sash windows have been replaced with steel frames. This rebuilding probably took place during the 1930s or 1940s. It must have occurred before 1946 when the house was first photographed (Figure 1).

- 6.1.3 The roof** The stack above the front rooms rises to its original height but it has been rendered since the 1946 photograph was taken (Figure 1). The original valley construction has been removed and replaced by a flat bitumenized roof. The stacks for the back rooms and closet wing have been reduced and rebuilt above the flat roof. These alterations probably date from the 1960s.

- 7.1.3 The roof** The original valley roof construction which survives on other houses in the street, has been replaced by a modern bitumenized flat roof which probably dates from the 1960s. Since the 1946 photograph (Figure 1) was taken, the front stack has been reduced to two flues. In the same brick and therefore apparently at the same time, the rear stack was capped off. The closet stack does not survive above roof level. The alterations to the stacks probably date from the 1960s.

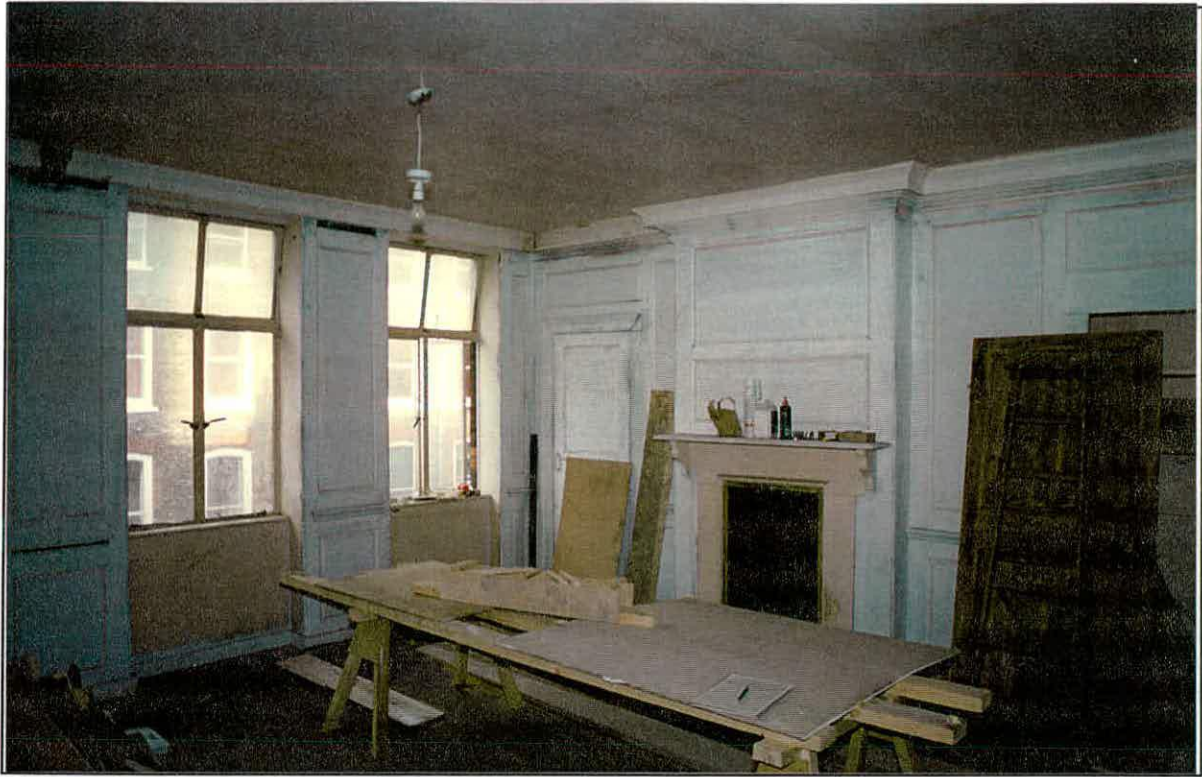
**Figure 15** No 38, second floor front room looking south-east

- 6.3.1 The second floor front room** *Ceiling:* new plaster board ceiling. *Cornice:* original timber cornice, with part stop returns above the windows. *Panelling:* original ovolo moulded plain panelling. Original cupboards and doors survive either side of the chimney breast. The panelling has been newly altered by the addition of feathered MDF panels screwed onto the originals to simulate raised panelling. The original partition wall between the front and back rooms has been removed. The presence of a section of what appears to be a rusting 'L' section steel spanning the opening suggests that this intervention occurred during the 1930s or 1940s. *Dado:* the original rail survives mostly in-situ. *Skirting:* plain board, not moulded. *Doors:* original ovolo moulded two panel doors to landing and to cupboards survive in-situ. *Windows:* modern steel frame windows. The brick columns between the windows were enlarged when the facade was rebuilt,

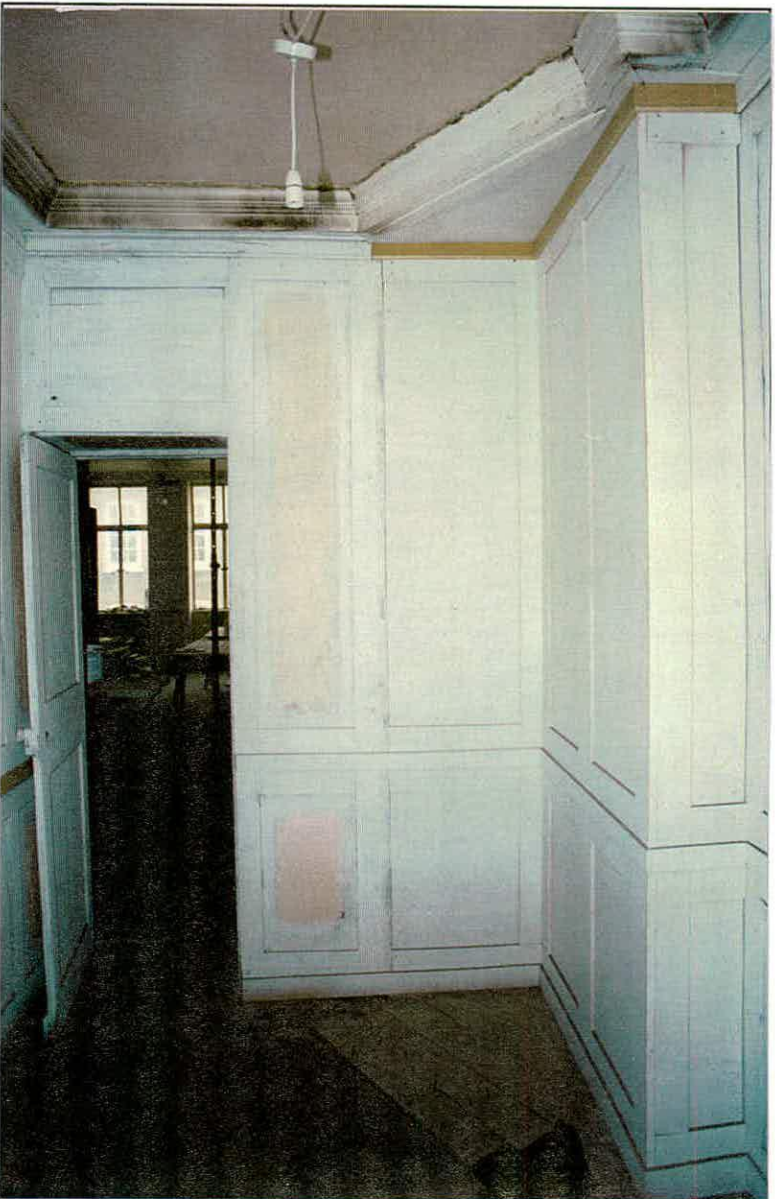
Figure 19 No 38, second floor closet looking east

- 6.3.3 The second floor closet** *Ceiling*: new plaster ceiling. *Cornice*: original, partly newly replaced on west wall, follows plan of original diagonal stack. *Panelling*: original plain panelling, newly replaced in area of original diagonal stack. *Dado*: mostly modern and newly replaced with a plain unmoulded batten, profile could be original. *Skirting*: mostly newly replaced, original possibly survives in south-west corner. *Doors*: original plain two panel door to back room. *Windows*: new sash box, window in north wall infilled with brick and cupboard with glazed doors, although the doors have thick glazing bars and the cornice, which appears to be original breaks forward above the cupboard. *Fireplace*: removed, floorboards and panelling suggest that this has occurred recently. *Floor*: mostly original wide floorboards but newly replaced in the area of the removed fireplace.

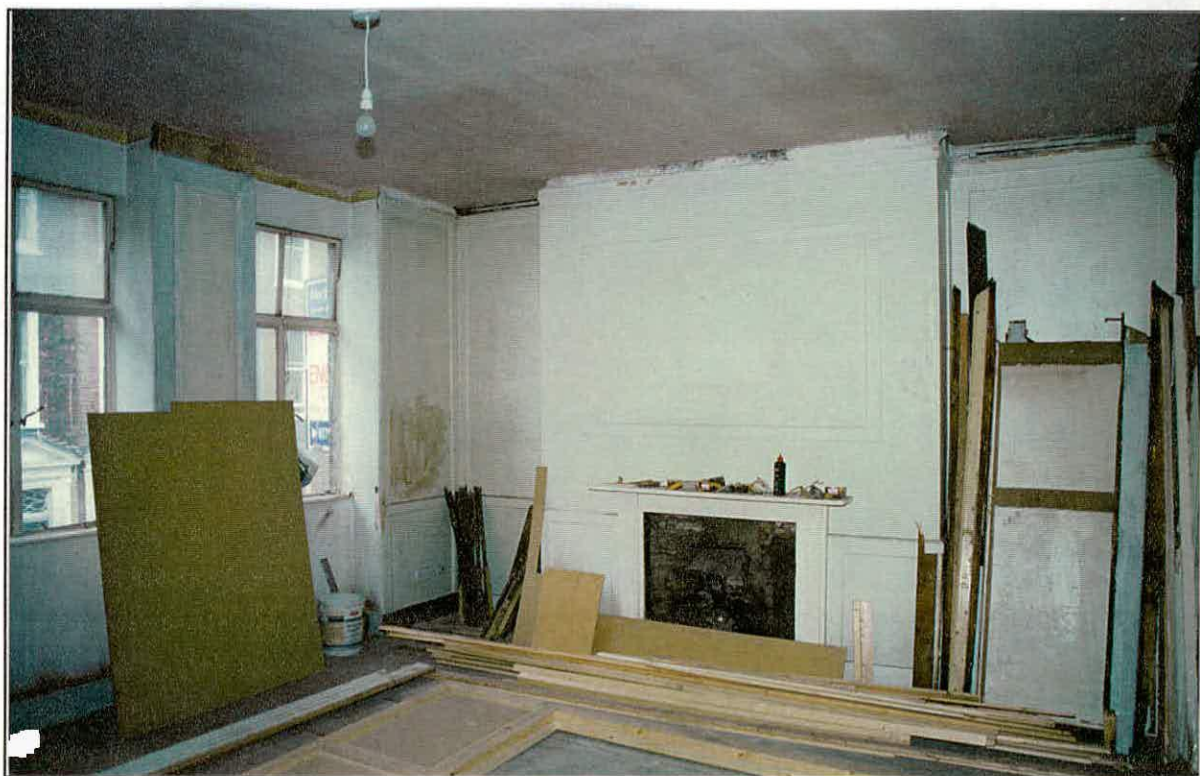
**Figure 22** No 38, first floor front room looking south-east

- 6.4.1 The first floor front room** *Ceiling*: new plasterboard. *Cornice*: plain board, modern replacement of original timber box cornice. *Panelling*: original raised and fielded ovolo-moulded panelling survives except on the fireplace wall, which has been replaced with modern plain board. The plain panelling in the recesses either side of the chimney breast is the original, plain because it formed the lining of cupboards. The panel wall between the front and back rooms is missing. A new wall is in construction. The original wall was probably removed in the 1930s and

replaced with a double door to the back room. *Dado*: ovolo moulded board, modern, not new *Skirting*: bead moulded board. *Doors*: six panel door matches panelling. *Windows*: modern steel frames. The rebuilding of the facade wall removed the shutters. *Fireplace*: reeded timber surround with paterae, c 1810. *Floor*: boards a mixture of old and modern.

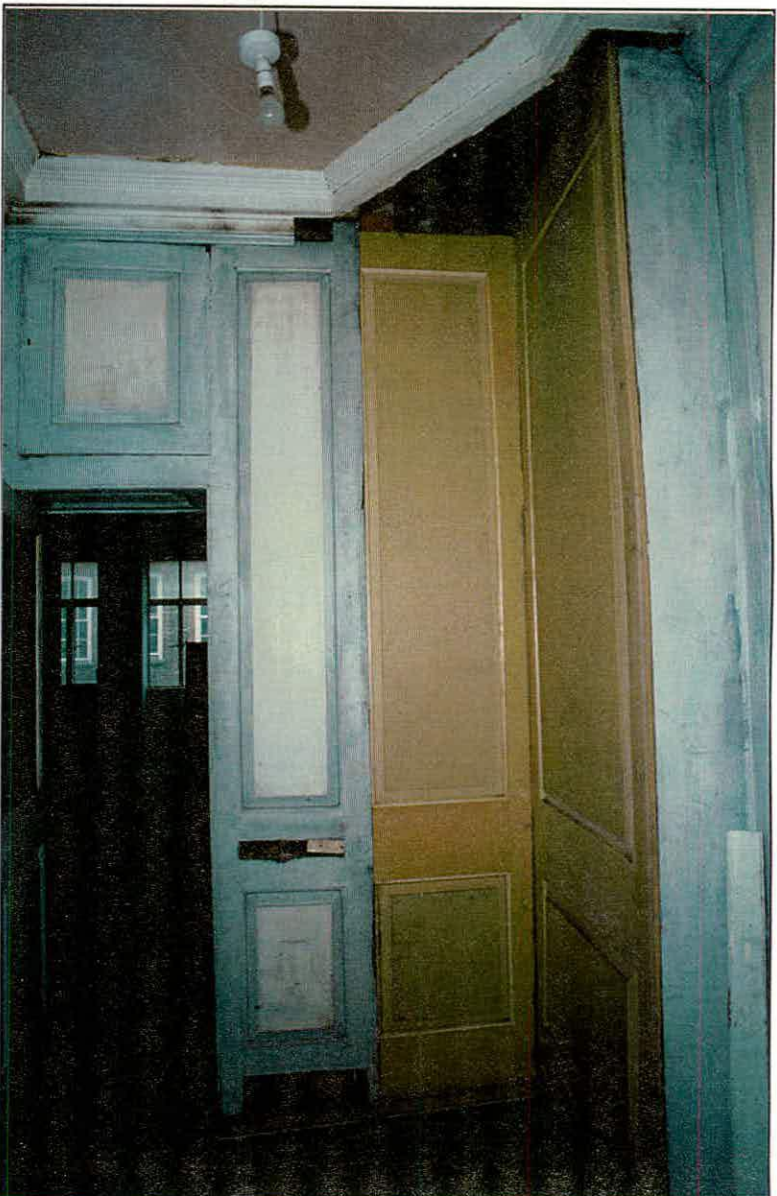
Figure 27 No 38, first floor closet looking east

**6.4.3 The first floor closet** *Ceiling*: new plaster ceiling. *Cornice*: original timber box cornice follows plan of the original diagonal corner stack. *Panelling*: raised and fielded ovolo moulded panelling, mostly intact. Diagonal corner stack removed and walls lined out with new medium density fibreboard panelling. *Dado*: original moulded dado survives in part. *Skirting*: *Doors*: The door has raised and fielded and ovolo moulded in two panels to match the wall panelling. It is hung on 'H' hinges which are probably original. Modern glazing has replaced the upper panel. *Windows*: the west window box seat and linings appear original although the shutters have been removed. The sash box is new. The window in the north wall has been infilled and shelving and a cupboard below the dado were probably installed in the later C19. *Fireplace*: original diagonal stack removed probably in the 1920s. *Floor*: wide floorboards, probably original.

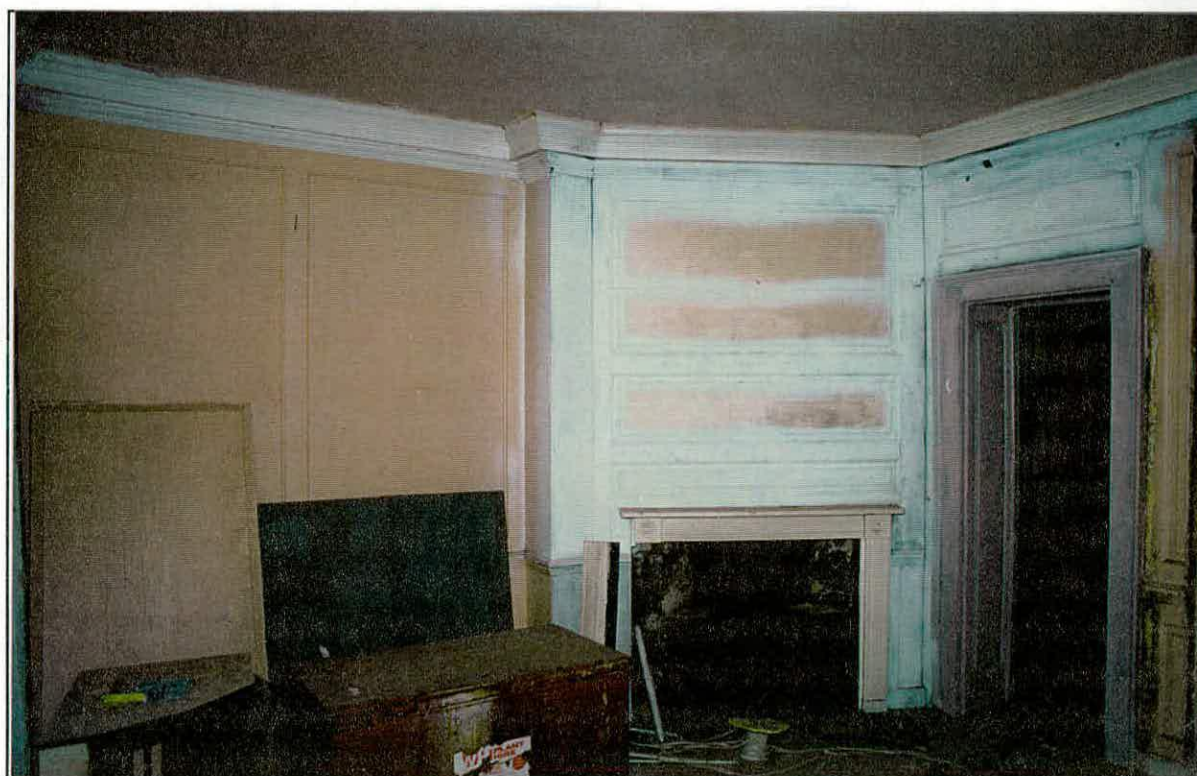
Figure 36 No 38, ground floor back room looking south-west

**6.5.2 The ground floor back room** *Ceiling*: new plasterboard. *Cornice*: original timber box cornice. *Panelling*: original raised and fielded ovolo moulded panelling survives throughout, except where double doors have been inserted into the wall with front room. *Dado*: original moulded dado mostly still in-situ. *Skirting*: bead moulded board. *Doors*: *Windows*: the shutters have been removed and the linings replaced with modern board, the south reveal is now splayed. A structural timber has been inserted into the shutter box void on the north side. *Fireplace*: reeded timber fire surround with paterae, same type as those on the first floor, c 1810, cast iron grate probably contemporary with the surround. *Floor*: mixture of old and new boards.
