REPORT ON SELECTED FARM BUILDINGS AT

FORTY HALL

LONDON BOROUGH OF ENFIELD

Survey and Historical Description

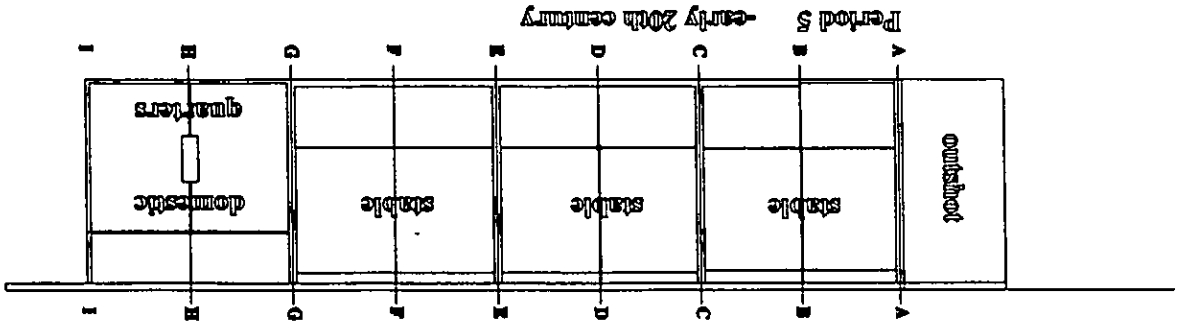
alterations to south brick elevation to incorporate present
 remembrance/access: 2 bays at west end converted for accommodation

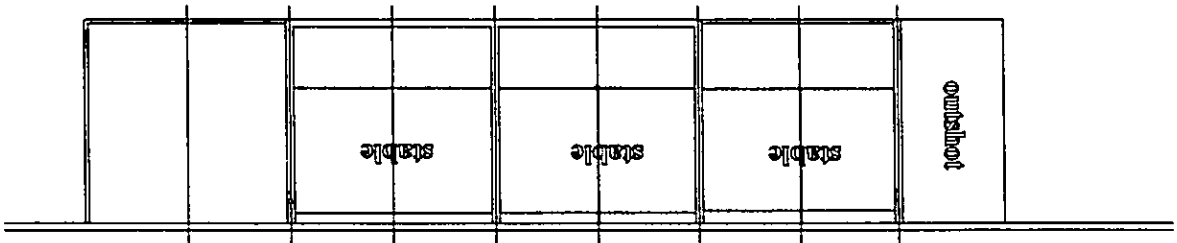
Period 4 - 19th century
 removal of east gable wall and under-building of roof structure
 with brick: introduction of 'outhouse': additional stabling in
 eastern bays

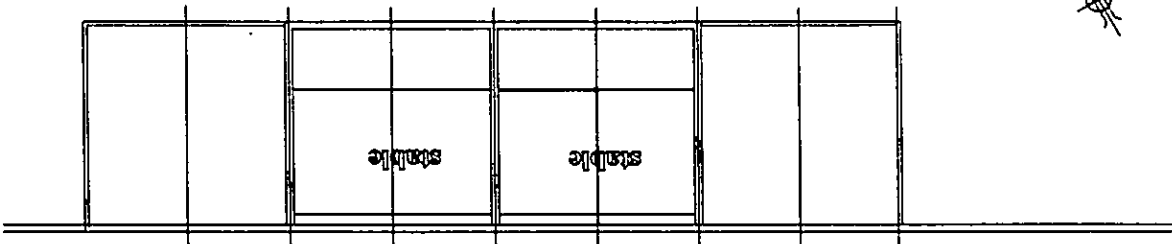
Period 3 - early 18th century
 timber-framing to central bays removed and roof structure
 under-built in brick: introduction of timber upper-floor with new
 'stable' use

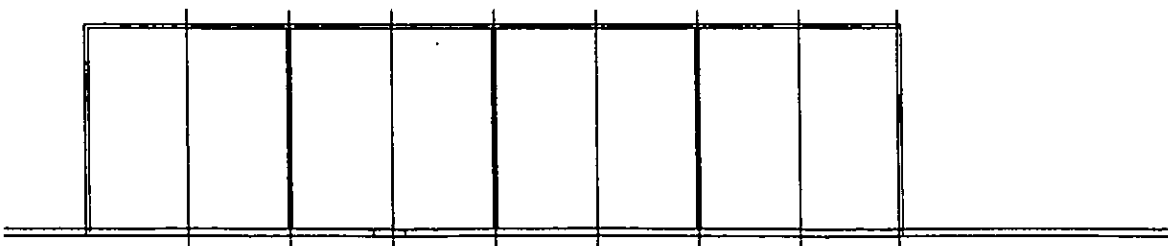
Period 2 - late 17th century
 Boundary wall raised to support roof structure of new
 3-bay timber-framed agricultural building

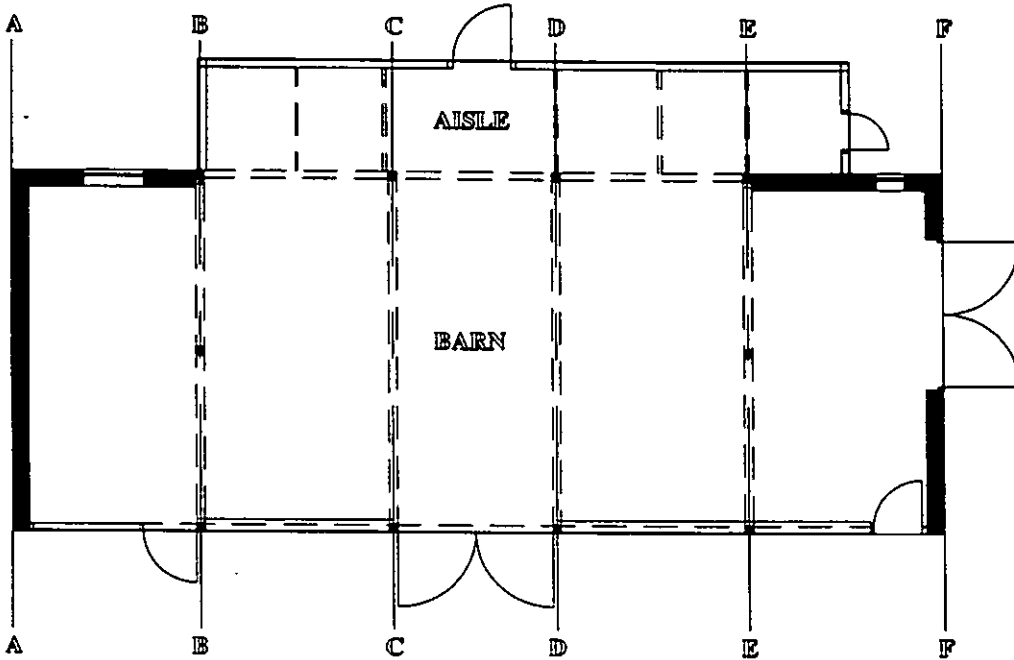
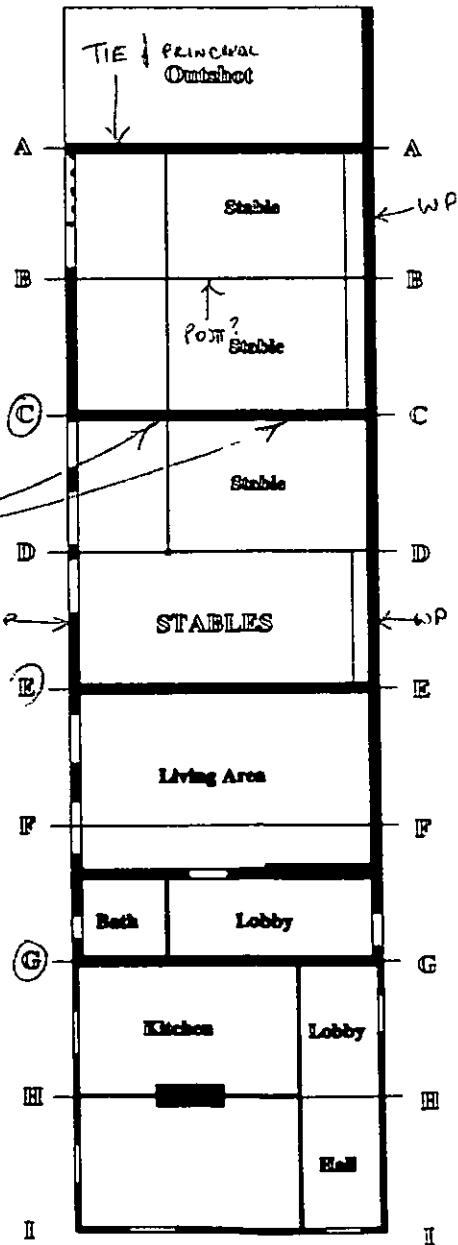
KEY PLAN

TIE - 1465-1499 → (C)
(OAK)

TIE - 1488-1503 → (E)
(OAK)

TIE - 1476-1503 → (G)
(OAK)
