RAF Perranporth, St Agnes, Cornwall: an archaeological survey

SURVEY REPORT

Archaeological Investigation Report Series
AI/44/2002

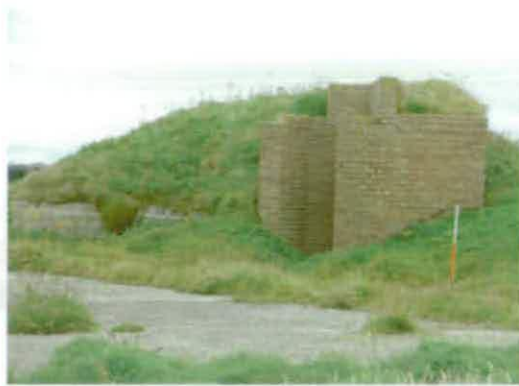
Plate 3. Brick shelter entrance. Early type dispersal pen.

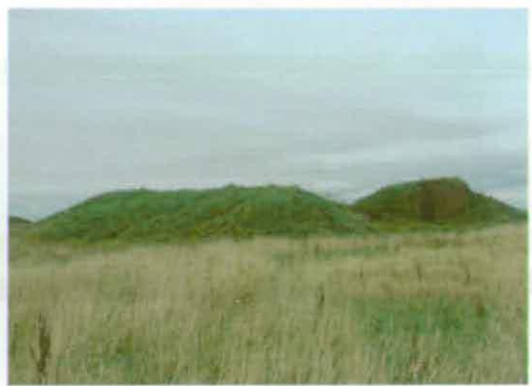
Plate 4. General view of the early type dispersal pen.

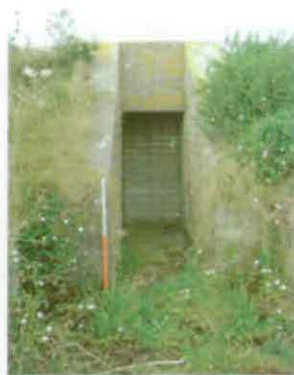
Plate 5. Concrete shelter entrance. Later type dispersal pen.

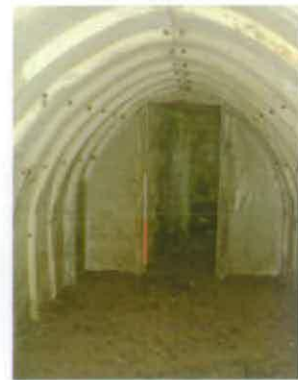
Plate 6. Stanton shelter interior.

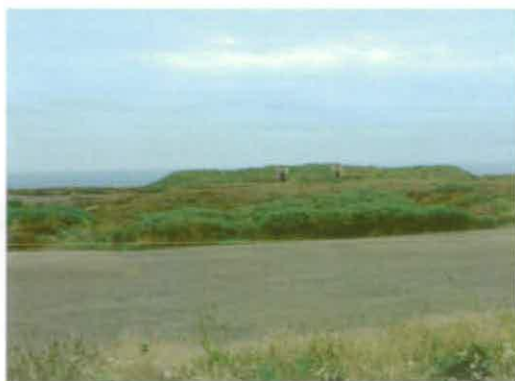
Plate 7. General view of later type dispersal pens.

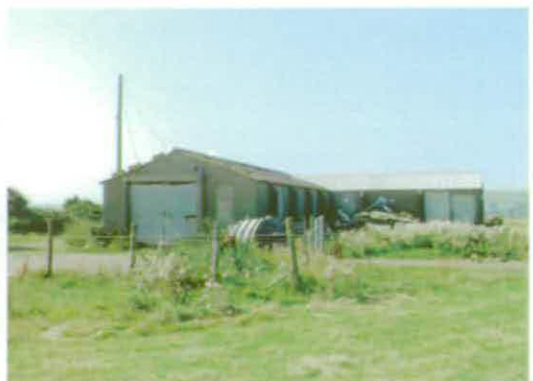
Plate 8. Flight office.

constructed of blockwork walls on a concrete base with three, or at the NE complex (116) only two compartments, set at right angles. The example in the SE complex (63) survives as a standing structure, the others are only concrete platforms. The surviving example is a single-thickness blockwork building with external piers which support an apex roof. Only one section of the original asbestos roof remains intact, the other two, which were badly damaged, have been replaced with modern materials in recent times. Most of the original window and door openings have been blocked up but wide doorways have been inserted in two places. WWII graffiti survives inside this building but this was not recorded during the present survey.

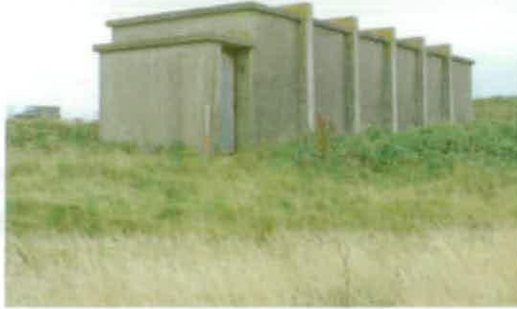
Plate 9. Night sleeping shelter.

The layout of each flight complex depended on its position on the airfield relative to the nearness of facilities. Each was equipped with a Small Arms Ammunition store (64, 77, 94, 115), a rest room (120, 121) or crew room (89); plus latrines and various small buildings. All these survive as concrete platforms only. The two northern complexes also had night sleeping shelters (90, 116). Only one of these now survives (90); it is a rectangular cement rendered building with an entrance lobby; external concrete piers reinforce the walls and support the flat roof. (Pl. 9).

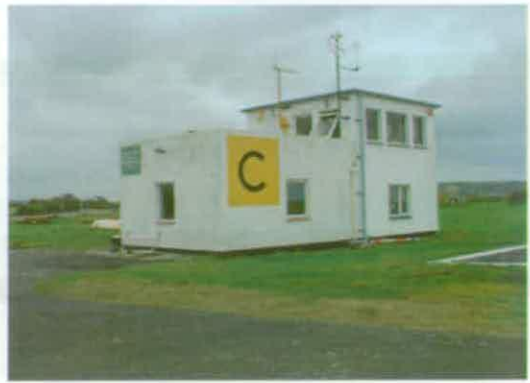
Plate 10. ATC building.

55. Control Tower (new)	PA55a-b		Well preserved and in use.
60. Blister Hanger	PA60a-c	SM3295701	Tarmac base & metal fittings.
61. Cloud height projector plinth	PA61	SM3295701	Concrete base.

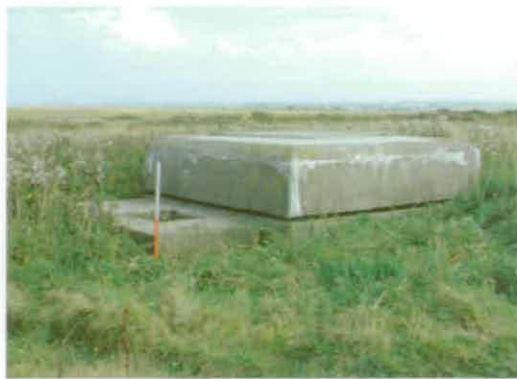
Plate 11. Battle headquarters.

The role of the Battle HQ was the co-ordination of the airfield's defence in time of ground attack. It comprises underground rooms entered by an open flight of concrete steps at the eastern end. A reinforced concrete observation cupola, with a narrow slit along each side below the hardened roof, is visible above ground level. On its northern side is an emergency exit hatch with an internal metal ladder. The cupola, surrounded by undergrowth is not capped with soil and the concrete skin on the roof is failing. The crucial metal supports for the 360° viewing slit are badly corroded and the hatch over the emergency exit is missing. The external stairs are in good condition but the underground rooms are filled with water to a depth of 0.6m.

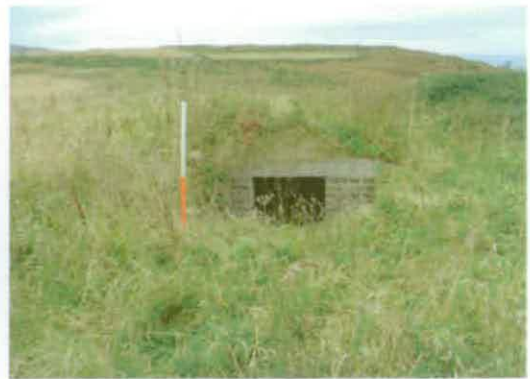
Plate 12. Machine gun pit.

The two machine gun pits (GP) consist of below-ground 'U' shape pits faced with brick. In the centre of the floor is an iron spigot onto which a pedestal with a machine gun was mounted, probably a Lewis or Vickers model. At one end of the pit is a rectangular, concrete roofed shelter, covered by a low mound of earth and at the other is an ammunition locker (Fig. 9; Pl. 12).
