**MULTI-BEAM SURVEYS OF THE DESIGNATED WRECKS ON THE  
GOODWIN SANDS AND THE DOWNS**

**PROJECT REPORT  
2018**

**August 2018**

**Ref: 7770**

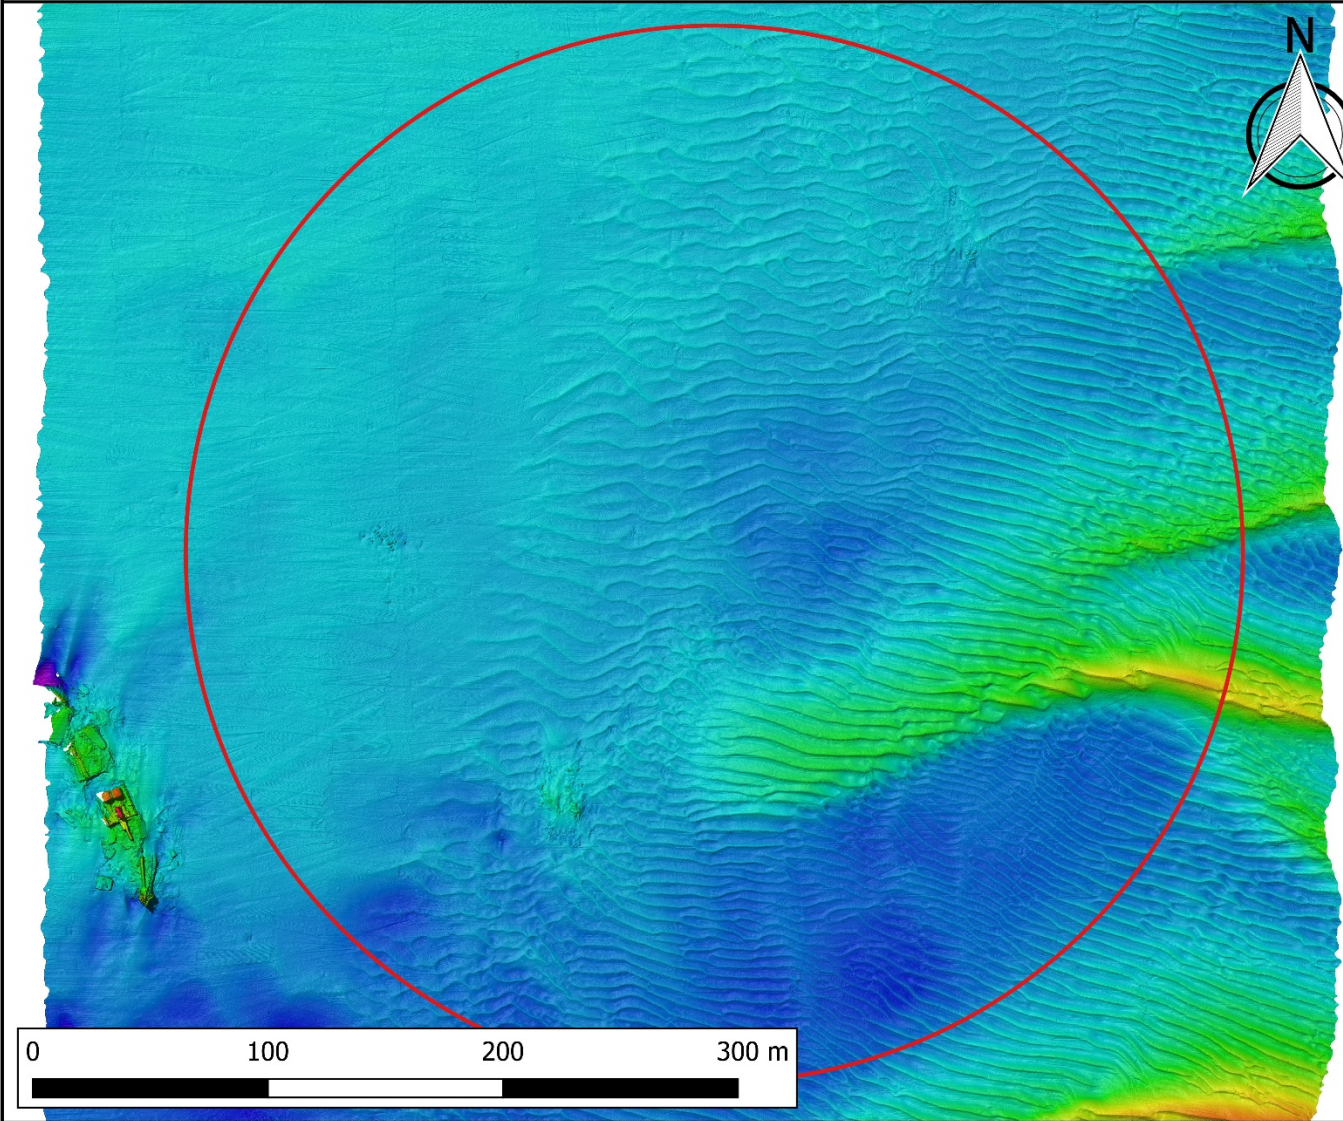
Figure 1: Rooswijk whole site and designated area.

- 4.4.1. The East site has now been completely covered by the southern migration of a large subaqueous dune. The direction of this dune has been tracked since 2015. It has moved approximately 24m between March 2017 and April 2018 (Figure 1).

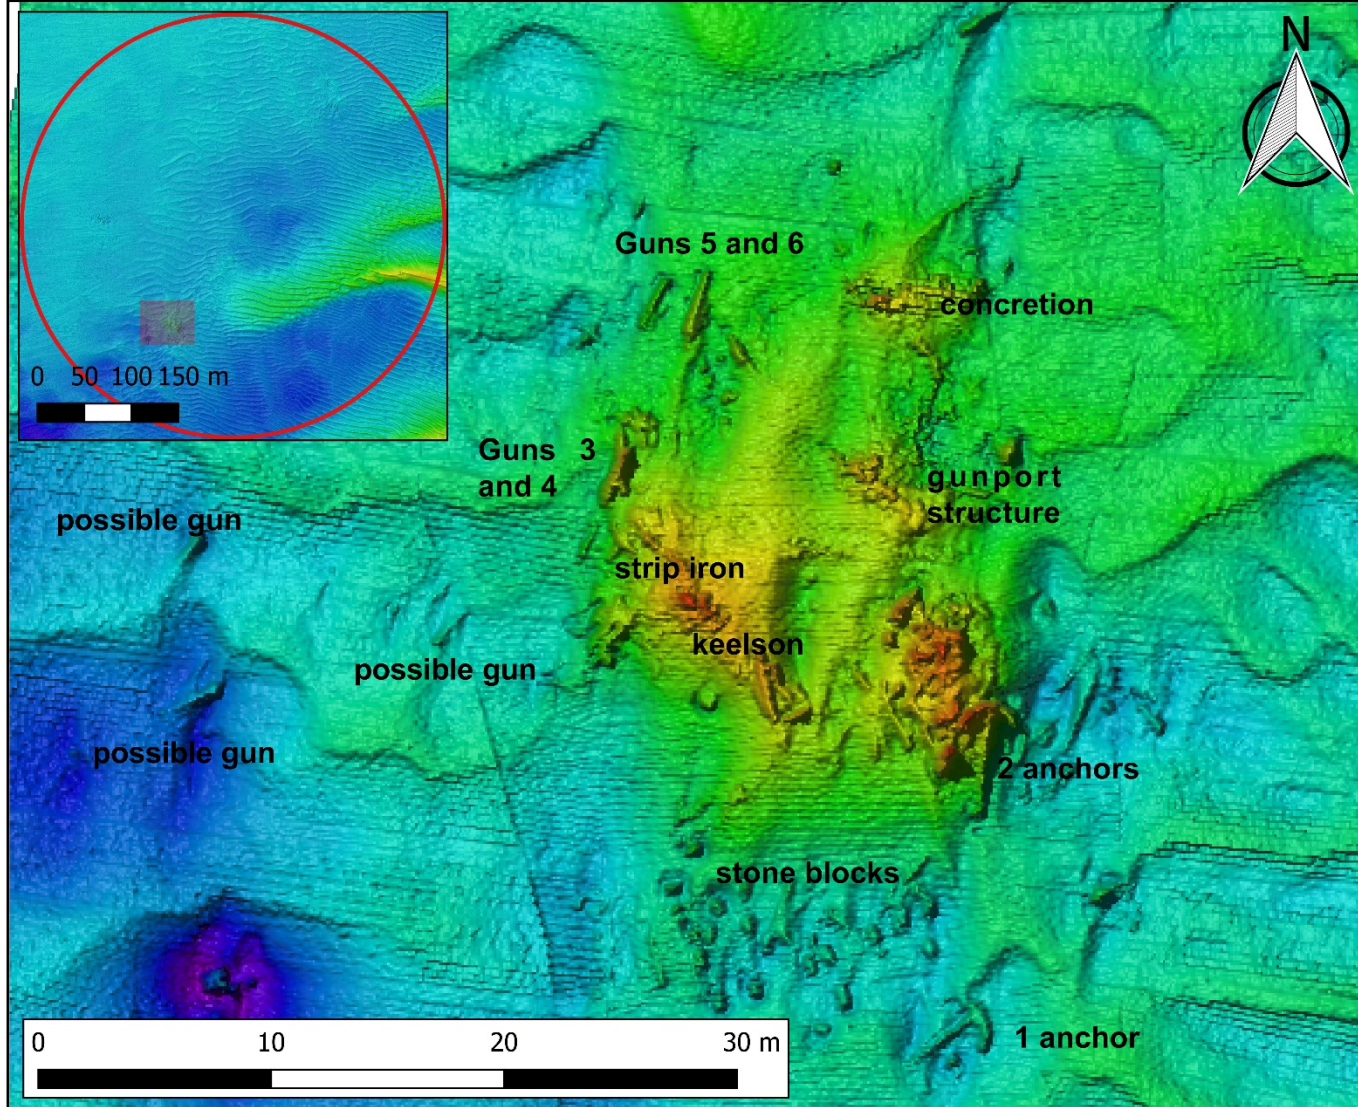
Figure 2: The main site with exposed features labelled.

- 4.3.2. There has been noteworthy bed level loss at the southern end of the site. This has revealed numerous rectangular anomalies covering an area of 12 x 6m. These anomalies are highly likely to be the stone cut blocks that have been recorded on the East site, as well as seen on other areas of the Main site (Figure 2).

- 4.3.3. Three metres southeast of these anomalies is an anchor, which is significantly more exposed than observed in the 2017 data. The length of the anchor from the crown to the end of the exposed shank is approximately 3.65m and the width across the flukes is approximately 2.7m (Figure 2).

- 4.3.4. Scour has occurred in the area east of the two anchors (one anchor on top of the other known from diving the site) at the southeast end of the wreck mound. This has revealed a 5 x 4m area of exposed features (Figure 2).

- 4.3.5. The area immediately northwest of the anchors is significantly exposed and from the excavation of this area (trench1) in 2017 it is known to contain boxes of cargo and cut stone blocks (Figure 2).

- 4.3.8. There are three linear features outside the main wreck mound to the west. There is a high potential that these could represent partially exposed guns (Figure 2).

- 4.3.9. There is another anomaly approximately 24m southwest of the main wreck mound. It is roughly 2.4 x 1.4m with a distinct scour all around it. (Figure 2)

- 4.3.12. On the eastern edge of the main wreck mound is a section of structure that has been identified as a gunport structure (PA 2017). This was covered in a sheet of teram at the end of the 2017 excavation. However, this area is visible on the 2018 data suggesting it may have come off due to the reduction of surface sediments in this area of the site (Figure 2).

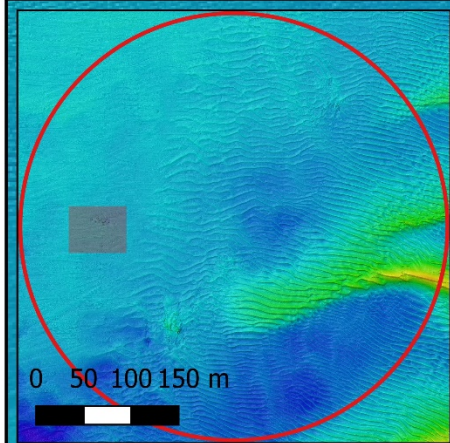
Figure 4: Exposed features on the North site.

- 4.5.1. The Northern site, which consists of a scatter of concreted barrels, has not changed since the 2017 survey. The extent and number of exposed features is the same as seen previously (Figure 4).

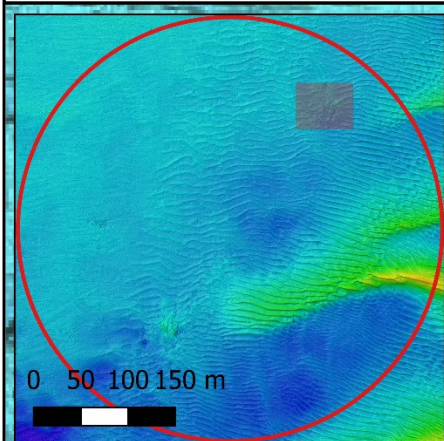
Figure 5: Exposed features on the Gun site.

- 4.6.1. The Gun site is approximately 270m from the centre of the main site. The 2017 multi-beam bathymetry data revealed possibly nine guns, which was confirmed by diver ground-truthing during the *Rooswijk* 1740 excavation project. This area of the site appears more pronounced in the 2018 data with possibly up to 11 guns now exposed (Figure 5).
- 4.6.2. There is a main cluster of eight guns with two 21m further to the north and one potential gun 24m to the southwest of the centre of the cluster (Figure 5).

- 4.6.3. The increase in the number of guns and the fact all of the features are more pronounced suggests there has been bed level loss in this area of the site (Figure 5).

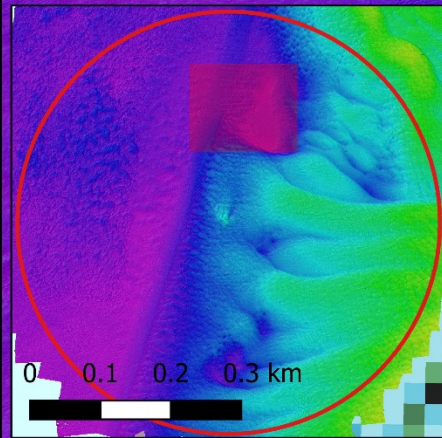
Figure 9: The scatter of anomalies to the north of the main wreck-mound.

- 4.7.11. To the north of the main wreck a large area of the seabed within the designated area has experienced bed level loss. This appears to have been caused by the migration of the sand bank in a northeasterly direction. The result has been the exposure of a scatter of debris consisting of several potential guns. The scatter of debris covers a length of 95 m by 55m and is between 105 and 200m from the northwest end of the site (Figures 9-11).

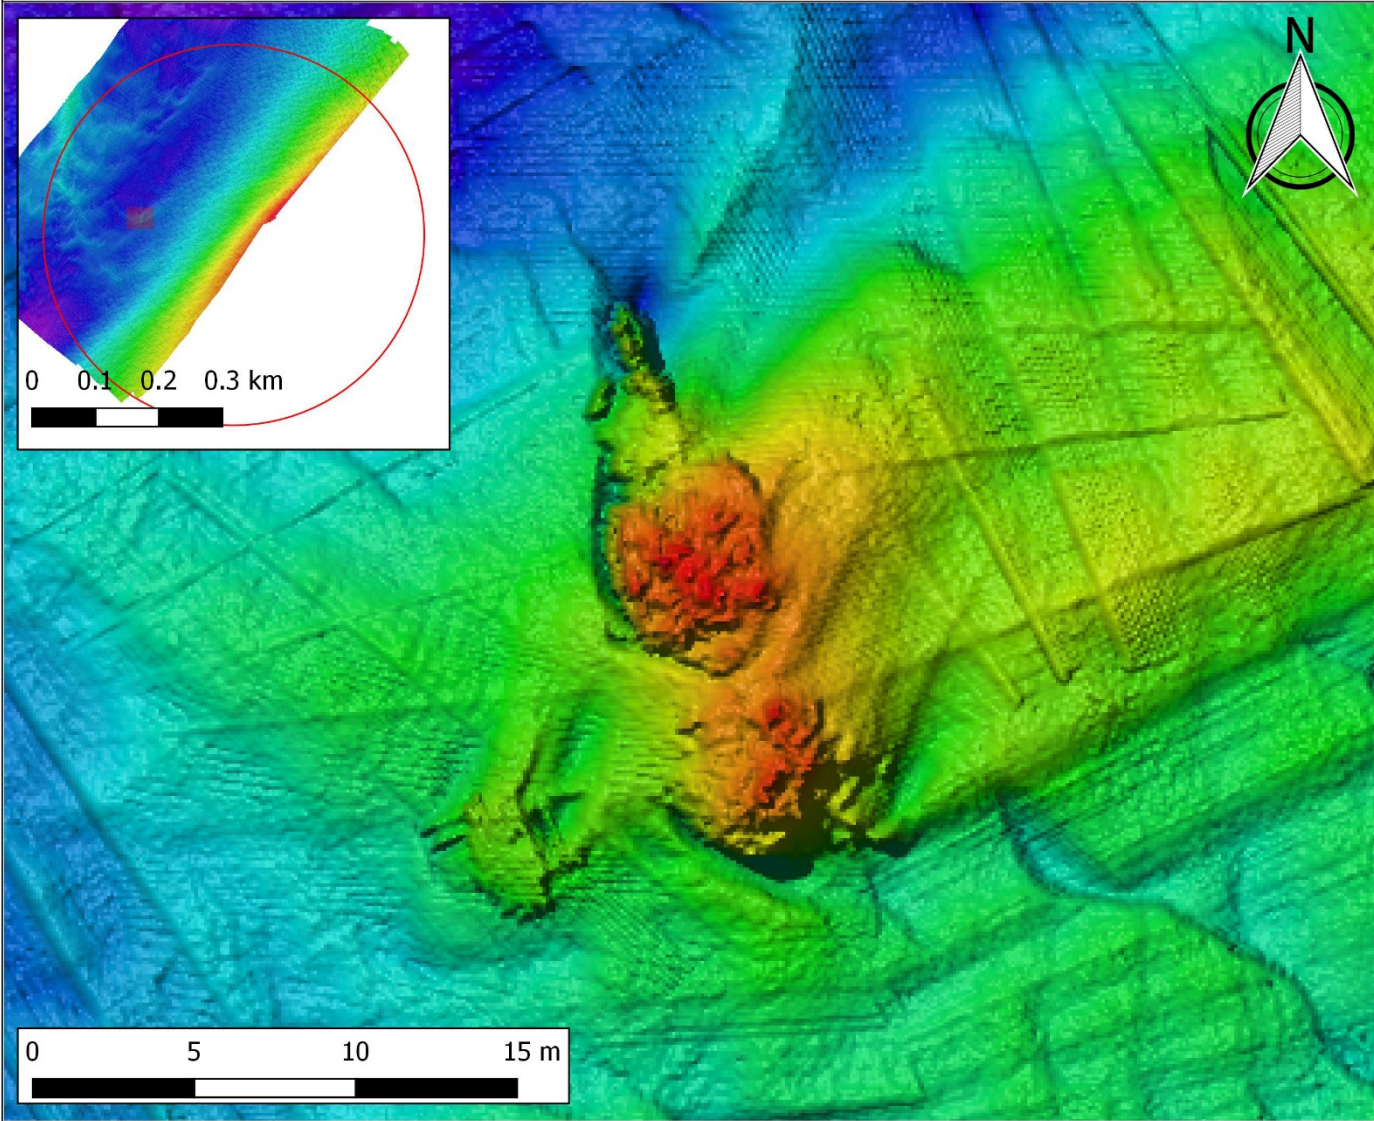
Figure 13: The wreck site west 120m west of the Stirling Castle.

- 4.8.6. This site is currently 19m long by 5m wide, orientated NNW/SSE and is distinctly vessel shaped (Figure 13). This was first detected during a side-scan sonar survey by the ADU in 2001(ADU 01/12). It was dived by the Licensee of the *Stirling Castle*, Robert Peacock, shortly after the survey and before becoming re-buried. Robert Peacock described finding a clinker constructed vessel, its size and construction suggesting a possible medieval date (ADU 01/12). Following recent conversation with Robert he also observed at least two iron guns at the northern end of the site with the muzzle ends putting north. This suggests a forward-facing firing position alluding to possible bow chasers as opposed to guns on the broadsides facing out (pers. comm. Peacock 2018).

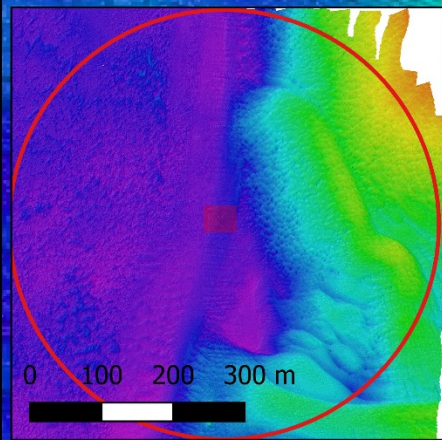
Figure 15: A close-up of the Restoration's south mound close to the centre of the designated area.

The south mound consists of several exposed features over an area of 19m long by 6.5m wide, on an NNW/SSE axis. It is unclear from the multi-beam bathymetry data alone what these features could be. A diving assessment of the site would be recommended to identify the exposed remains and its condition.

- 4.14.2. Depending on the results of the recommended 2019 MBES survey of the *Restoration* PA would recommend a diving assessment of the site to identify the exposed remains and its condition.

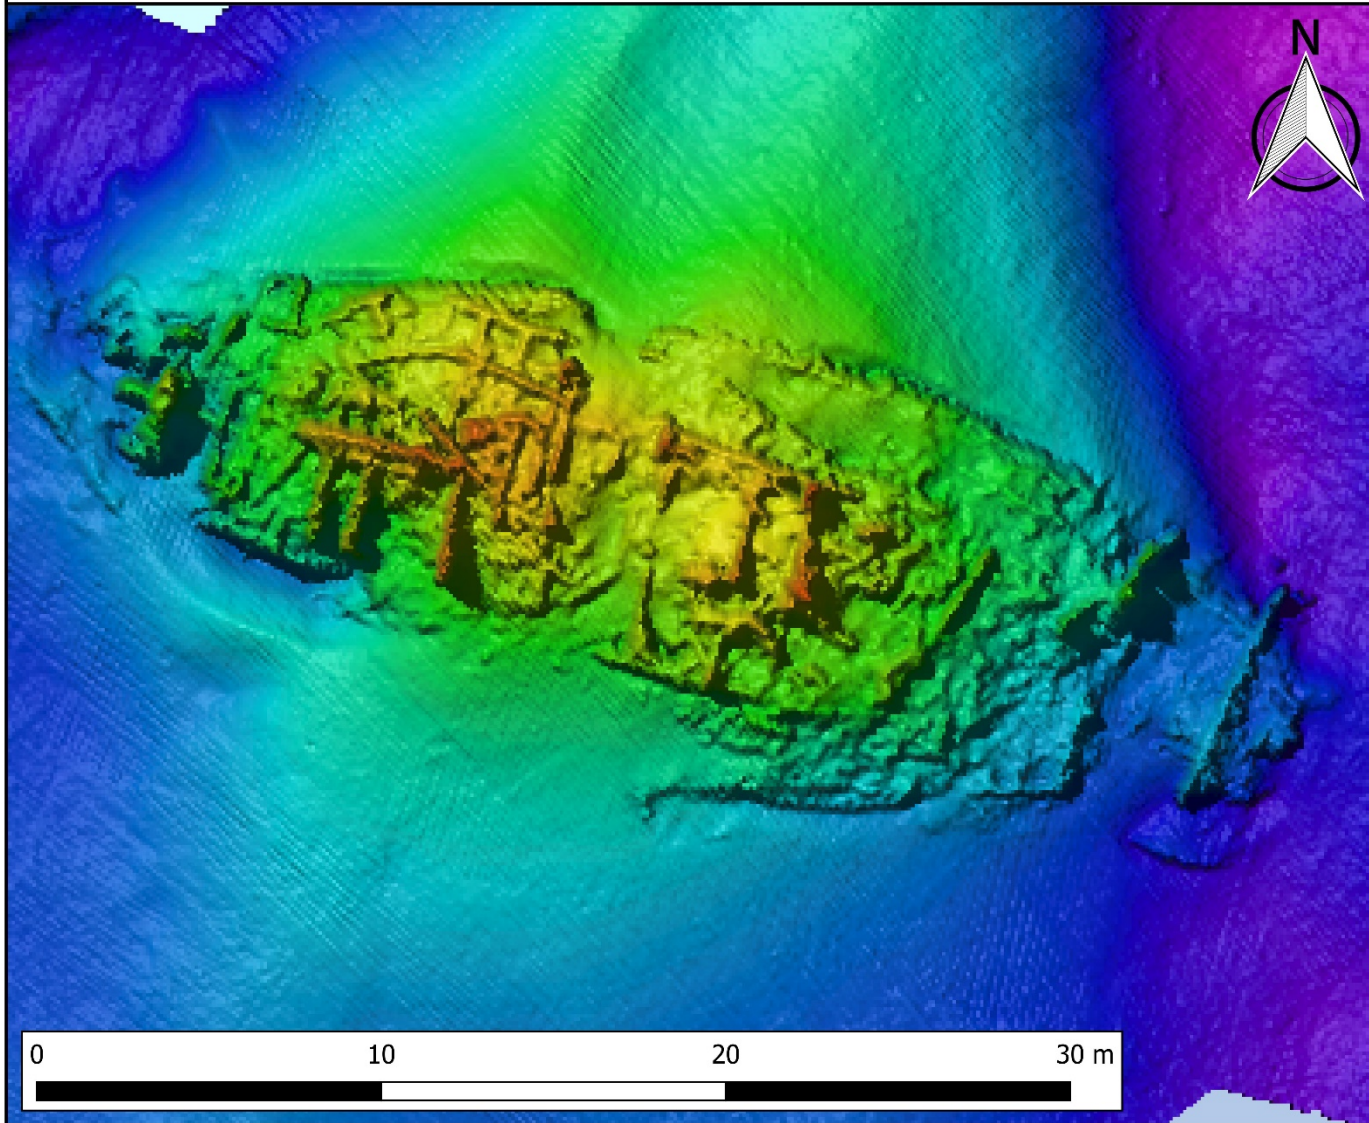
- 4.12.5. With such an exposed wooden wreck its condition is always going to be on a downward trend while exposed. This is apparent from the 2018 data where unsupported structures between amidships and the bow have shifted towards the starboard side (Figure). This structure is composed of three deck beams orientated N/S with the remains of a 5m long section of deck structure on top, orientated W/E. The structure on top of the deck beams has shifted towards the starboard side by 1.2 – 1.8m (Figures 18 and 19).

When the wreck was surveyed in 2006 by the ADUS it was relatively intact and much of the starboard side and stern area were buried. Continued exposure and further loss of seabed sediments on and around the wreck have left it extremely vulnerable to physical and biological degradation. This has been the cause of the wreck sites' deterioration.
