FORT PITT, CHATHAM, KENT AN EARTHWORK ANALYSIS OF JACKSON RECREATION GROUND

SURVEY REPORT

Magnus Alexander

NGR: TQ 7485 6770

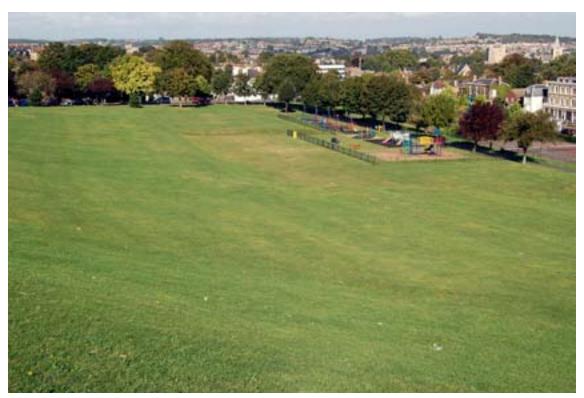
In the north-west corner of the survey area is a rectangular terrace oriented roughly along the natural slope, west-north-west to east-south-east, and defined by clear slopes measuring a maximum of 120m by 32m. This is also both a negative and a positive feature and is partly occupied by a children's playground. At the western end of this area, on its southern (uphill) side, is a smaller sub terrace, also rectangular, that measures approximately 60m by 20m. On the sub-terrace are the remains of a structure of some form (a) visible at its western end both as a small but well defined scarp and in places by building remains just below the turf. It is less well defined to the east but was 13m wide and approximately 18m long. In the internal angle between the sub-terrace and the main terrace is a very slightly raised area. The triangular area between the playground terrace and the sports field consists of an apparently natural slope crossed by a gentle scarp probably created by the removal of material from below (b). This scarp merges with the natural slope at its western end and in the east appears to run under the central terrace earthworks. It has some slight undulations running down slope and at one point clearly bulged out. There is a secondary scarp above the main slope. Above this the ground is uneven but the only clear feature is a small ridge running down hill (north/south) with a slightly amorphous gully immediately to the west. Below the scarp the ground is more level with an irregular mound approximately in the centre. To the west of this is a shallow spur projecting from the scarp and at the west end of this area are several hollows including one broad flat-bottomed gully running into the recreation ground at right angles to City Way. To the east of the playground terrace is a clear but gentle slope (c) that had been cut by the terrace at its western end. Above this (south) is a second

fainter slope parallel to the first. All the main slopes in this area were similarly oriented running roughly horizontally along the natural slope.

Fig 2: The north-west of the survey area, looking north-west

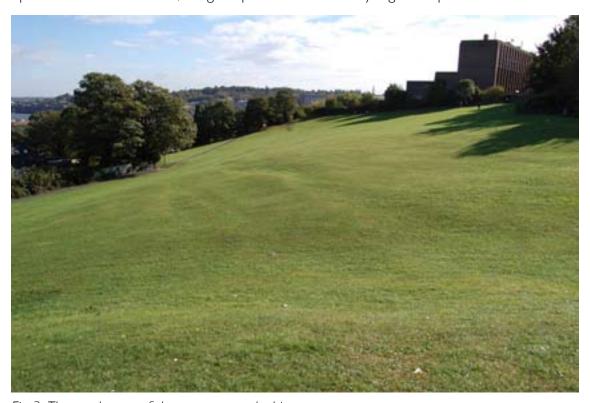
Most of the area to the east of the sports field consists of moderately steep natural slopes dropping down towards the north and north-north-west forming a slight bowl. The far eastern boundary of the survey area is marked by a tall retaining wall for the fort moat beyond. There is a clear slope, partially obscured by vegetation, dropping away from this wall forming a faint glacis (d), which runs up the natural slope. At the south end the boundary turns west and running alongside this is a more level area defined by a slightly steeper scarp running east-west parallel to the boundary and about 6m from it (e). Within the corner between these two sections is an entrance into the college. A foot path has been worn into the slope here slightly eroding the east/west slope creating a short slope on the downhill (northern) side. To the west the recreation ground boundary again turns south and another flat area, defined by a west facing scarp running parallel to the boundary and 6-7m from it, runs for about 60m before ending at a north facing cross slope. This level area is cut by a small gully. Just below the corner between these latter two sections are several scooped features that appear to be later than the other slopes and have disturbed them. However, the east to west slope appears to run out into the recreation ground for a short distance rather than running around the corner to meet the north-south slope. Below these features, to the north, is a linear earthwork that ran roughly east west along the slope dropping slightly towards the west (f). This probably originally consisted of a fair sized bank, possibly with ditches on both sides but it had weathered down to a simple slope with flatter areas above and below. At its eastern end it is cut by modern features and abutted those associated with Fort Pitt. At its western end it appears to end at a slight bulge that was part of a complex

series of interrelated earthworks (g). Above the bulge a scarp of a similar size to the linear described, continues along the slope further to the west and above this are a few smaller parallel slopes creating some small terraces. These are all cut at their eastern ends by a sub-rectangular feature (h). At their western ends a series of gullies and banks run diagonally up the steeper ground here from north-east to south-west (i). Some have the appearance of track ruts but others are less regular. Just to the west of these is a short section of another scarp that ran along the natural slope on a similar orientation to the small terraces above the larger slope mentioned above (j). These features ended abruptly leaving a narrow blank area running directly down slope, between them and the earthworks of the sports field. Above these complex earthworks the ground slopes upwards with a few broad, irregular platforms defined by slight scarps.

Fig 3: The north-east of the survey area, looking east

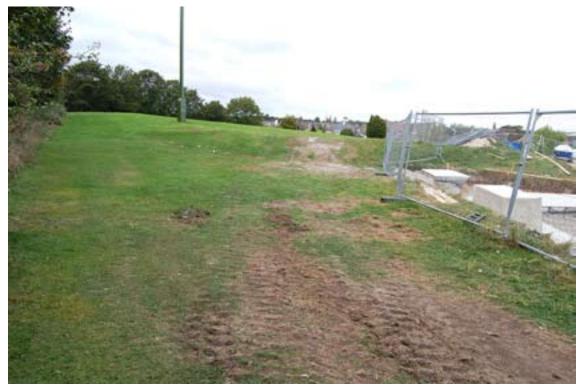
The area to the south of the main terrace is near the crest of the natural topography here and slopes down more to the west than the north. A clear bank, oriented north-east to south-west, runs along the south-eastern side of this area parallel to the recreation ground boundary (k). On its north-western side the scarp is uneven, probably as a result of subsequent activity, and merges into the natural slope. To the south-east the scarp is more clearly defined. At the southern end of this feature the ground has been disturbed but the earthwork appears to turn to the south-east and runs into the corner of the recreation ground. Between the bank and the recreation ground boundary is a broad ditch defined by a shallow scarp to the north-west with a narrow flat area between this and the scarp of the bank; the south eastern scarp can be seen but not surveyed due to heavy vegetation. At their northern ends the bank and ditch have been truncated by subsequent activity but the bank clearly aligns with a clear east-north-east facing scarp with a slight counterscarp (I) that also runs parallel to the

south eastern boundary of the recreation ground for about 10m before turning away from it to the north west where it can be seen to continue through the construction site (September 2007) for the skateboard park. A post for a CCTV camera has been installed on the bank at the point where it turns, the cable trench for which is clearly visible as a vegetation mark running away to the west where a junction box has been installed next to the pavement alongside City Way. Below (west of) the south-west end of the bank described above a small south facing scarp runs west before curving around to the north where it forms a shallow gully before petering out. Immediately below this is a small scooped feature. From here a southwest facing scarp runs into a series of north-north-west facing scarps that ran parallel to City Way (m) becoming increasingly faint, until they reach the haul road for the skateboard park construction site. Within the triangular area defined by this feature, the slight bank to the east, and the haul road to the north, were a few vague and intermittent features, the best preserved of which could be seen to form ridges on two general alignments; east to west (n) and northnorth-west to south-south-east (o). They were too faint to record accurately but their general alignments were surveyed. In the eastern part of the area, an apparent series of sub rectangular platforms could be seen defined by slight scarps and ridges, the clearest of which was to the south. However, as several of the defining features align with the general trend of ridge features in this area they are unlikely to be platforms. To the west two scoop features immediately above the main scarp down to City Way were recorded but were clearly associated with modern works. Across the survey area several concrete bases with fixings were recorded, these were apparently for park benches, now gone.

Fig 4: The south of the survey area, looking south west along the south eastern boundary showing the remains of the earthwork that ran across to Delce Tower

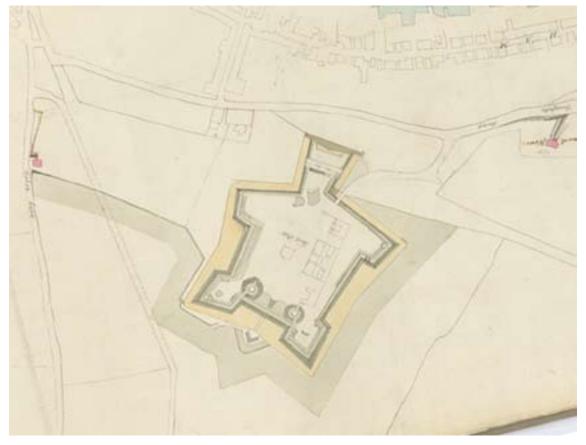
A map of 1813 (National Archive MD 174, 31 PT E; Fig 5) shows the fort in its almost complete form. The northern casemates and additional internal buildings have been constructed and the ravelin and the two outlying towers are also included. Externally, works are shown around the south west corner of the bastion. A covered way is shown with a south facing glacis that ran north-east, parallel to the moat, before turning north west and then west north west running across to Delce Tower on Delce Road (TQ74626772). This feature aligned directly with the earthworks recorded in this area (j) and is cut by the sports field and the skateboard park. In particular the shallow gully is probably all that remains of the trench itself and the denuded bank formed part of the glacis. Fort Pitt House is also shown and the area to the west that later became the bowling green and tennis courts is shown as a separate enclosure suggesting that the terracing here may date to this period.

Fig 5: John Handfield's map of 1813 (TNA: PRO, MD 174, 31 PT E)

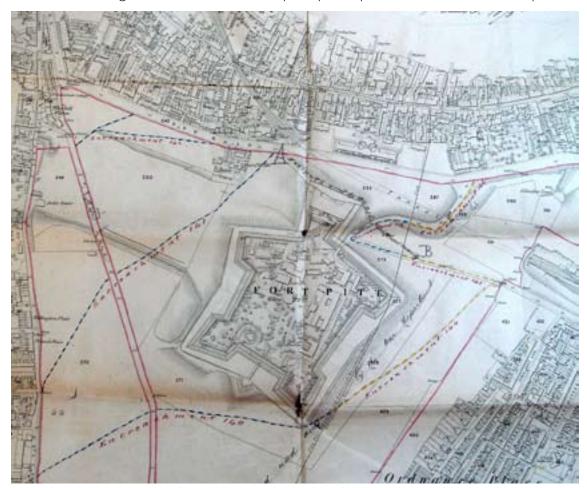
An annotated 25 inch Ordnance Survey map of 1875, based on the 1866 survey, (TNA: PRO, WO 32/18207; Fig 6) shows the same information as above but the footpath is noted as an encroachment, suggesting that it was of relatively recent origin. It also shows the fort itself including works in the survey area which are broadly the same as those shown on the 1813 map, though considerably more detailed. The fort was surrounded by a moat with an external retaining wall. This appears to be on the line of the current boundary of the recreation ground. Beyond this the map shows a clear glacis much of which is still preserved as earthworks (d, e, f). On the north west corner of the main fort is a projecting outwork of some form, slight traces of which are also preserved. More complex outworks are recorded outside the south west bastion. These seem to be a small south facing bank some of which seems to remain and, to the south of this outside the study area, a substantial cut feature that must have been seriously damaged when the access road to the college was inseerted on this line in the 1960s. A path

is shown leading to the north running parallel to the outer wall of the fort here in a gully or trench defined by slopes to east and west. The western slope is shown with a substantial counter-scarp probably forming a glacis and the path peters out where this bank turns from running slightly east of north to running west of north. This outwork then turned to the west-north-west, where a small ramp is shown running up onto the top of the glacis, and then ran towards Delce Tower. This section is shown as having a ditch behind the glacis but has been destroyed by the sports field and skateboard park.

Fig 6: Annotated Ordnance Survey 25 inch map, 1875 (TNA: PRO, WO 32/18207)

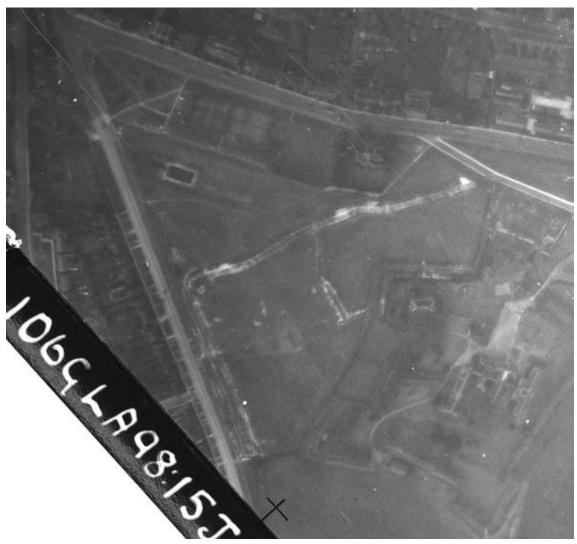
Photographs from January 1945 (RAF/106G/LA/98, 1077; Fig 7), though poor, show, in addition to the above features, that elsewhere in the park most of the modern elements described above are visible including the terrace containing the bowling green and tennis courts. The moats along the western side of Fort Pitt appear to be open and the line of the earthwork originally running across to Delce Tower can be seen. The far south of the study area is defined by the cut used by the access road to the current Mid-Kent College from City Way and an earthwork is visible on this alignment (and in later photographs) though it is narrower and appears more in keeping with the fort out works.

Fig 7: Aerial photograph of 1945 (RAF/106G/LA/98 1077, 15 Jan 1945, English Heritage (NMR) RAF photography)

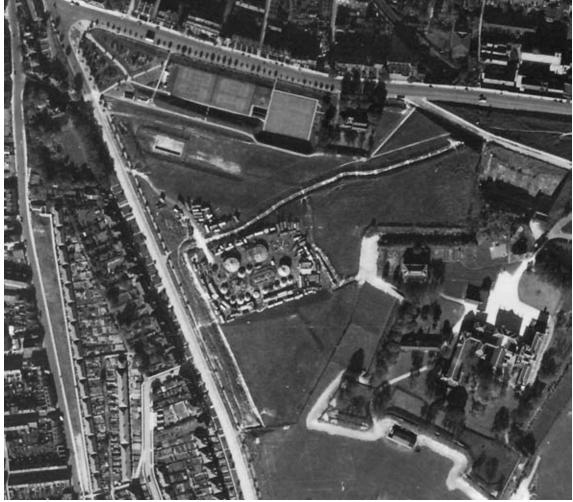
Figure 8: Aerial photograph of 1946 (RAF/CPE/UK1789 4174, 11 Oct 1946, English Heritage (NMR) RAF photography)

Most of these works are visible on the photograph of 1946 (RAF/CPE/UK1789 4174; Fig 8) which is dominated by a fair taking place on the sports field and several rides and numerous stalls can be seen. A track runs southwards onto the field from City Way, clearly to allow access as many vehicles appear to be parked next to it on the moderately sloping ground below the field. This track shows brightly, presumably from the exposed chalk, and much of the wear must have been contemporary with the photograph. The intermittent use of this area by travelling fairs may account for some of the very minor earthworks in the area. Access onto the sports field was by a casual track that is visible on aerial photographs. Between the track and City Way a disturbed area is visible which was also present in 1945 but its nature could not be determined. To the north of this, between the large rectangular feature and City Way, the ground appears to be disturbed and a cut feature is visible. Taken together these might suggest outlying defensive works relating to City Way. The rectangular feature probably constructed in early 1942 on the terrace above the tennis courts clearly shows as a substantial negative feature, most likely a reservoir. On the lower part of the terrace to the east of the probable reservoir there appear to be large worn areas, also faintly visible in 1945 but their origin is unknown. Large pale areas around the west and south west bastions of Fort Pitt itself suggest that moat in these areas had recently been infilled. The remains of the earthwork that

connected Fort Pitt with Delce Tower can clearly be seen and there appears to be a gap in the earthworks about halfway between the top edge of the sports field and the outer boundary of the fort. This is not original and probably marks the line of a later path or service trench crossing the area.

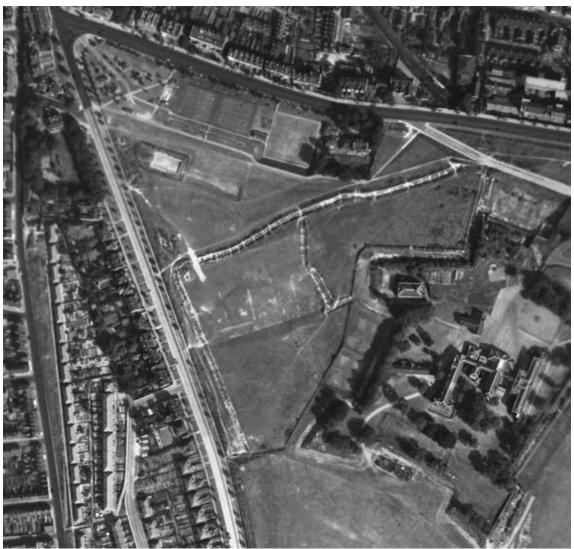
Fig 9: Aerial photograph of 1947 (RAF/CPE/UK2301 5123, 9 Sept 1947, English Heritage (NMR) RAF photography)

The clearest image of the wartime defensive earthworks is on the aerial photograph of 1947 (RAF/CPE/UK2301 5123; Fig 9). It can be seen that the main section, which ran from the north eastern corner of the recreation ground west south west and across the face of the downhill slope to the sports field consisted of a ditch with a substantial bank on the downhill (northern) side and a smaller bank on the uphill side in the more open eastern area. Semi-regular paths appear to have been worn across this feature which can be seen in 1946 and possibly in 1945 and it is possible that intermittent barriers existed, such as coils of barbed wire which could be extended at short notice to create an unbroken barrier. The barrier running parallel to City Way appears to be less substantial, using the slope up to the sports field at its northern end, and apparently consisted of two linear features, probably fence lines, possibly with a shallower ditch between them.

At the southern end of this feature the ground appears more disturbed and a clear ditch is visible where it meets the east-west cutting running across from City Way to the point of the south west bastion of Fort Pitt. A path ran to the north and west of these linear features which is also visible in 1945, and around the north western corner of the sports field this had caused considerable erosion. Immediately to the north of this area was a diamond shaped area of disturbed, scrubby ground also present in 1945 and 1946. In the latter image less scrub is visible and the feature may have been relatively recent. The track used by the fair to gain access to the sports field is also clearly visible. Above this area, on the corner of the sports field, the structure noted above is visible. This appears to be unroofed and consist of two interlocking 'L' shaped walls. Across the sports field numerous pale scars can be seen some of which can be seen on the wartime images, and so will relate to military activity. Some do not and may be marks remaining from stalls and other features associated with the fair. Elsewhere little has changed although the pale scars around the bastions of Fort Pitt already appear to have grassed over.

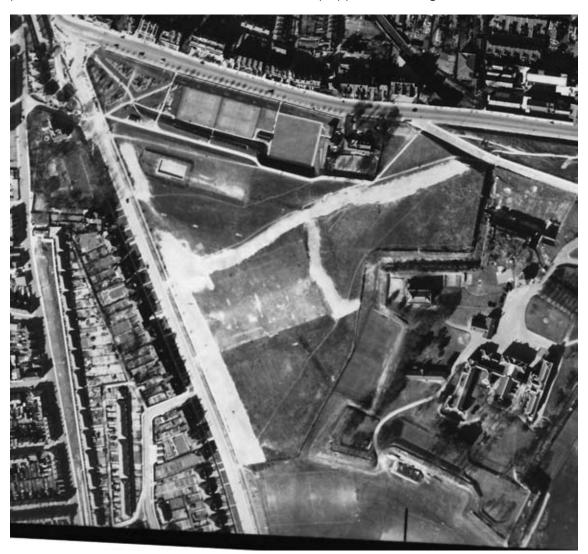
Fig 10: Aerial photograph of 1948 (RAF/CPE/UK2534 5208, 24 Mar 1948, English Heritage (NMR) RAF photography)

The most significant features of the 1948 photographs are the large areas of pale ground where the Second World War defences had been, clearly resulting from works to reinstate the recreation ground (RAF/CPE/UK2534 5208; Fig 10). The areas of chalk to the east of City Way, north of the main defences, suggest that the features here may have been defensive. Some attempt also appears to have been made to level up the sports field. Photographs from 1950 show that it took some time for the ground to recover (58/491, 7 Apr 1950, 5020).

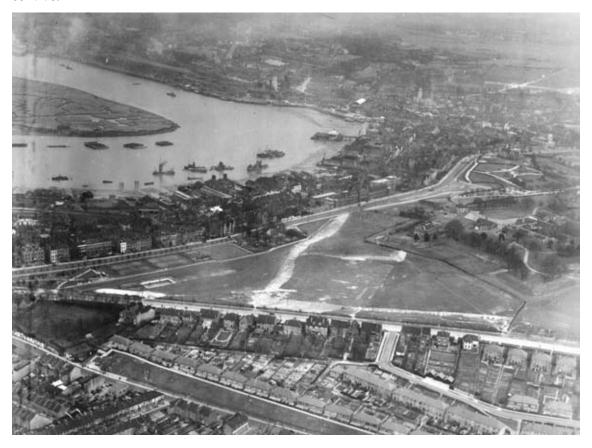
Oblique photographs from a few weeks earlier in 1948 add a little additional information (RAF.CPE/UK/2440 0073, Fig 11). The form of the structure on the corner of the sports field can just be seen and confirmed as two interlocking 'L' shaped walls, apparently about chest height. The sunken structure in the north-west of the recreation ground can also be seen and appears to be holding some water and probably has ladders running up the sides. The area of Delce Tower is visible immediately to the left of and slightly below the reservoir. The base of the tower and a wall running north away from the tower (to the left) can be seen, both of which are shown on maps as early as 1813 and which still survive.

Fig 11: Oblique aerial photograph of 1948 (RAF.CPE/UK/2440 0073, 4 Feb 1948, English Heritage (NMR) RAF photography)

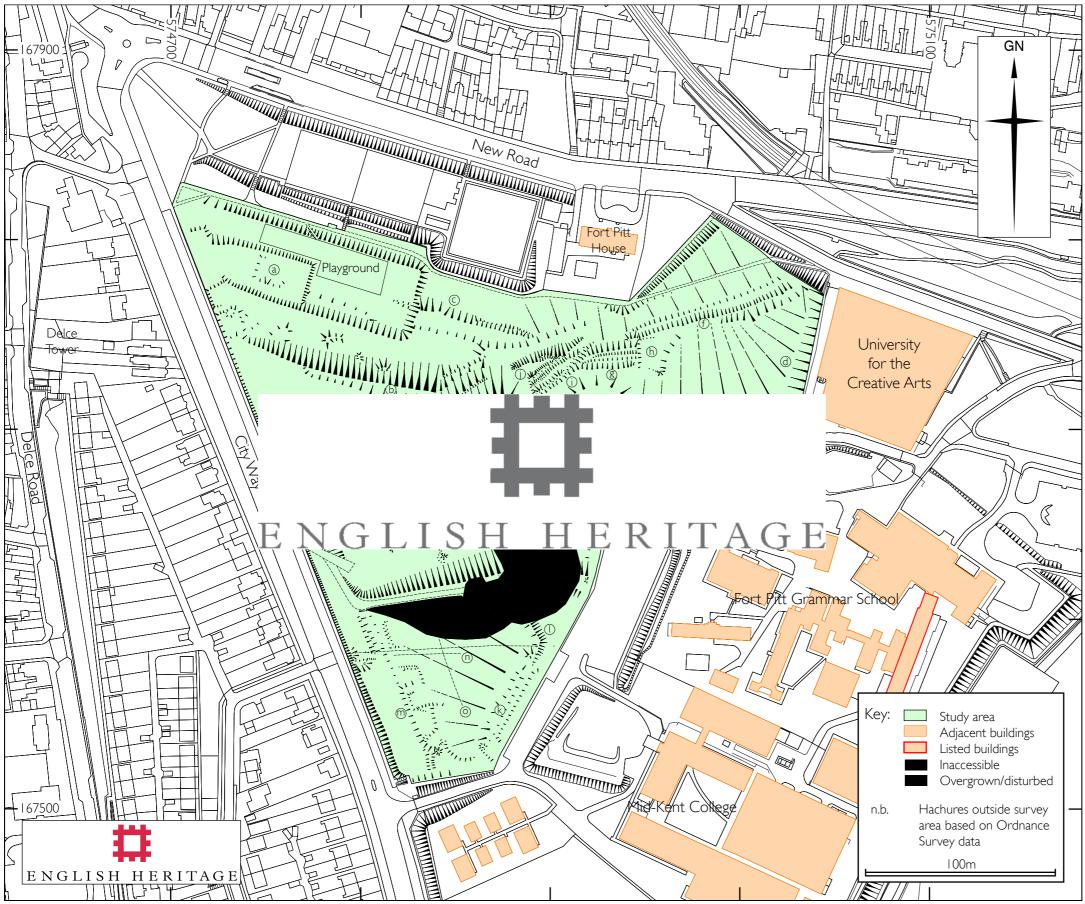
Figure 12 – Survey

The rest of the site can be divided into three areas. Letters in brackets refer to Fig 12.

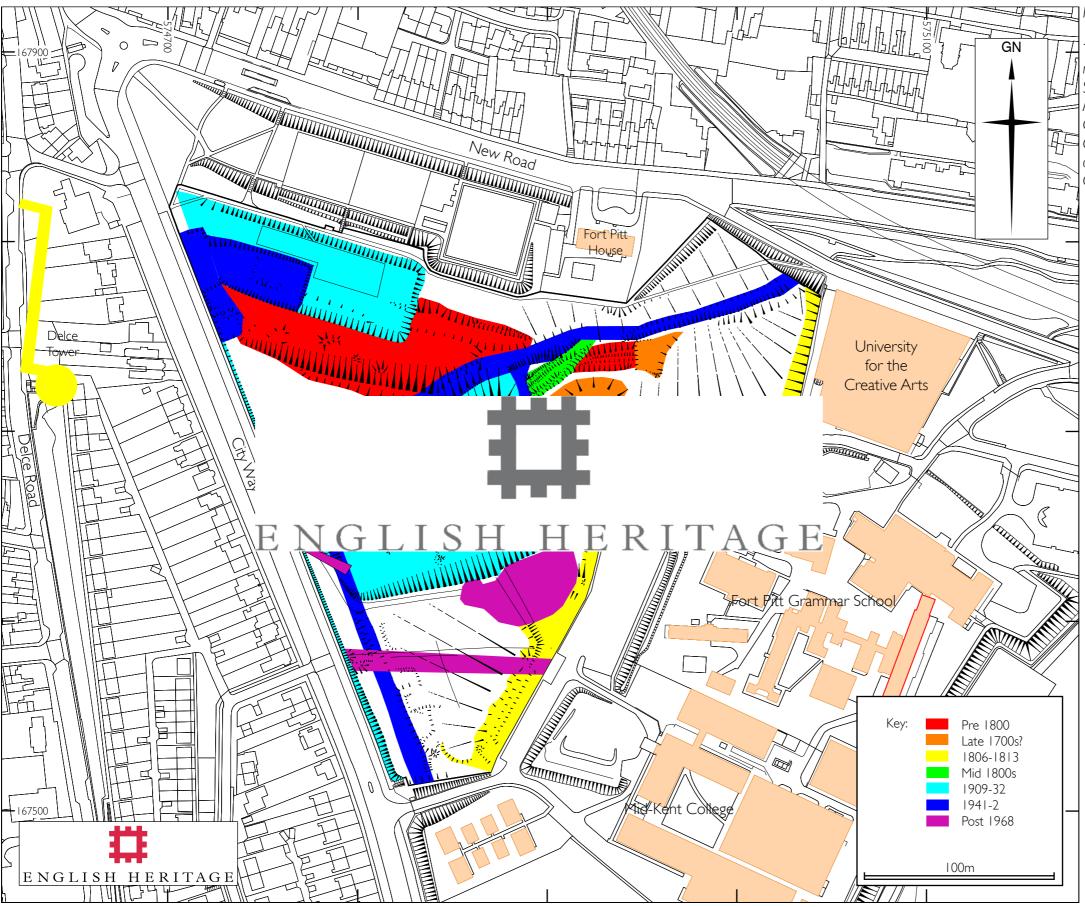
Figure 13 – Interpretation

There appear to be six main phases of activity represented by the earthworks surveyed within Jackson Recreation Ground. See Fig 13.
