# BINDON MILL AND MILL HOUSE, WOOL, DORSET

## HISTORIC BUILDINGS REPORT

ANALYSIS AND ASSESSMENT OF THE  
BUILDINGS AND MILL MACHINERY

Research Department Report Series No 23/2006

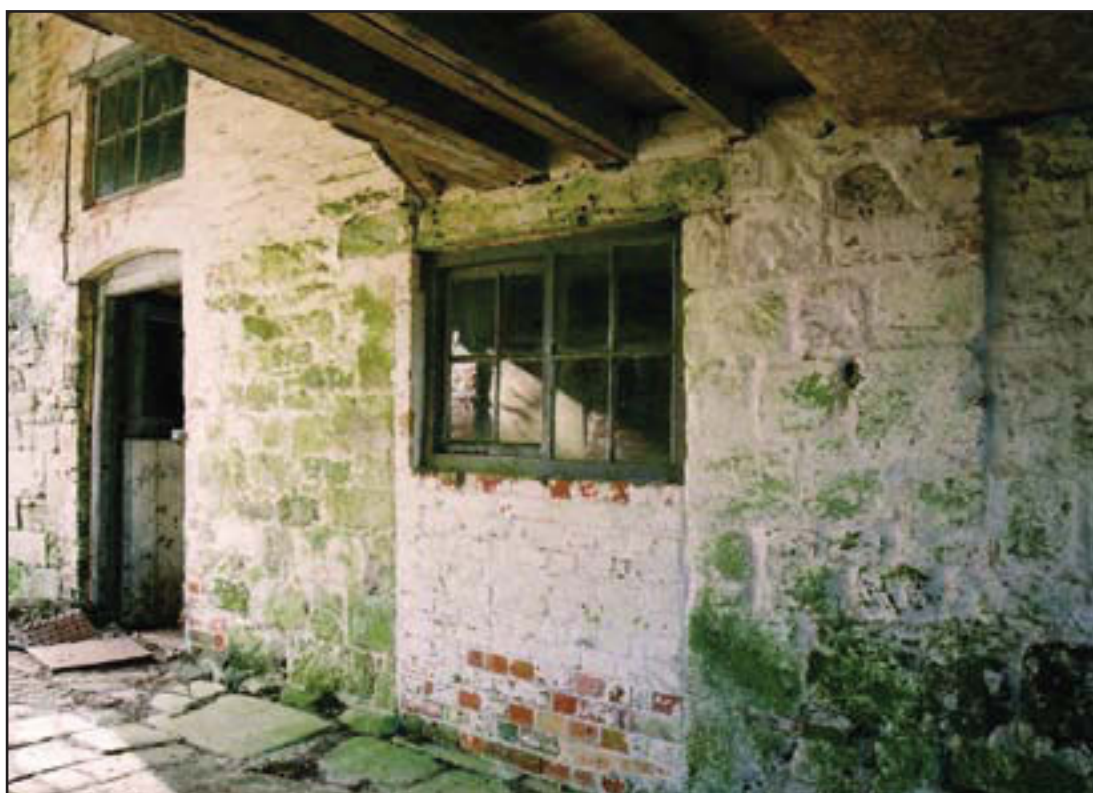
**Figure 1.**

*The east wall of the original mill, viewed from the north east. This shows the blocked main doorway with inserted window and the present doorway, probably in place of a former window (to left). [OP04323]*

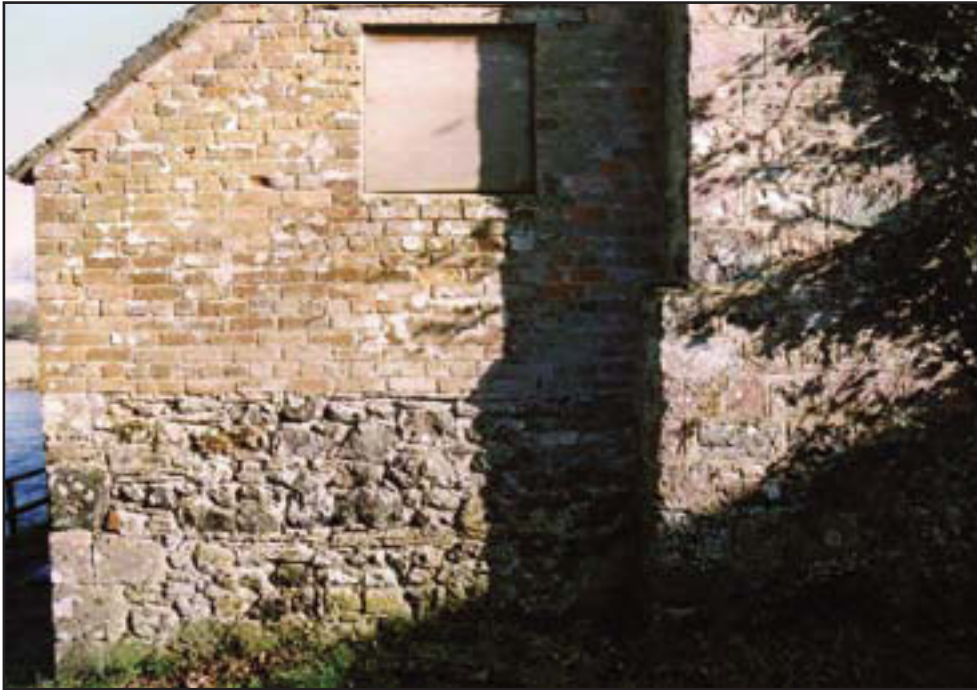
**Figure 2.**

On the northern wall of the mill, there is a horizontal set-back of about 0.15 metres, the purpose of which is not clear. This is particularly noticeable on the western elevation, because the later northern outshot is itself set back by 0.32 metres from the wall of the main range. At this time the mill still appears to have been a simple elongated, rectangular, north-south building, this phase dictating the general form of the building, with its half-hipped northern end. The local Purbeck slates, which survive only in the lower courses, would have covered the whole roof originally.

*North-west corner of mill from the west, with northern outshot to left. This shows the horizontal set back in the north wall of the main mill building. [OP04324]*

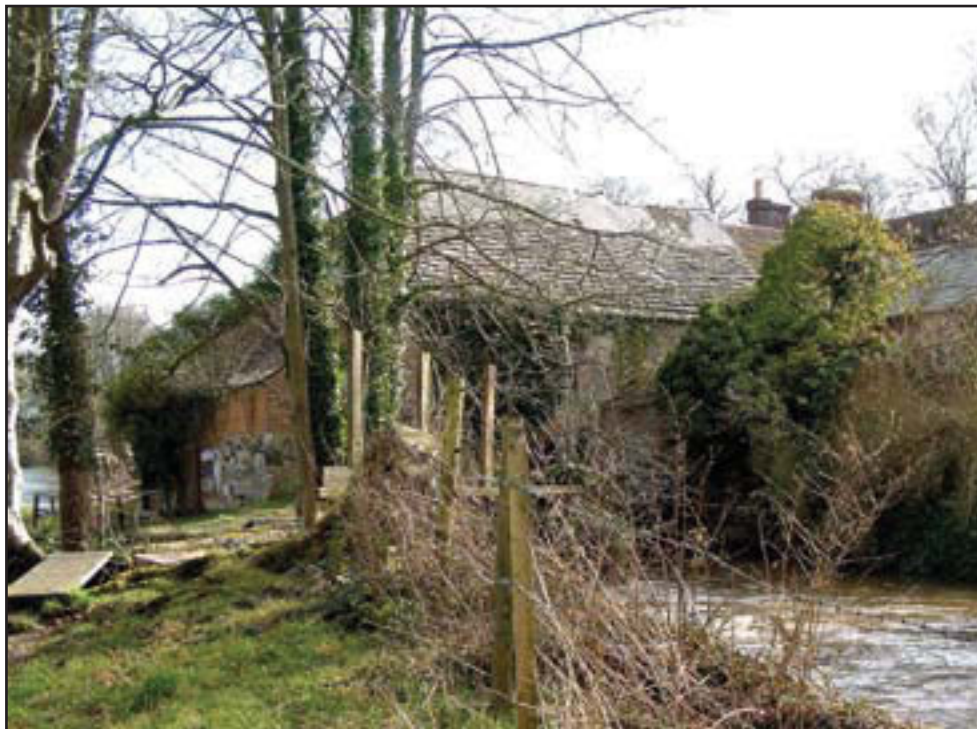
**Figure 3.**

*The mill seen from the north west, showing Purbeck slates on the lower part of the roof. [DP021001]*

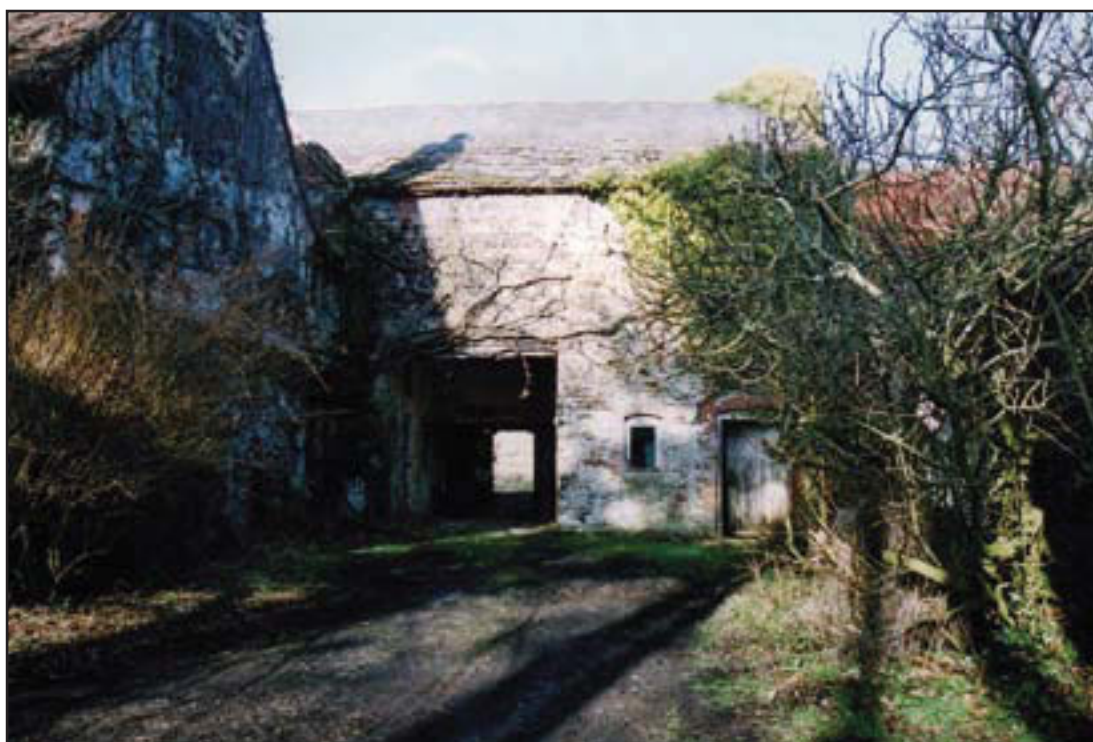
**Figure 4.**

*General view of mill and house from south, showing the eastern range of the mill (centre), the covered wagonway, and the east gable-end of the house (left). [OP04325]*

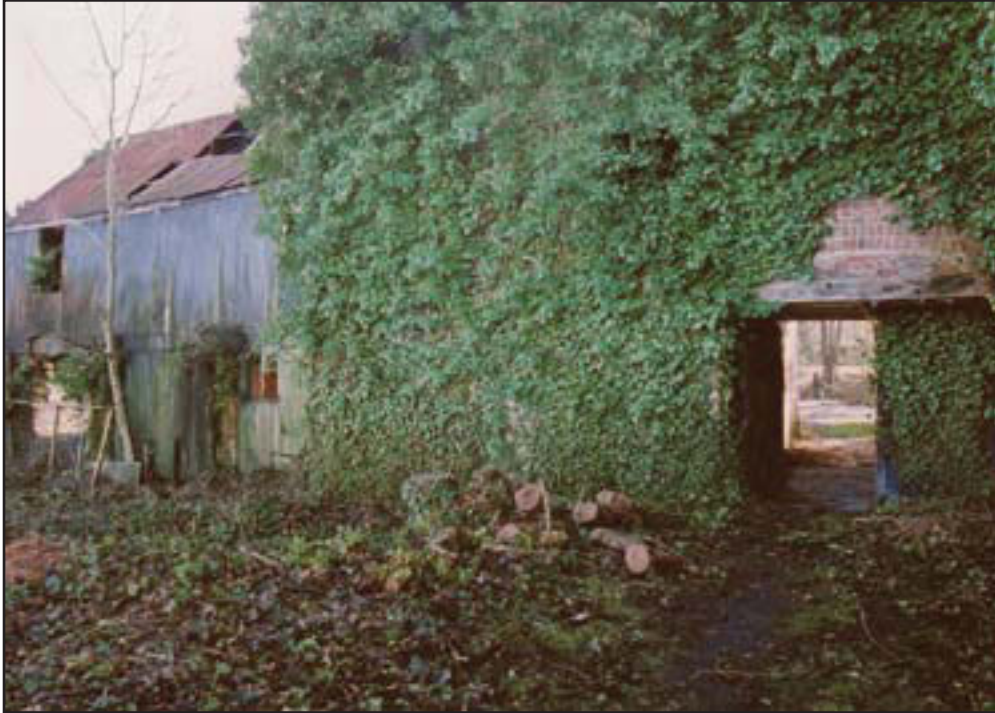
**Figure 5.**

*The east range of the mill (centre and right) from the north west, showing the phase-4 brickwork, the northern end of the wagonway and the extent of the vegetation cover. [OP04326]*

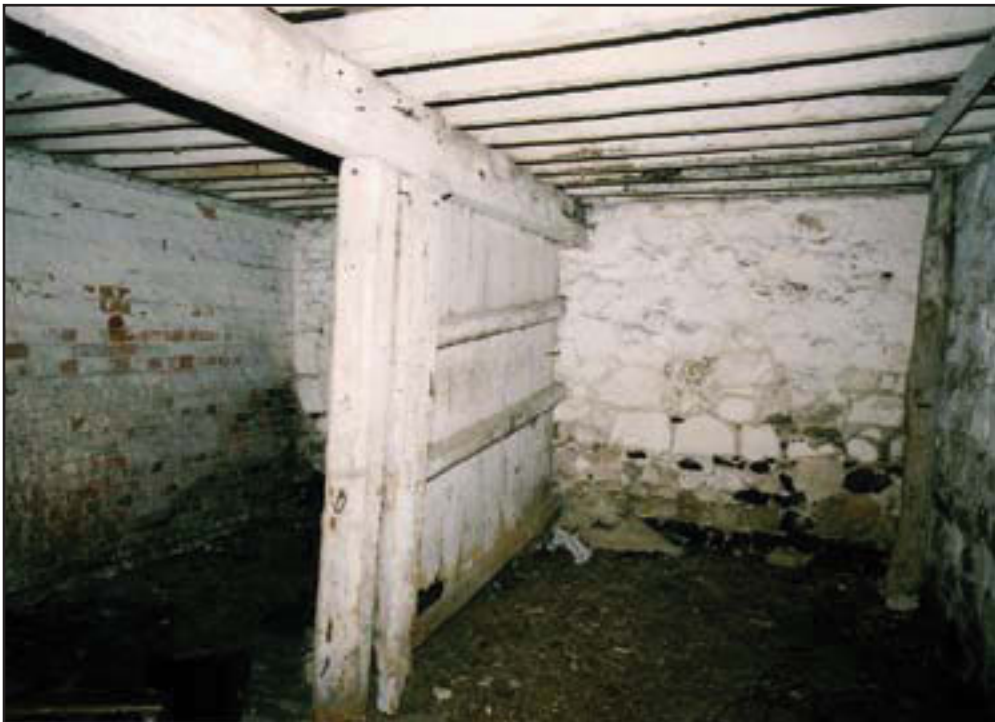
**Figure 6.**

*Stalls for horses in the east range of the mill, viewed from the south east. This shows the use of chalk blocks on the internal faces of the north and east walls. [OP04327]*

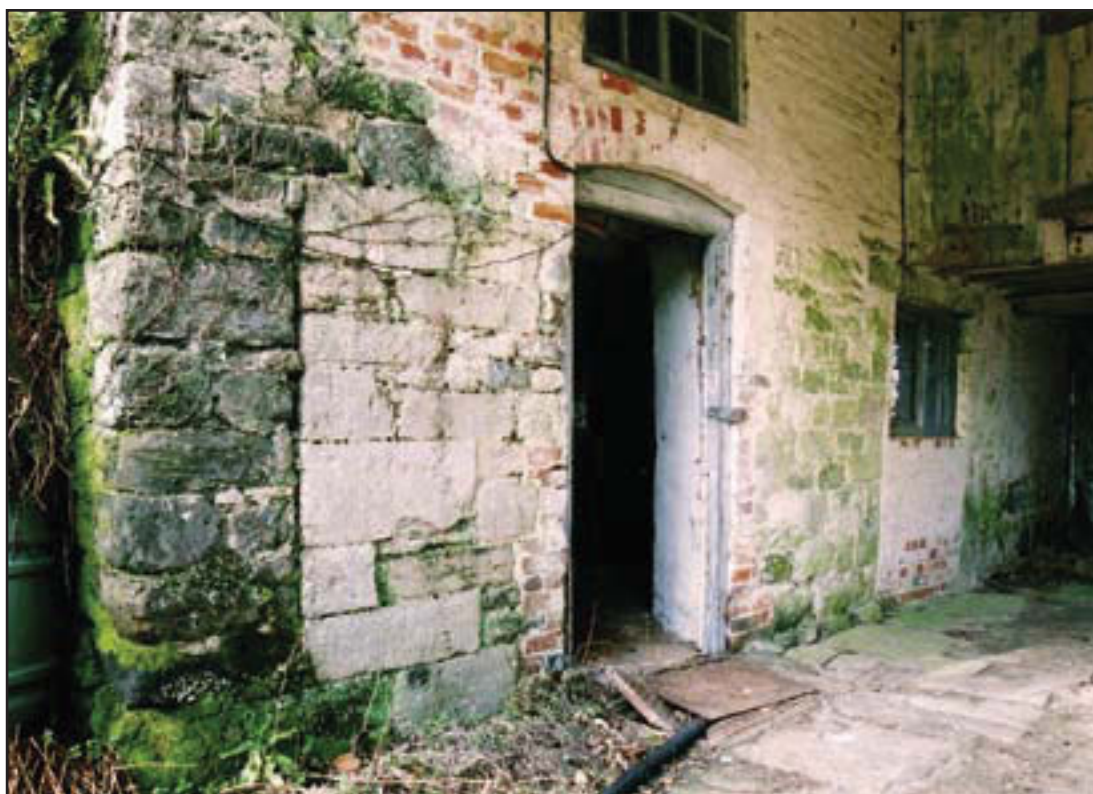
**Figure 7.**

*The east wall of the original mill, viewed from the south east. This shows the original south-east corner, of ashlar, with later stonework, to the left, added during the eastward extension of the mill. The brickwork above is part of the 1890s rebuilding. [OP04328]*

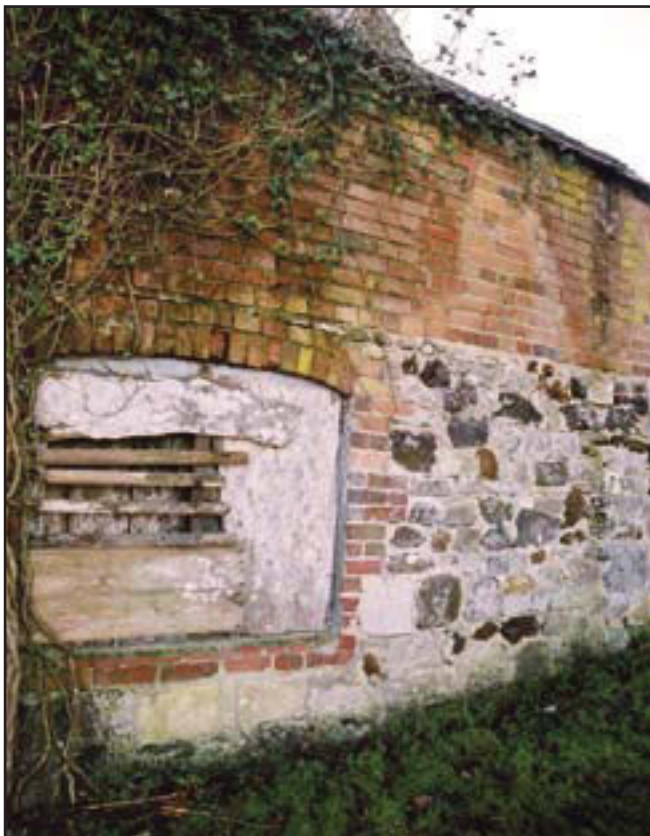
**Figure 8.**

*The north wall of north extension to the mill, from north east, showing the two phases of construction and the iron-stone and re-used ashlar masonry. [OP04329]*

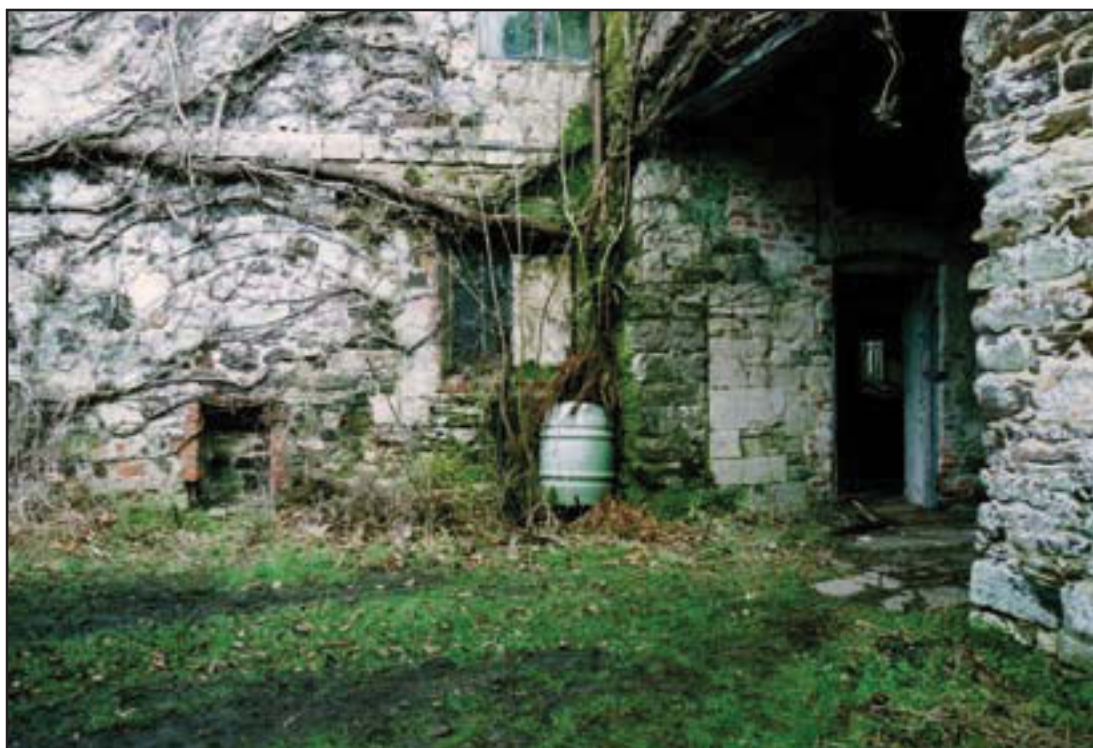
**Figure 12.**

*The east gable-wall of the house and the south end of the wagonway, viewed from the south east. This shows the re-set stonework of the arch, and the chamfered stone course positioned at the set back. [OP04332]*

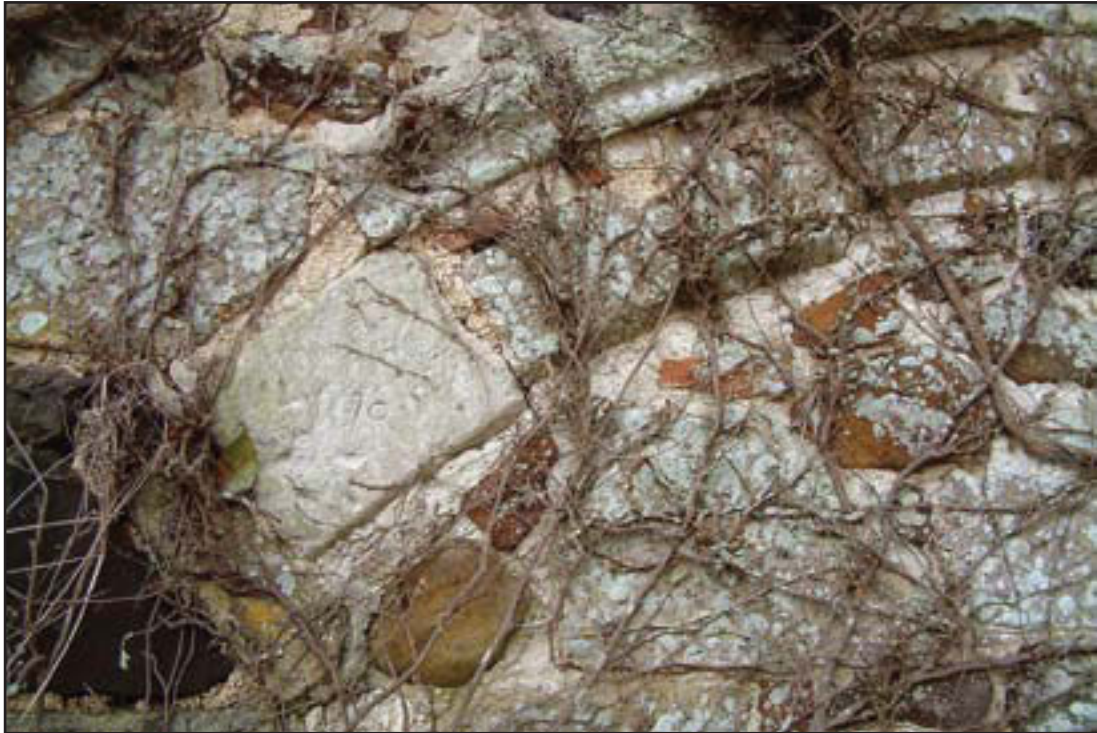
**Figure 13.**

*Detail of stone arch on east wall of house, showing stone inscribed with the date 1770. [DP021005]*

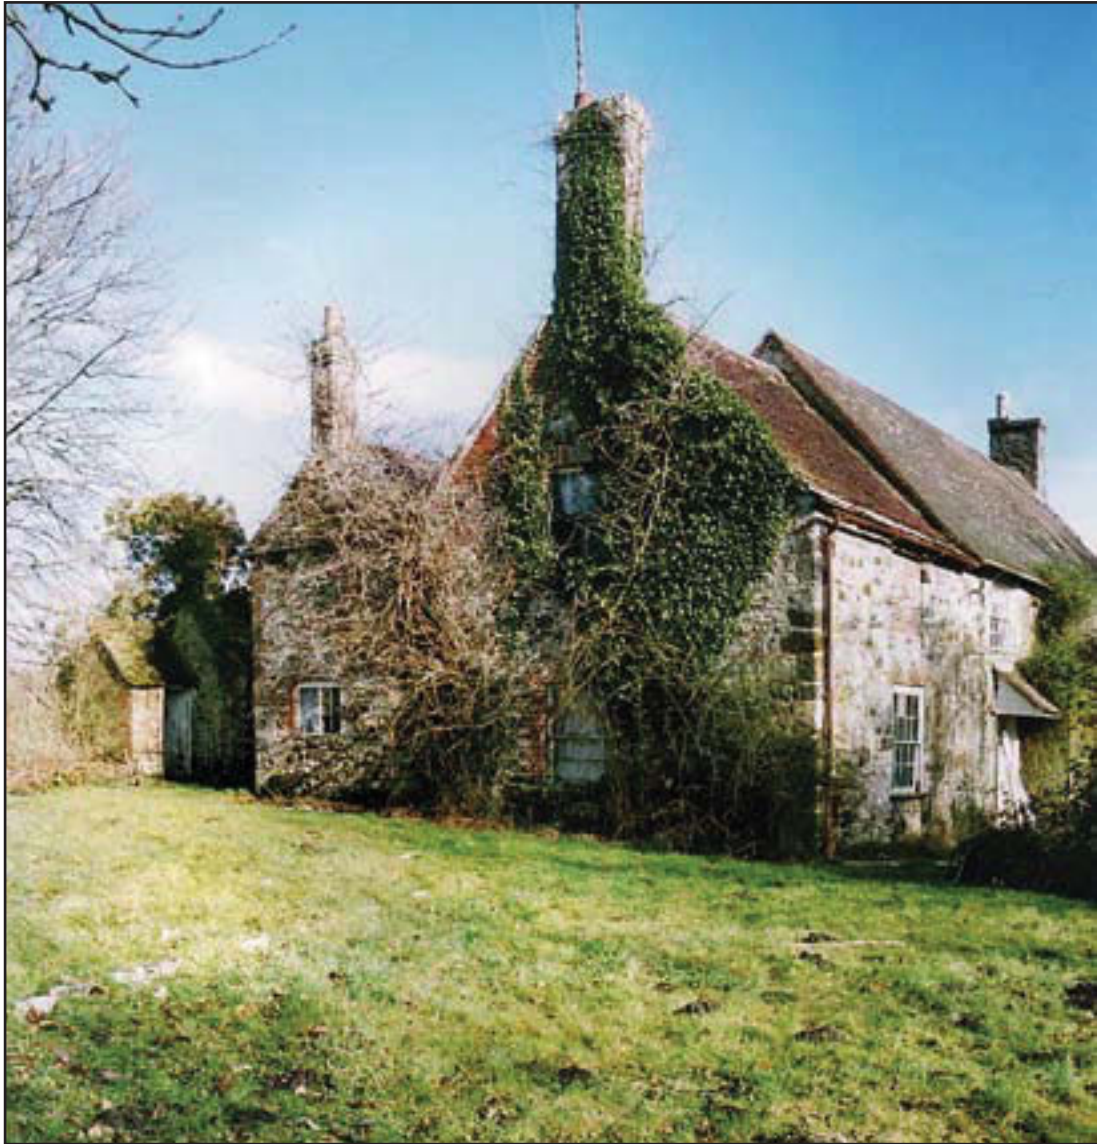
**Figure 14.**

*The house viewed from the south west, showing the three main phases of the house, with the washhouse and privy to the left. [OP04333]*

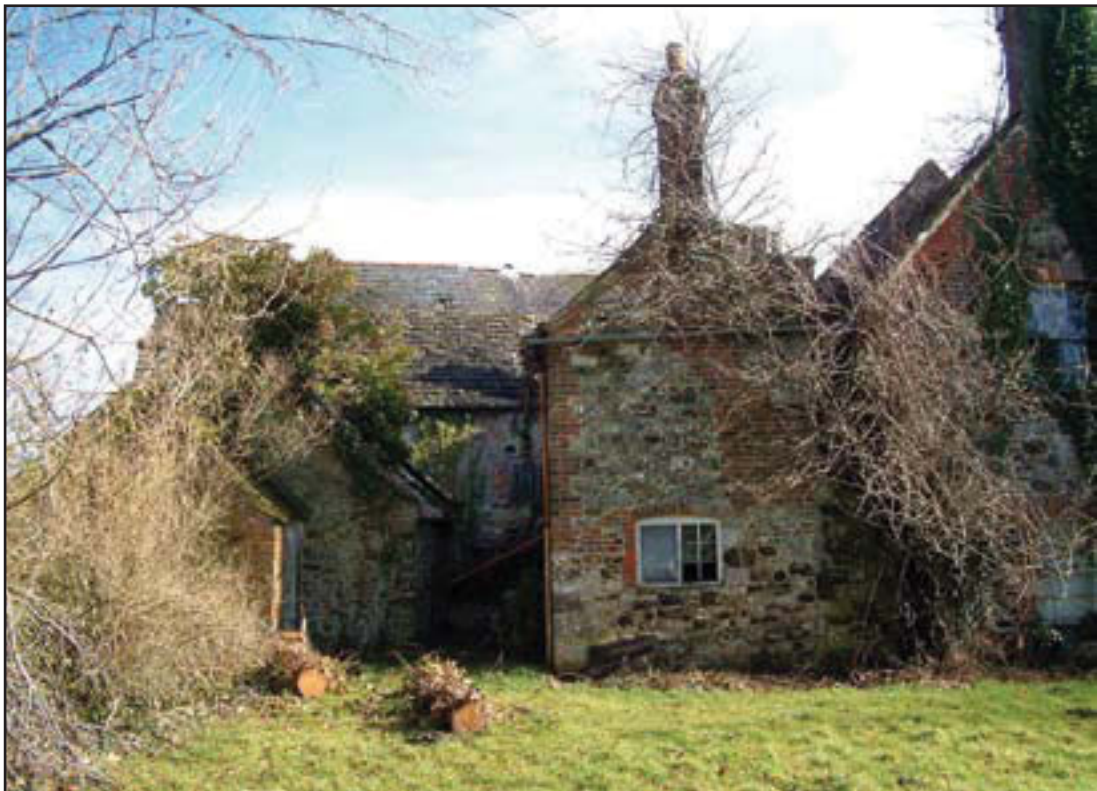
**Figure 15.**

*The house and outbuildings viewed from the west. The change of phase in the rear range (centre) is visible to the left of the window. [DP021004]*

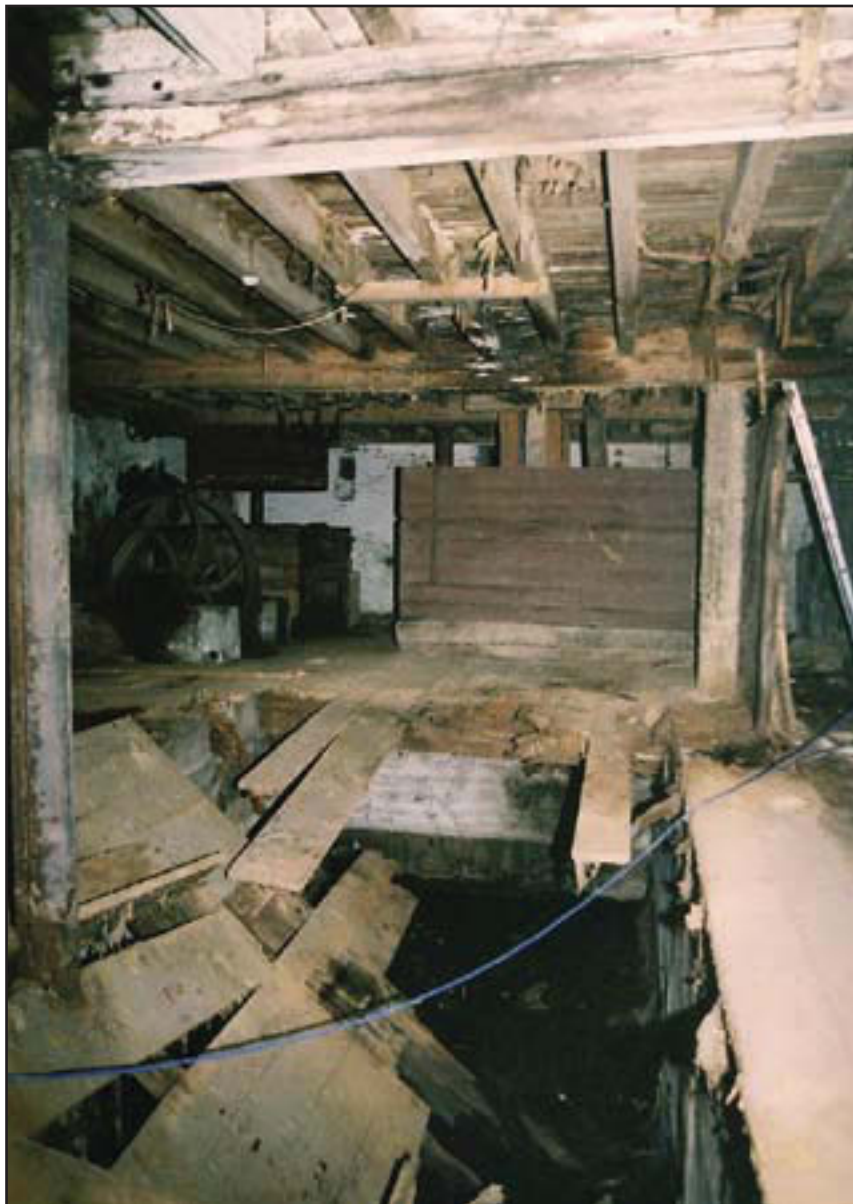
**Figure 18.**

*Interior, ground floor of mill, viewed from the south, showing the concrete-lined pit in the foreground, with the later, cast-iron column, and the drives from the turbine in the far (north west) corner. [OP04335]*

insertion into the remodelled building, probably carried out in the 20th century to deal with bulk transport. A double-length cast-iron column supporting the first floor has had to be added, with the lower part within the pit. That this is not contemporaneous with the other columns is suggested by a different pattern to the moulding on the capital, and the absence of Joseph Armfield's name. That it has replaced a previous, shorter column is indicated by the chamfers with run-out stops which respect its position on the main transverse beam it supports. This beam, in contrast to the others seen in the mill, is of oak with chamfers, suggesting it may be a survivor from the phase-2 mill, but, if this is so, its cross-section is small in proportion to its span.

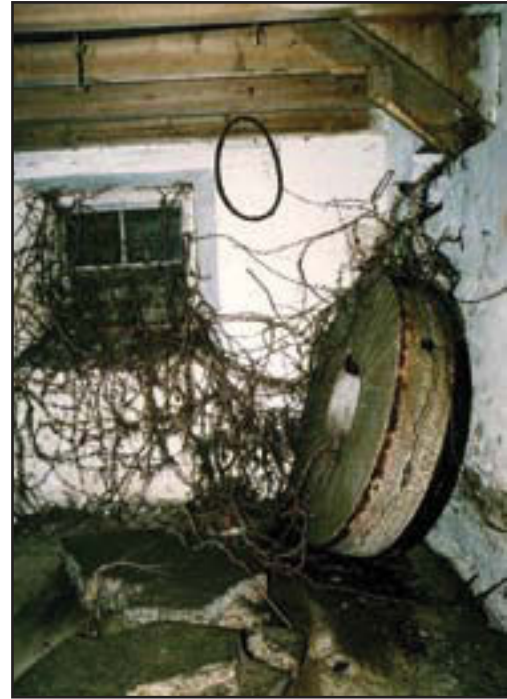
**Figure 21.**  
*Interior, first floor of mill from east south east, showing composition runner-stone with fragments of another lying on the floor. [OP04338]*

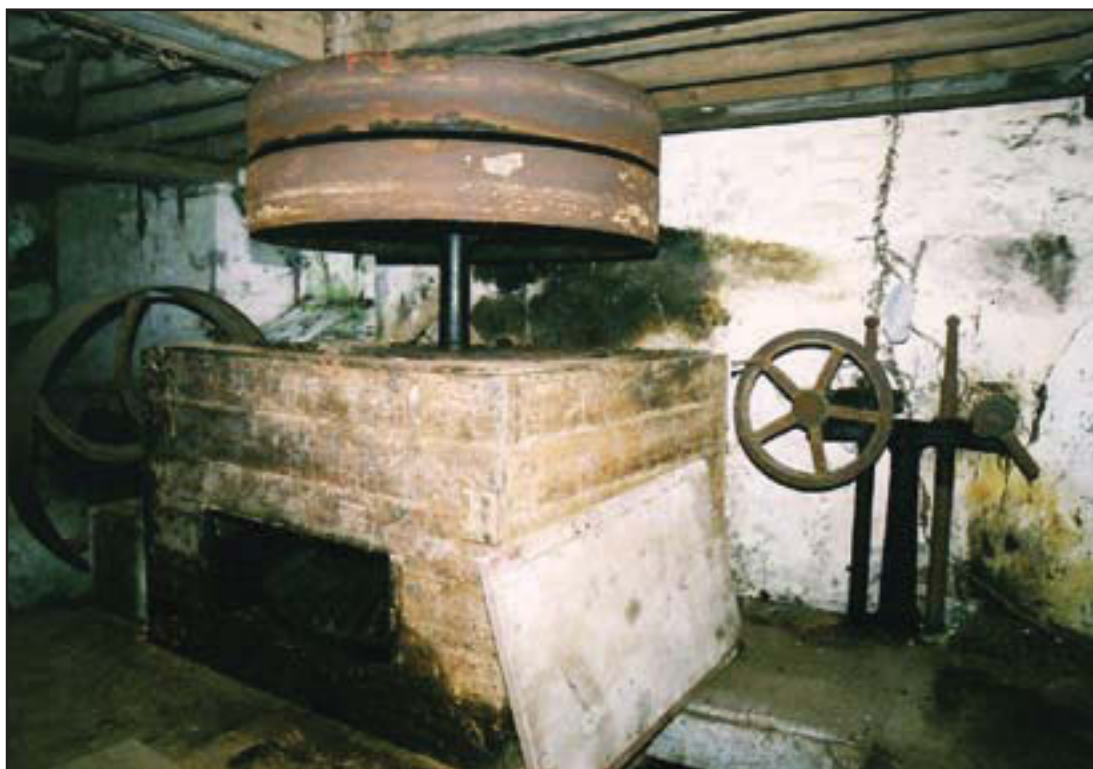
**Figure 24.**

*Interior, ground floor of mill, viewed from the north east, showing drives from turbine, belt wheels for millstones (top) belt-wheel for roller-mills (left) and control gear for turbine (right). [OP04341]*

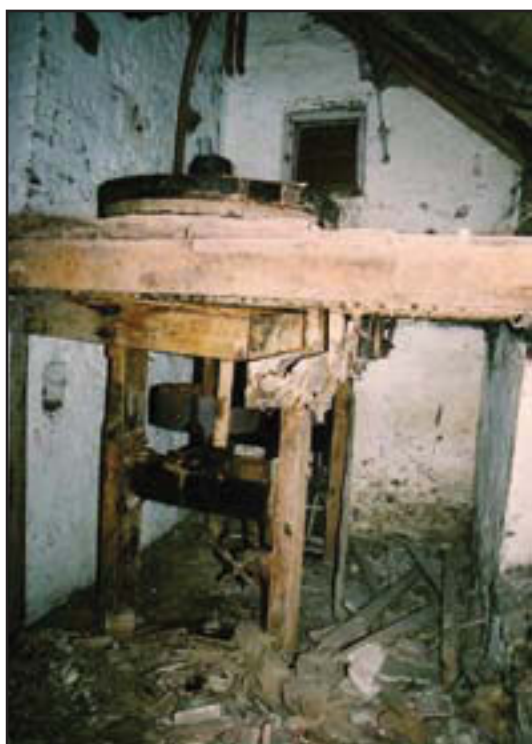
**Figure 25.**

*Interior, ground floor of northern extension of mill, viewed from the north east. This shows the wooden hurst-frame with millstones above. The belt-wheel on the stone-spindle was formerly driven by a belt passing through the hole in the wall to the left. [OP04342]*

functional construction and not of outstanding quality. Of the millstones it supports, the eastern one is badly cracked and the one to the west is in a dangerously unstable condition. The stone crane is a good example of a piece of equipment which has been lost from many mills. The turbine is of a standard type by a prolific maker, and is thus not of exceptional interest in itself. A great number were installed in low-head situations such as this, particularly in Hampshire and Dorset, and it is estimated that perhaps as many as 20 turbines still exist in this county. It is worth pointing out, however, that the turbine would be capable of being repaired to working condition, and could prove a considerable economic asset for whatever future the building is given. As regards the remainder of the extended mill building, it is not exceptional, either architecturally or mechanically. Of the working parts, nothing seems to have survived the remodelling of 1893, and therefore these, too, are of limited significance. Bindon Mill and Mill House is, however, an important element in the local landscape, particularly with regard to its relationship with the rest of the abbey complex.

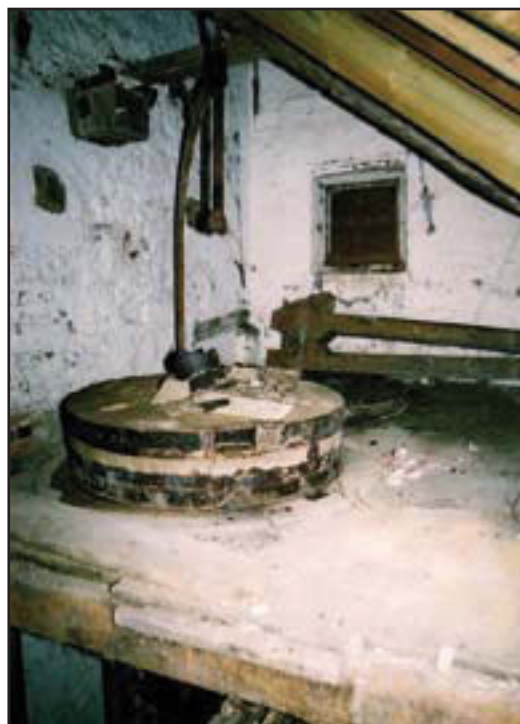
**Figure 26.**

*Interior, first floor of northern extension of mill, viewed from the north east. Shows the two pairs of composite millstones and the stone-crane. The casing of an elevator lies against the far wall. [OP04343]*

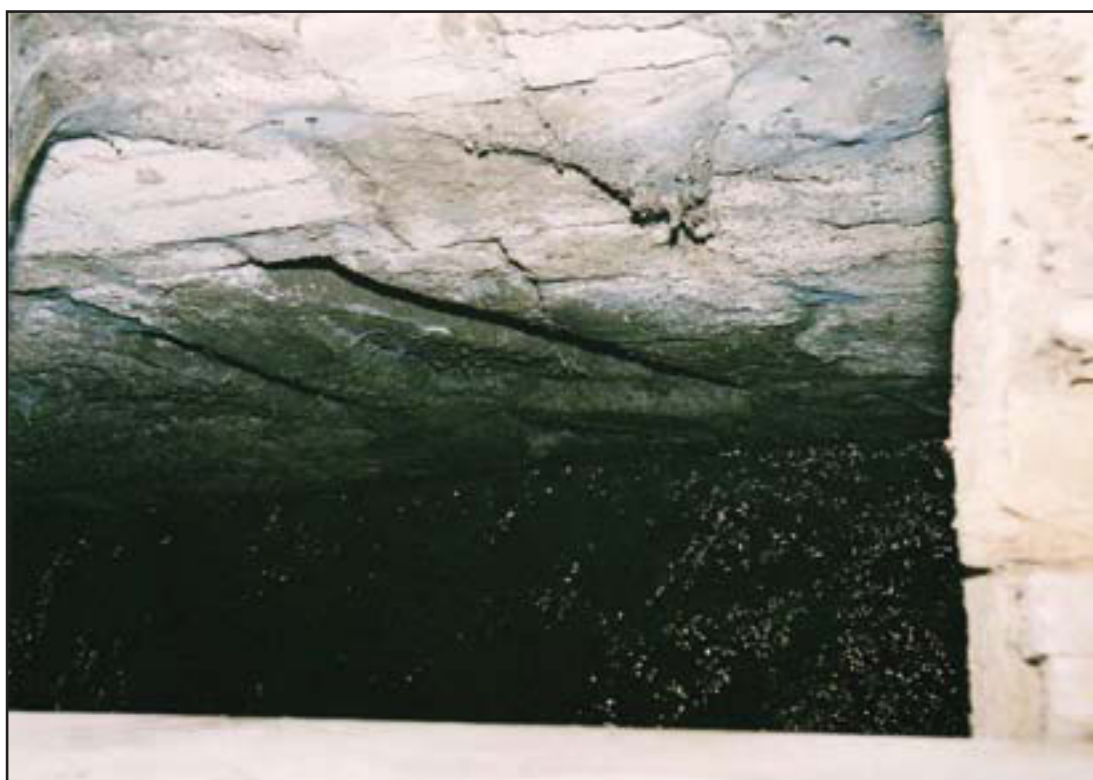
**Figure 27.**

*Interior, ground floor of mill. North wall of wheel-race, from south east, showing two inclined rebates in wall defining two generations of penstock, which controlled water supply to the former waterwheel. [OP04344]*

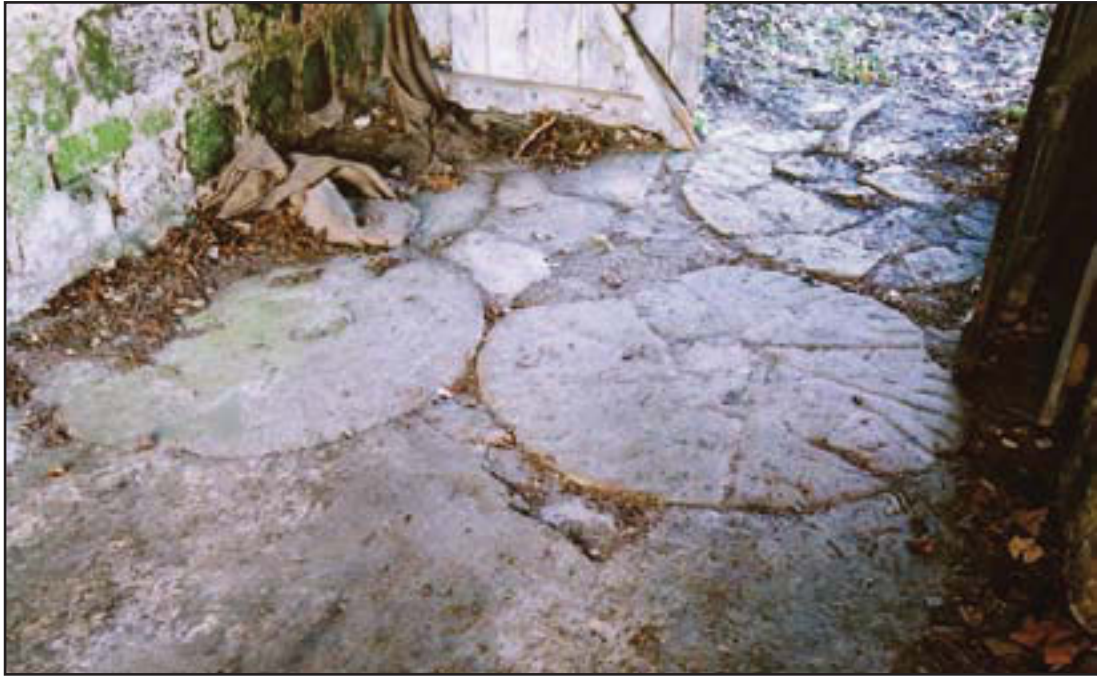
**Figure 28.**

*Abandoned millstones set in the floor at the north end of the covered wagonway. Viewed from the south east. The two nearer examples are Peak stones and the third is a French burr. [OP04345]*
