St Paul's Cathedral: archaeological recording of installation of new lift and external cleaning, 2006–11

Sitecode: PUF06

**John Schofield
Cathedral Archaeologist**

August 2011

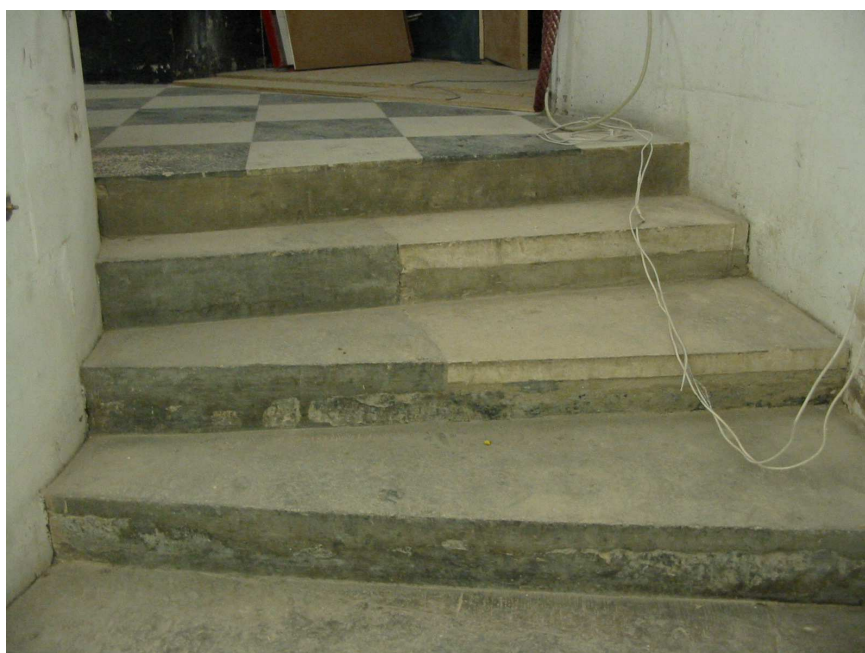
The landing between the two flights of steps, at church floor level, was work of the 1970s when the lift was put in. This was removed, along with the floor of the adjacent passage to church floor level, for a distance of about 1m northwards into the passage (the intentions shown in Fig 5). The first two steps leading down to crypt level (marked -1 and -2 on the plan, Fig 5) were also removed. These also contained recent repairs (Fig 7).

Fig 7 The steps leading down from church floor level, showing the recent patchings of the upper treads (steps -1 and -2), and the landing which along with the uppermost two treads was removed as part of the works; looking west

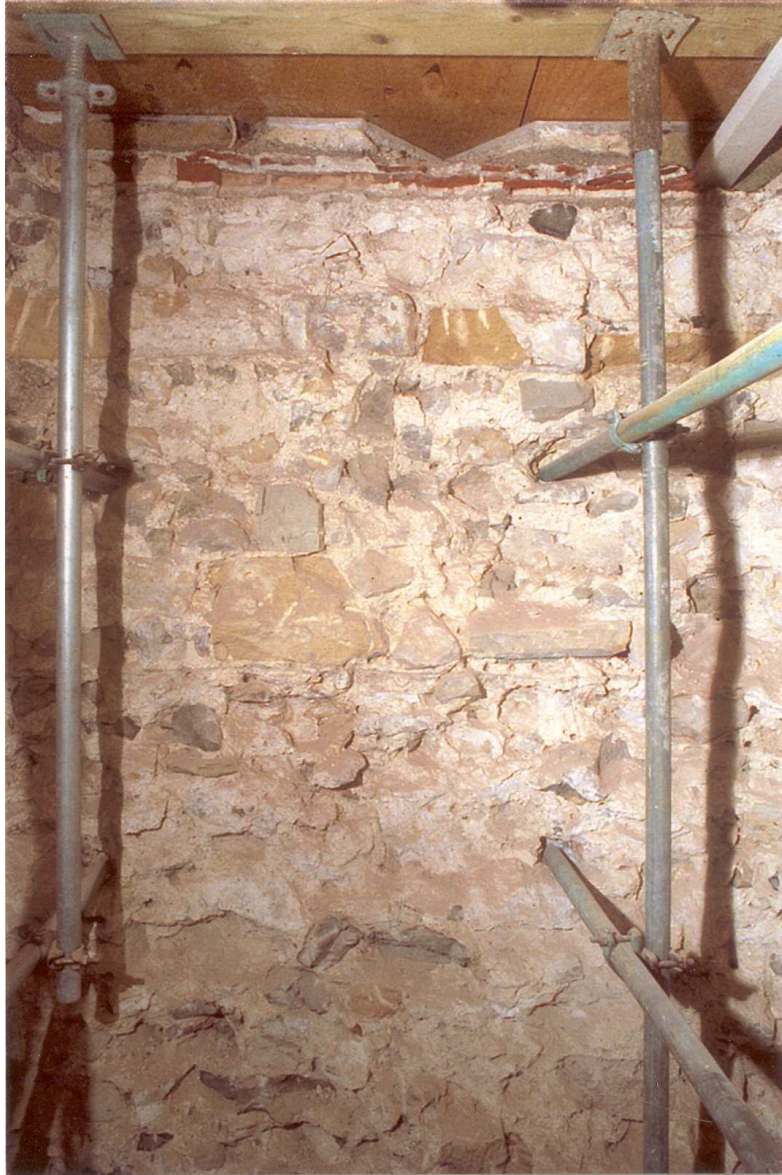
The removal of the landing and excavation of the core of the south wall of the nave beneath the passage into the church floor revealed the courses of the core itself. The north elevation of exposed masonry, the limit of excavation beneath the passage, is called Section 1, and is shown in photographs Fig 9 and Fig 10. The masonry exposed (in effect an east–west cut through the middle of the Wren nave wall, at church floor level and below) was just over 3m in height and about 1.8m wide from west to east. At the top of the section were the edges of marble tiles of that part of the passage which was to remain; beneath them was a layer of either flat roof tiles or perhaps thin floor tiles, with occasional pieces of thin brick, in a pink mortar with charcoal flecks. The core of the wall below was of rubble of several kinds of stone with occasional brick (Reigate stone; Caen, flint) in rough courses, in a similar pink mortar with charcoal flecks. 330mm below the tiles was an

identifiable course of squared stones within the foundation; no special structural purpose is attached to these, and they may only have been a course within the foundation. They did not appear in the north or south sides of the excavated area (see Fig 11).

Fig 9 Section 1, cut through the masonry below the passage at church floor level, looking north (for explanation see Fig 10) (MoLAS neg 12407002)

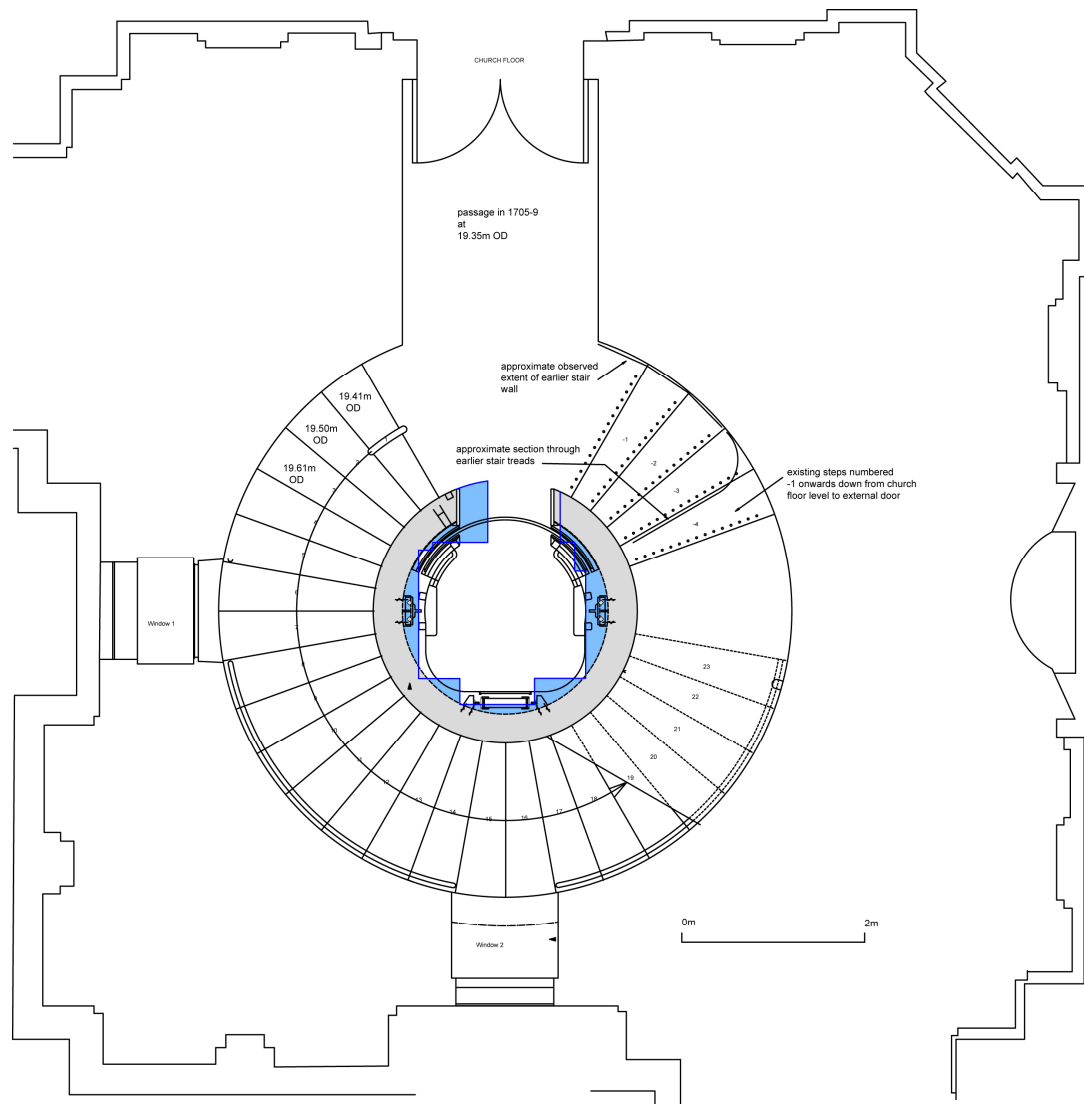
Fig 16 Plan of the stair at church floor level, showing the lines of the ashlar wall found below, and the approximate line of the observed section through the first-phase stair (adapted from PMT drawing SP170 5168)

There is clearly a slight ‘error’ in that the first step after the landing, now, is only 60mm (6cm) high. But it seems to be original, and so is the height of the passage at 19.35m OD, which is at the same level as the church floor. The levels of the first three steps after the present landing are shown on Fig 16.

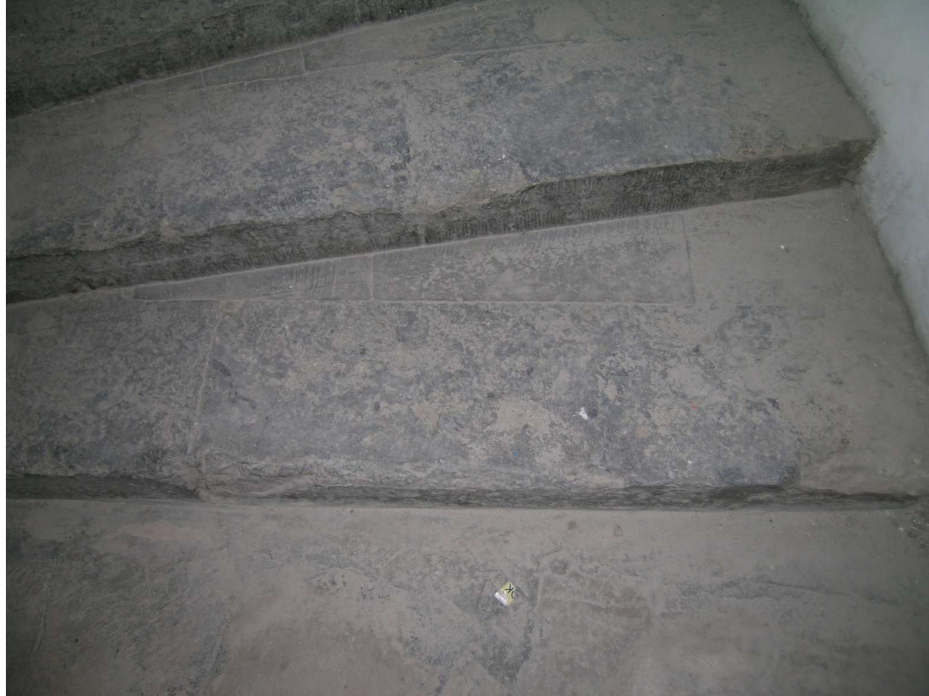
The steps leading down from church floor level to the external door were much decayed and some renewal was proposed. After investigation and discussion, the solution in late 2007 was to replace some of the most decayed examples with pieces taken from near the top of the stair near the Whispering Gallery.

The existing state of steps, and their construction, is shown in Fig 17. Most steps seemed to be of the construction shown: probably wedge-shaped pieces at the rear, but a front edge of rectangular slabs, of varying lengths. They were not keyed into the outer wall; whether they keyed into the inner wall of the stair could not be identified.

Fig 17 The steps leading down from church floor level to churchyard level, showing their condition and how the steps were constructed, before works started

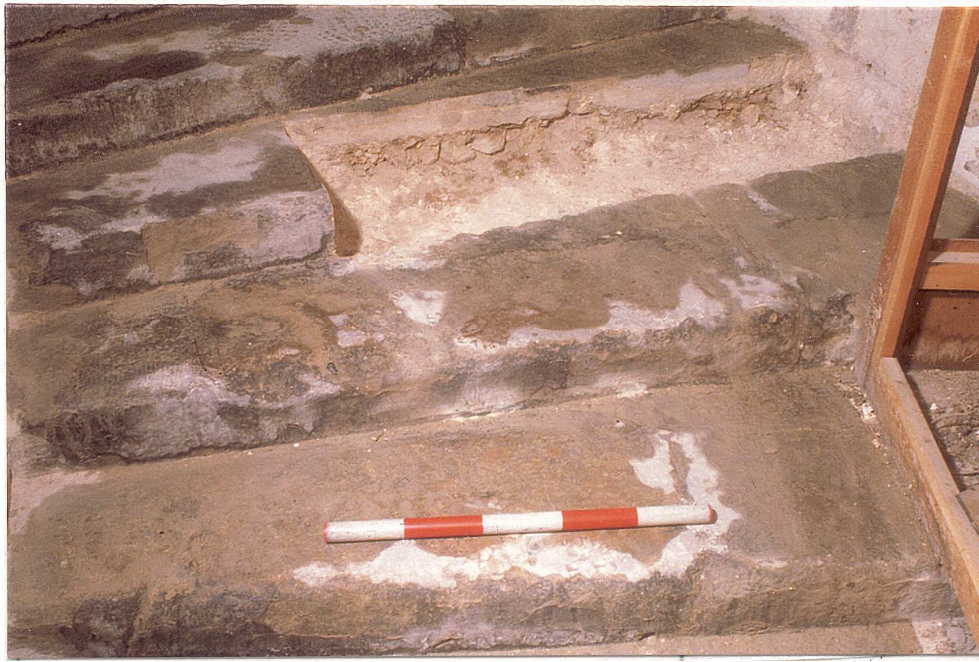
The British Geological Survey was engaged to sample one of the stair treads. The step which was sampled was fourth up from churchyard level, numbered ‘-18’ on the architect’s plan (i.e. 18 steps below church floor level). The sample was declared to be ‘pale greenish-grey, sandy, glauconitic limestone, i.e. Kentish ragstone (report for BGS by Dr Graham Lott, 28 November 2006). This stone was then also partly removed (Fig 18).

Fig 18 Tread 18 and the steps around it after half of the tread had been removed (0.5m scale) (MoLAS neg 00107005)

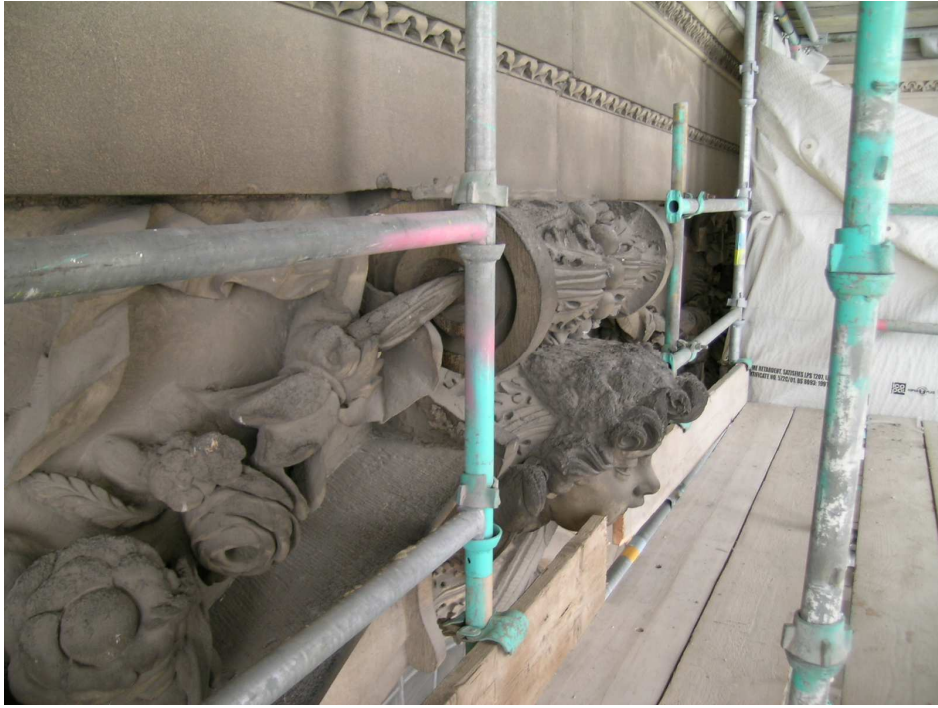
Fig 25 Decoration above window 3, looking east, before cleaning

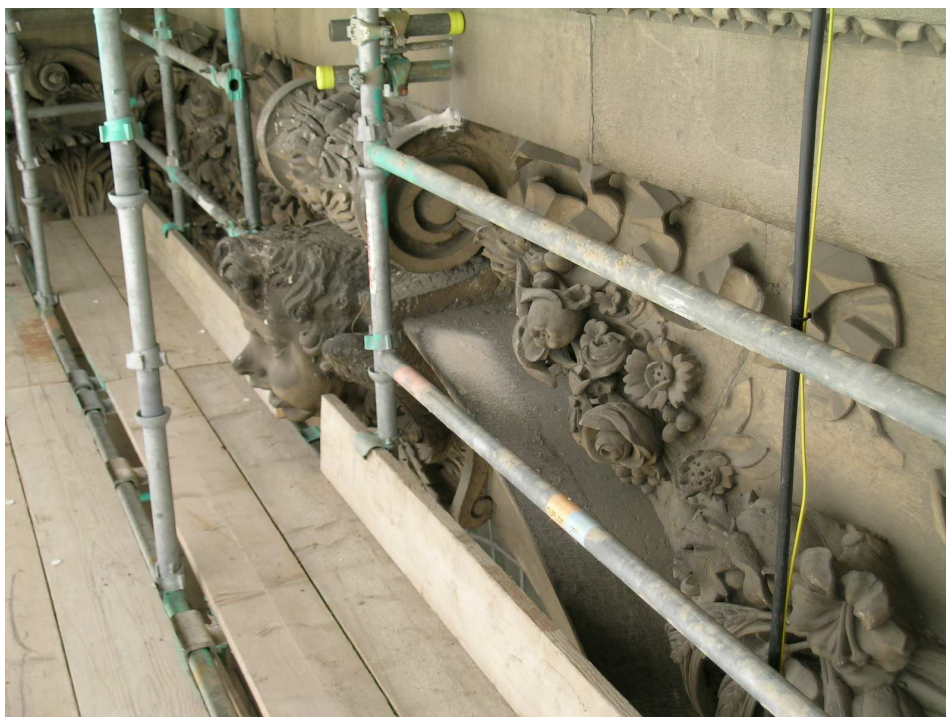
Fig 27 Decoration above window in bay SN1, looking west, before cleaning

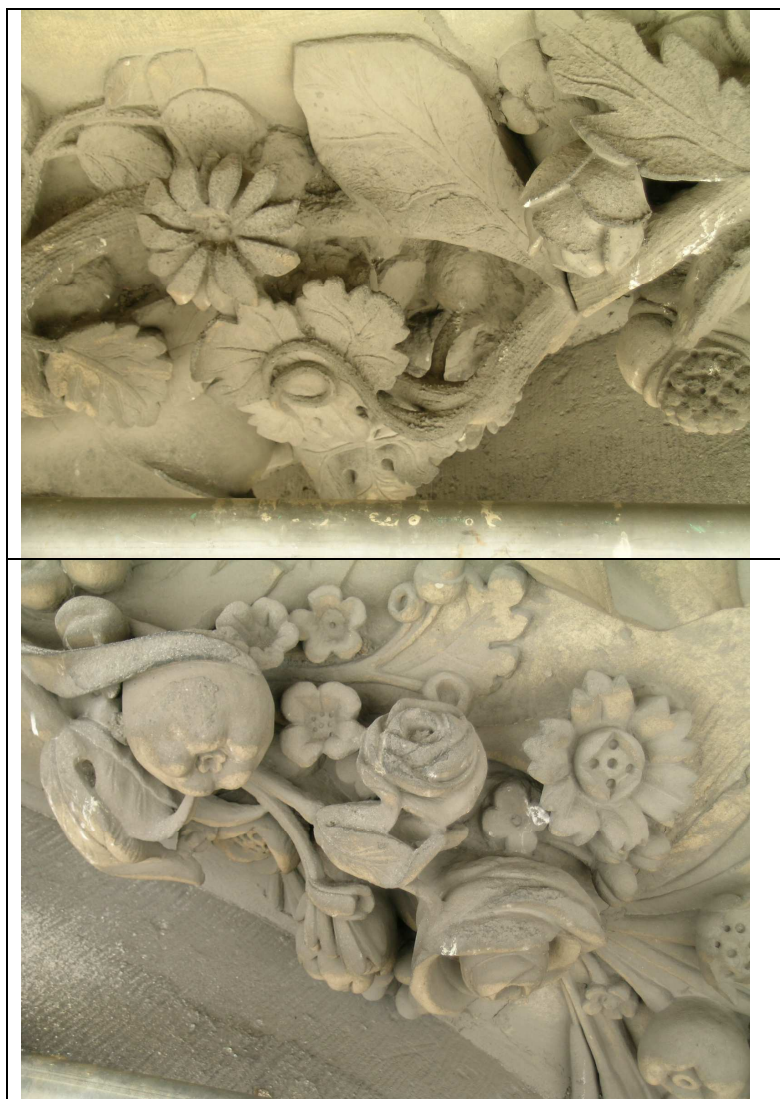
Fig 28 Details of the swags before cleaning, January 2007(JS photos)

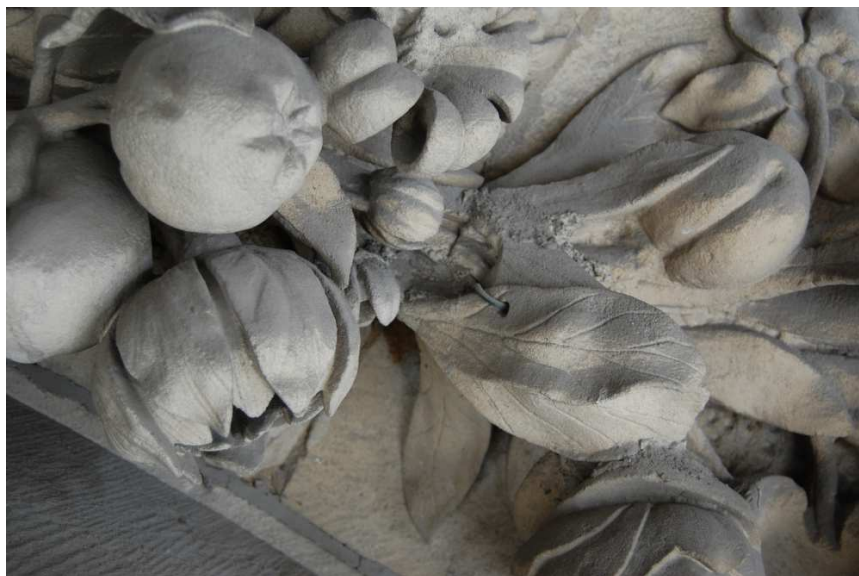
There are scattered instances of elements being held in with wires, which I think are later repairs (eg Fig 48). There is no evidence of any armatures, in the sense of metal rods originally placed within the flowers or vegetable forms.

Fig 48 An example of a wire ?repair to a leaf fragment, from one of the swags
