Report No.381/01

May 1995

Tamworth Castle, Staffordshire:
A Report on Watching Briefs of Drainage Works
on the Motte and Coach House

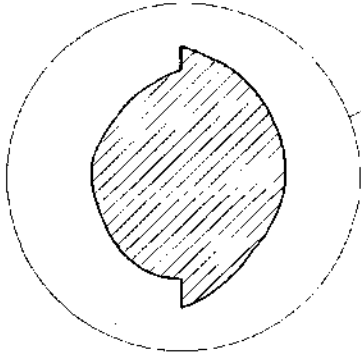
Cross-section of mullion 1:10

About 2.7m south of the Coach House there was a dog-leg in the drain line under the centre of the northernmost of two moulded stones set horizontally in the ground, presumably to act as a retaining wall to prevent the encroachment of the motte onto the brick-paviour yard in front of the Coach House. Closer inspection indicated that the two moulded stones were probably re-used window mullions just under 2m in length and 0.5m in width, with traces of whitewash surviving in patches on the inner face of the mullions (see inset sketch in Figure 1 and photographic Plates 1 and 2). Hill-wash had almost buried these features to such an extent that, prior to the excavation of the drain-run it was not possible to discern their original function. The two mullions were photographed, and sketches made of their cross-section and location. However, no further recording was carried out at this time because the two mullions were not affected by the groundworks for the drain. (A further record was subsequently compiled by the Staffordshire County Archaeology Officer, Mr R.Meeson).

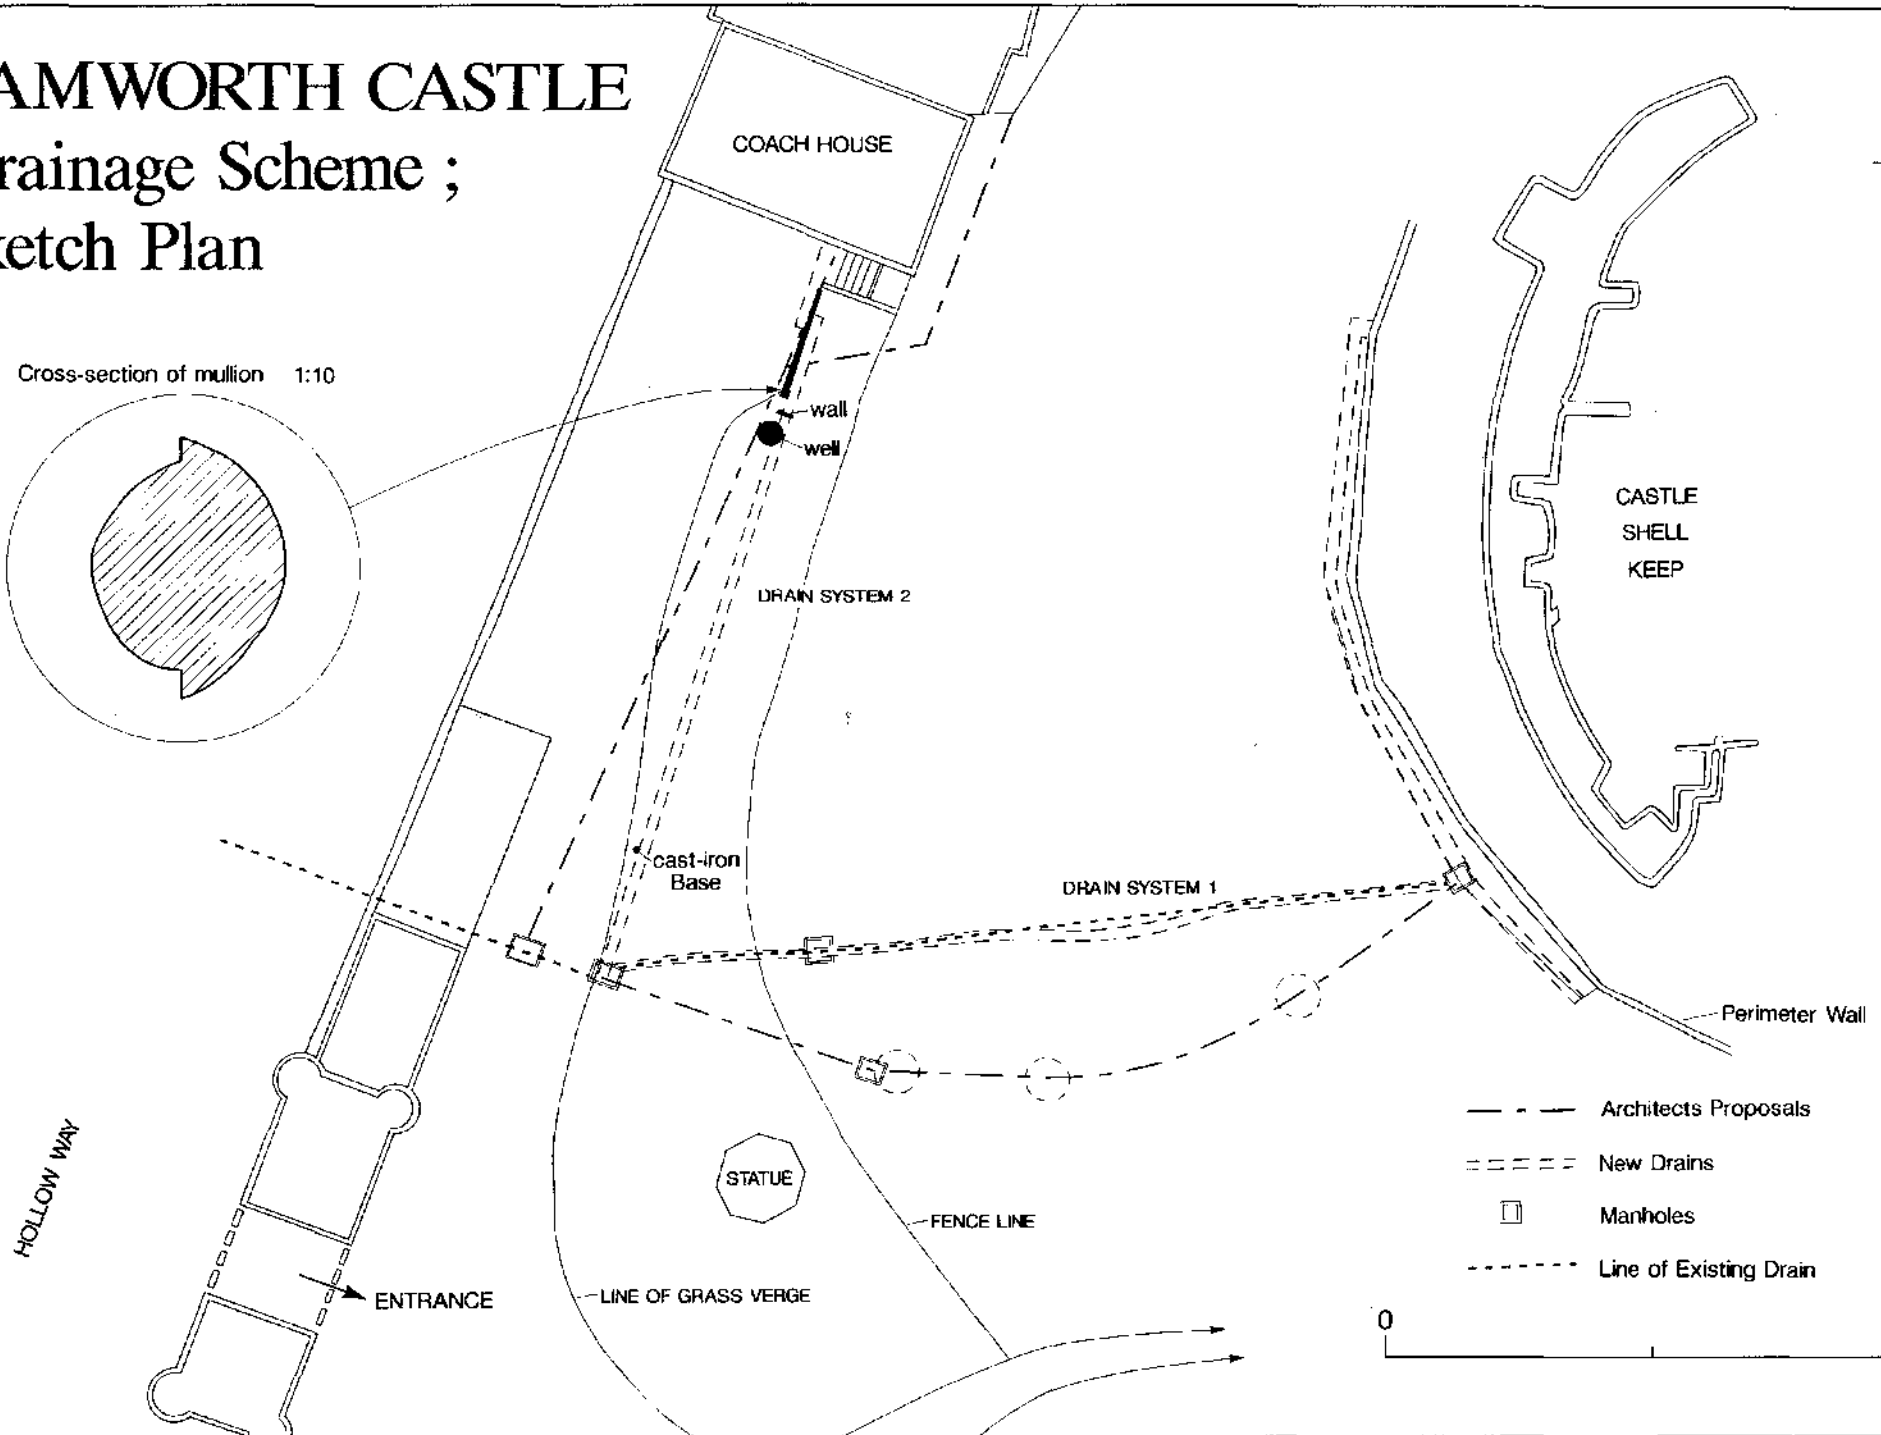
Drainage Scheme ; Sketch Plan

The drain system here consisted of a central main drain down the motte bank, and two feeds which ran along the perimeter wall of the castle into a collector manhole situated at the top of the main drain, adjacent to the outer castle wall. The main drain-fall was dug inside the pre-existing drain-cut wherever practical, to minimise disturbance to archaeological deposits. However, slight diversions were necessary in places where trees had grown over the old drain-line. These deviations are shown on Figure 1.
