LITTLE WESTON MOAT Shropshire

Monument Survey and Restoration 1989

LITTLE WESTON MOAT, CHIRBURY, SHROPSHIRE

Report on Survey and Restoration Works 1988-89

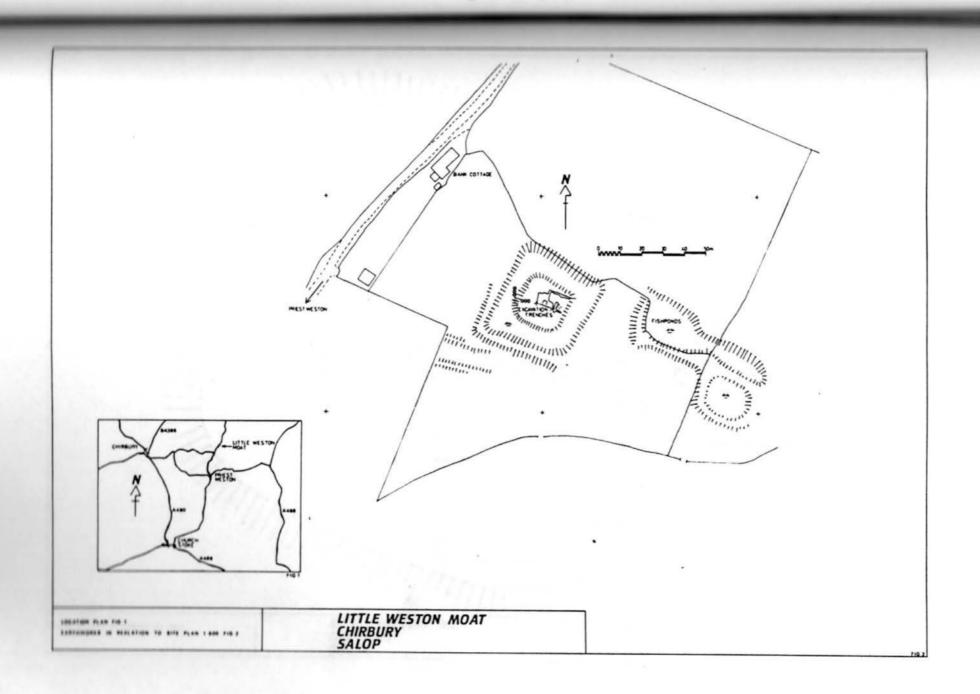
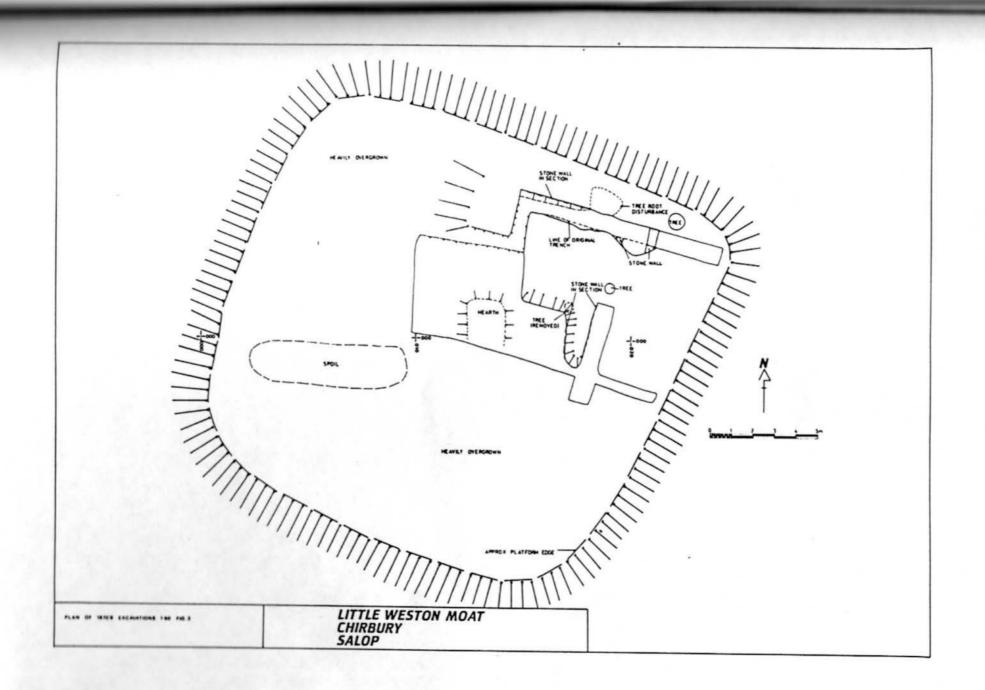
Little Weston Moat is situated 400 metres north-east of Little Weston, Chirbury, Salop. The moated site and adjacent related? earthworks are currently in a fairly good state of preservation (Figs. 1 and 2). The moat and platform area measure \underline{c} . 55 x 65 metres. The ditch (14 metres wide in places) is partly silted up and waterlogged for much of the year. The platform (\underline{c} . 20 x 20 metres) is heavily overgrown by scrub, which also extends over the north and east sectors of the moat.
