Robury Ring, Shropshire

An Archaeological Field Survey

Robury Ring, Near Wentnor, Shropshire (SAM.52)

Shropshire County SMR No. SA.456

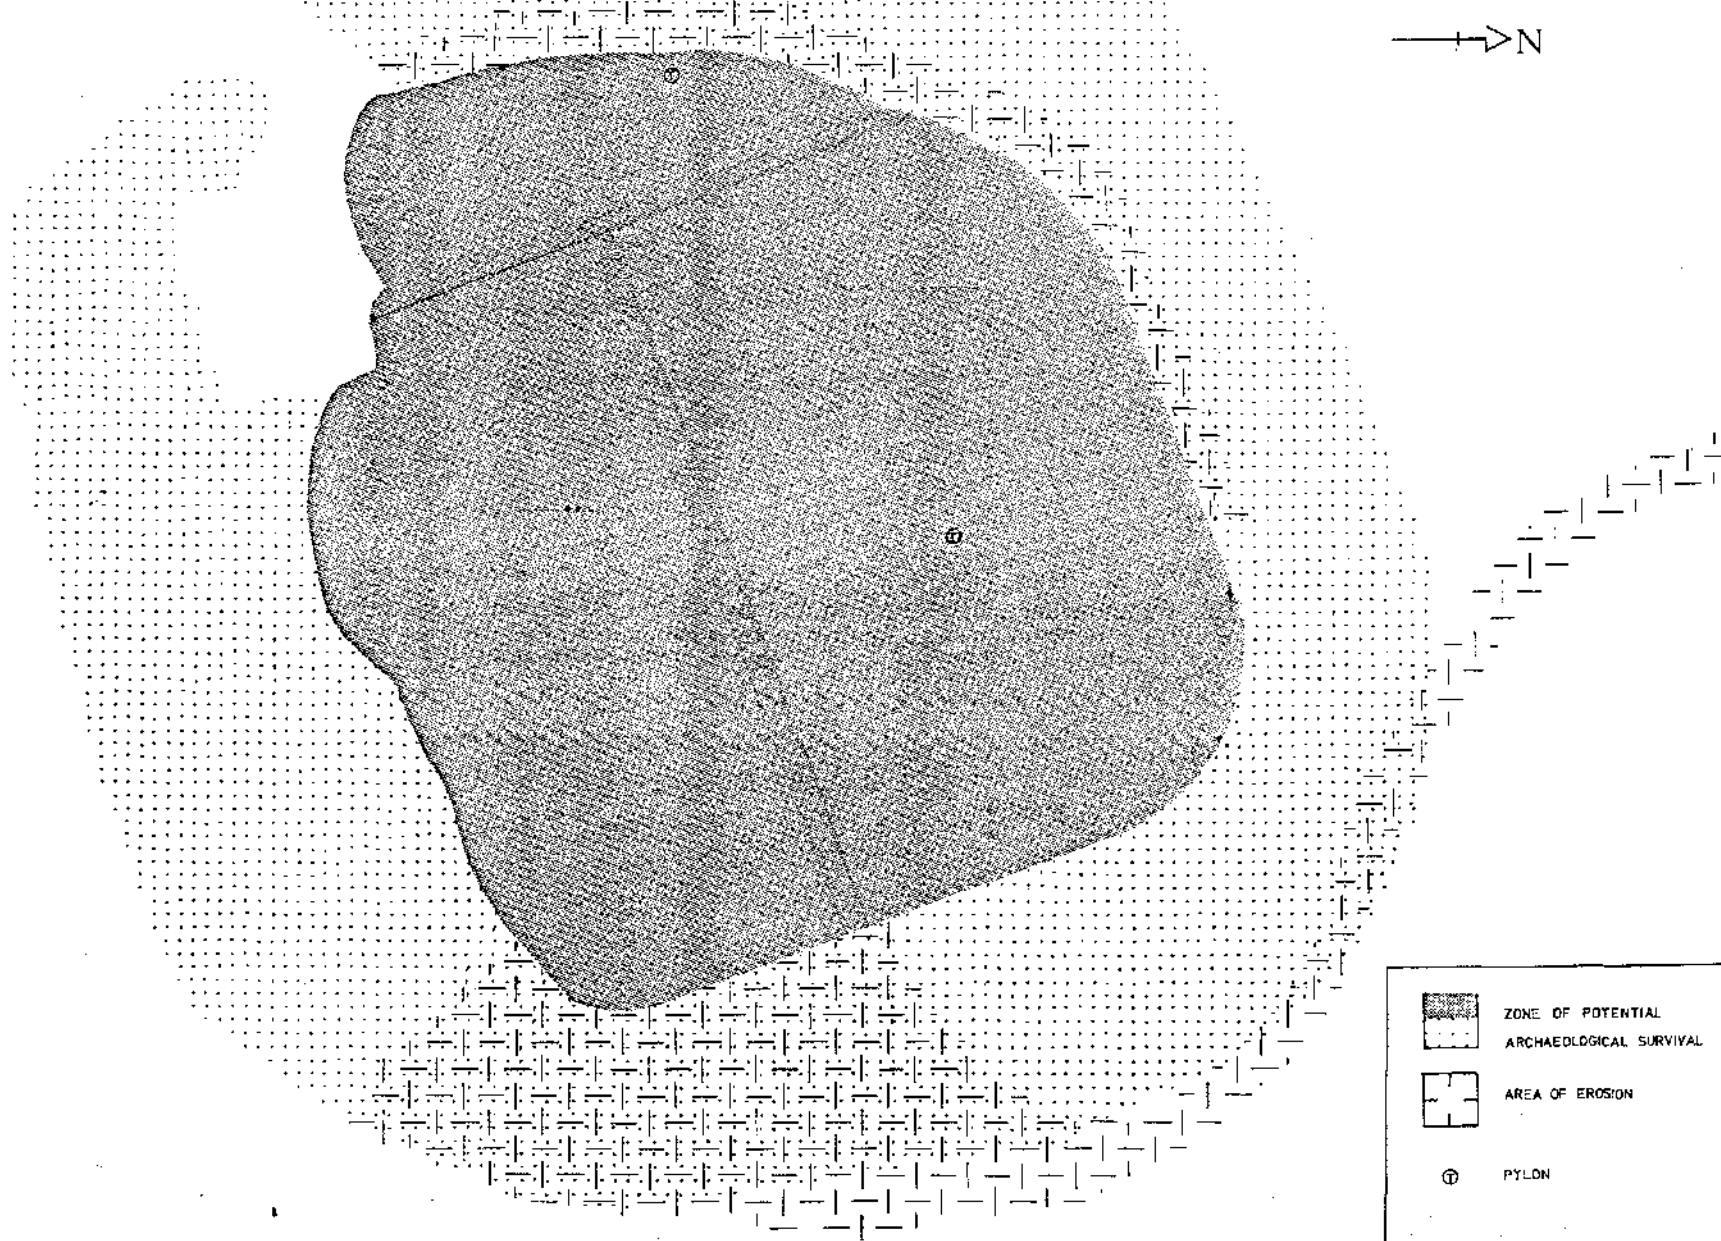
ROBURY RING

Robury Ring lies on Prolley Moor, which was enclosed about 1858. Since then, recent ploughing in alternate years has nearly obliterated the double ditch and outer bank. Intensive animal grazing and vehicle movements in recent years have also contributed to this destruction, particularly to the east. Currently, what appears to be the face of the original inner bank to the north-west, is being actively eroded by animals and the elements. Erosion in the interior of the original earthwork has been greatly reduced by the dumping of modern topsoil and rubble, prior to the construction of modern yards and farm buildings. However, the farmhouse, unlike the other farm buildings, appears to have been constructed by terracing into the inner rampart.

Without better knowledge of the potential for preservation of archaeological features and deposits within the enclosure it is difficult to assess the impact of the farm outbuildings and yard layouts upon that resource. Those most recently constructed (to the north and east) may have had the greatest effect, but elsewhere (particularly to the west) some levelling up of the interior may have given extra protection. In general, the ramparts have probably suffered the most damage through levelling, although the outer ditch (or ditches) may have survived buried, quite well. The access drive and farmhouse are likely to have caused the maximum destruction to the original monument. Two zones of preservation potential are depicted on the survey plan overlay; that within the inner rampart line distinguished from a zone covering the defensive perimeter, where preservation can at best be only partial.
