**Building Recording at  
Halesowen Abbey, 1989/90**

**Iain Ferris**

**Birmingham University Field Archaeology Unit 1990**

## Building Recording at Halesowen Abbey, 1989/1990

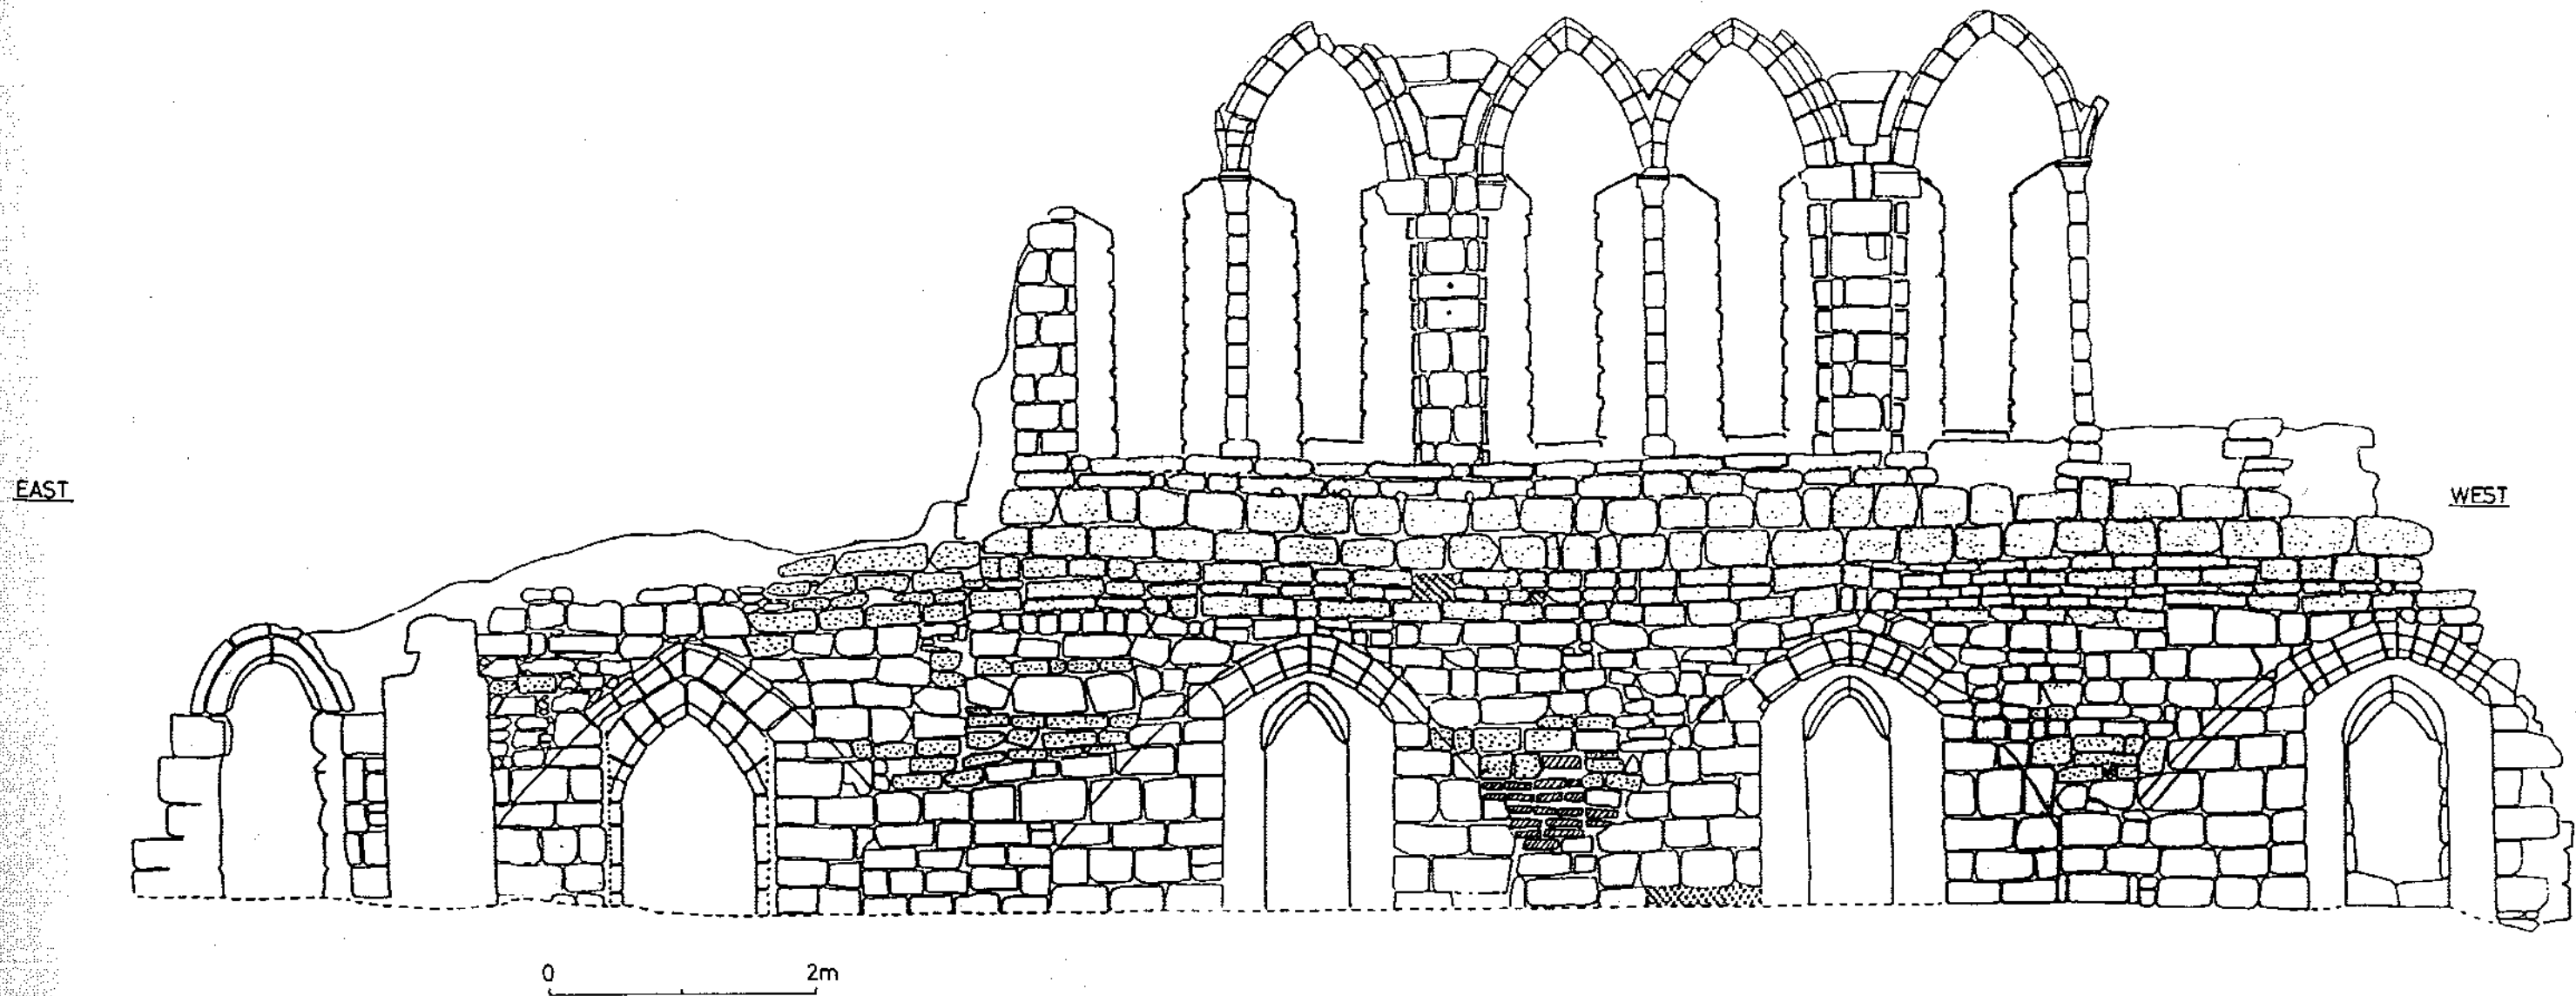
Figure 3 Structure 2. North, Interior Elevation. (Jones/Ferris)

There is a distinct vertical break towards the eastern end of the wall (as seen on the north elevation) which is also marked by a slight but nevertheless noticeable, change in the alignment of the wall towards the north east. To the west of this break the walling is relatively easily understood, consisting of two tiers of windows each providing light to one floor of what was obviously a two-storey building. The bottom storey would appear to have been a vaulted undercroft with the scars of the vaulting being noticeable on the inner, northern face, around the three small, single-light windows (AE1, AE2, AE3) with their pointed, arched heads, and splayed jambs, only the westernmost of which (AE3) still retains its sill. Scars for two piers or corbels from which the vaulting would have sprung are noticeable between AE1 and AE2, now infilled largely with brick (SE1001), and between AE2 and AE3, now infilled with sandstone blocks (SE1002). There is no evidence for these windows having been glazed and they may simply have been provided with shutters.

Again on the inner face, can be seen the level of the floor between the two storeys, marked by a band of green sandstone (SE1003), the lower build being almost exclusively of red or purple-red sandstone (SE1000). The upper storey was lit by lancet windows, with angled and internally splayed jambs, of which five survive (AE4, AE5, AE6, AE7, AE8), AE4 to the east

(missing part of its east jamb and its head) forming a pair with AE5; AE6 with AE7; and AE8, to the west, being the sole survivor of a third conjectured pair. The southern, or outer, face of the wall is strengthened by two buttresses (AE9 and AE10), up to first floor level only, while a scar (AE11), to the east, may mark the position of a third buttress.

On the inner face, at the east end of the wall, interpretation is made more difficult by the fact that the walling does not survive above a height of c.2.40 metres. Nevertheless, it can be seen that to the east of the above-mentioned vertical building break is a doorway (AE12) which may have been part of a through-passage (or slype?), whose eastern limit was formed by a north-south aligned wall, now represented only by a scar (AE13), and its western end perhaps being formed by a timber partition corresponding with the vertical building break. The form of the stonework arch above the doorway, and the scar left around this feature, suggest the former continuation of the vaulting. It is likely that this doorway was inserted in the position of a former window, though whether this would have involved the destruction of some of the vaulting at this time cannot be said. The walling beyond the north-south wall stub (AE13), pierced by another doorway (AE14), would appear to be a later (?medieval) addition.

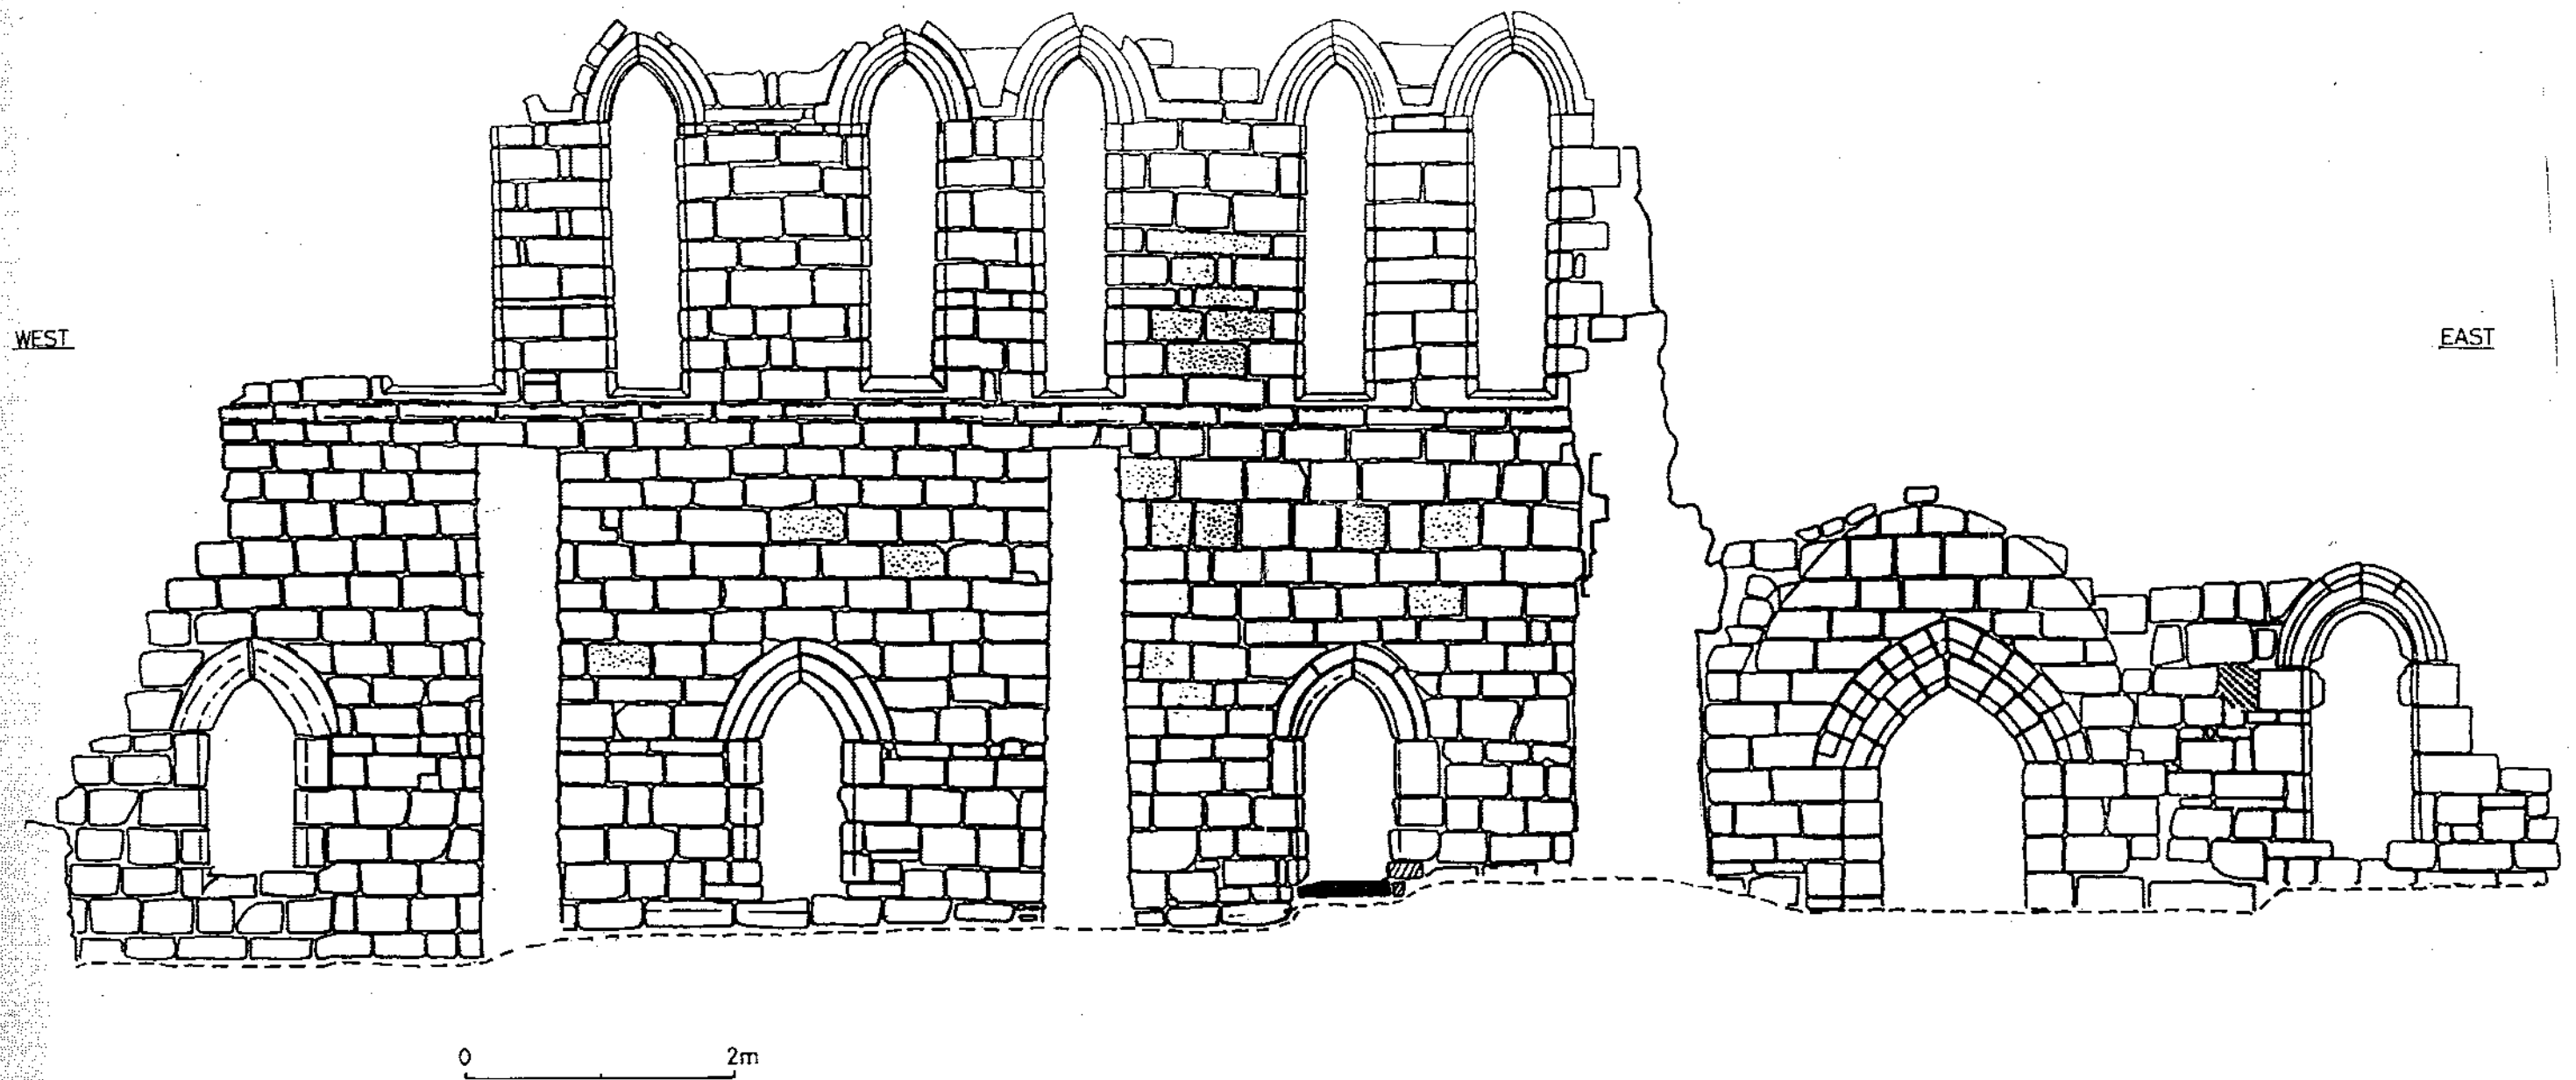
Figure 4 Structure 2. South, Exterior Elevation. (Jones/Ferris)

face of the wall, with a number of carved grave slabs, one of which is now inside the Infirmary building, built into the wall fabric. A tall doorway to the east can be identified with AE14, while a stone-built dog-kennel (the dog itself is rather unconvincingly playing in the foreground) is built up against the wall face between AE14 and AE12. An undated, but presumably later, view of the same wall shows the truncated east and west ends of the wall before its incorporation into the garden boundary wall, and a new feature, between window AE3 and doorway AE12, an arch-headed niche cut into the upper face of the ground-floor walling, but this feature does not appear on any of the other illustrations, and its purpose is unknown.

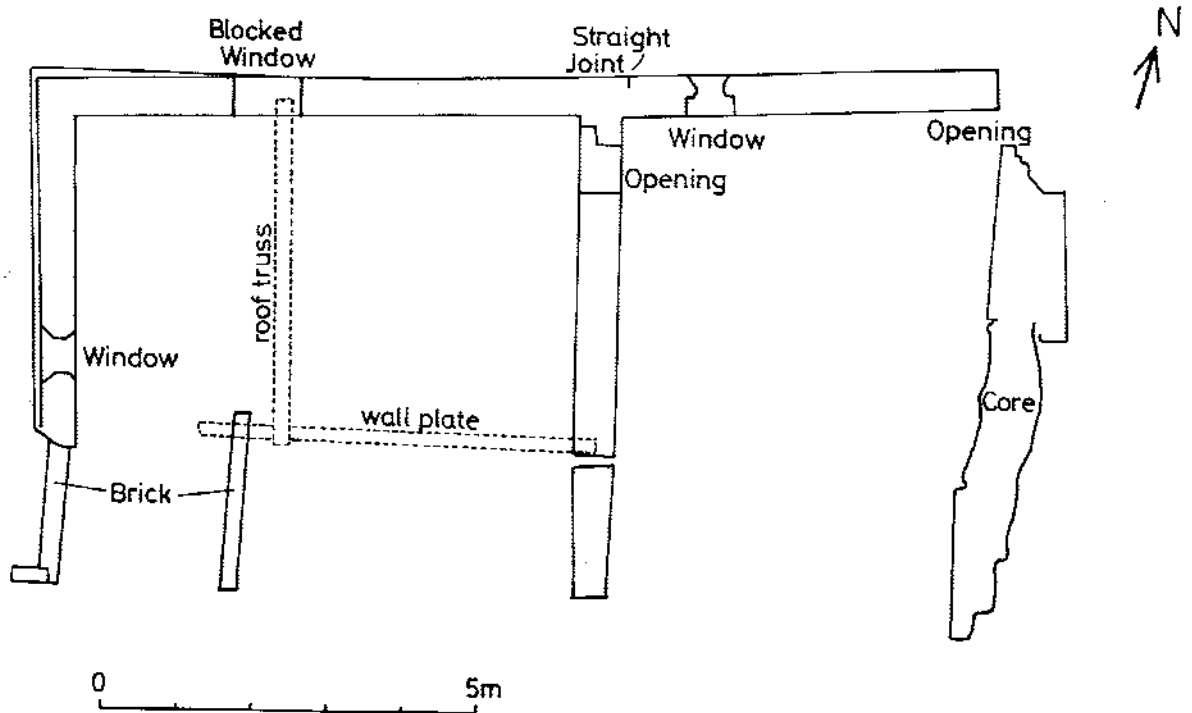
Figure 5 Structure 3. Groundplan. (Sewter)

To the west of Structure 2, and standing a little away from the main farmyard complex in splendid isolation, is Structure 3, an open-fronted, south-facing shelter-shed or cart lodge. The building is in a poor state of repair and an area of tiles is missing from the roof at the west end; the inside is covered with a substantial quantity of compressed straw and manure, perhaps to a depth of up to 1 metre, obscuring any floor surfaces and the bases of the internal walls. The building was planned and elevations were drawn of all the external wall faces. In addition, the internal faces of the north and east walls were drawn, as were the lower levels of the west gable wall and of both faces of the stone, internal dividing wall.

Aligned roughly east-west, the building is c.13 metres long and 6.75 metres wide, the apex of the roof being at least 6 metres above the internal floor level. Open along its south front it is internally divided into two unequal parts (that to the west being c.6.75 metres long and that to the east c.5 metres) by a north-south aligned cross-wall of stone. The western bay is partially sub-divided by a brick wall, not running as far back as the north wall, this short brick wall forming part of the support for the frontage.

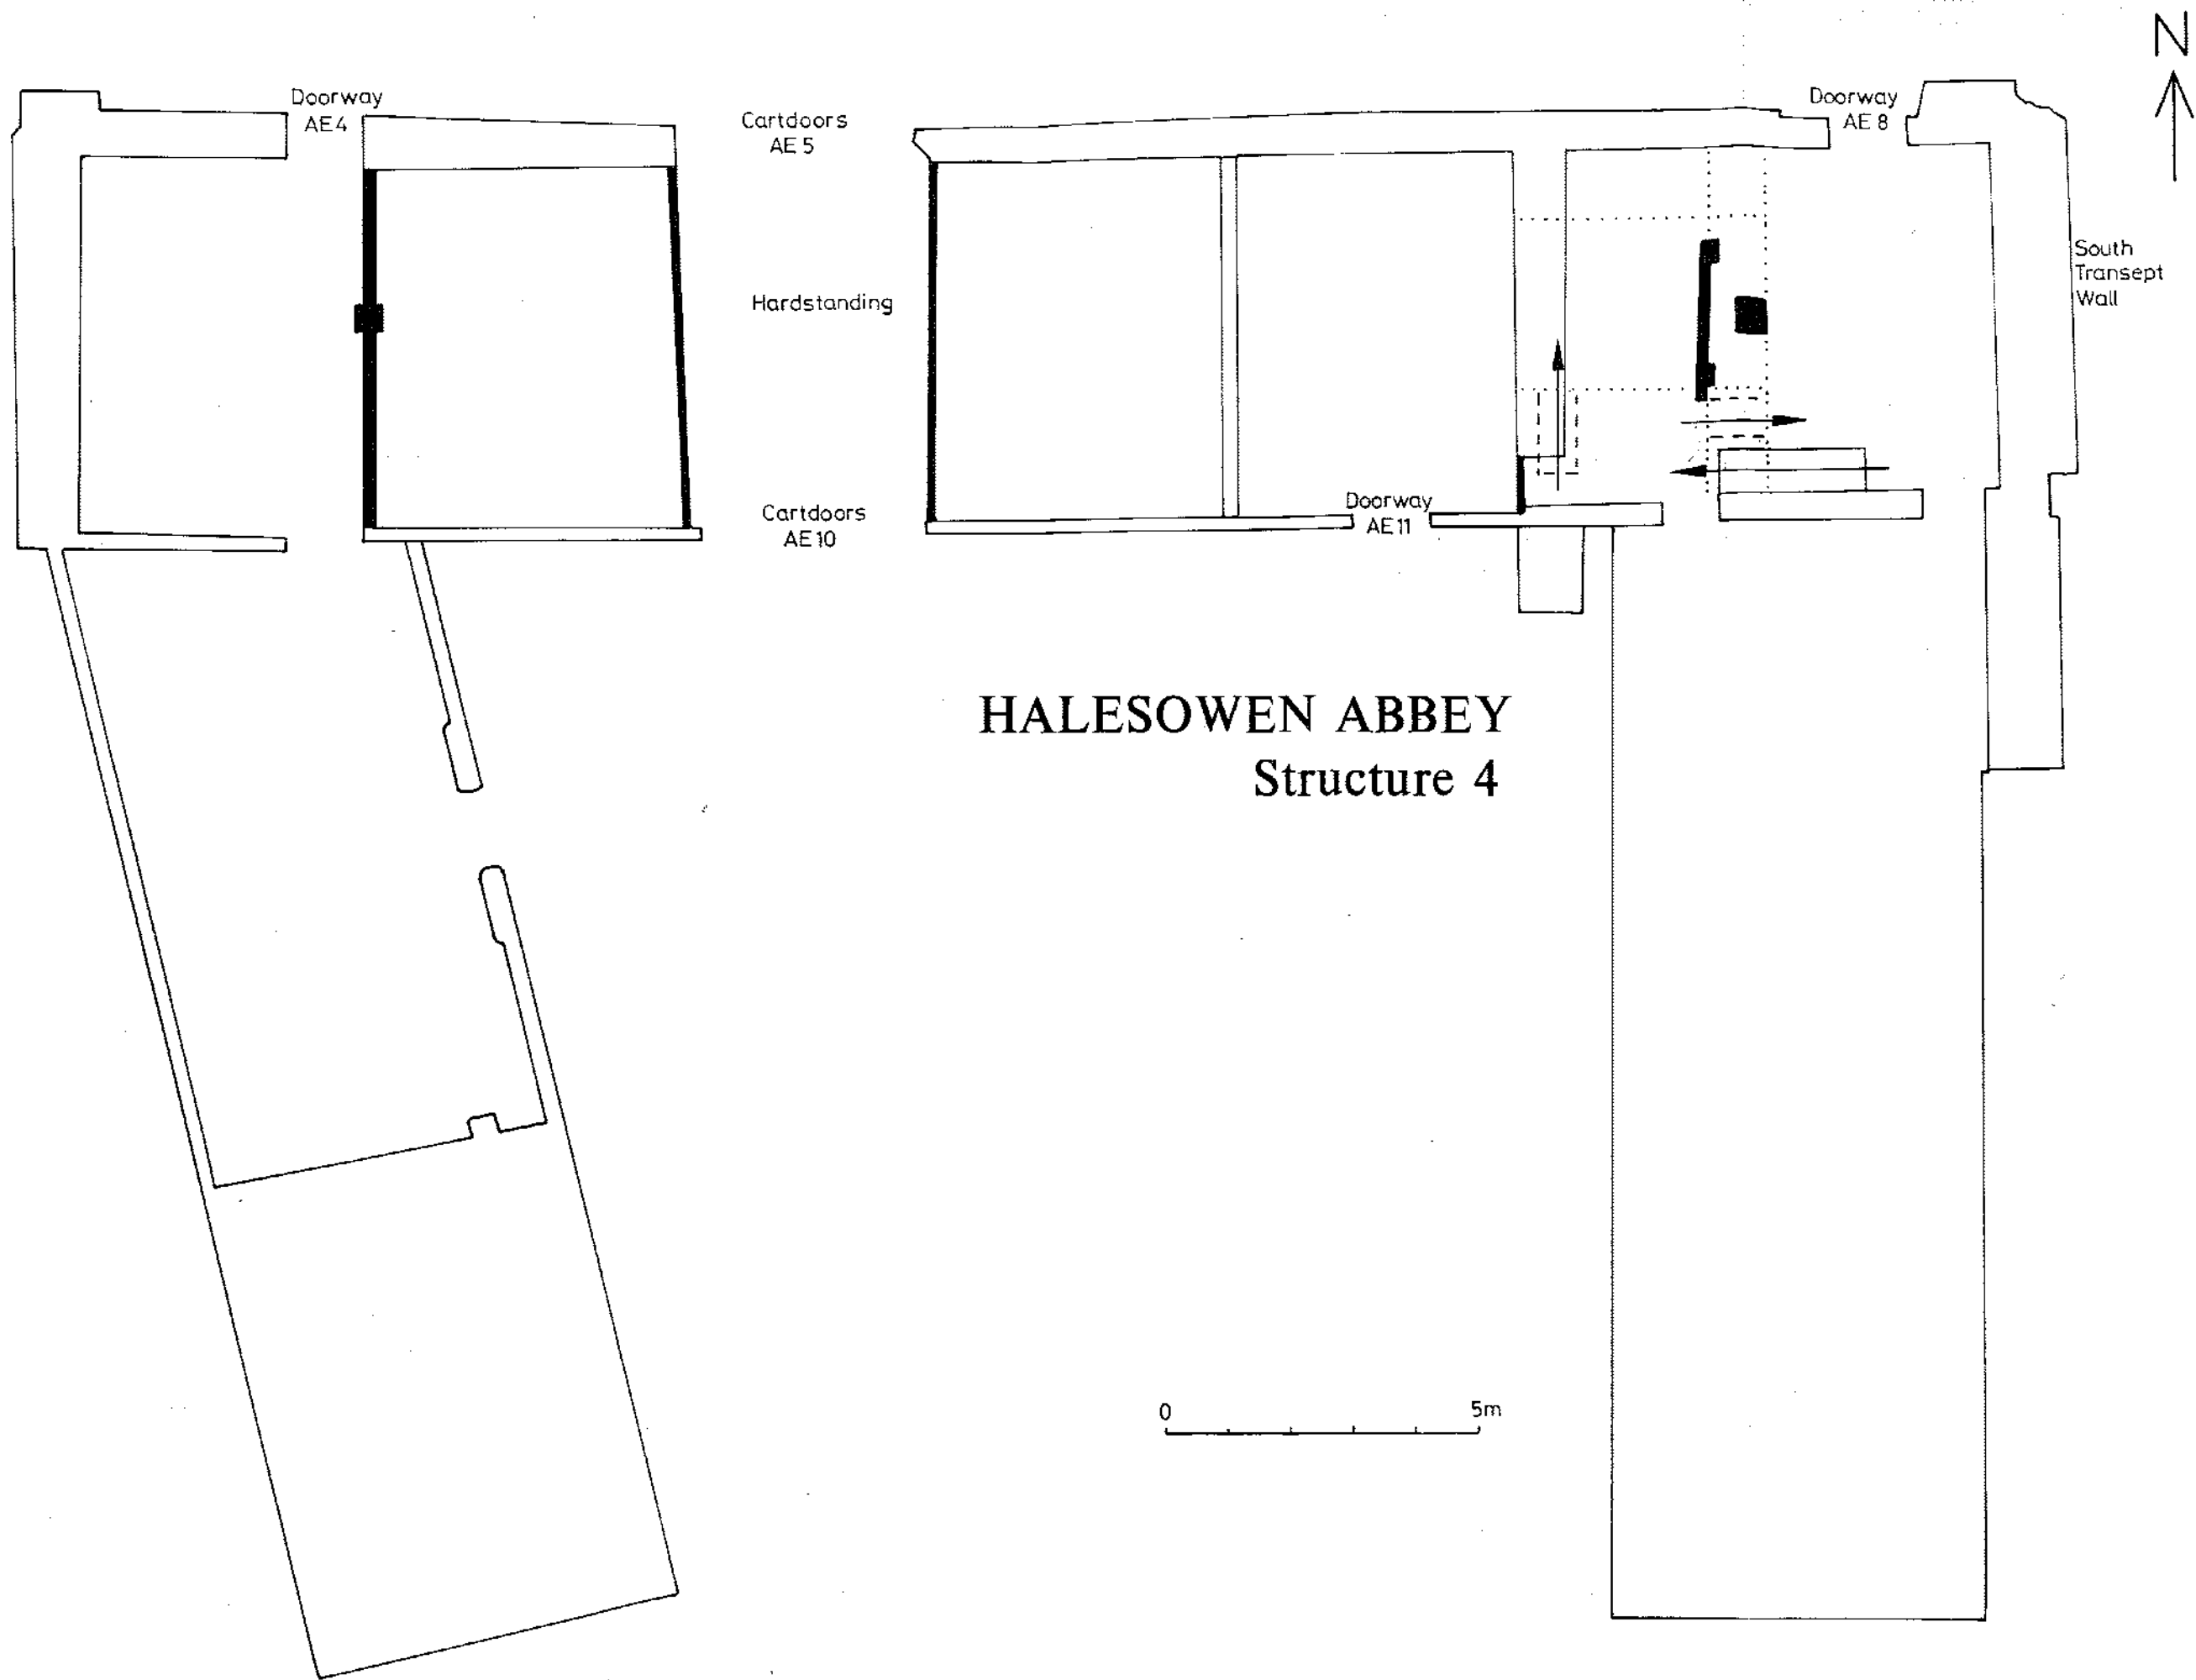
Figure 11 Structure 4. Groundplan. (Stereberg)

Structure 4 lies to the north, and forms the north side of the present farmyard. It is a rectangular barn, 31 metres long and 6.5 metres wide, aligned more-or-less east-west, with a roof apex at c.8 metres above the internal floor level. It is divided into seven bays, with a floor over the two easternmost bays, creating a loft space at this end of the building, and a smaller loft over the single bay at the west end. There are pairs of opposed wooden doors (cartdoors) in the long walls, not centrally located, but placed more towards the western end of the building. A well laid surface of stone hardstanding forms a floor in the cart bay while elsewhere floors are probably of brick. However, the building still

contains considerable quantities of rubbish which obscure the floor levels in most of the building. The roof over the west end has suffered damage from a recent fire while the general state of disrepair, with the cart doors now hanging off, has been further exacerbated by recent vandalism.

The barn is built of a mixture of materials - timber, sandstone blocks, sandstone rubble and brick - which very much reflects the types of build, and reuse of materials, already seen in Structure 3. Again, like Structure 3, it is possible to identify some medieval masonry incorporated within the building, as well as medieval stonework reused in the later builds. As has already been noted, the eastern gable end of the barn butts up against the west wall of the south transept of the monastic church, while parts of the south wall of the nave of that church are certainly incorporated within the north wall of the barn, as at the west end external face of this wall (Figure 13). Again, by examining the interior faces of the wall, around doorways AE4 and AE8 (Figure 14), it can be seen that wide, arched doorways of medieval build (AE17, AE18) still exist in situ here, that to the west end of the wall probably being the entrance into the church reserved for layfolk and that to the east being in the position of the processional door into, and out of, the cloister to the south. Other portions of church wall may be incorporated within the barn's north-wall fabric - indeed the rubble build used in much of this wall, to the east of the cart door, may simply be the consolidated exposed core of the medieval wall, while the lower portions of the sandstone wall to the west of the door may be medieval. The inner face of the west wall of the barn, at least at its lowest level (the unusual thickness of this

Both Structures 3 and 4 would repay some further survey work, and monitoring of their repair and consolidation, if this is to happen, since certain logistical problems (that is, rubbish dumped inside both structures obscuring floor levels and the bases of some walls and, in Structure 4, an infestation of rats in the western end of the building where some old dumps of grain form an attraction) prevented complete recording. It would also be useful, in order to complete the study of the farm, to record the other farm buildings, especially as these are due to be renovated and converted for use as workshops. With Manor Farm no longer a working farm this provides an opportunity to catch in stasis the final manifestation of an activity that has dominated the site for at least as long as the monastic activity which it succeeded.

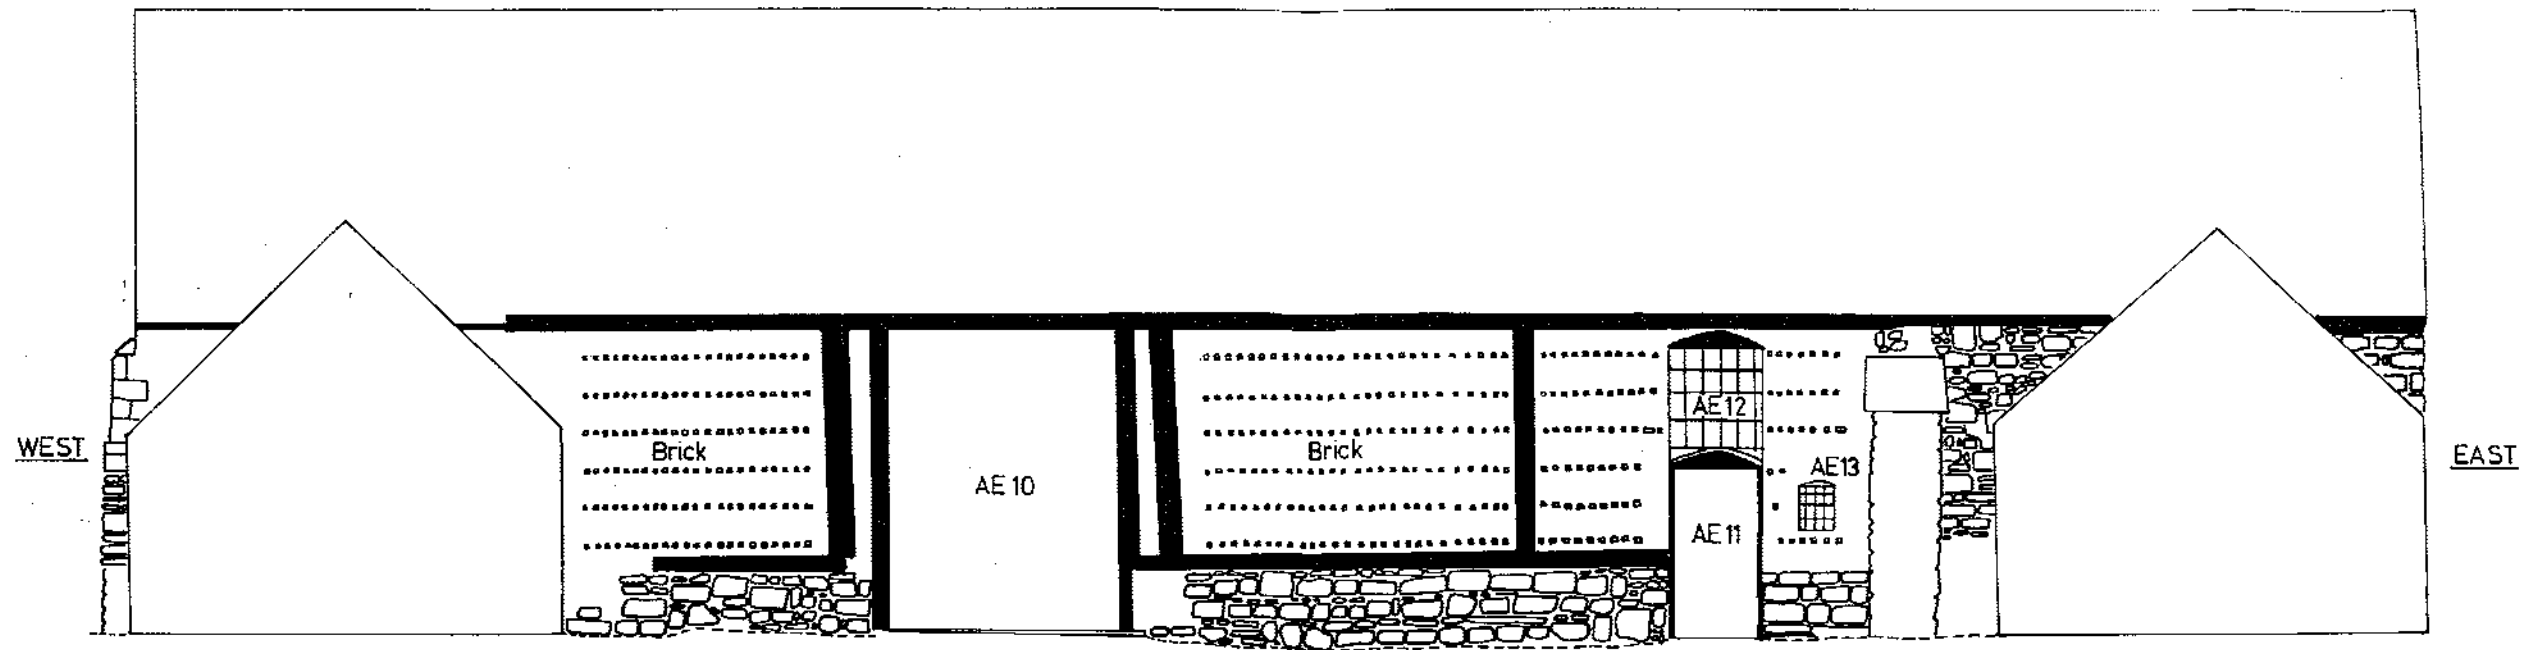
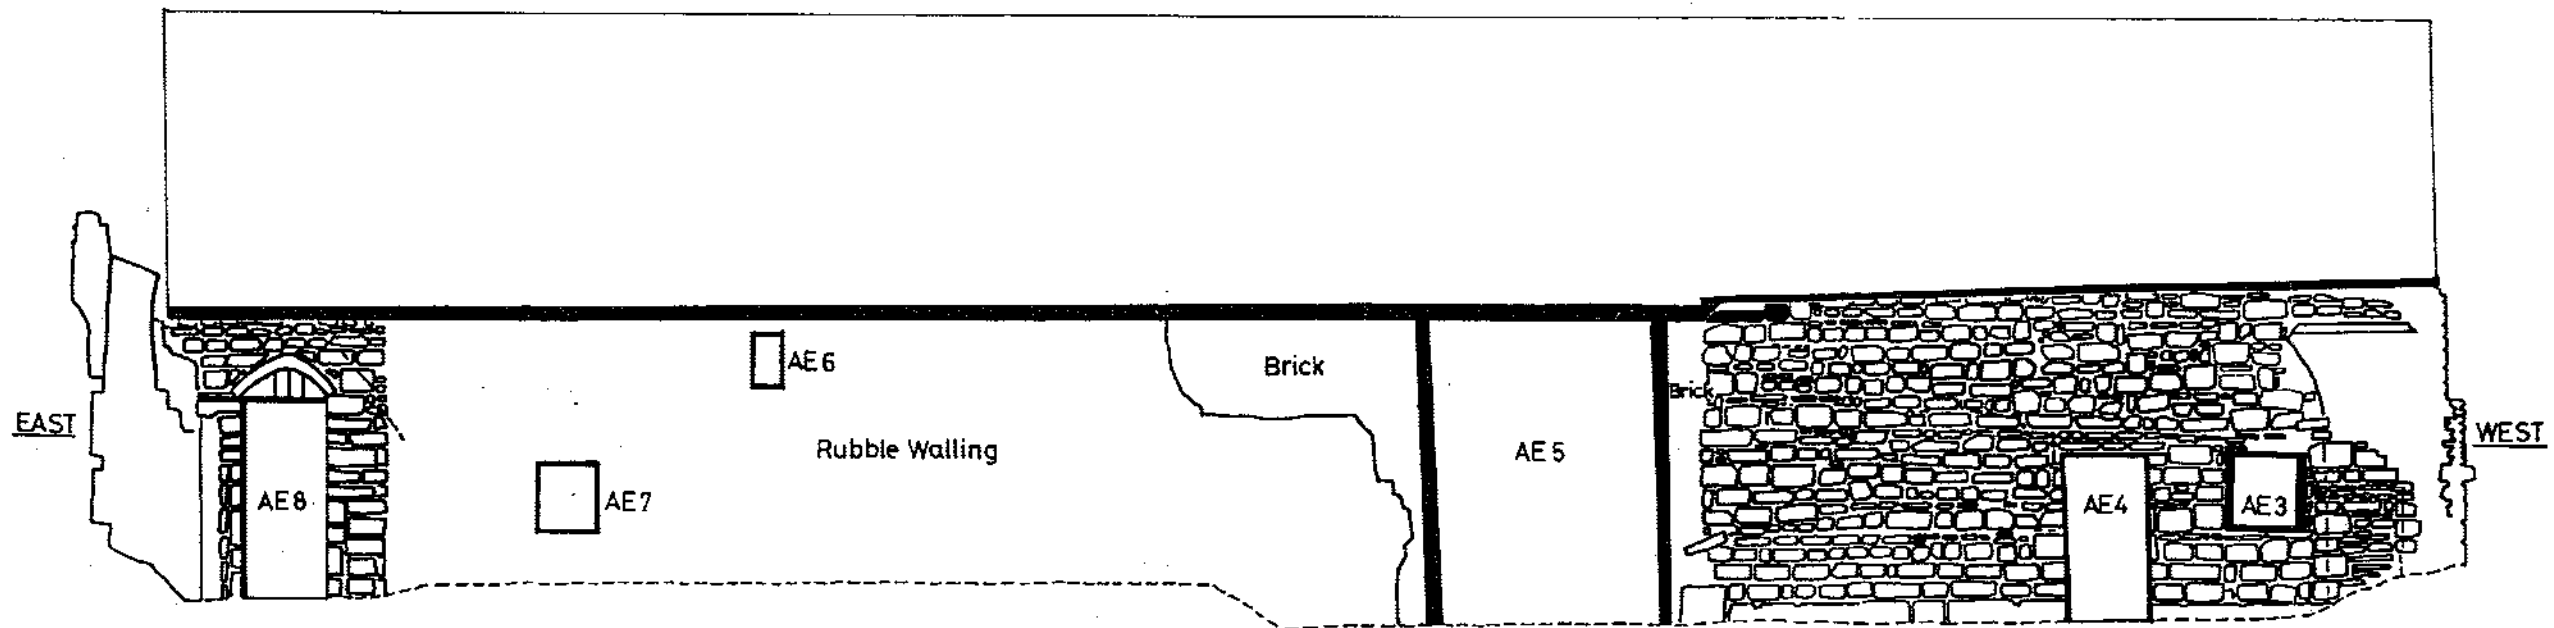
Figure 12 Structure 4. Elevations of North and South Walls. (Ferris)

The brickwork in the main build of the southern wall of the barn, pierced here by numerous ventilation openings, the bricks being 3 inches thick, is a single build, though bricks of other sizes are found elsewhere in the barn, mainly being used for infilling and repair. There is a discontinuity in build and fabric both to the east and to the west of this 'ventilated' brickwork and its associated timber framing (see Figure 12).

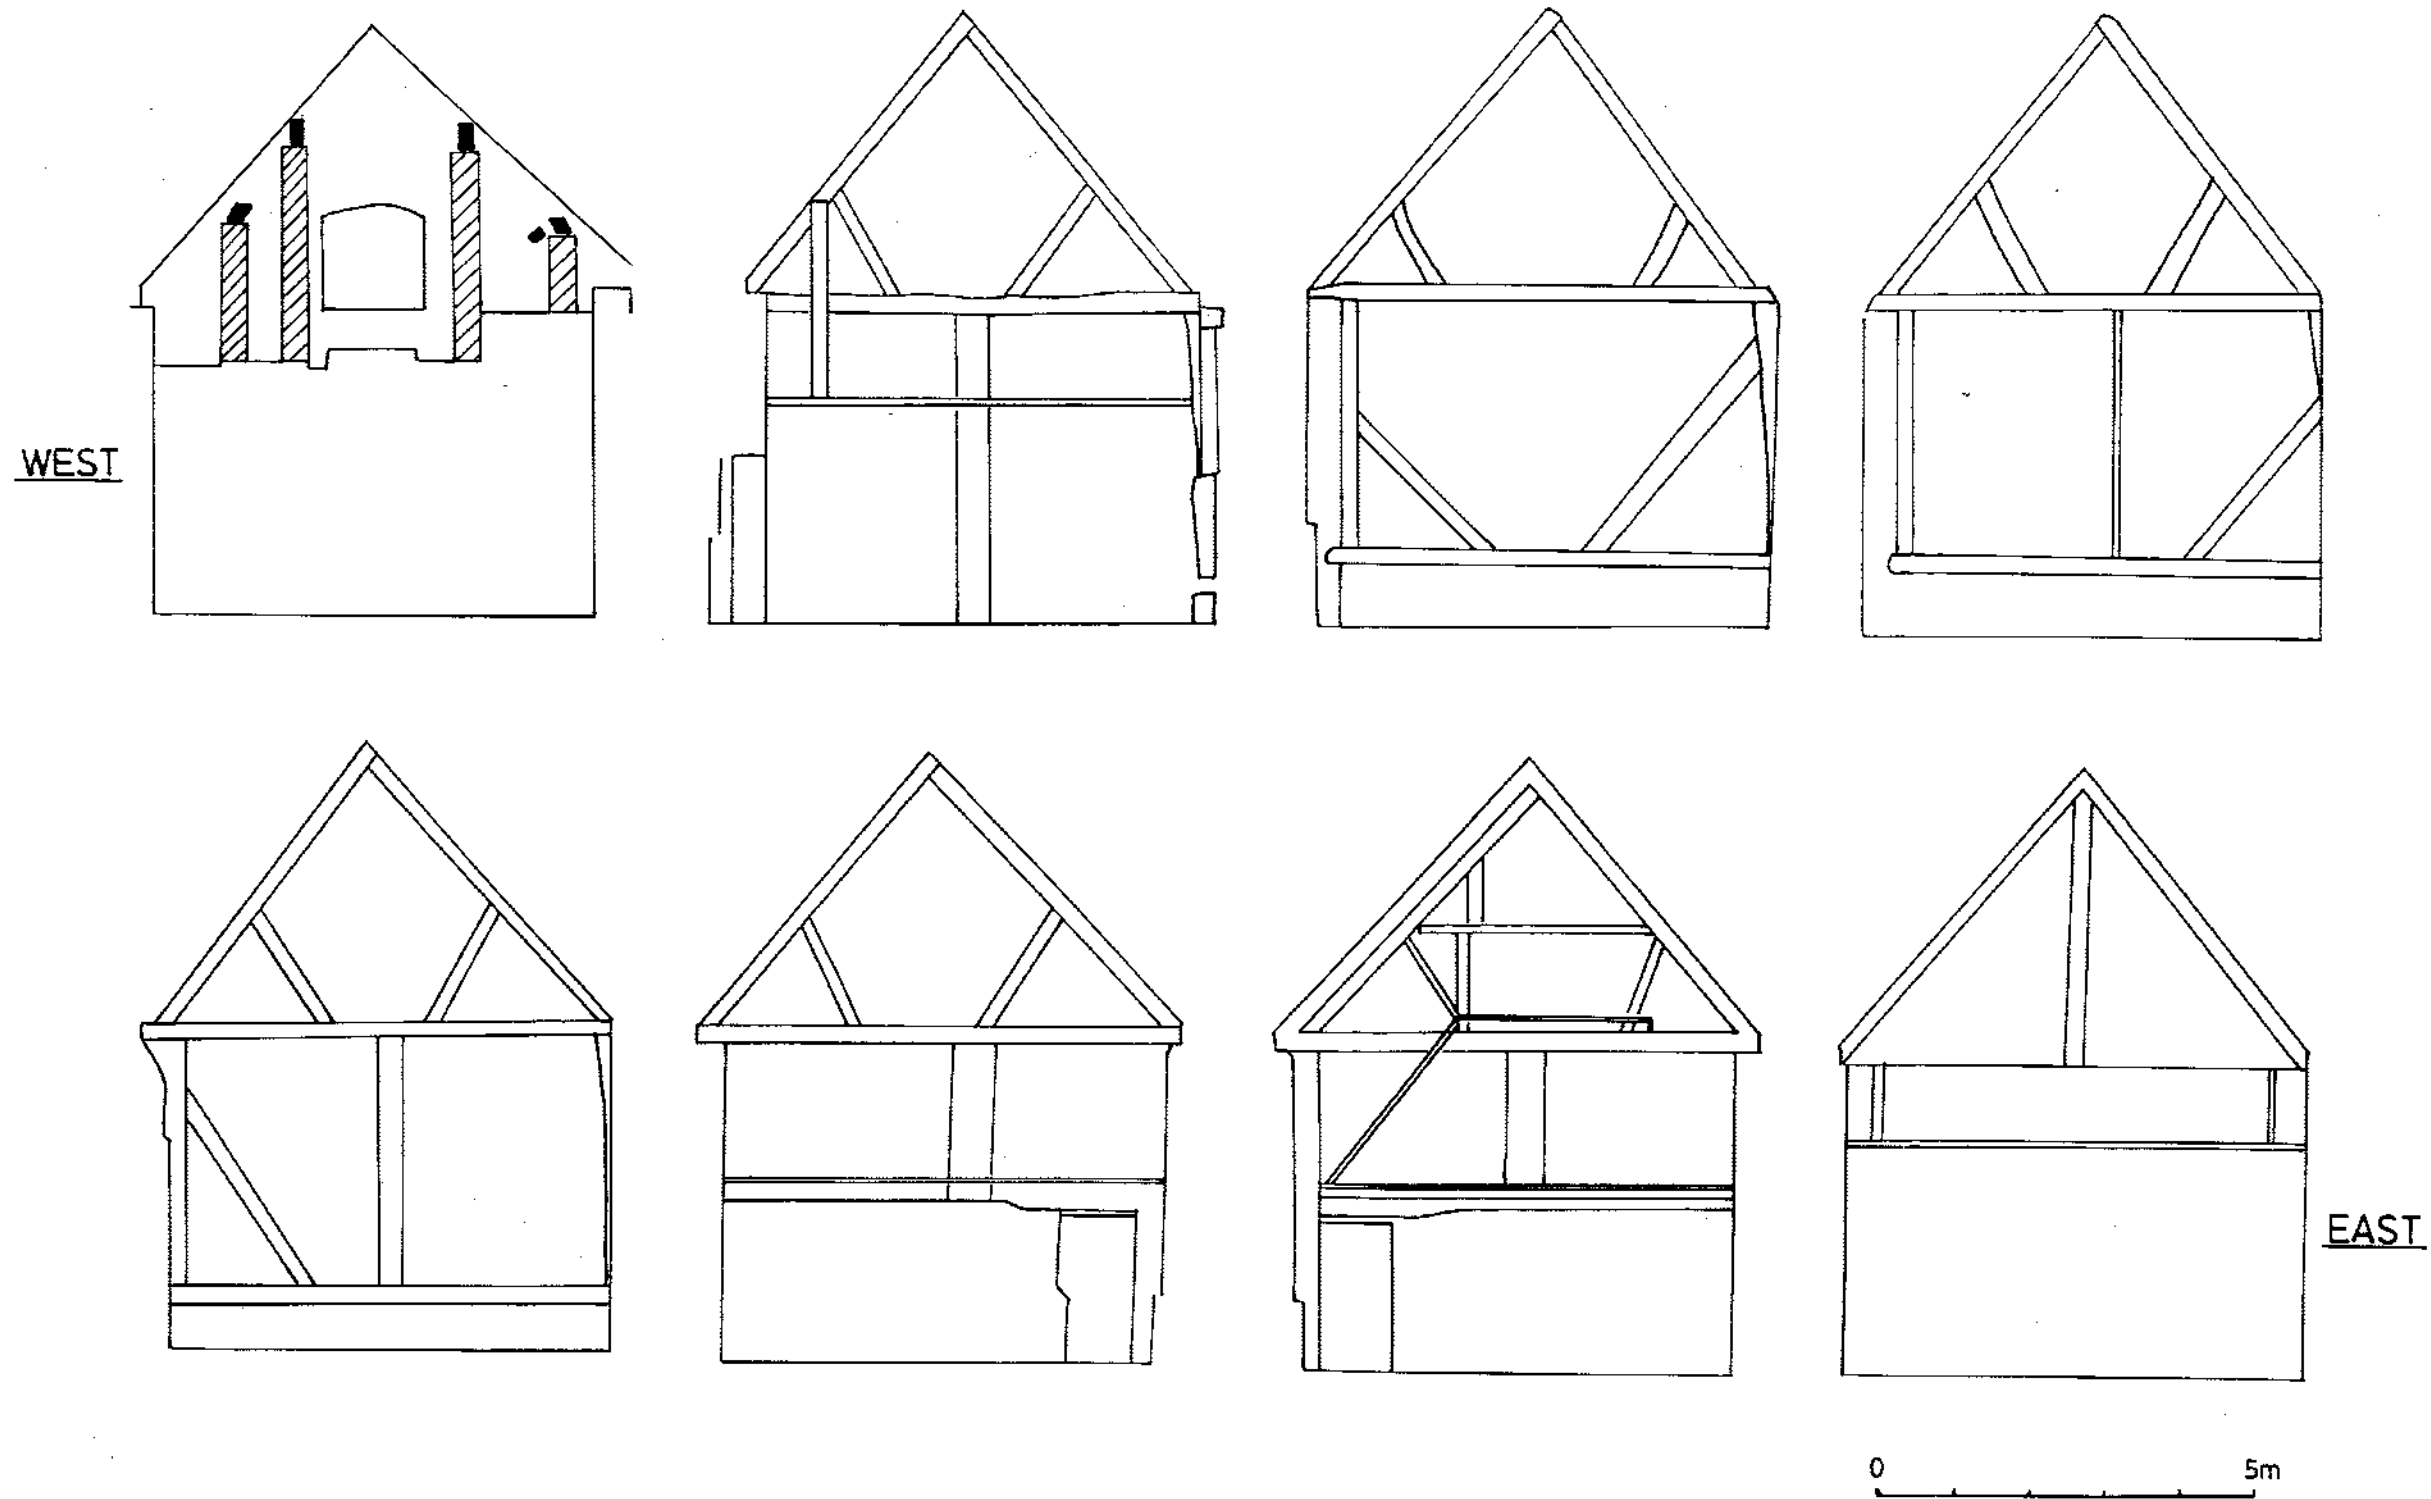
Figure 15 Structure 4. The Roof. (Ferris)

It seems likely that prior to the construction of the present barn there was an earlier, smaller barn here, as is suggested by an examination of the roof (Figure 15), there being noticeable remnants, along its southern side, of a possible cruck-frame in the central section of the present barn. The present roof arrangement, a uniform queen-strutted roof, although obviously reusing timbers, is a single build, although the use of brick trusses to support the wall plate and the purlins at the western gable end of the building suggests that the most westerly bay is an extension to the structure, and the same may be the case with the most easterly bay.
