Birmingham University Field Archaeology Unit

Report No.161

**Building Recording at Owen Owen 1991
An Interim Report**

Steve Litherland and Shaun Richardson

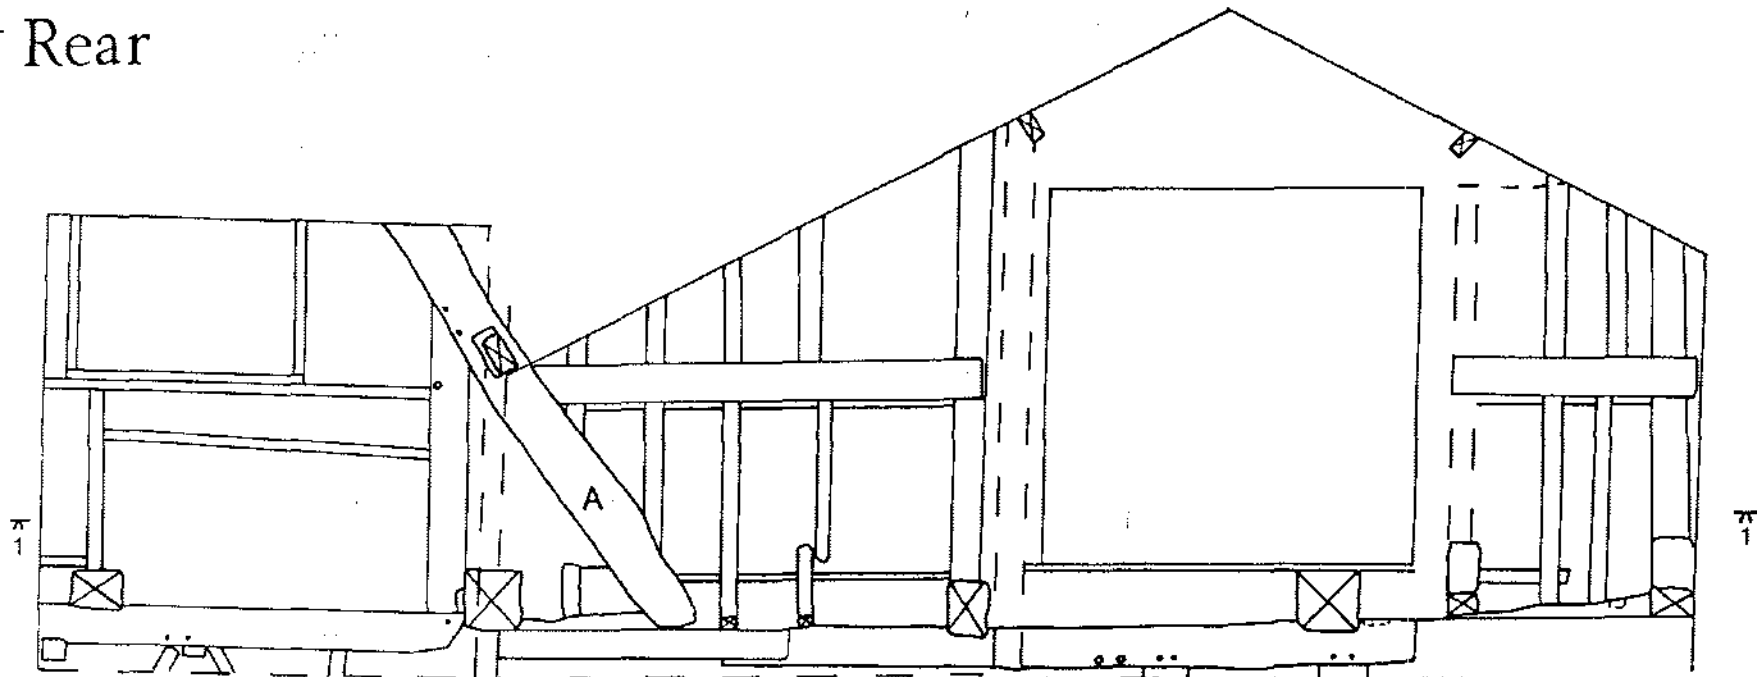
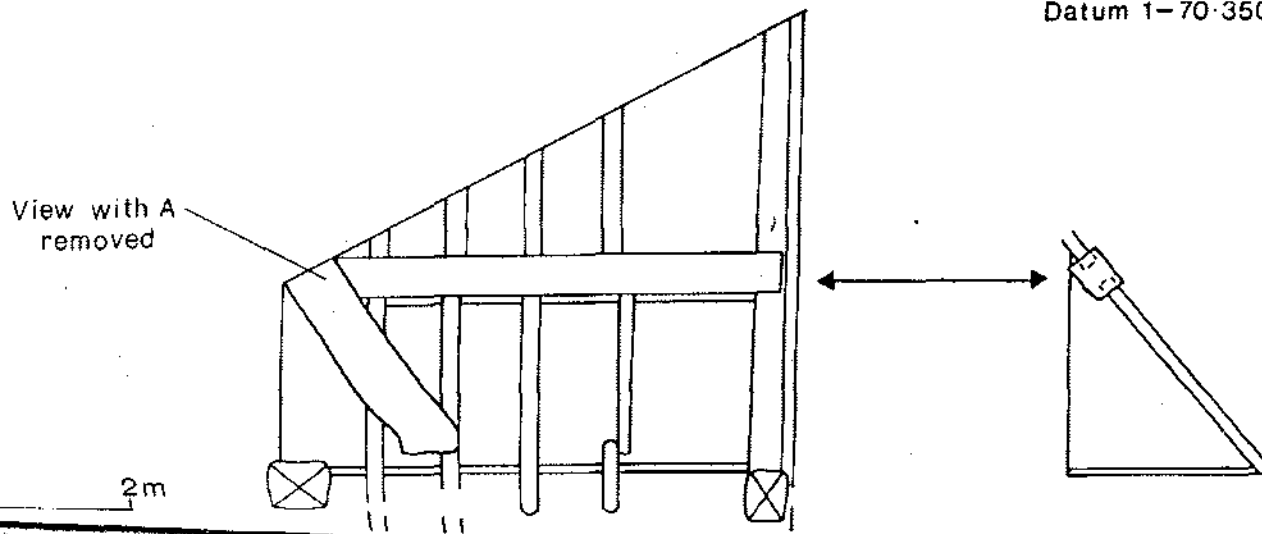
A 2 Rear

Ref: A2 The back wall dormer-end, rear wall-plate and purlin and rafters of Cartwrights Mansion were recorded where exposed at second floor level to try to understand the relationship, if any, of this structure to any others behind. Although later repairs and alterations had removed or obscured some of the framing, the main structural elements were still discernible.

The roof has collar-and-tie-beam trusses with raked struts above the collars. It appears that the two front dormers are original because of the presence of additional collar trusses to support the framing of the dormers, and the same would seem to apply to the rear dormer nearest to 21 High Street. The gable end of this dormer has no decorative ogee bracing like that seen on the front of the building, but instead is crudely infilled with two different brick builds. Below a level roughly equivalent to the line of the roof purlin the bricks measure 9 by 2.25 inches, while those above, which form the surround of an inserted sash window, are larger, measuring 9.25 by 3 inches and obviously of a later date. The dormered extension, giving access to the second floor of Structure P, is a later addition, cutting through

the purlins and rafters between two main structural frames. Therefore, it would appear that only one dormer would have overlooked the courtyard at the back of the house. Further stripping, to allow examination of the underside of the rear wall-plate would be desirable, because limited access hampered examination of the main posts of the intermediate bays (which are probably concealed behind the decorative arching at first floor level). In addition, there might be further evidence about the relationship of Cartwrights Mansion to any structures immediately behind, because the tops of two studs observed at the northern end of the back wall suggest that any other structure on this side of the rear dormer would not have had open access to the rest of the house.

Structure A (Cartwrights Mansion). Further inspection of the rear wall of this property would be desirable in order to examine its relationship to the structure behind. This would include; an examination of the underside of the wall-plate, and if possible inspection of the main posts concealed behind the decorative panelling on the first floor. Inspection of the underside of the exposed flooring on the first floor is also recommended, especially in the passageway area; this would require the stripping of the false ceiling below (this point also applies to the floor area to the rear of Cartwrights Mansion in Structure P).

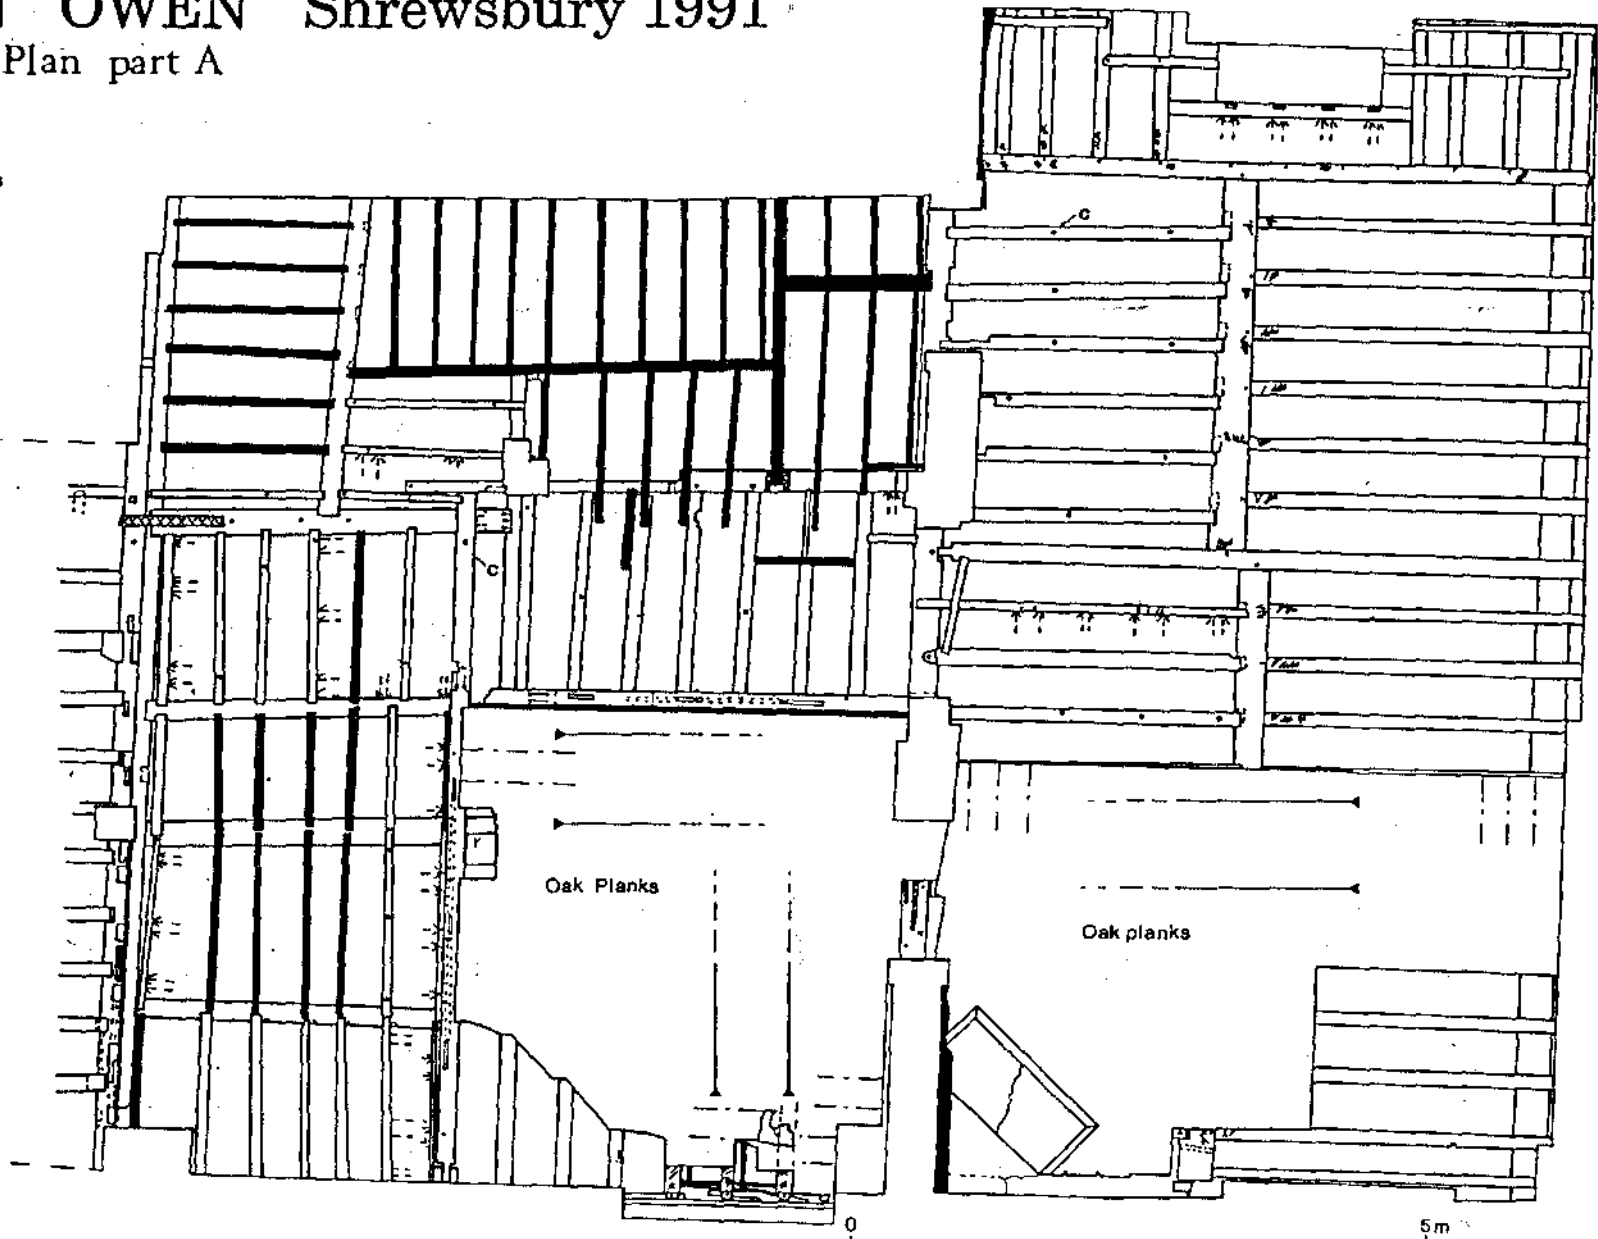
P 1 Floor Plan part A

Ref: P1 To the rear of Cartwrights Mansion another section of old oak flooring was exposed, and inspection of the main bridging-beams

revealed a number of joints in the timbers cut for vertical studding. These have been interpreted as representing the ghost outline of another structure, measuring approximately 4 by 4m in plan, built in the courtyard area to the rear of the house, and giving it an L-shaped plan.

The rear wall-plate has a stop-step chamfer on its outer face, a feature also observed on a similar timber, jointed into the end of this beam, running out into the courtyard. However, it would appear that this was another reused timber, possibly from the demolished second floor of the building, later built to infill the courtyard area. The probable remains of an outhouse measuring approximately 2 by 2m were seen attached to the side of this structure. The other timbers comprising the floor are a mixture of modern softwood and other reused timbers arranged in a very haphazard manner over what used to be the rear courtyard. As noted above, further selective stripping to the back of Cartwrights Mansion would be required in order to determine the exact nature of the relationship between Cartwrights Mansion and the building immediately behind it. In addition, stripping of the ceiling of the ground floor underneath both buildings would reveal more about their respective plans.

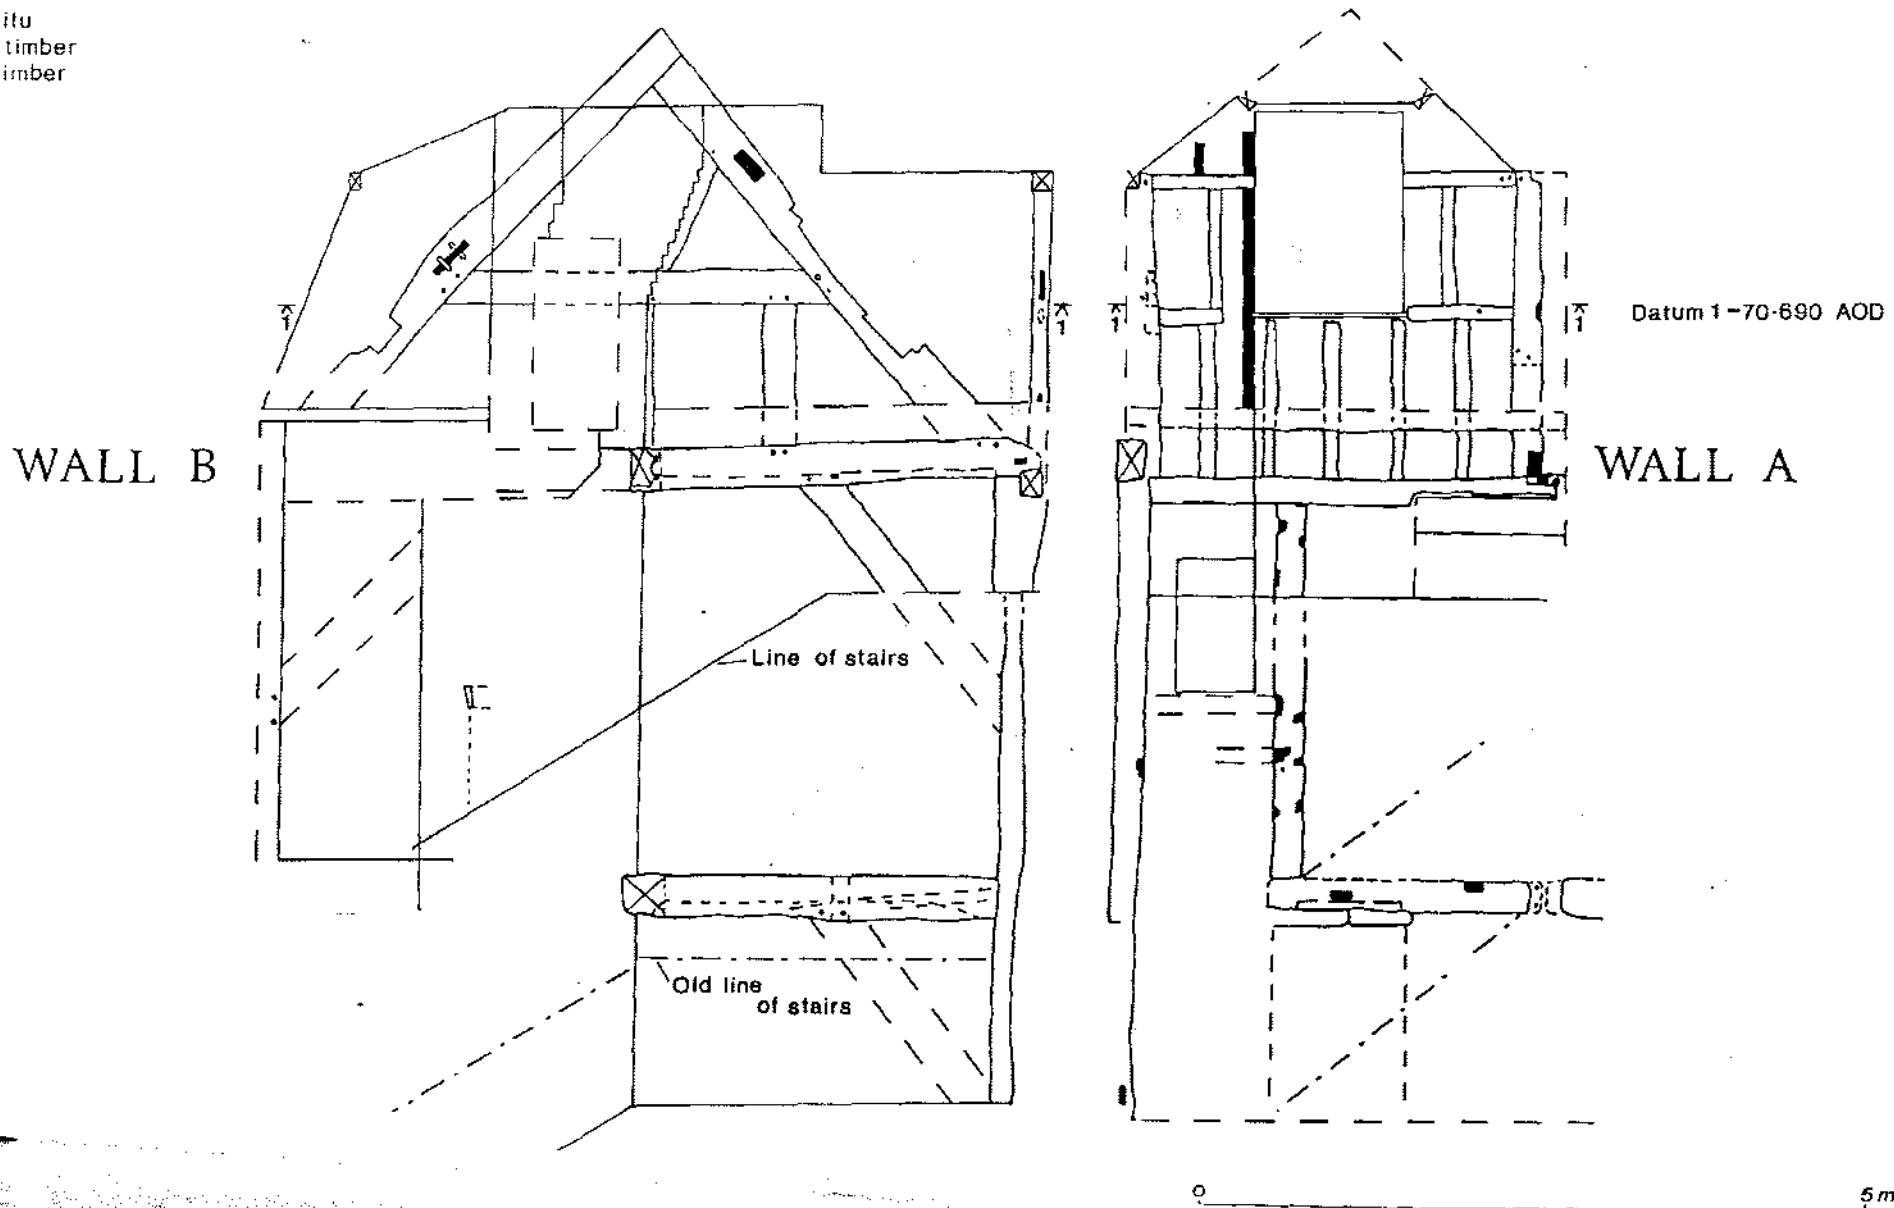
Pp 1-2 Stairwell

Ref: Pp1 and 2 Soft-stripping revealed the remains of another back-plot structure, further east, which would have completed the enclosure of the courtyard. While sections of the external walls of the first and second storeys were observed from the roof prior to stripping, it is clear that despite areas of mutilation or demolition, a great deal more of this structure has survived than was originally supposed. Above ground floor level, horizontal and vertical elements were observed on the first and second floors, and in the adjacent stairwell.

The building is located about 13m behind the High Street frontage, and measures approximately 10 by 6m. It is on a slightly different alignment to Cartwrights Mansion because of a kink in the property boundary at this point. Although largely obscured by a later fireplace, the main frame of the end gable is largely intact above first floor level. The basic roof design is similar to Cartwrights Mansion with both collar-and-tie-beam trusses and raked struts above the collar. In

addition, there is a further level of studding between the collar and the tie-beam which suggests that this gable was originally free-standing, and, as such, was given a decorative facade. In common with the main bridging-beam on the first floor, the tie-beam has a deeply-cut chamfer on the internal face. Not all the tenoned purlin seats are visible, being either obscured behind the chimney, or crudely repaired, but it would appear that there were two main sets. Below the roof the design appears to be identical for both lower floors, consisting of a tie-beam supported by two diagonal braces to the main posts, which itself supports the central bridging-beam of the floor. Although two posts of intermediate bay frames were found running up the rear wall in the area of the stairwell, (the bays measuring approximately 2.6m and 2.0m in width respectively), these have been removed from the front.

Moving westwards, the front external wall of the first bay (which can be seen from a lightwell to the rear of Cartwrights Mansion) is still largely intact, although the later insertion of the staircase, a sash window, and the mansard roof has greatly altered its internal structure. Elements of framing, including studding and cross members can be seen in the top storey above the line of the roof, although that these are original features of a dormer extension cannot be confirmed because the tie-brace seating on the main frame rafter has obviously rotted and been replaced. On the first floor a curious intermediate post, which does not correlate with the back wall, and which has a number of angled joints cut into it at irregular intervals was observed. The function of these joints is unclear, but they may have been made for some decorative panelling above the passageway running along the side of the property. Between the main frames of the first bay an intermediate stud, running the length of the first floor wall, can be seen both internally and externally, before the outside wall over the passageway is obscured by a later lean-to, infill structure.

Structure Pp. The removal of all the modern flooring over the first floor area of this building is recommended, as is the stripping of the back wall at this level to fully expose the main framing. In addition, the relationship of the oak flooring on the second floor to the later mansard-roofed building needs to be established through limited stripping around the main bridging-beam.

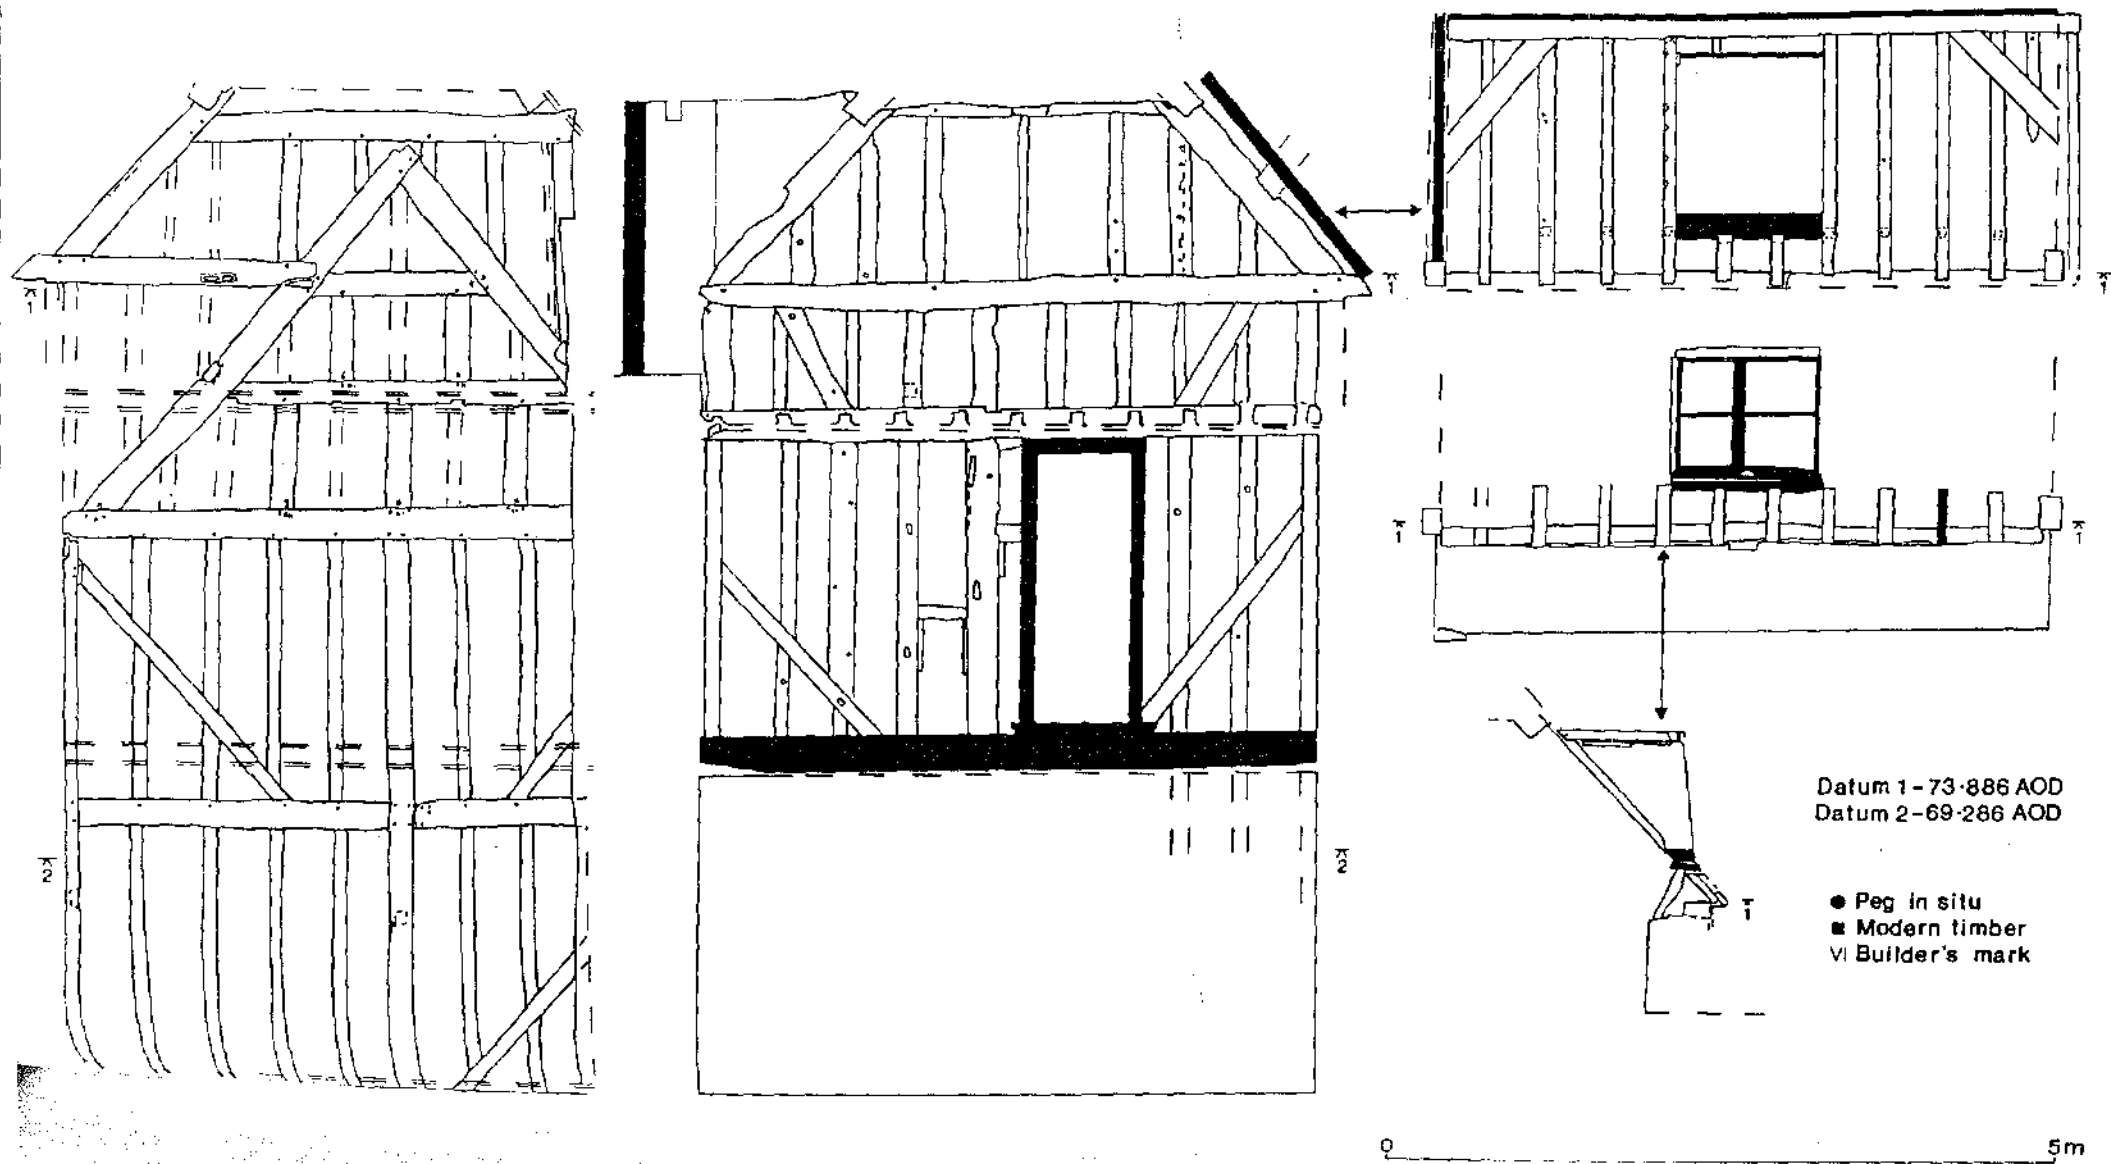
J 1-3 with roof in section

Ref: J In common with 22-25 High Street the other substantially timber-framed building known to exist within the complex, 45 Pride Hill, was mainly recorded by Carole Thickers, the timber-frame specialist co-ordinating the building recording. Therefore, discussion of this structure from an archaeological perspective will follow proper evaluation. However, to the rear of the main front frame of this building, behind a later, inserted brick corner-chimney, an area of much-mutilated framing was revealed by soft-stripping

on the second floor. Discussion of these few timbers can only be meaningful in relation to the rest of the structure, but, from an initial examination it would appear that the main horizontal frames for the studding, and what appears to be a doorway, are probably contemporary with the later phase of timber-framing, when an additional storey was created by opening out the roof. Hypothetically, this framing may be part of a stairway access block, although further soft-stripping of the floors between No 45 and this area is required in order to possibly clarify this point.

Structure J. It is recommended that the flooring to the rear of this structure, on the second floor annexe, is removed in order to establish any connection between this area and the main frame.

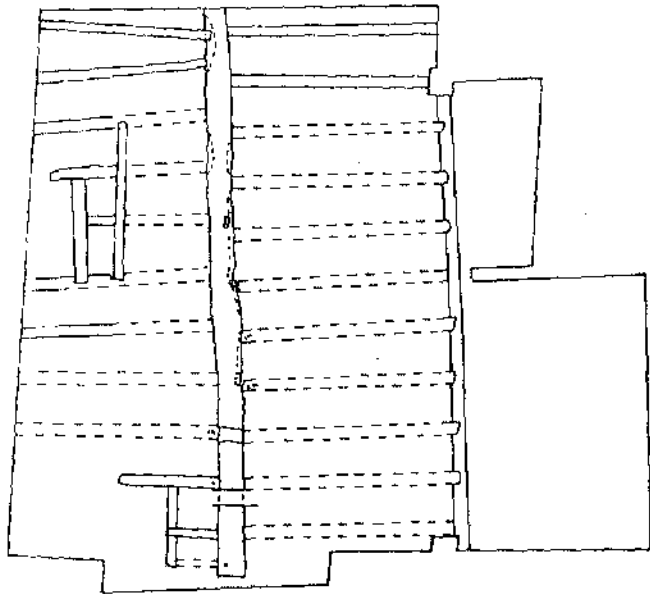
P Level 2

The construction of the stairwell, mansard roof, and the extension from the back of Cartwrights Mansion, has either obscured or destroyed most of the structure at second floor level in what would have been the loft, with the exception of an area of oak floor at the northwest end of the building. Curiously, this floor is about 0.5m above the beam levels in the adjacent stairwell. There are two possible interpretations of this anomaly: firstly, that this section of flooring was raised or reused when the mansard-roofed extension was added, or secondly, that there were, in fact, two separate structures within this building, at different levels. However, the latter interpretation is unlikely given the continuous span of the wall plates at first floor level, but cannot be entirely precluded until a further examination is made of those areas of the building not accessible at this stage of work.

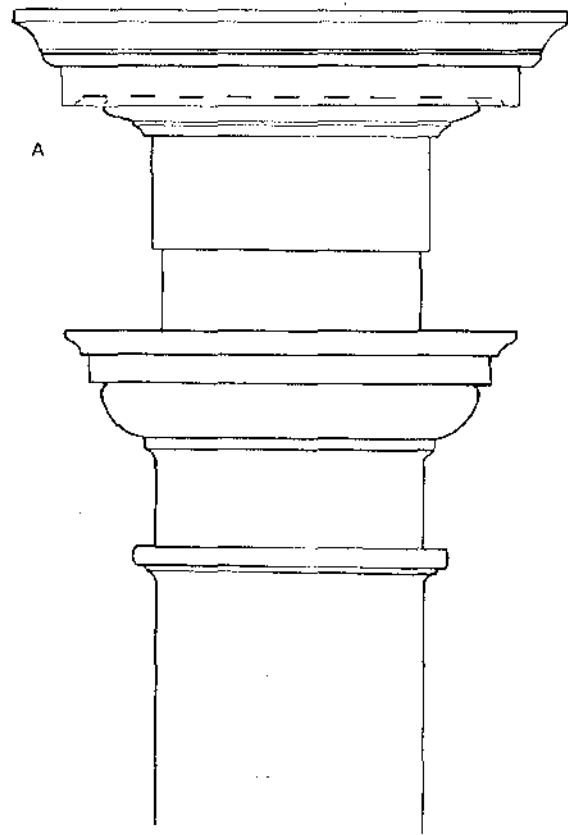
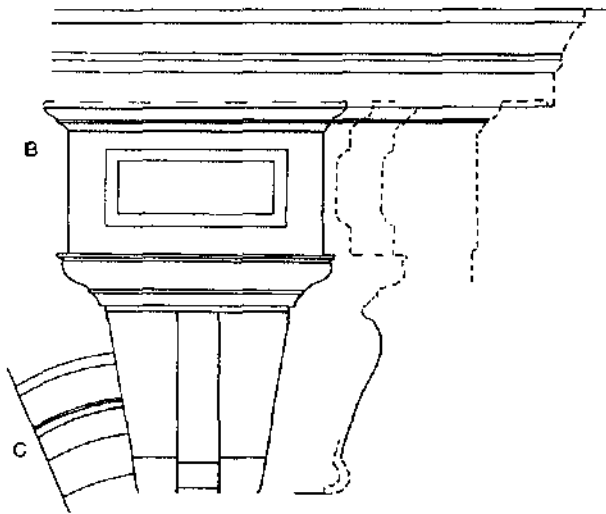
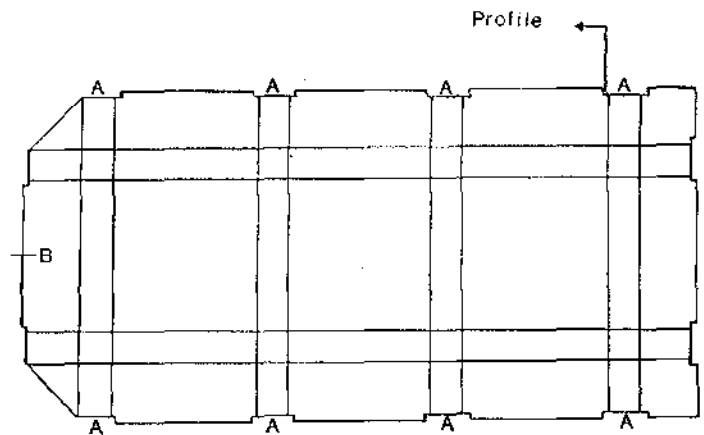
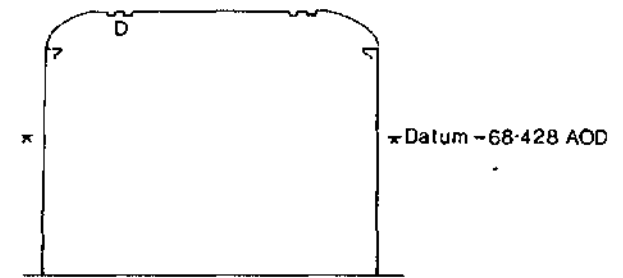
Trading hall

Structure O had been identified by the documentary-based model as a building requiring further examination because of the lack of documentation relating to it. In addition, the function of this originally free-standing, hipped-roofed, load-bearing, brick structure was in doubt because of the ornate plasterwork which appeared to be more in keeping with a religious hall. Examination of the structure, which is rather commonplace, and in particular the plasterwork, has led to the conclusion that the rather heavy design is more in keeping with a Victorian imitation than a Georgian building, as was originally proposed. Re-examination of the documentary evidence, namely two plans made in 1857 and 1875 of the rear of Owens Mansion, before and after redevelopment by the draper Thomas Hall, confirms that this building, called the show room, was built like the Arcaded Hall, sometime between 1857 and 1875, as the area covered by the building was, in fact, at an earlier time a scullery and store. Prior to demolition it may be appropriate to inspect this structure in more detail in order to check further the layout and development of the complex.
