**Archaeological Recording at  
Eastcote Manor Moat Bridge,  
Solihull, West Midlands**

Birmingham University Field Archaeology Unit  
**Project No. 446**  
January 1997

by  
Mark Hewson

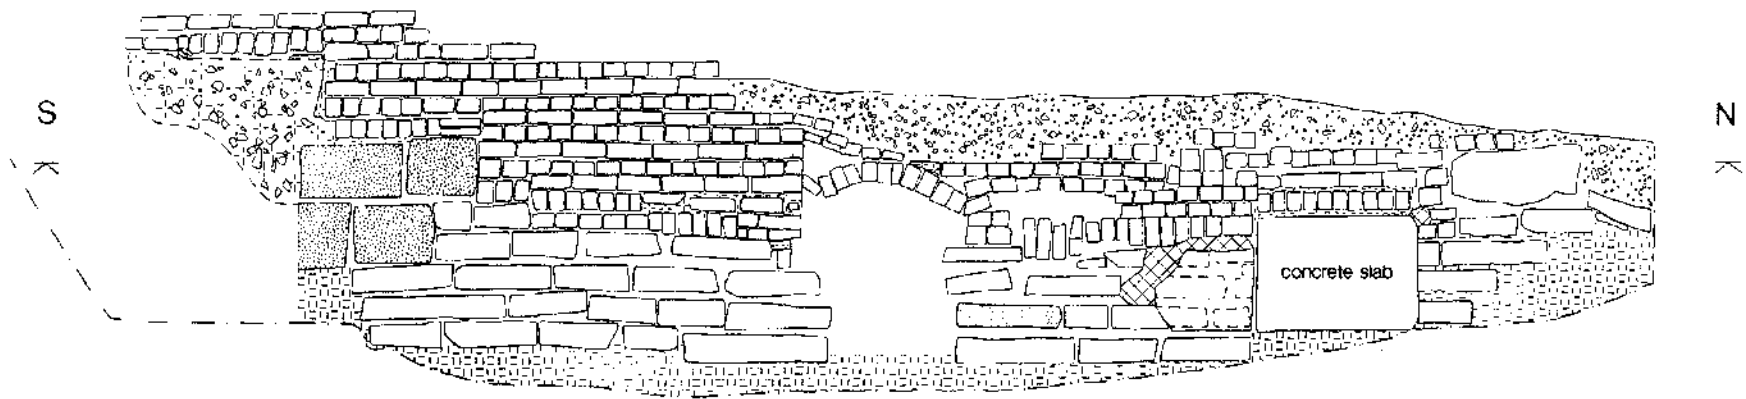
Fig.3

The earliest phase of the surviving structure on the north-east facing elevation was made up of four courses of dressed green sandstone. Commonly these blocks measured c. 0.13m. in height and were cut to a variety of lengths (for detail of all dimensions see figure 3). These courses were loosely mortared together with yellow sandy mortar which was waterlogged and in a bad condition. Natural red clay appeared to be sealing the joints, though whether intentionally incorporated or naturally deposited during the life of the structure is unknown. At the southern end of the structure, four large blocks of dressed and mortared red sandstone, above the green sandstone and abutting the brickwork could be seen (for dimensions see figure 3). It was evident that further blocks of red sandstone continued into the moat bank at this end; however further recording here was not possible due to difficulties of access. The northern extremity of the structure had in recent times been partially reinforced, to the depth of the foundations, with what appeared to be a reused concrete paving slab. Subsequent to the recording of this modern addition, the slab was removed, revealing that the course of green sandstone blocks continued across the length of the structure. The concrete slab was bonded to the earlier sandstone courses with roughly applied concrete. The remainder of the structure on this side was made up of c. 0.80 - 1.00m. of modern brickwork bonded below to both the red and the green sandstone. This brickwork was for the most part arranged in alternating courses of headers and stretchers and terminated in a parapet that ran the length of the bridge, although the parapets on both sides of the structure had been removed prior to the current phase of rebuilding work. The arch was made up of a single span of eight modern bricks mortared together and bonded below to the brickwork of the most recent build of this elevation. It was clear that the arch was in a poor state of preservation due to root action in and around its supporting structure and to the weight of modern vehicles passing over the bridge.

Following the recording of this elevation, the contractors were able to remove c. 0.50m. of the structure along the length of the bridge and to excavate down a further 0.75m. below the moat's water level. This work revealed that the natural red clay continued to at least this depth, but there was no sign of the natural sandstone geology as is reportedly the case for the south side of the moat (Joint Data Team, Brief for Archaeological Recording at Eastcote Manor; Solihull, West Midlands). Additionally, this work revealed that on both sides the outer bridge structure, in its earliest extant phase, was made up of green sandstone to a width of two blocks, the core of the bridge being made up of a matrix of silty-clay and gravel. At the level of the more recent brick courses the core of the bridge was made up of matrix of silty-clay and gravel plus modern brick and tile rubble.

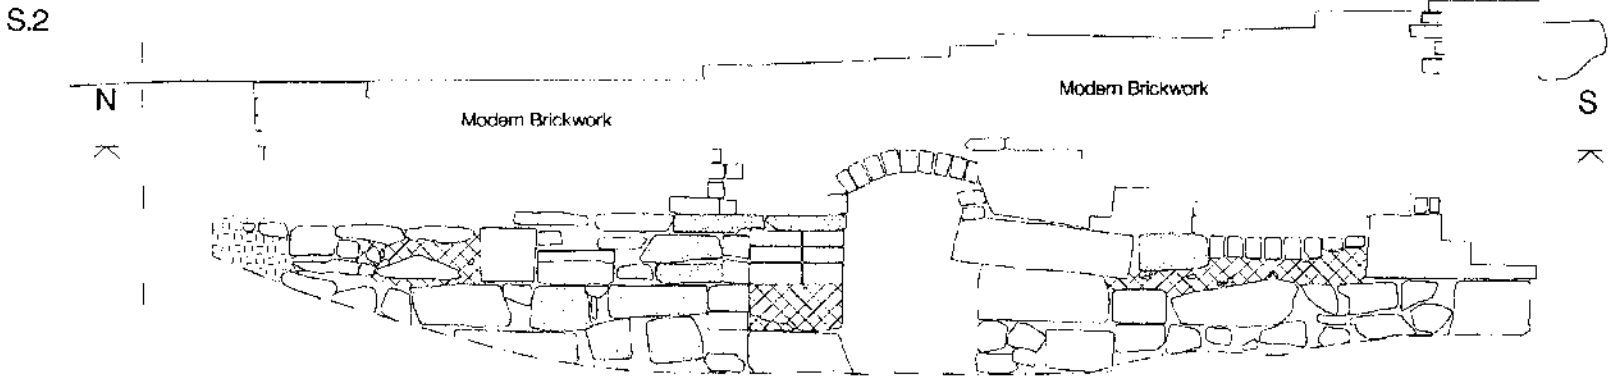
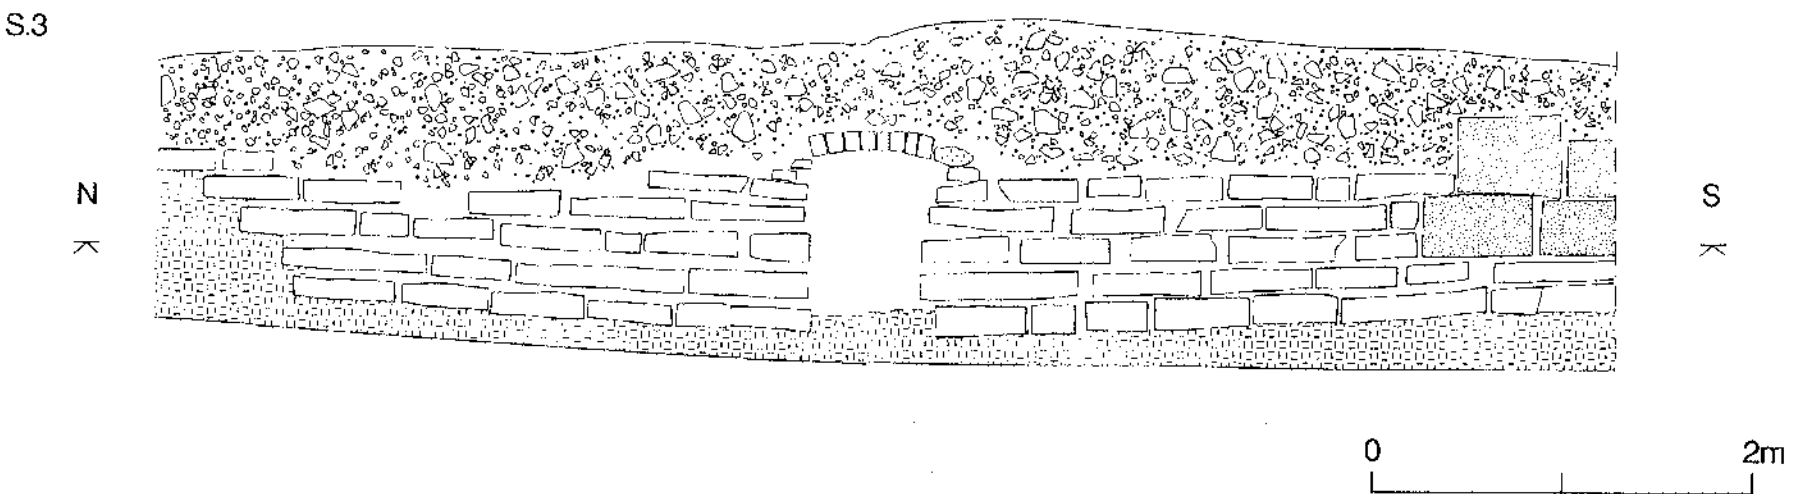
Fig.4

This elevation was prepared and recorded in the same way as the above mentioned north-east facing elevation. The lowest courses appeared to be in worse condition than those of the north-east facing side. Blocks of dressed green and red sandstone were included throughout these lowest courses. Modern brickwork made up most of the bridge structure on this side, much of which was in poor condition, with the exception of that at the southern end. The arch was of mortared modern brickwork, also in poor condition due to root action and the weight of vehicles passing above. Following the conclusion of recording work on this side the contractors again were able to remove the outer 0.50m. of the structure along the length of the bridge and to excavate down 0.75m. below the water level. This work revealed (as expected) that the whole bridge appears to be founded on natural red clay. In addition the removal of the outer 0.50m. of the structure here revealed an earlier phase of the bridge. This was similar to the primary phase on the north-east facing side. There were five courses of dressed green sandstone blocks c. 0.13m. in height and of various lengths (for dimensions see figure 4) running the length of the bridge. These blocks were bonded together with yellow

sandy mortar similar to that of the north-east facing elevation, though in this case the mortar appeared to be in better condition. At the southern end it was observed that a series of large, dressed red sandstone blocks had been added. These were bonded to the green sandstone blocks with what appeared to be a similar mortar to that bonding the green blocks themselves. Above the green blocks, the remainder of the structure here was made up of modern brick and tile rubble plus silty-clay and gravel.
