Birmingham University Field Archaeology Unit  
**Project No.521**  
March 1998

**A short report on two pieces of archaeological recording  
at Stokesay Castle, Shropshire, for English Heritage**

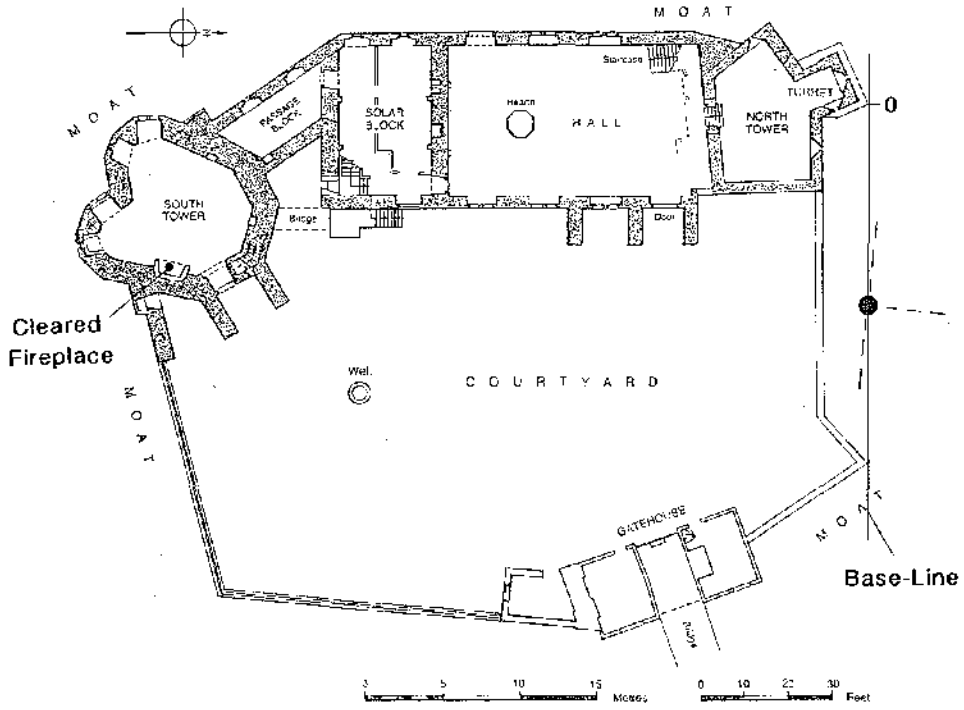
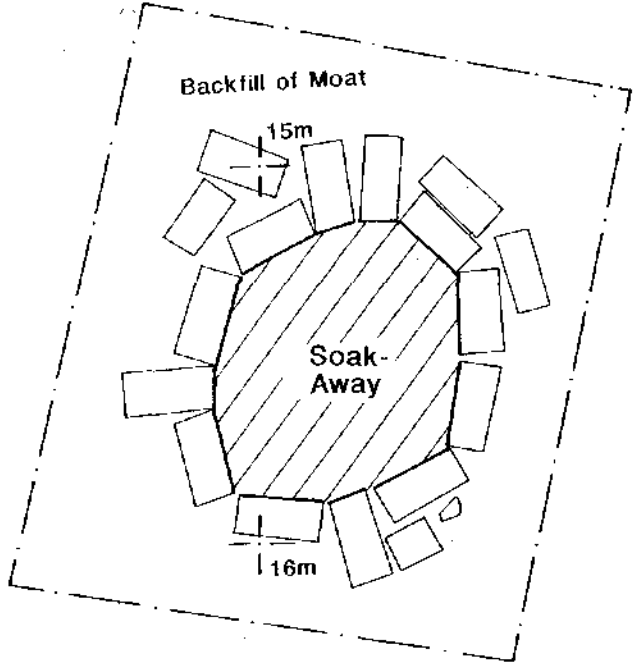
Fig.1

A trial pit was opened around the brick-lined feature in the moat, and the overlying topsoil and degraded timber-cover removed. The remains of a rusted sheet of galvanised steel, which sealed the whole of the feature under the rotted timbers, were also removed. The topsoil contained a mixture of pottery of late-19th century, and recent, date, together with a few broken stone roof tiles, which had spilled from a pile of demolition material dumped into the moat over the curtain wall of the castle. The circular feature measured approximately 0.6m in diameter internally and was roughly 1m in depth, but was half-filled with loose soil and rubble (Plate 1). The sides were built of red brick laid in a single-brick-thick, stretcher bond wall which was not mortared together. The bricks were frogless, and measured nine inches in length by four and three-eighths of an inch in width and three inches in depth. The bricks, which were regularly-fired with very few inclusions and of a very uniform size, were probably mass-produced using a cutting rather than a moulding method. Traces of mortar adhering to the bricks indicated that they had been salvaged and reused. Three clay-pipe drains fed into the feature from the north, east, and west.

The feature is interpreted as a soak-away of fairly recent date, constructed to aid drainage from the moat. From a site management perspective, the soak-away probably still retains a useful function and is structurally sound. It is suggested that the soak-away be made safe by the provision of a drain-cover of an appropriate design and size. This would also allow regular maintenance of the drains.

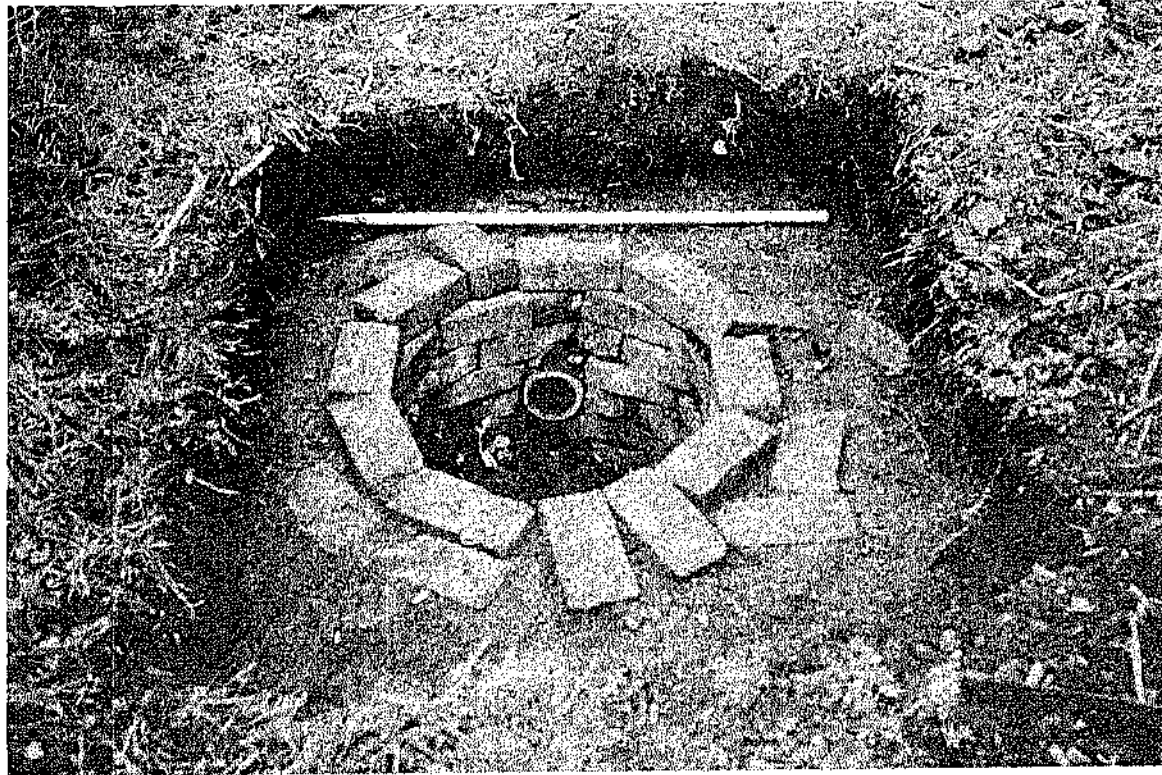
| Plate 1 | Soak-away |

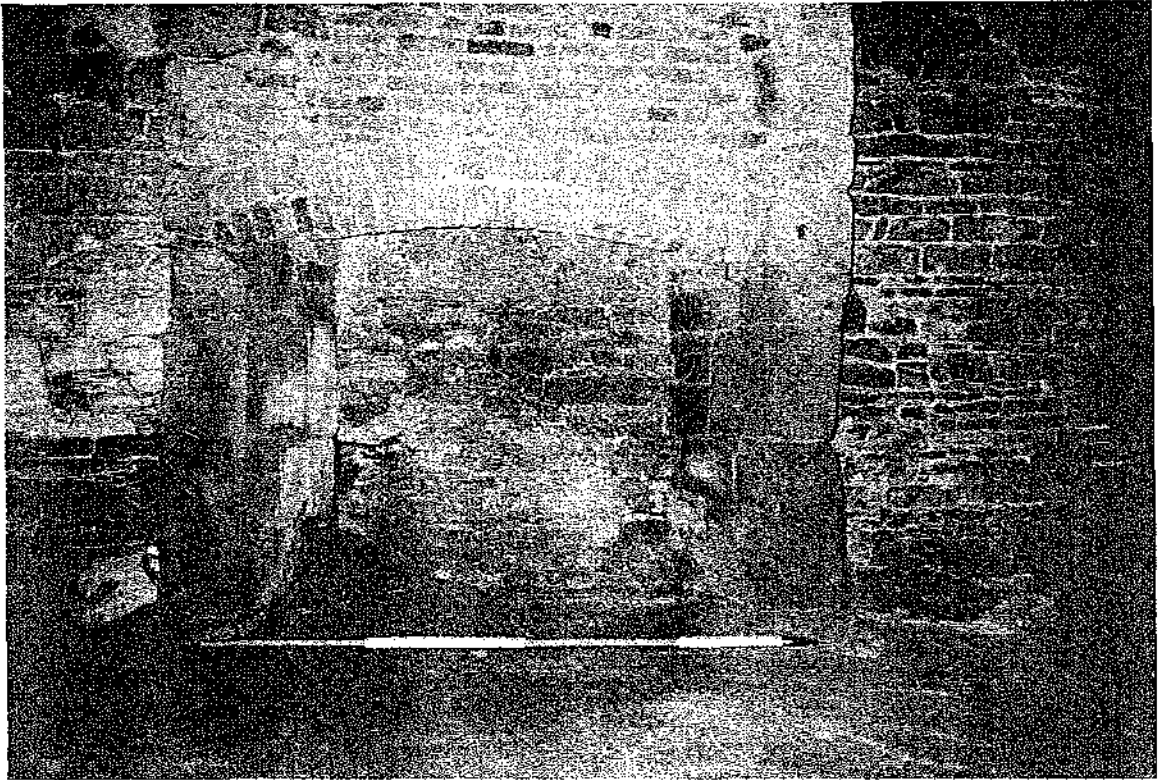
The fireplace inside the south tower was cleared of debris which was sifted for artefacts of archaeological interest before disposal of the waste material in plastic bags (Plate 2). Apart from a mixture of soot and sand, several bricks and fragments of stone had dislodged from the chimney lining. This material had spilled into the fireplace after a lathe-and-plaster ceiling, which blocked the chimney, partially collapsed under the weight of the accumulated soot and debris (Plate 3). The bricks and stone fragments were bagged and placed in the store next to the toilets. A collection of pens and pencils, two broken bottles of 'Tizer' and 'Vimto', an empty packet of pre-government health warning Players No.6 and an empty box of pre-decimalisation Swan Vesta Matches, seems to indicate that it is possible for visitors to throw things down the chimney.

| Plate 2 | Fireplace, after cleaning |

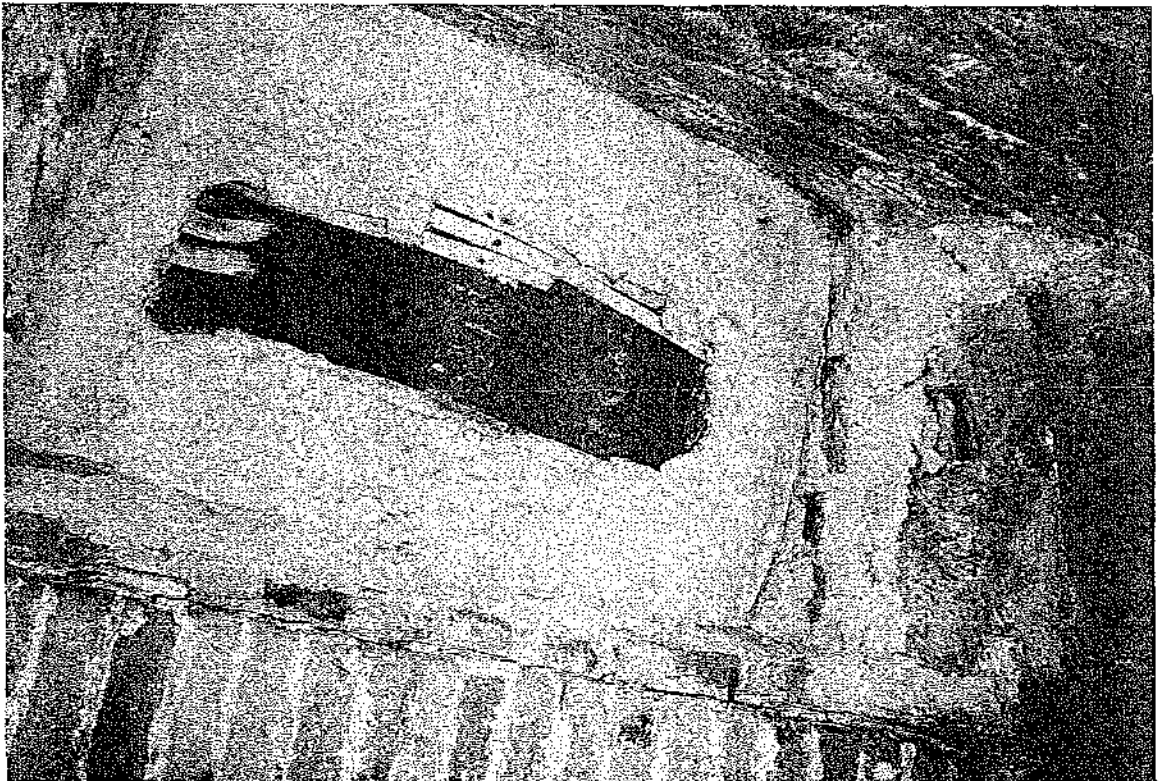
The accumulation of debris in the fireplace was due to the failure of the lathe-and-plaster blocking of the chimney. It is suggested that the part of this blocking which remains *in situ* either requires repair, or complete removal. The quantity of material which had accumulated in the fireplace would also suggest that the chimney-lining is in need of repair. After repair work on the chimney has been carried out the installation of an openable mesh grille in the chimney might be considered. This would retain ventilation through the chimney, thus diminishing problems with dampness, while catching any large objects thrown down, or becoming dislodged from the chimney. Any small material weathering from the chimney-lining could then be brushed regularly from the fireplace, which, combined with visual inspection, would also provide a warning of any imminent repair work being necessary.

| Plate 3 | View of damaged lathe-and-plaster blocking of chimney |
