**Himley Quarry, Stallings Lane,  
Kingswinford, West Midlands**

**Archaeological Field Survey**

Birmingham University Field Archaeology Unit  
**Project No. 680.1**  
March 2000

by  
CHRIS HEWITSON

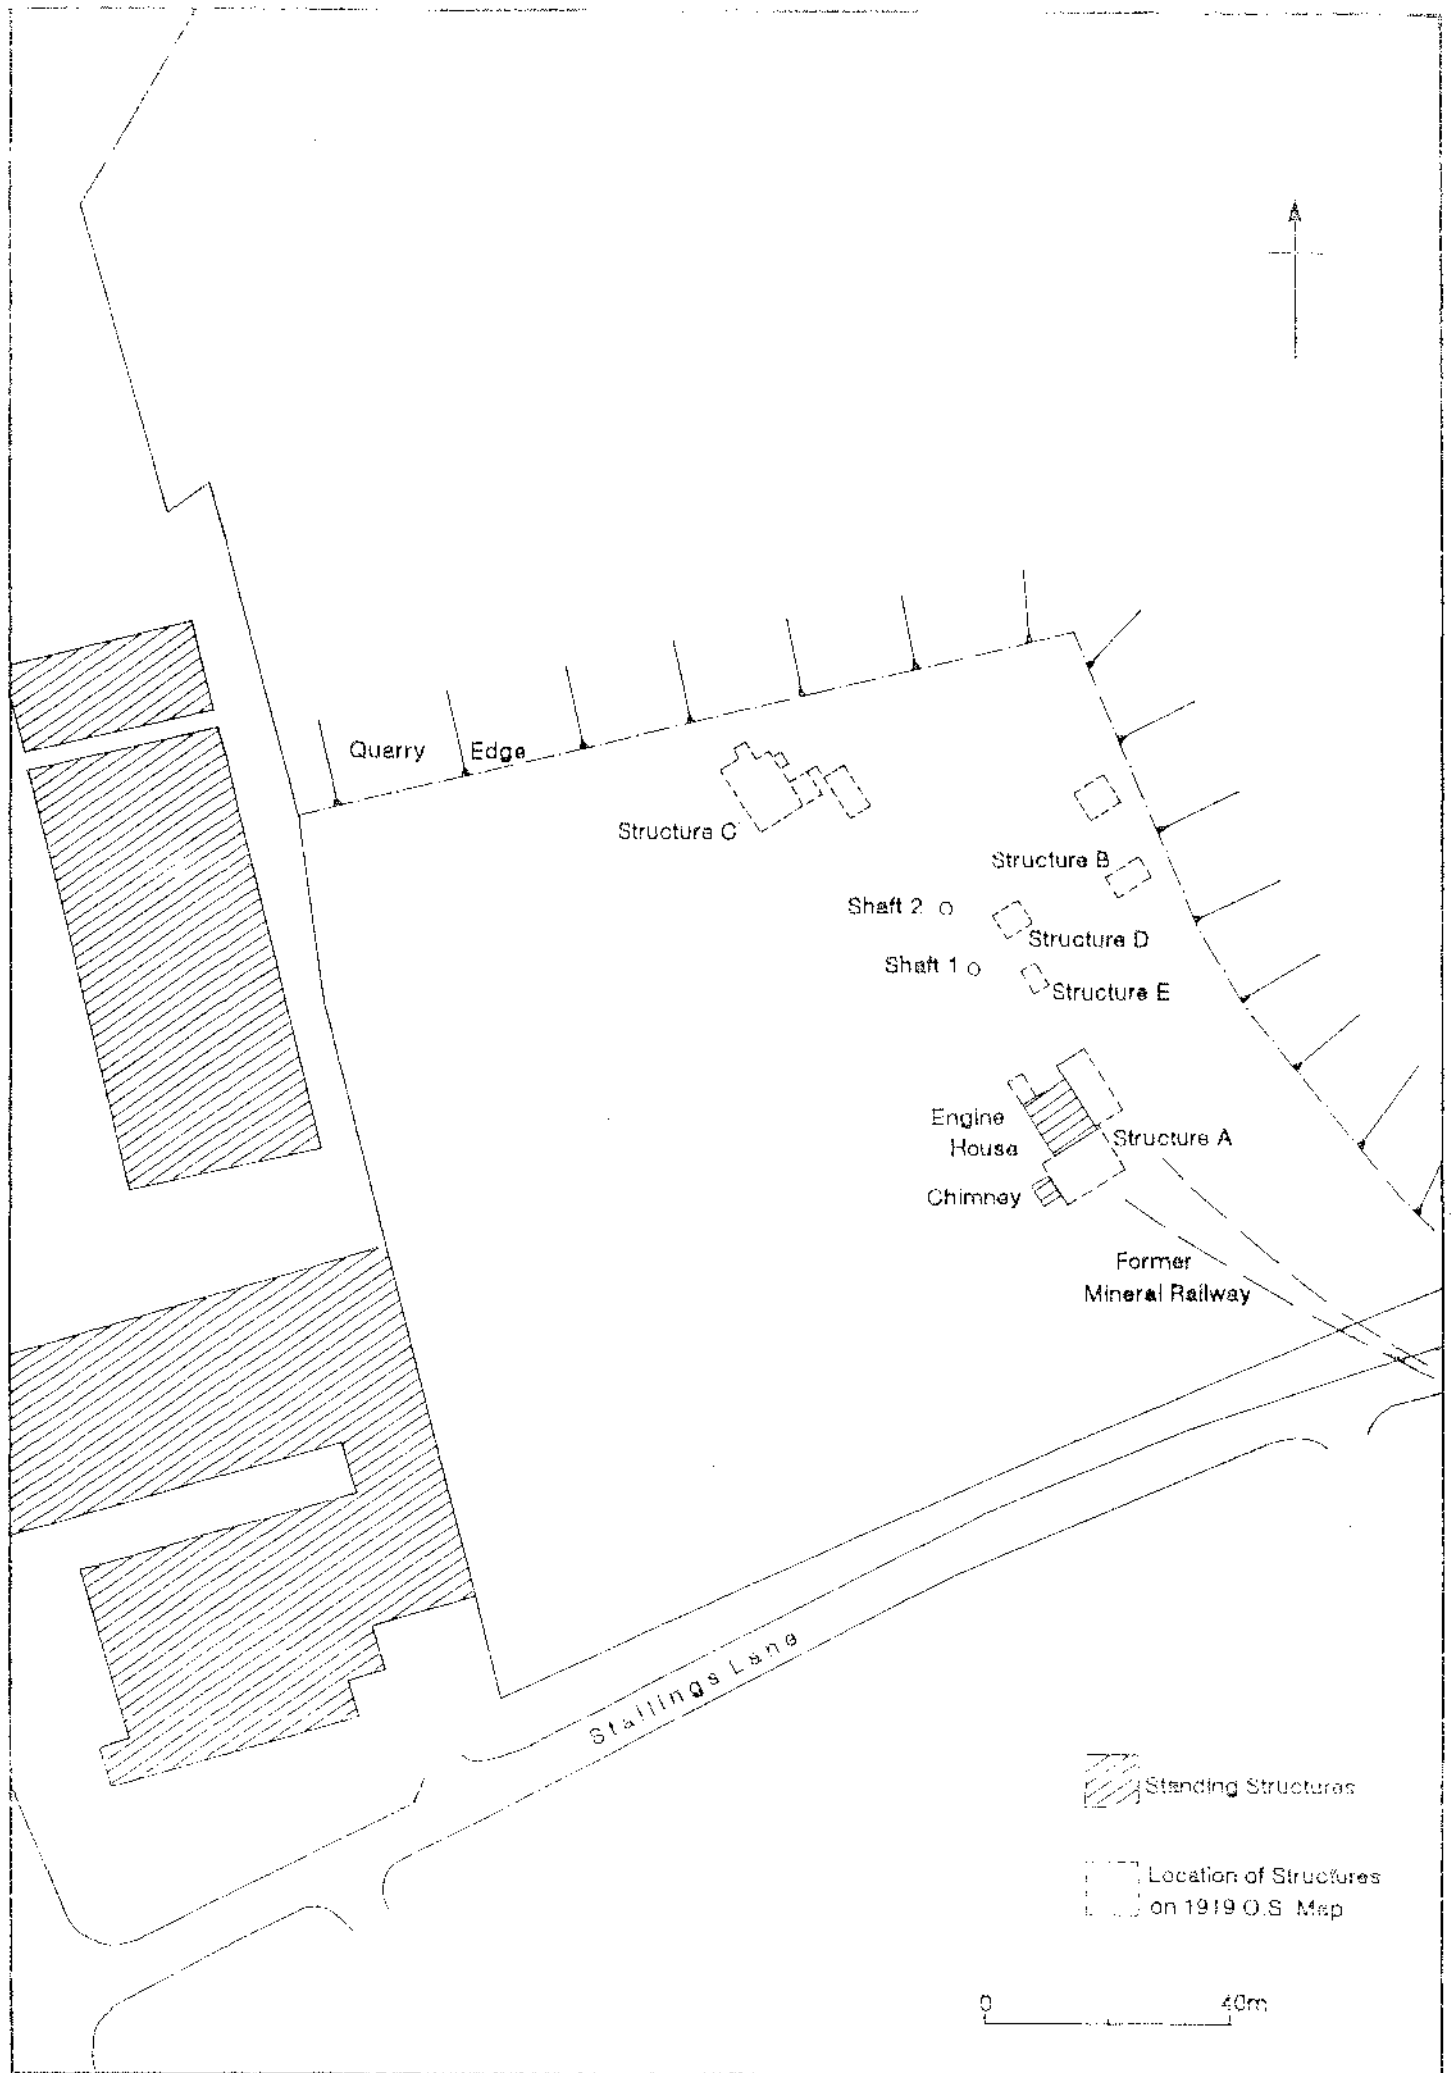
Fig.3

The two remaining **mineshfts** detailed in the SMR entries were located c.20-25m to the north of the engine house (fig. 3). Both mineshfts heads were heavily overgrown. The southern shaft denoted as **Shaft 1**, was c.2.3m in diameter. It was constructed in clamped brick, and filled with loose rubble and soil with a single metal shaft extending vertically upwards, leaving a remaining depth of c.1m. The second shaft, **Shaft 2** was located c.8-10m to the north. Its diameter was c.2.2m, with it being filled with loose rubble leaving a depth of c.0.4m. It was constructed in machine-cut engineering bricks and was of later construction than Shaft 1. A low remnant of rectangular plan wall was located adjacent and to the east of the shaft.

The remains of the **Stables** mentioned in the SMR reference have entirely been demolished. They are located directly adjacent to the quarry edge (Fig. 3), which appears to be located further east than denoted on the quarry map (Fig. 2). All that remains is a moss-covered rubble spread, c.20m in length north - south and c.10m wide east - west. It survives to a height of c.0.5m in the north-west corner. Clearly the stables had been levelled some time ago. The size of the spread suggests it may be a combination of the demolition of the two buildings (the **Stables** and **Structure B**, Fig. 3) visible in this locale on the 1919 Ordnance Survey Map.

The walk-over survey revealed the remains of part of **Structure C** (Fig. 3) located c.30m north-west of Shaft 2, 10-15m from the quarry edge. It was represented by a roughly circular rubble spread c.3m in diameter, with a metal rod sticking out. A single three-course wide wall, four courses high survived to the east. Clearly this cannot represent the structure in its entirety and further remains must exist below ground.

The remains of **Structures D and E** (Fig. 3) were not located by the walk-over survey. Likewise, the remains of the **mineral railway** (Fig. 3) were not revealed. However, the area of land to the south-east of the engine house complex was clearly raised above that which sloped away to the road. This may represent the remains of an embankment, which has been subsequently obscured by the deposition of mining spoil.

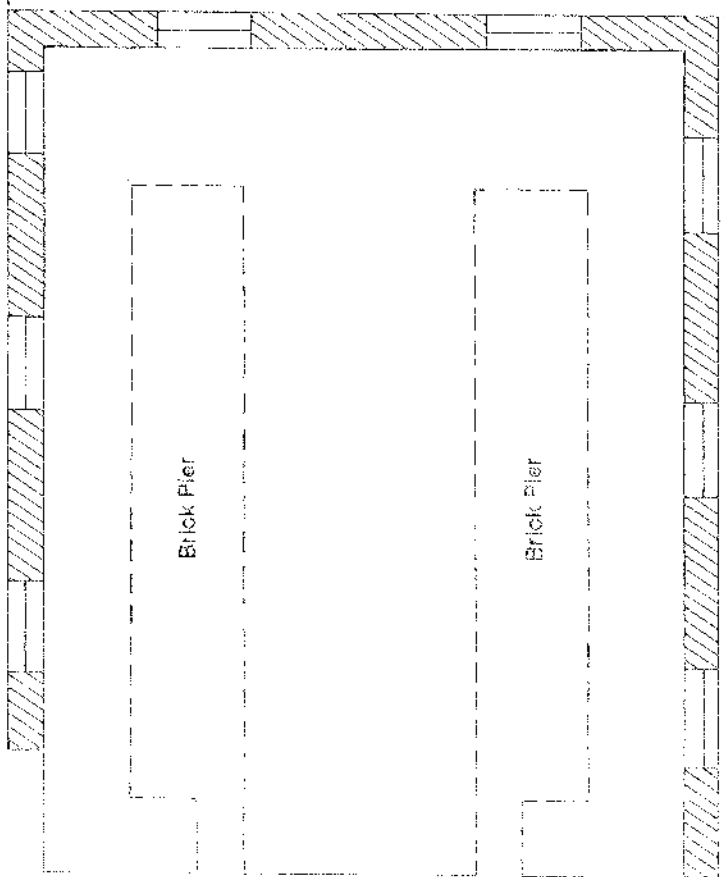
The ground plan of the building is still visible (Fig. 4). The interior is sunken in comparison with the surrounding levels (Fig. 6b). Three brick walls sunk down within the footprint, and running the length of the building were noted; these were presumably the engine plinths. In the north-west corner of the building, an entrance slopes down to the sunken levels of the interior.

To the south-east of the engine house and in front of the flue of the chimney, is a series of **three parallel brick plinths**, approximately 6m in length and 1.5-2m wide (Fig. 4). They appear to relate to the engine house, and lead to the flue entrance, suggesting that machinery which related the two structures was located here. The 1919 Ordnance Survey Map shows a structure (**Structure A**, Figs. 3 and 4) between the chimney and engine house that relates in plan to these brick plinths and is directly associated with the chimney flue. However, this structure would have obscured the two openings in the south-east wall of the engine house, and there is little evidence they were blocked-in. Two possible explanations exist. One, this structure was later than the adjacent chimney and engine house. This can be discounted because the engine house and chimney are of identical build, and the structure between them clearly relates one to the other. Therefore, a contemporary build of the complex would seem more likely, with the connecting structure a low building which did not obscure the windows.

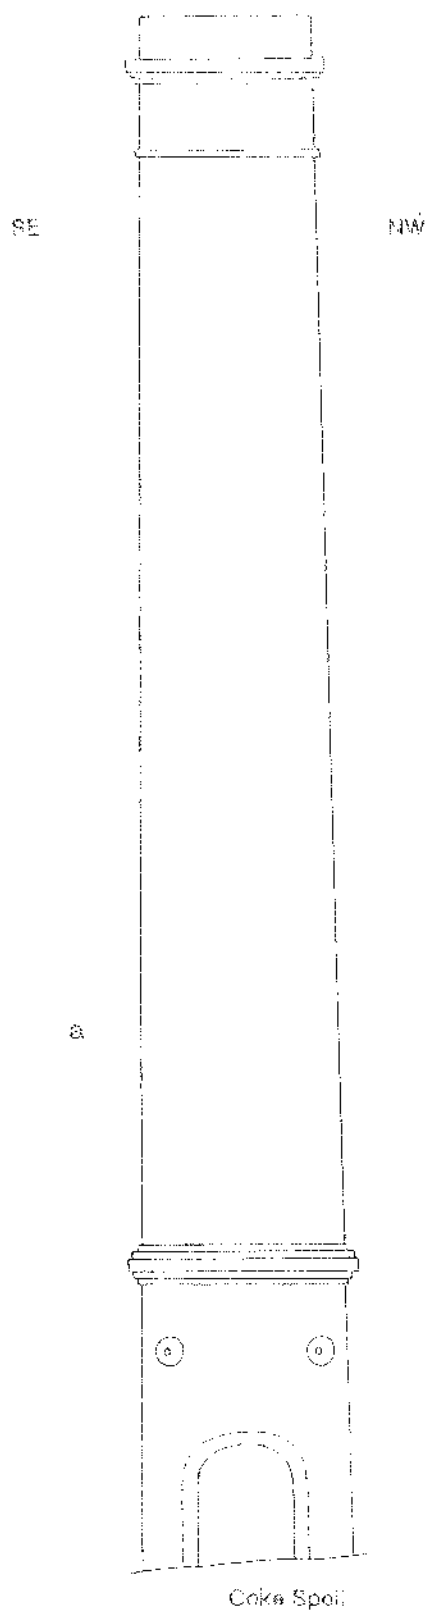
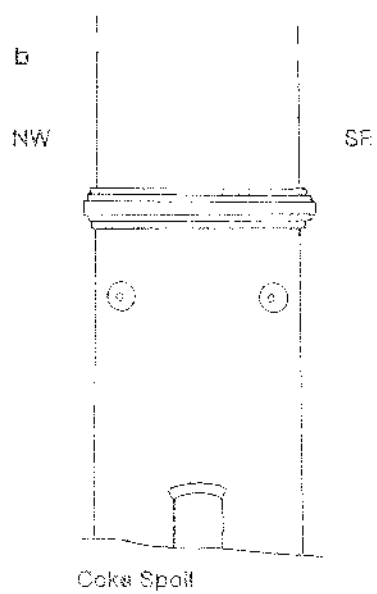
Fig 7

The **chimney or boiler stack** (Fig. 7a, Plate 5) is well-preserved and survives to its full height of c.18m, tapering from 2.45m (8 feet) square at its base. It is constructed from a mixture of red clamped bricks and blue engineering bricks, in the English Garden Wall bond. The size, age and bond of the bricks suggest the structure was contemporary with the engine house. The north-east elevation has a semi-circular arched flue hole at the base of the chimney (Plate 6), around which is decorative two-course, cut brickwork. The reverse elevation (Fig. 7b) has a small, segmental-arched opening, for the removal of ash and coke. There are two over-sailed brickwork strings seen at higher levels of the chimney.

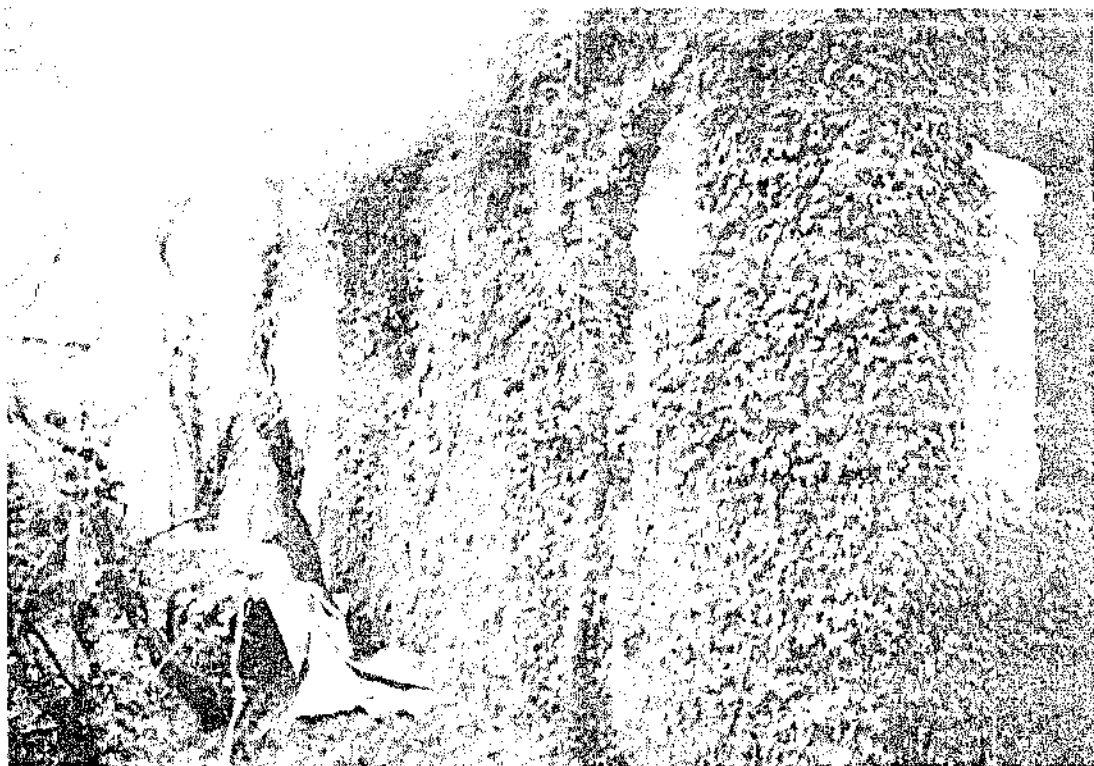
**Plate 3: South-East Elevation of the Engine House**

The south-east elevation (Fig. 5b, Plate 3) is the tallest elevation as the ground level is lowest here. It has two semi-circular arched windows, common in form to those noted above, and set high in the wall. Two small later cut holes are located between the windows.

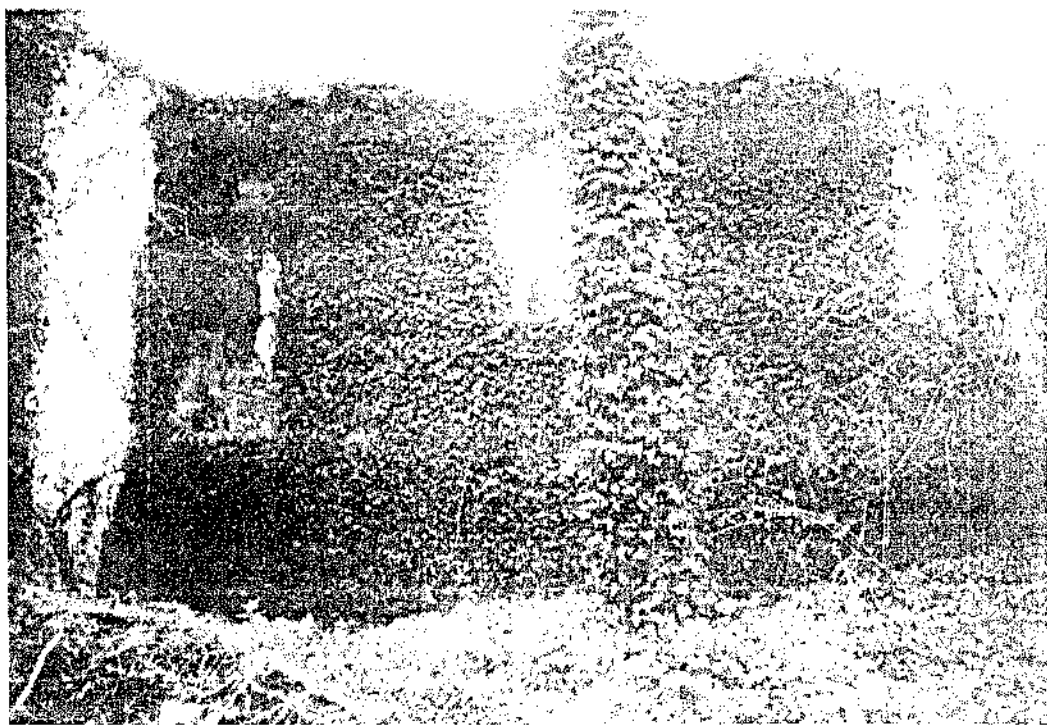
**Plate 4: North-East Elevation of the Engine House**

The north-east elevation (Fig. 6a, Plate 4) like its opposite was originally of three bays, however only one arched window and one rectangular window now remain. The remainder of the elevation has been demolished at the north-west end, including the most northerly window. The form of the windows was identical to those described above in full. The rectangular window appears to have replaced an earlier semi-circular arched window. The 1919 Ordnance Survey Map reveals a small structure at
