**An archaeological
assessment of the Old
Farmhouse and Dairy,
Merridale,
Wolverhampton,
Black Country**

Birmingham University Field Archaeology Unit
Project No. 777
March 2001

by
Stephen Litherland and Sarah Watt

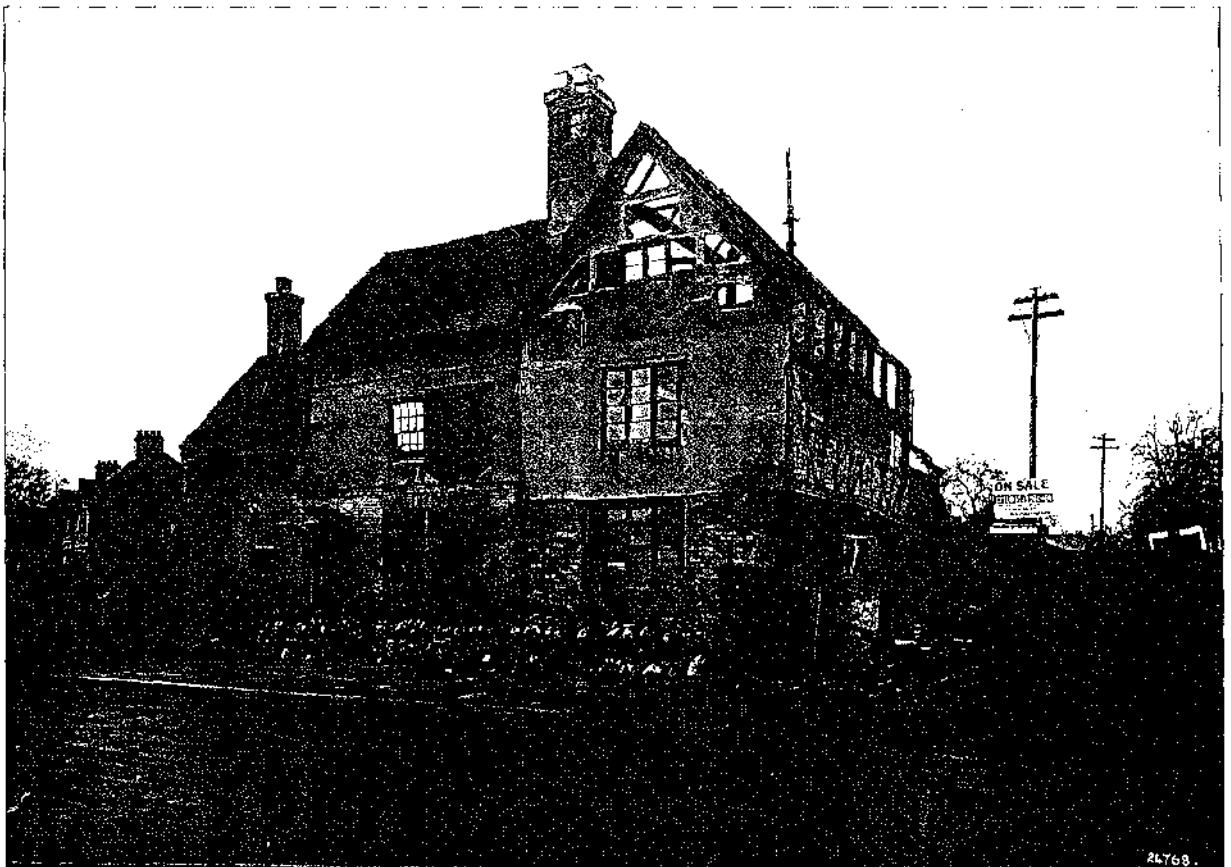
Plate 5

Photographs taken by Mander in January 1930 show the farmhouse in a very dilapidated state (Plates 4 & 5). The cross-wing was missing its roof tiles and most of the uppermost panels of the timber frame were empty. The cross-wing retained the suggestion of a jetty on its northern face, although the jetty of the eastern gable had been under-filled with brick. Shortly after these photographs were taken, the surveyed building was refurbished and the ground floor converted into three shops. There was a plan drawn up in c. 1930 that illustrated the floor plan prior to these alterations (Fig. 6). By 1938, housing development had encroached on the site of Old Merridale Farm. Merridale Avenue had been inserted to the north of the farmyard and rows of semi-detached houses were built on the land previously covered by gardens and fields. The pond was also filled in and partly built over. The northern range of farm buildings was demolished, along with a house to the west. A further set of photographs taken in 1961 shows another campaign of repair to the farmhouse. These photographs also show the remaining farm buildings along Merridale Lane shortly before these were demolished. The light style of the timber framing, together with large brick-filled panels and sawn-timber kingpost roof, are all indicative of an 18th-century date of build.

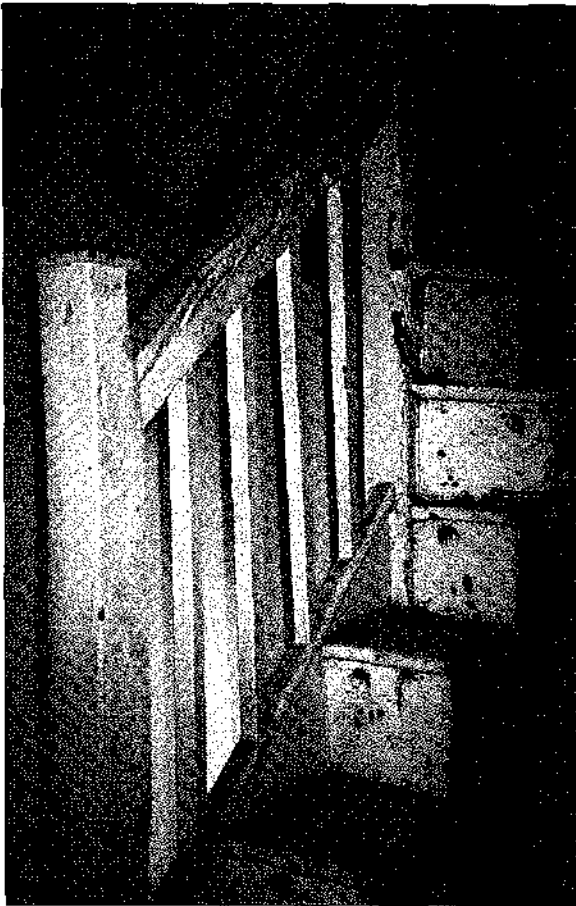
Plate 7

Staircase: Newel post staircase, original to gabled stair tower (Plate 7). Newel posts and handrails pegged together, but risers and treads have probably been replaced. Original horse hair based plaster to walls and beneath staircase damaged by water penetration.

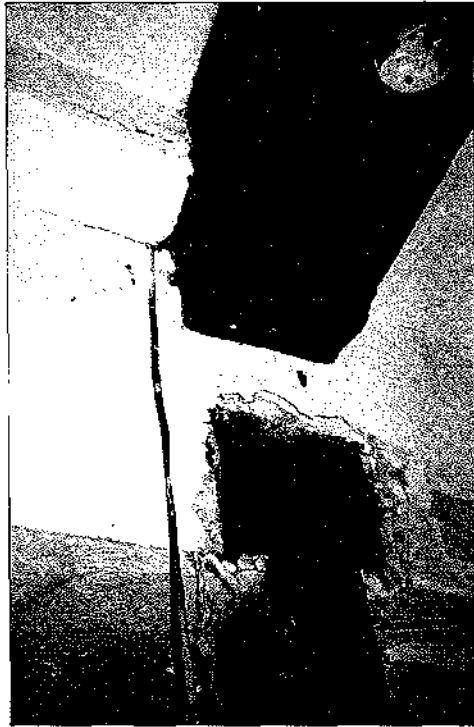
Plate 9

North wall: All modern, see south wall of G1, above. Axial floor beam supported on RSJ after removal of fireplace (Plate 9).

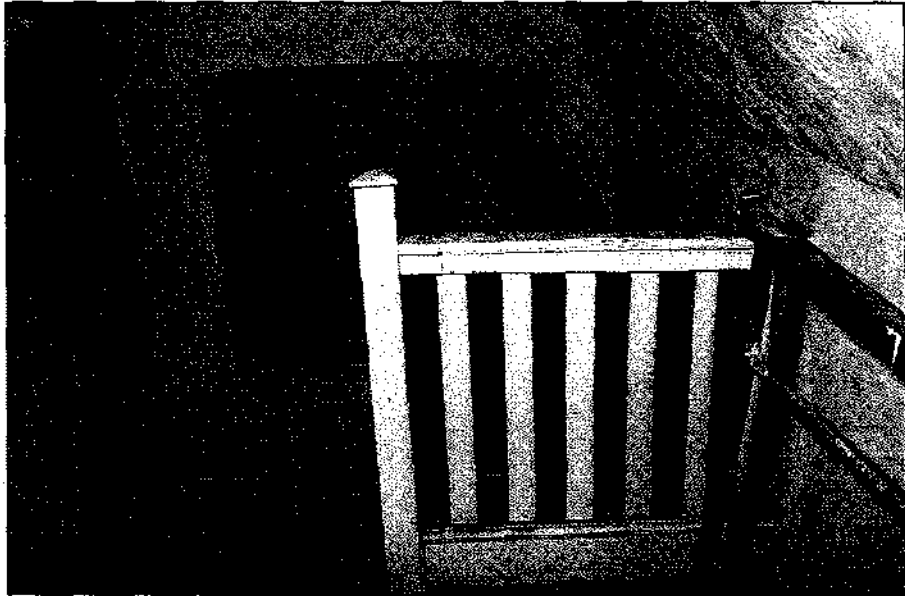
Plate 16

As G3 and S3, below, but not replaced balustrade (Plate 16).
