**An Archaeological
Evaluation and Building
Record of Rock House
Farm and Rock Holme,
Great Haywood,
Staffordshire**

Birmingham University Field Archaeology Unit
Project No. 902
May 2002

by
Malcolm Hislop

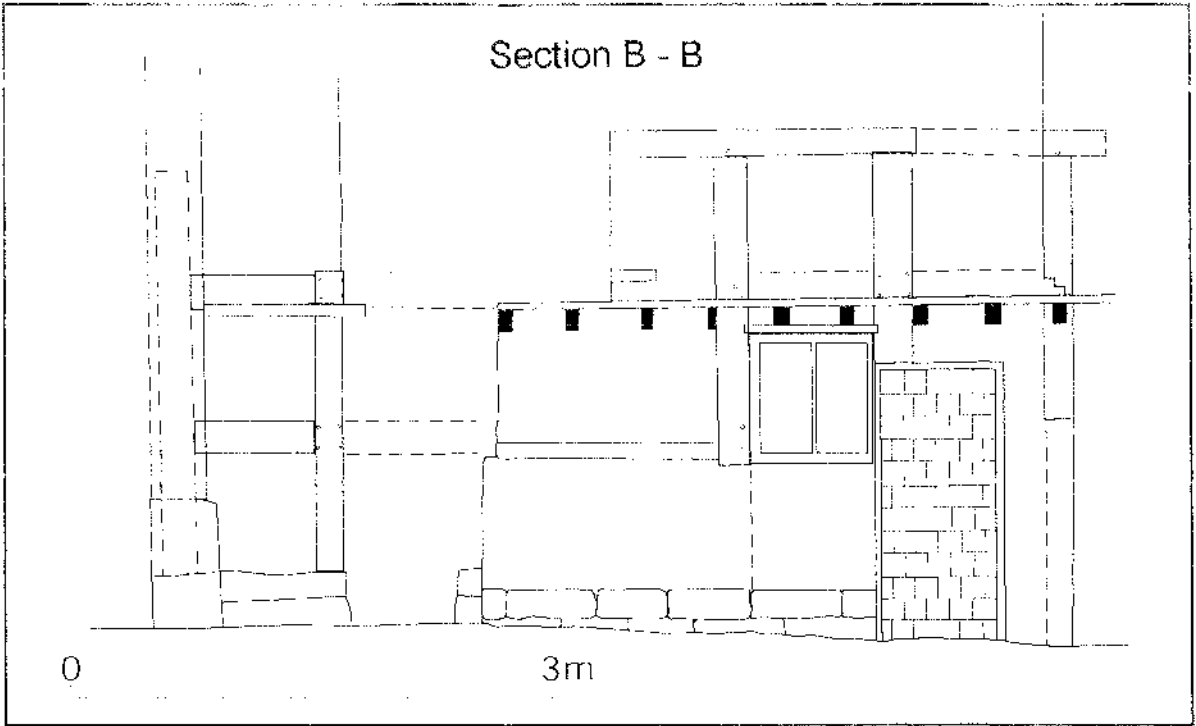
Fig.13

this phase are evident in the east (Figure 13, section B-B), west (Figure 8) and north (Figure 14, section C-C) walls of the south bay of Rock House Farm. The frame was of three tiers of rectangular panels, and was 3.16m in height from the bottom of the sill beam to the top of the wall plate. The studs were secured by one, and the rails by two pegs. On the east side (Figure 13) the panels were approximately 0.80m (2ft 7½") square. The frame has been much altered on this side, and it is evident that the doorway from the kitchen (Room B7) has been inserted by cutting through one of the original rails. The existing window to the pantry (Room B4), though it has been placed between two wall posts, has also cut through one of the rails. Towards the north end of the bay, the insertion of a doorway (now blocked) to the pantry has necessitated the cutting away of one of the wall posts.

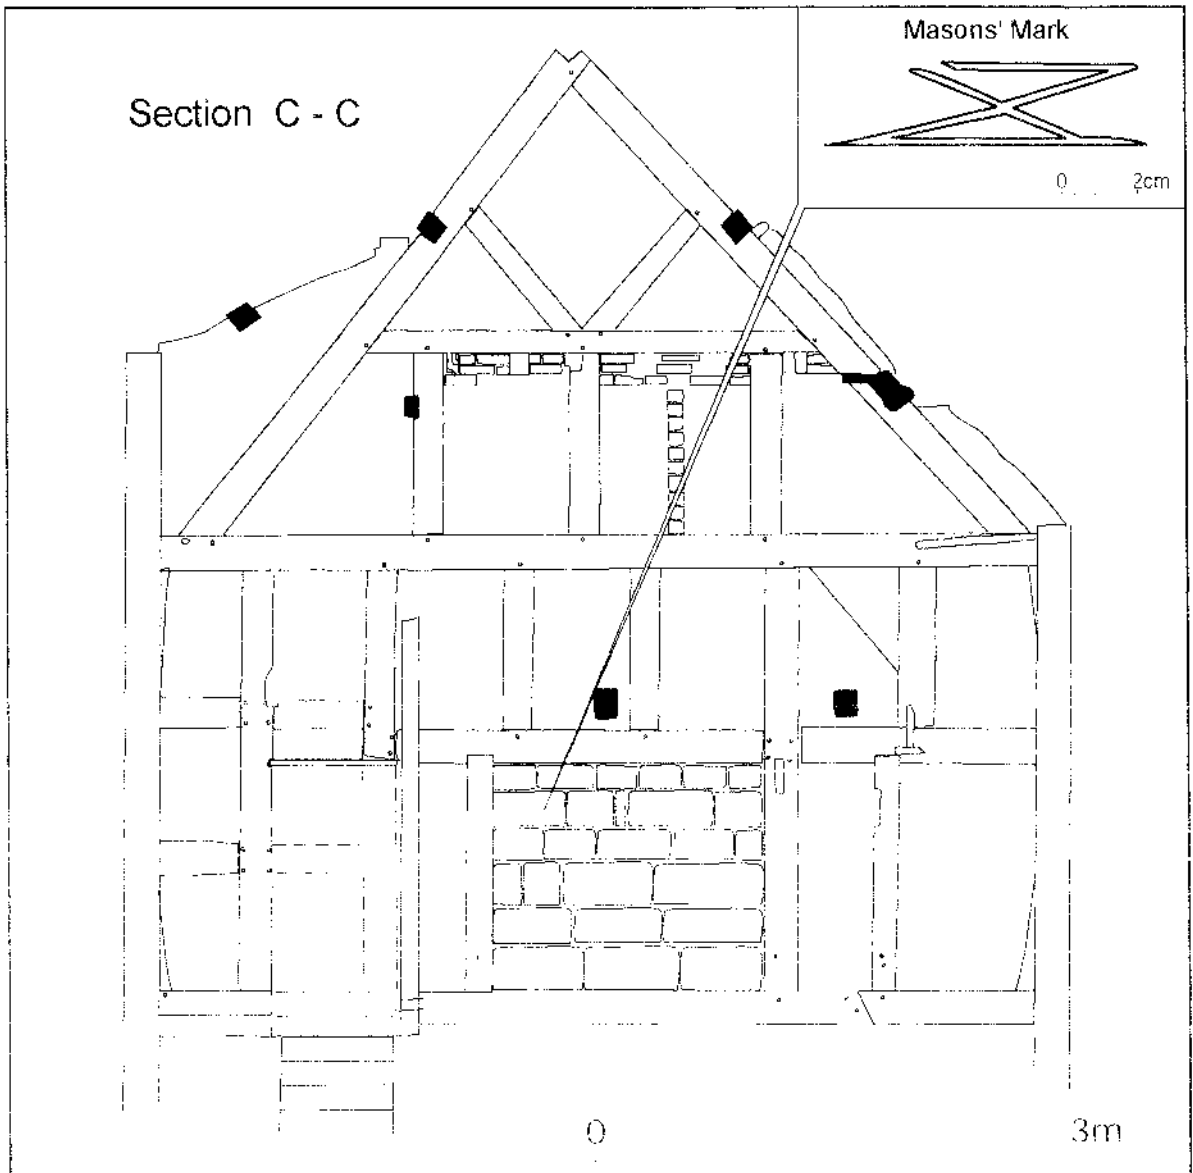
Fig.14

Unusually, the wall posts at either end of the northern frame (Figure 14) are splayed at the foot as well as at the head, suggesting, perhaps, that the sill beams of the east and west walls were set into the backs of the posts, above the sill beam of the cross frame in a reflection of normal wall head assembly. This frame is characterized by a slightly irregular pattern, being divided into three main sections below the tie beam by two posts situated roughly equidistant between the centre of the truss and an outer wall. To the east of the eastern post were three tiers of rectangular panels. The post and one of the rails have been cut away when a door was inserted, but peg holes and an empty mortise allow the original arrangement to be reconstructed. At approximately 1.72m above floor level, the central and western sections are divided horizontally by a middle rail, above which is a tier of rectangular panels. Below the rail, however, the arrangement is unusual. There is no evidence for an original division into small rectangular panels like the rest of the frame, though two studs have been inserted at a later date.

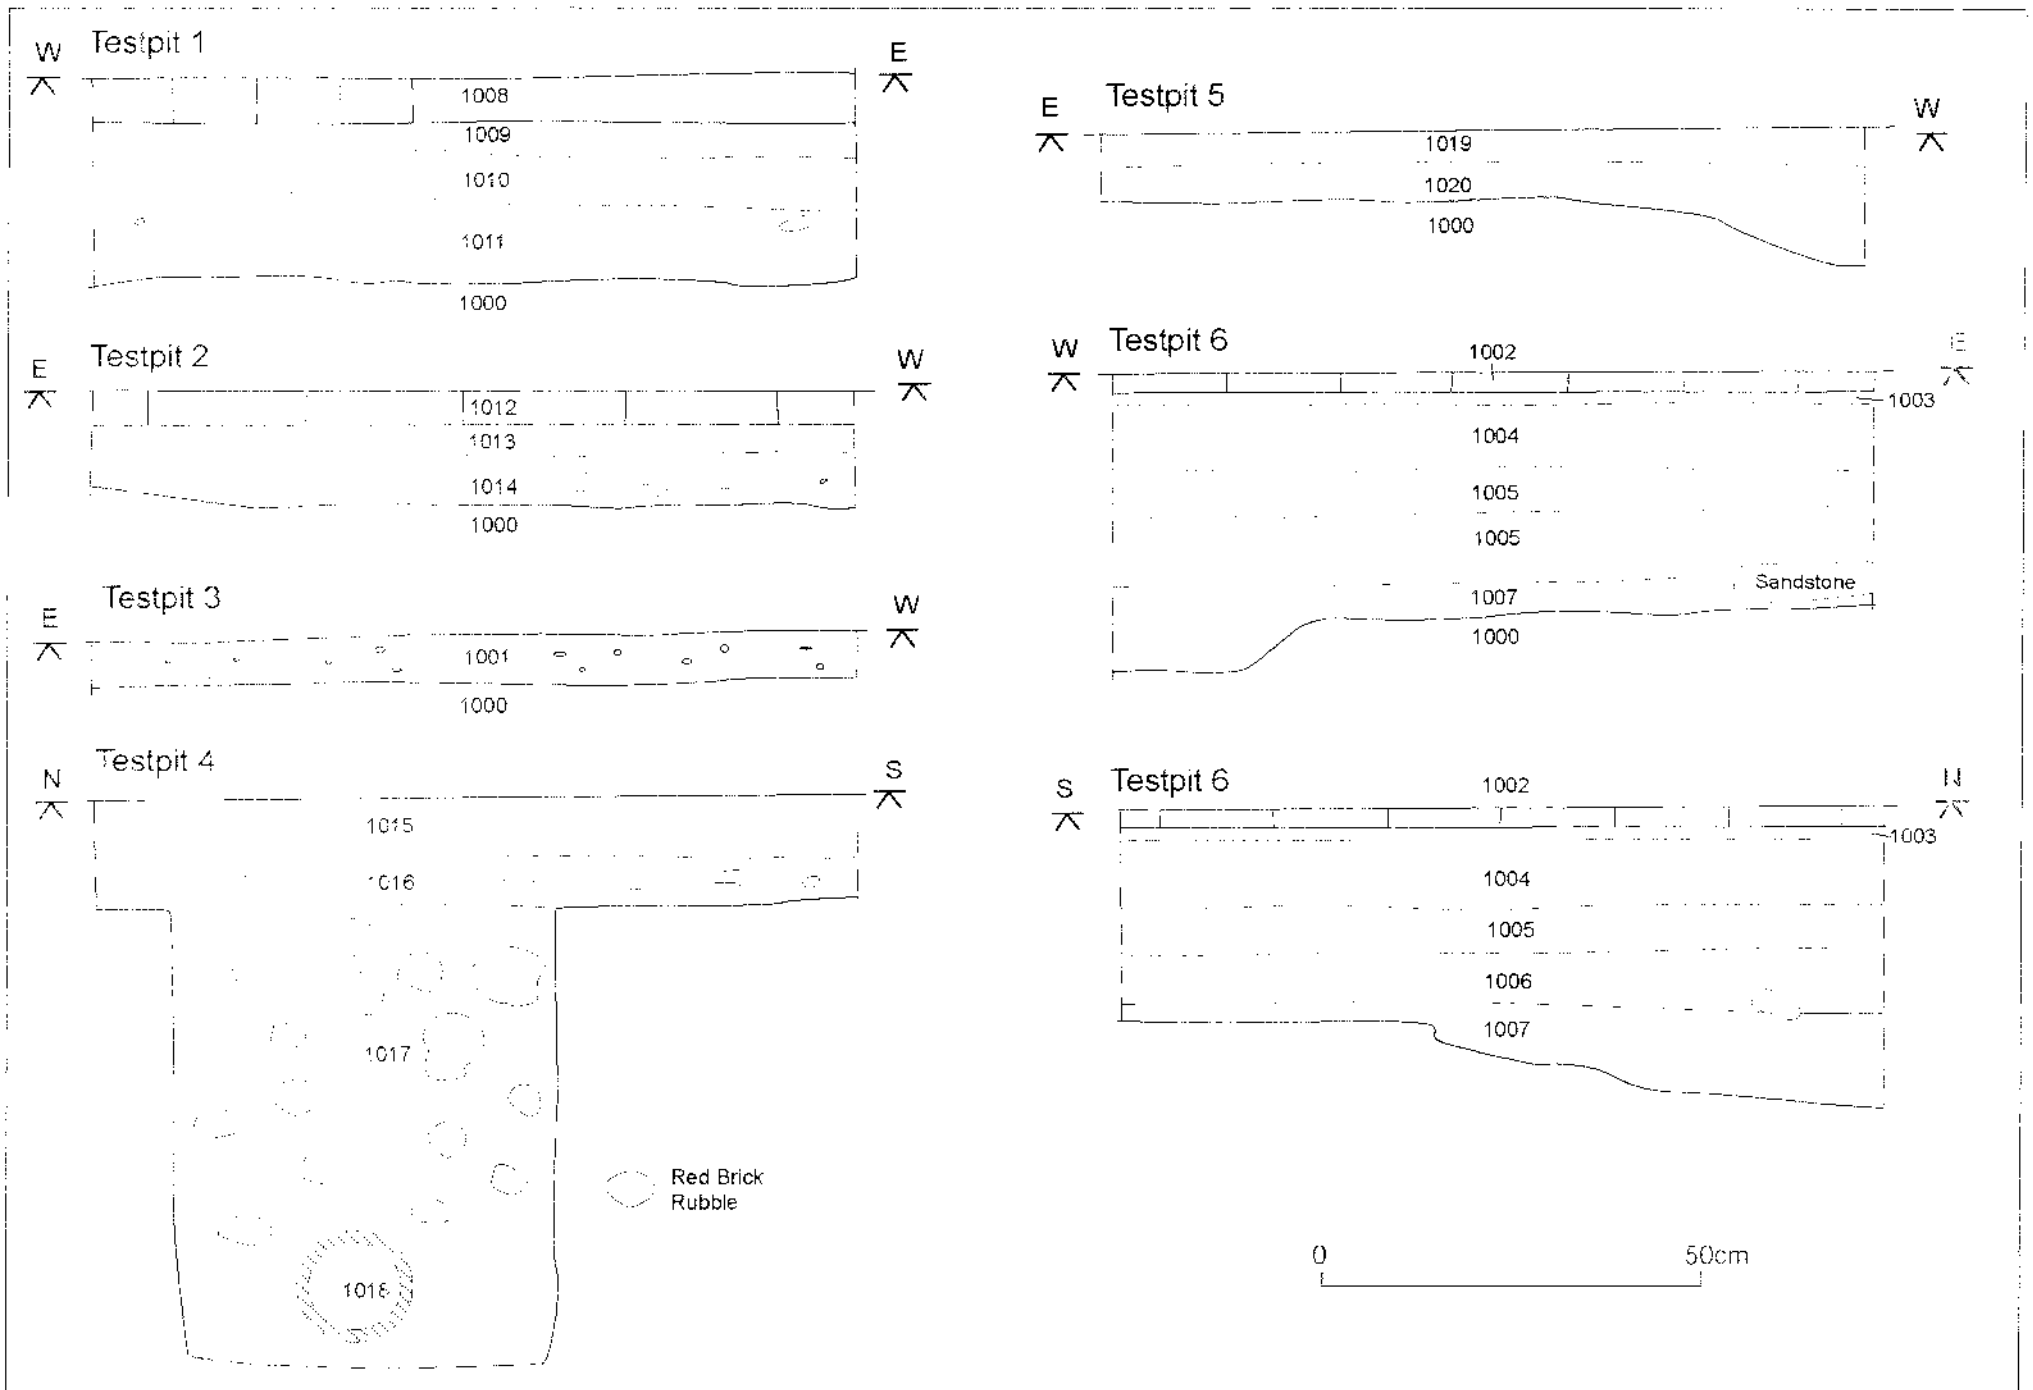
Fig.15

The trial pits (Figures 4 and 15) were situated in rooms A1 (TP 3), A3 (TP 5), A4 (TP 4), B2 (TP 6), B4 (TP 1) and B5 (TP 2). Four of the six pits (2,3,4 & 5) revealed minimal stratigraphy before the natural sandstone bedrock was exposed. In Trial Pit 2 this represented the natural level of the rock outcrop on the south east side of the site. In the other three, however, all situated in Building A (Rock Holme), the level of the rock represented the lowering of the ground surface contemporary with the reconstruction of 1893. The only find recovered was a piece of clay pipe from Trial Pit 2.

The other two trial pits, situated in Room B4 and Room B2 respectively, were rather more productive. Trial Pit 6 revealed a stratigraphic build up of between 0.59m and 0.75m below the tiled floor. Immediately above bedrock was a compact red/brown sand-clay layer (1007) mixed with charcoal and sandstone and pieces of slag, which contained two sherds of 17th century pottery. Above this was a mid-brown silt/sand layer (1006) from which was recovered ten sherds of 17th/18th century pottery as well as one medieval sherd of coarse ware of 13th / 14th century date. Overlying context 1006 was a compact red clay layer (1005) flecked with charcoal throughout, and containing some decomposed straw c. 0.02-0.04m thick; it contained five sherds of 17th/18th century pottery.

The lowest layer of Trial Pit 1 was a loose mid-brown sand/silt layer (1011), heavily flecked with charcoal and slag, and with some sandstone rubble lying across the trial pit and directly above natural. Seven sherds of a generally coarse appearance were recovered from this context. One rim fragment and a green glazed body sherd from another vessel are suggestive of a late medieval date, probably 13th to 14th century.

Regarding the below ground archaeology, the indications are that the early deposits were probably removed from Building A during the last decade of the nineteenth century when Rock Holme was rebuilt. The test pits in Building B (Rock House Farm), however, demonstrate that archaeological deposits of late medieval date may survive. It is recommended, then, that the entire area of the northern bay of the timber-framed house be totally excavated after demolition in order to recover further evidence about the chronology of the site, and about the internal arrangement of the medieval house. In particular, there is an opportunity to locate the position of the open hearth that must have existed in the first building phase, as well as structural evidence contemporary with or earlier than the cruck truss.

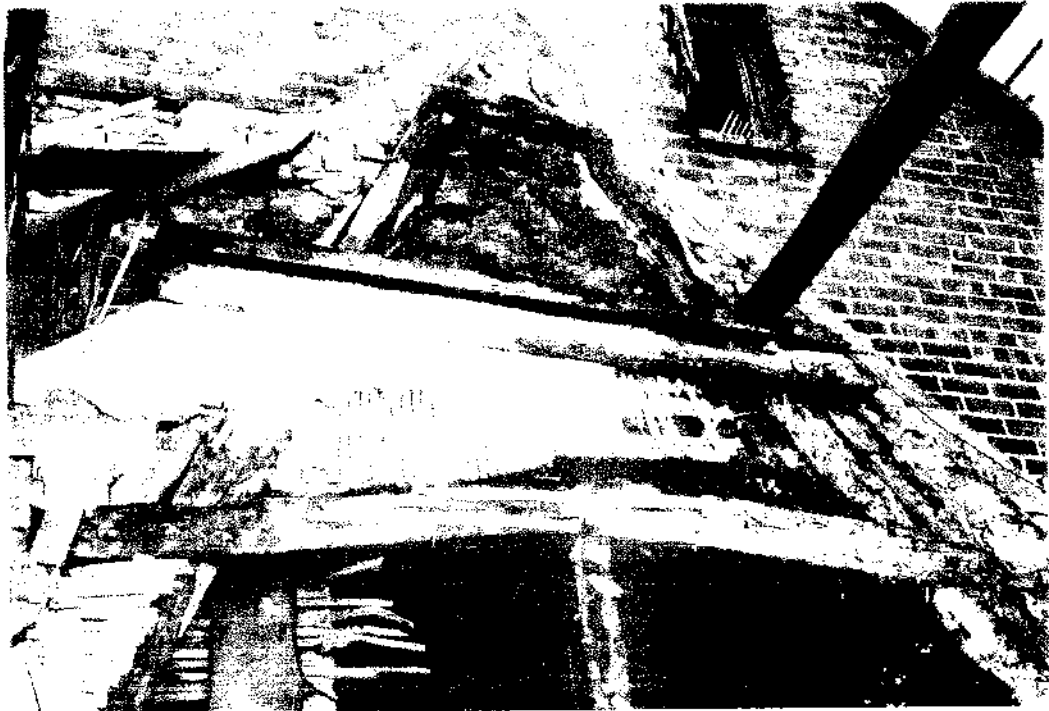
Plate 2

Wattle and daub fills the space between the collar and the apex (Plate 2), and a series of stave holes along the soffit of the collar suggests that the frame was also closed between tie beam and collar. Stave holes at the north end of the tie beam soffit show that there was some wattle and daub at ground level too, but here again, only a small portion of the soffit was exposed, so the evidence is only partial. On the other hand there is nothing to suggest that there was any infill between the back of the eastern cruck and the east wall.

On the north side, the upper timbers of the cruck, as well as the wattle and daub, are smoke blackened, an indication that the house to which this truss was related, was a single storey building, heated by an open hearth, and that this hearth was situated on the north side of the truss. The fact that the wattle and daub is also discoloured suggests that the frame is *in situ* rather than having been reused.
