Birmingham University Field Archaeology Unit
Project No. 956
March 2003

**Archaeological Recording at Halesowen Abbey,
Halesowen, West Midlands**

by
Malcolm Hislop and Steve Litherland

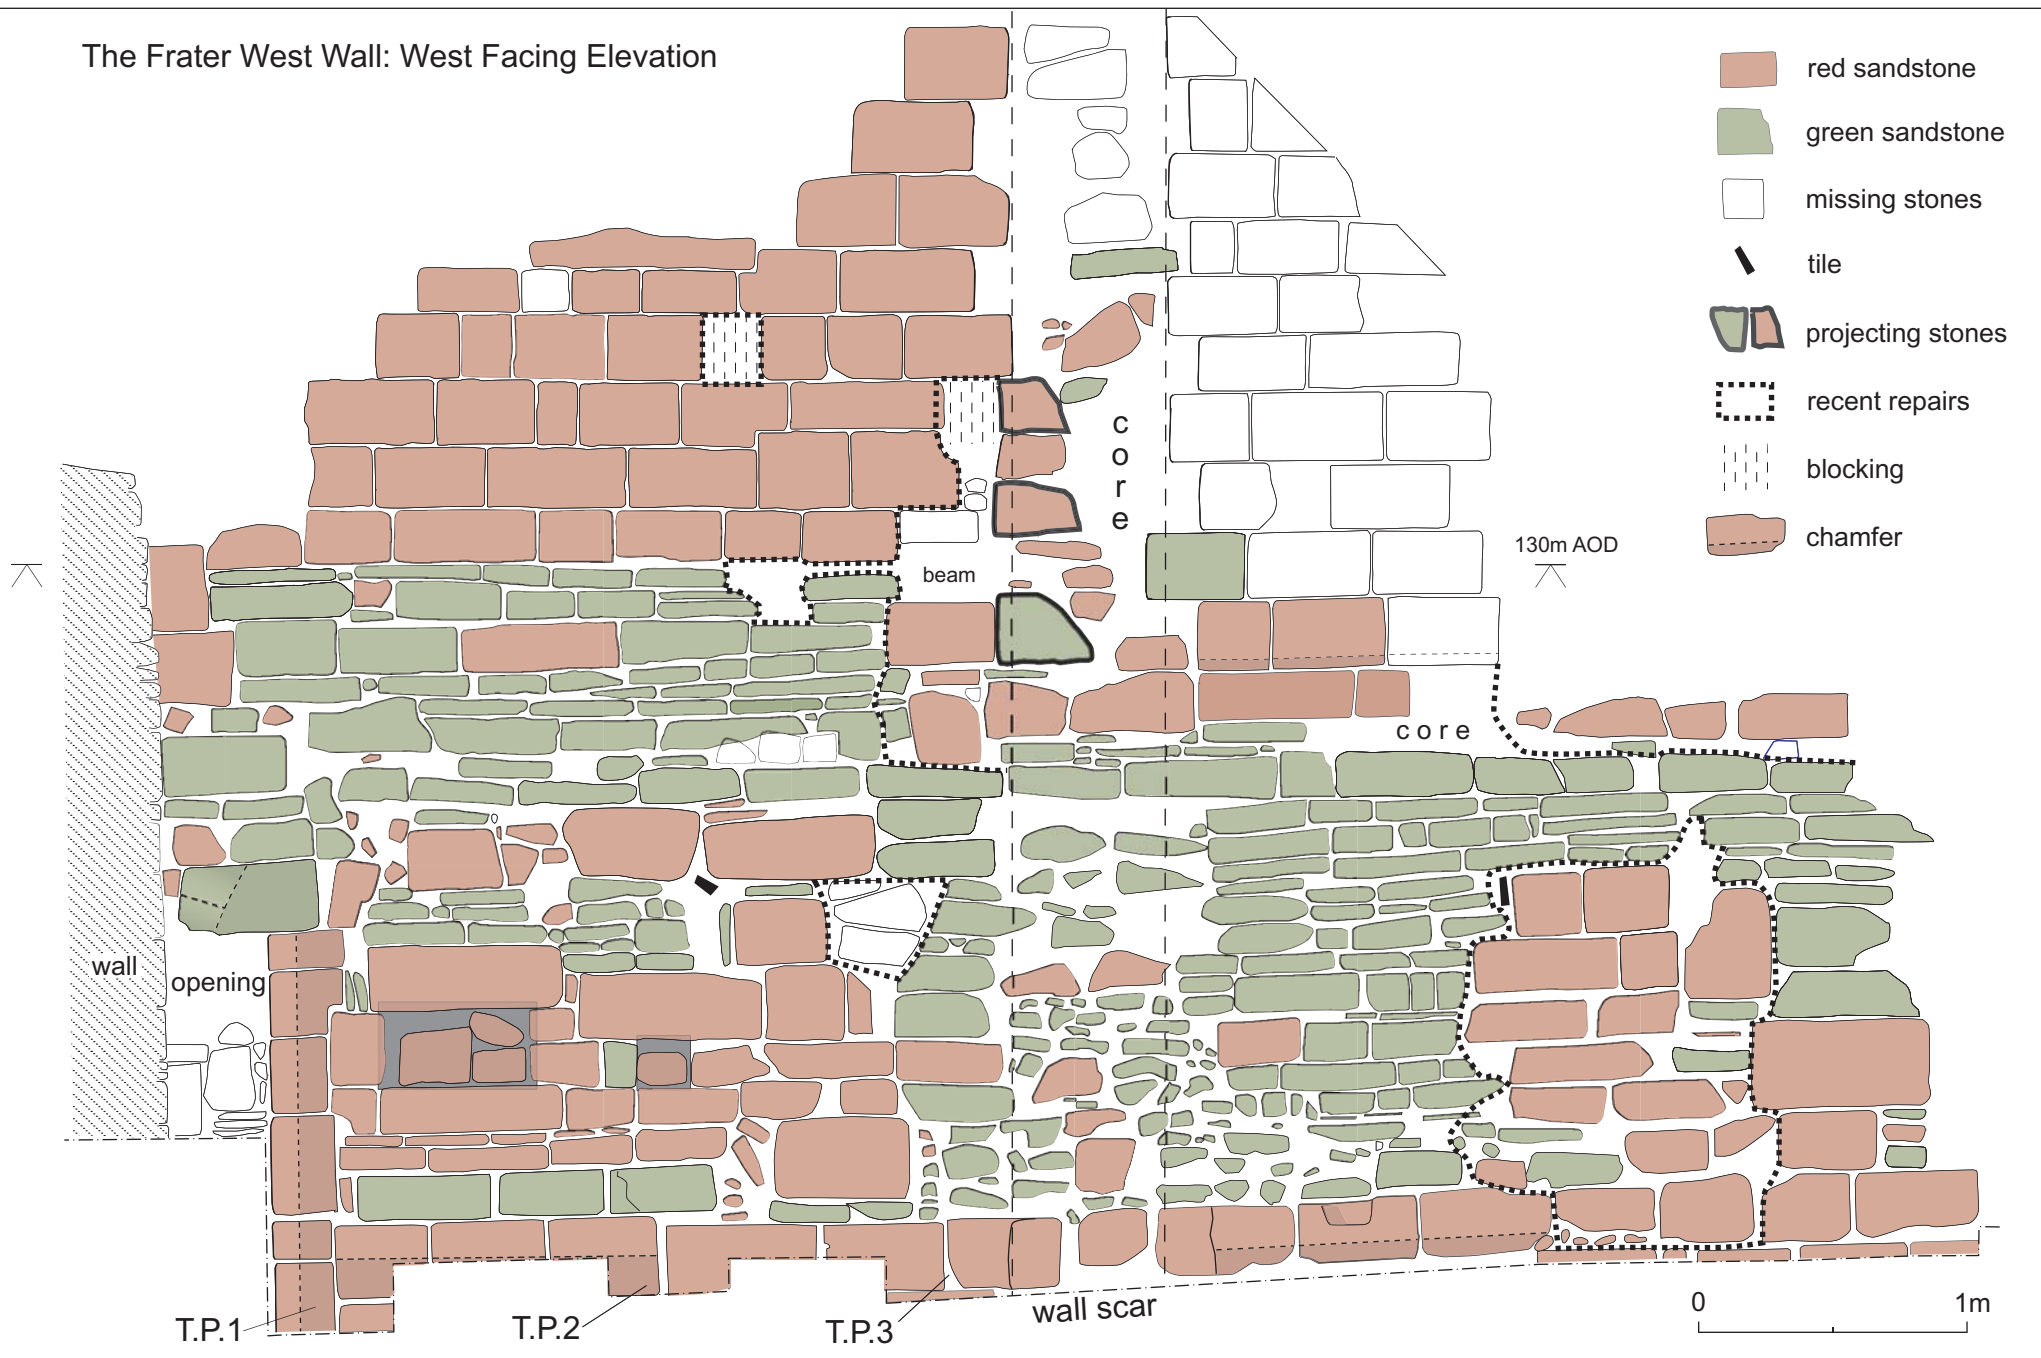
Fig.7

The chamfered plinth along the base of this wall is interrupted in the centre by a vertical scar of rubble core, approximately 0.6m (2ft) wide. The scar extends to the full height of the stonework and clearly indicates the former presence of a wall here. Also of note is the fact that above head height the dressed stones on either side of the scar were once keyed into this wall, whereas it is much less clear if this was the case in the lower courses.

At ground-floor level the extreme northern end of the elevation incorporates the remains of an opening, probably a doorway, now approximately 0.40m wide and retaining one chamfered jamb on its south side. The wall immediately above this door appears to have been largely rebuilt, but to the right-hand, or south, side of the rebuilt area remnants of the core bear the suggestion of the beginning of a north-inclining arch over the doorway. To the right, or south, side of this opening are two blocked rectangular recesses (Plate 9), each with a single large stone block forming the lintel. The northernmost (Plate 10) measures 0.54m wide by 0.28m high, and the southernmost 0.40m wide by 0.18m high. Neither is rebated to take a door or cover. One of these must be the 'small recess lined with thin tiles' recorded by Holiday in

1871 as being 'at a height of about 2ft from the ground' (Holiday 1871, 63). Holiday thought that this recess was originally an oven, but gave no supporting evidence. Immediately to the south, and also cutting the second recess, is an area of irregularly-shaped blocking incorporating reused masonry, approximately 1.5m high by 1m wide. The cutting of this opening also involved the removal of the base plinth to the wall. Behind this blocking was a deep irregularly-shaped cavity loosely filled with core stones. To the right, or south side, of the east/west wall scar noted above an area of original mainly green sandstone masonry continues for c.1m as does a short continuation of the base plinth.

The level of the first floor is indicated by a change in the stonework from green stone rubble to dressed red sandstone blocks. This change occurs at approximately 130m above the Ordnance Survey Datum (A.O.D.). To the south of the east/west wall-scar there is a chamfered offset at first-floor level, an indication that this was an external face, while to the north the walling appears to have been an internal partition between the Frater and a building to the south. Given the width of this wall, that essentially consists of a single depth of well-dressed rectangular blocks, it was probably not load bearing. At first-floor level there are two possible beam slots at centres 1.45m apart. Otherwise the main feature in this internal wall is a long thin stone which seems to have been a sill for an opening. The upper face of this stone is 1.2m above the level of the first floor.

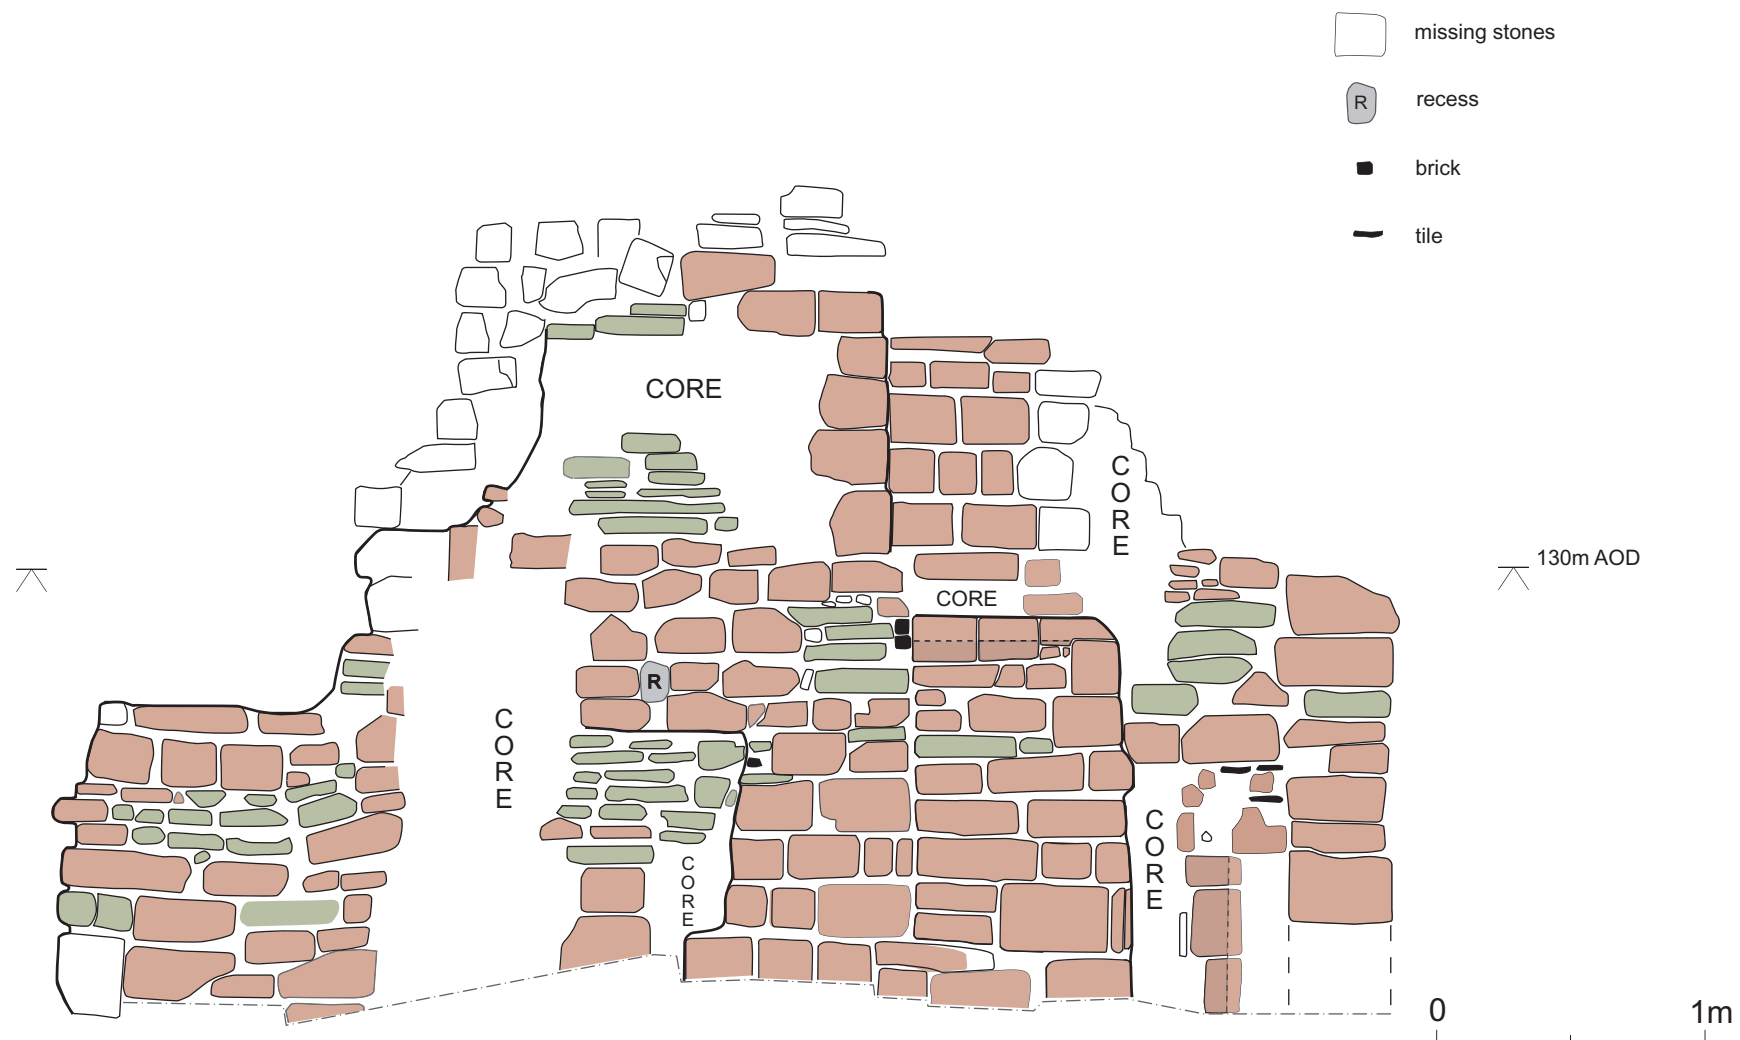
The Frater West Wall: East Facing Elevation

The east elevation was in a much poorer state of preservation than the west elevation, there are large expanses of core exposed and several areas of later blocking and repair. In terms of clearly monastic masonry, at ground level the other side of the doorway at the north end of the wall can be seen, its surviving jamb being rebated. Here too, the ghost of a former arch can be discerned in the curving character of the adjacent core to the south and above. One of the stones at the head of the present opening is chamfered on two sides, and has two deep keying grooves on its one exposed bedding plain (Plate 11). It is clearly a reused stone from a vaulting rib and must belong to a relatively late set of repairs. The exposed wall core immediately to the south of the door jamb represents the ghost of an angled opening that is identical to those seen on either side of the openings in the ground floor of the South Frater Wall.

The other area of clearly monastic masonry, as opposed to wall core, is situated at first-floor level. Here the wall is recessed, the stone work is dressed into regular rectangular blocks, and the wall is only one block thick. Between the ground-storey infill and the dressed stone blocks that form the back of this recess is an area of exposed core. Set into this exposed core is a large flat stone that juts out from the wall face at roughly 130m A.O.D. This is probably the only fragment of the springing of the first floor to remain *in situ*. Within the recess, 1.1m above this stone, is the stone sill already mentioned in the description of the west elevation (Plate 12). On this side of the wall the sill projects and is chamfered. There is little doubt that this stone is *in situ* because the corresponding stone of the left-hand (south) return is cut to accommodate the chamfered lip. This opening, within its recess, would have formed a distinctive architectural feature within the frater.

The rest of the stonework comprises a mixture of later rebuilding, blocking and exposed areas of wall core that is very difficult to unravel. At ground-floor level there is a distinct vertical break that is 1.76m to the south of the southern jamb of the doorway. The blocking to the right is the later, and is probably of 20th-century date, being bonded with hard Portland cement. The recording of a mason's mark on one of the stones confirms that it constitutes reused material from elsewhere around the abbey. To the left, or south of the vertical break, is an area of dressed stone that is similar in character to other areas of post-medieval building seen in the cart shed and elsewhere around the abbey, incorporating tile and the occasional brick to infill gaps between stones and level courses of masonry. Behind this dressed stone is a void. It is interesting to note that this void corresponds with the cavity behind the west-facing elevation – and, if so, it may represent the remains of a flue, or even part of an oven, of some sort. Only excavation may be able to clarify this point. The rest of the wall is mainly exposed core, which can clearly be seen from the differing width of the wall (Fig. 9).

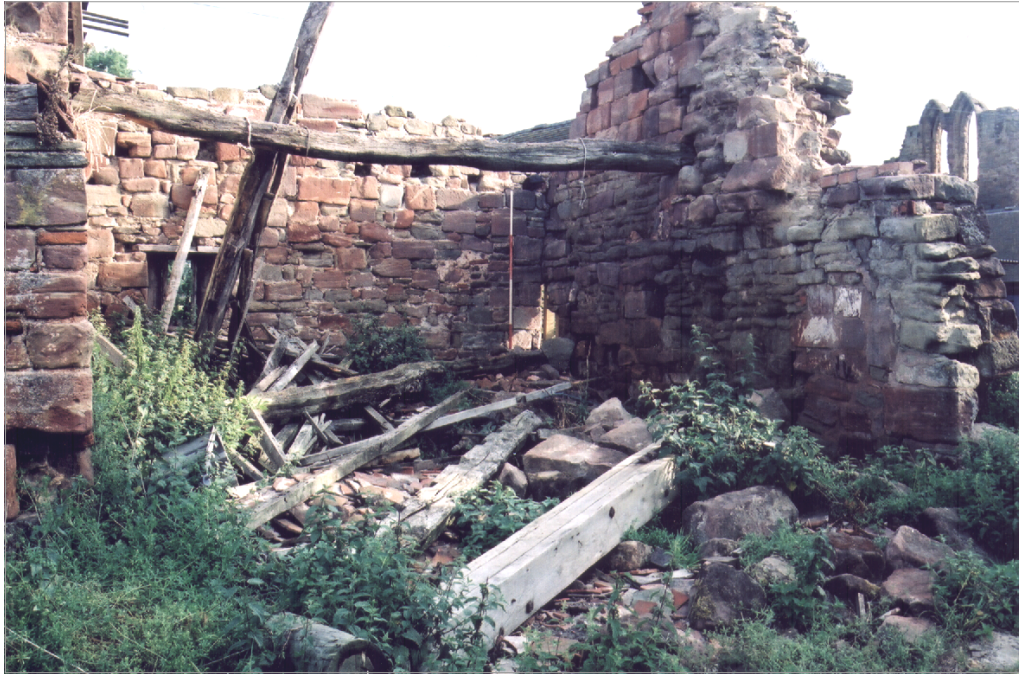
Unfortunately, because of the nature of the collapse, it was not possible to undertake a straightforward forensic reconstruction of the Frater West Wall. Most of the damage was caused by the twisting and dragging action of the pair of purlins set into the wall that had failed under the combined weight of the tile roof they were supporting and the westward lateral movement of the supporting walls of the cart shed built against the West Frater Wall. In particular, the effect of the collapse of the southern purlin on the section of medieval masonry into which it was set threw this masonry upwards and mixed it up in contrast to a normal lateral slump, where the stones generally retain their structural integrity. Additionally, some of the stone from the east side of the wall that had spilled into the main farmyard was later placed with the bulk of the material that had fallen on the west side of the wall (Plate 1). Nevertheless, it proved possible to reconstruct the position of nearly all of the main section of dressed masonry situated to the upper right-hand, or southern, side of the west-facing elevation of the Frater West Wall. This was achieved through a combination of measurement, verification with previous drawings and photographs, and comparison of the bedding depths of each stone.

Plate 1. General view of outer (west) face of frater west wall showing spread of fallen building materials.

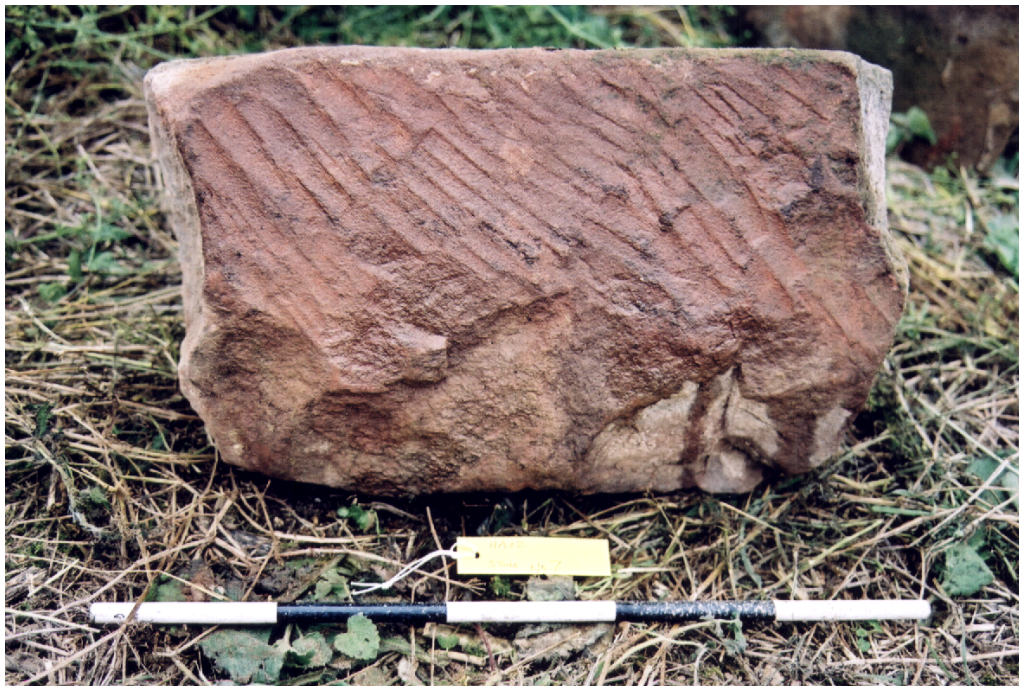
The stones are smoothed faced but retain coarse diagonal striated tooling marks (Plate 2), probably executed with chisels, on the concealed faces. Group A masonry can be seen in situ within the Frater West Wall and seems to be contemporary with the construction of the building, which, judging from the architectural details that survive in the South Wall, probably dates from the second half of the 13th century.

A squared block with rather coarse and irregular diagonal striations between 10mm ($\frac{3}{8}$ inch) and 19mm ($\frac{3}{4}$ inch) to the sides, though the outer face is plain.

Plate 2. Stone No.7, Group A tooling marks.

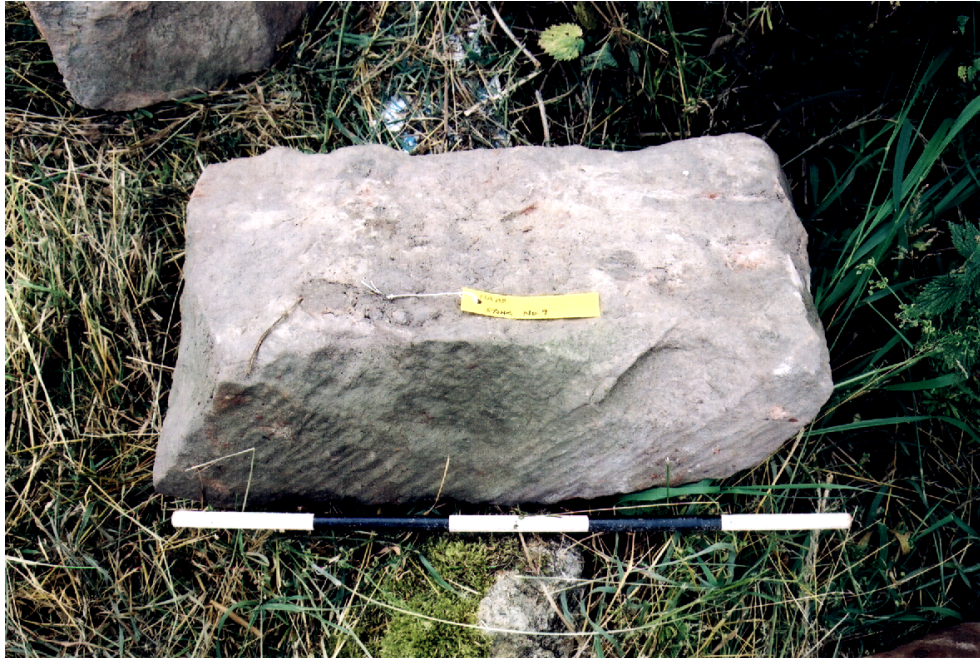
The masonry of Group B has fine diagonal striations on the exposed faces (Plate 3), whereas the concealed faces are only roughly dressed. As these items were incorporated into the Frater West Wall, and as they include at least two architectural fragments that are unrelated to the structure, they must be re-used material. As they come from the upper part, that is to say the least altered part of the wall, they presumably date from an earlier period than the frater.

The outer face of this stone has diagonal striations, varying in width from 3mm ($\frac{1}{8}$ inch) to 7mm ($\frac{1}{4}$ inch), as does one of the sides, suggesting that it might be a corner piece such as a quoin or the jamb of a window embrasure. There are no tooling marks on the bedding faces.

Plate 3. Stone No.9, Group B tooling marks.

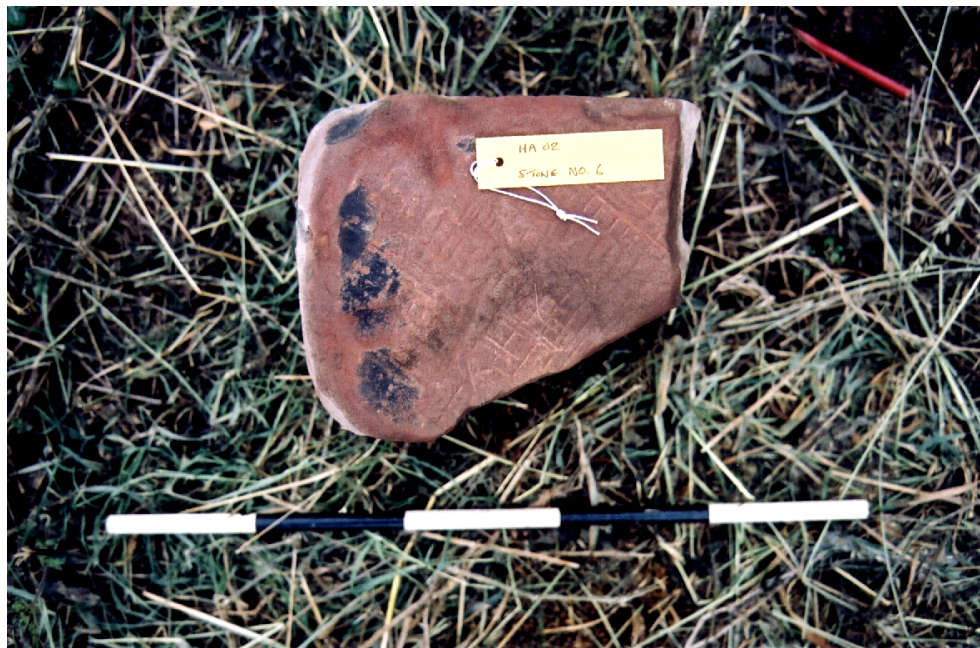
Only two small fragments make up Group C. They both have two sets of diagonal striated tooling marks that have been applied at right angles to one another to produce a chequer pattern (Fig. 3, Plate 4). These too must be re-used material.

This is only a fragment, apparently the angle of a squared stone. It has an unusual and interesting tooling pattern which comprises two series of diagonal striations that cross to form a chequer design. The marks are between 3mm ($\frac{1}{8}$ inch) and 10mm ($\frac{3}{8}$ inch) apart.

Plate 4. Stone No.6, Group C tooling marks.

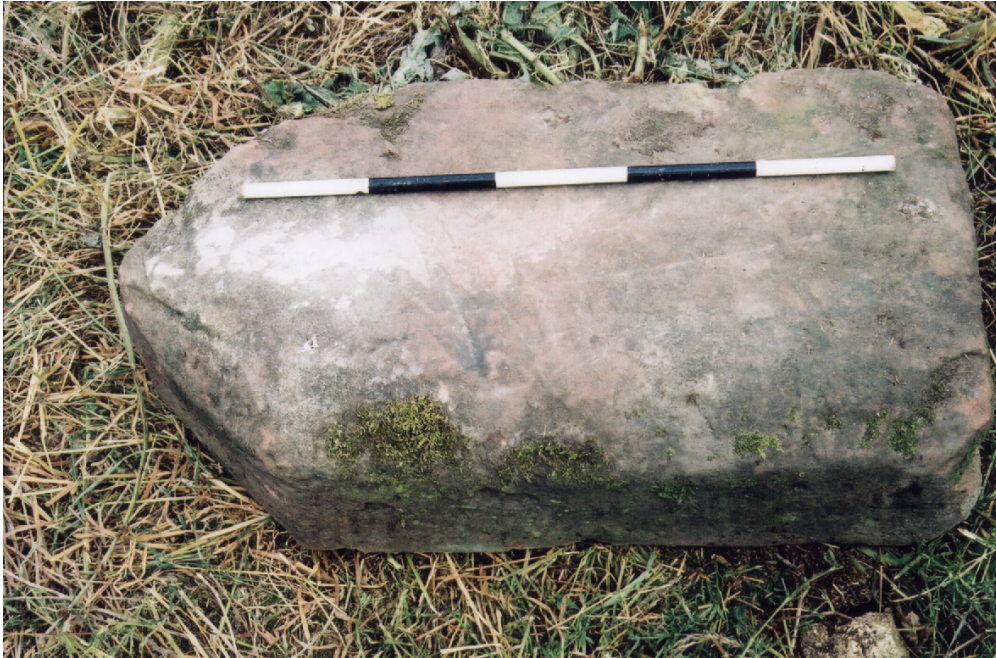
A large stone, measuring approximately 67cm long by 36cm wide by 20cm tall, with a triangular point at one end, giving it a pentagonal plan. The orientation of the block is clear from a 6cm chamfer along the upper edge of one of the long sides continuing around one of the sides of the pointed end. This stone may have formed part of a plinth or offset, whereas the angled end suggests that it was at the corner of a structure. It is either a re-used piece or was one of the plinth stones from the frater. No tooling marks are visible.

Plate 5. Stone No.1.

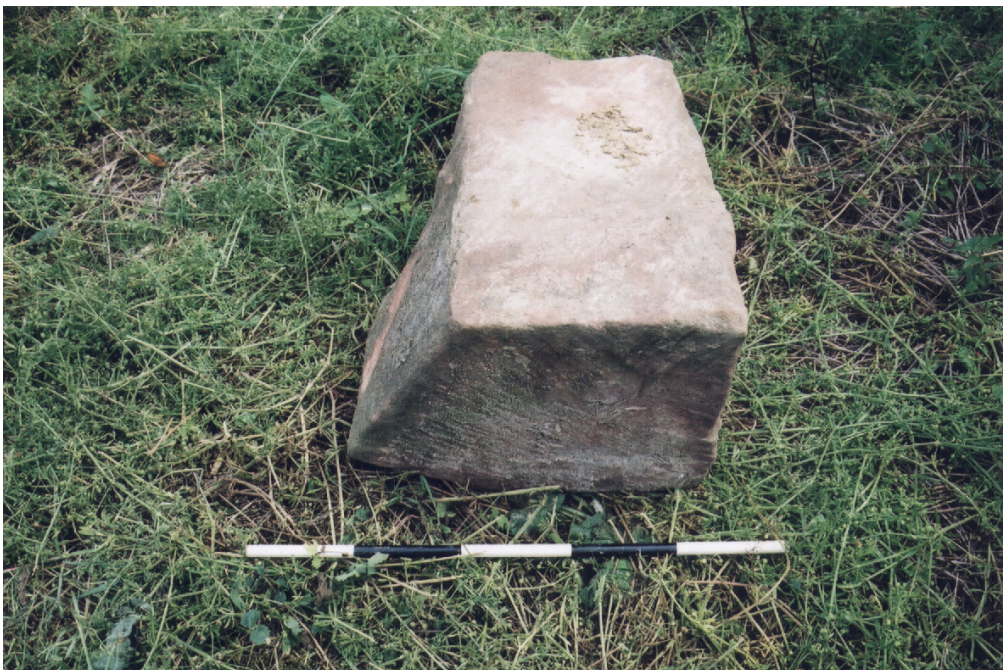
A block with a lower bedding face approximately 40cm long by 35cm wide. The outer face of the stone is angled so that it slopes back from the base to an upper bedding face that is only 25cm wide. It can be identified with the southernmost stone of the first-floor offset that was recorded in 1989. The upper bedding face and the sides of the block have diagonal striated tooling marks, but the angled front is smooth.

Plate 6. Stone No.2.

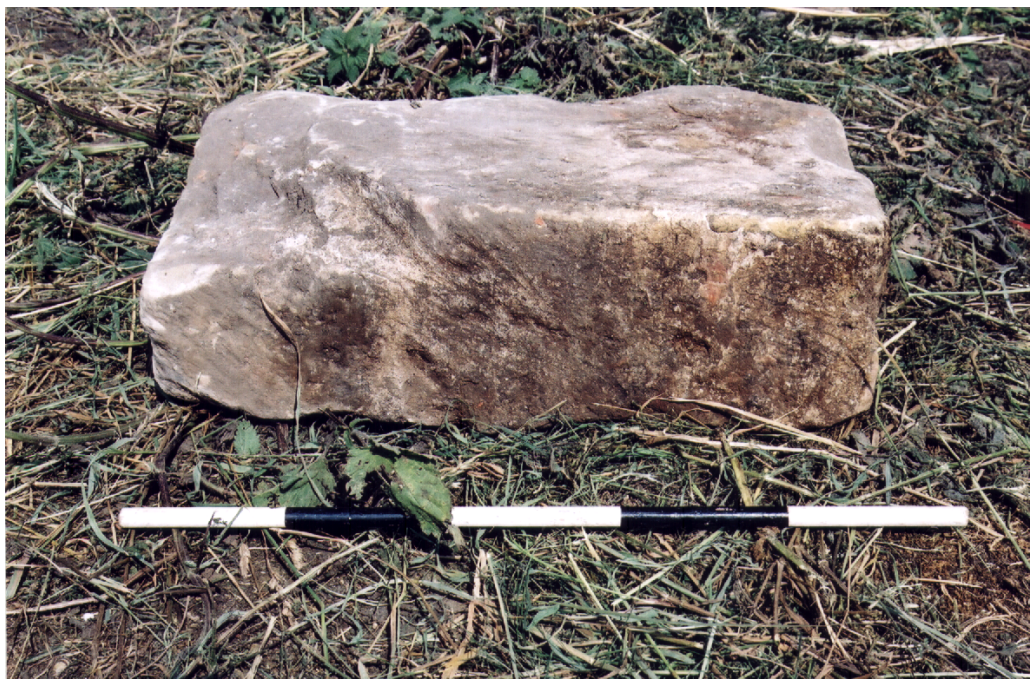
Like Stone No.1 this is a re-used architectural fragment. It is about 46cm long and towards one end is the corner formed by the meeting of two chamfers at a 90° angle. This is evidently the vestige of a chamfered window surround, and the stone itself represents either a sill or a flat lintel. The outer face of the stone retains diagonal

striated tooling marks between 3mm ($\frac{1}{8}$ inch) and 7mm ($\frac{1}{4}$ inch) wide, but there are no marks on the bedding faces.

Plate 7. Stone No.5.

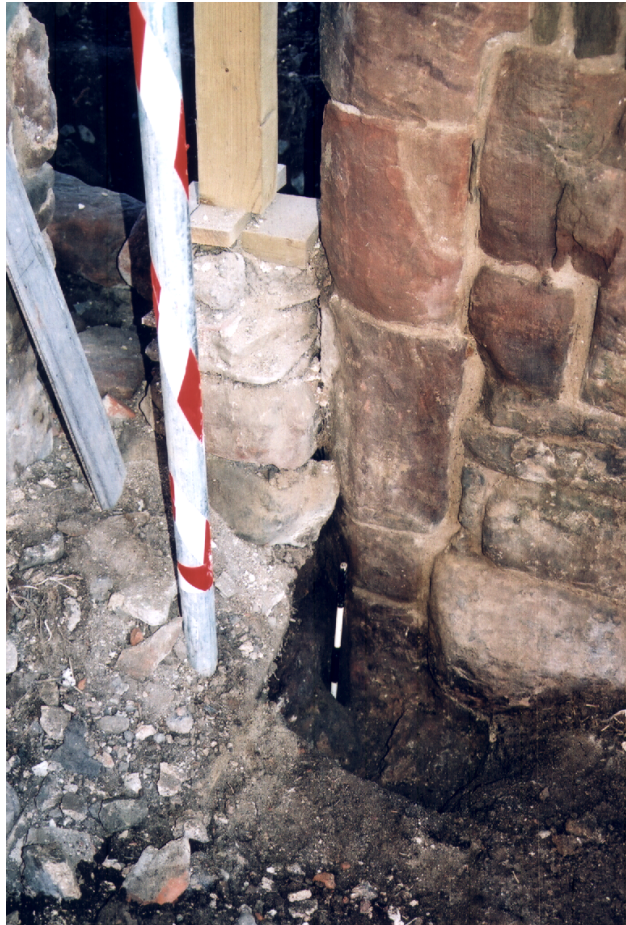
Situated immediately in front of the door jamb at the north end of the wall, Test Pit 1 revealed two small flags of a red sandstone floor to the south of the doorway, approximately 30cm (1ft) beneath the top of the plinth. No dating evidence was obtained, but it is tempting to interpret these flags as a remnant of monastic flooring given their apparent structural association with both the door jamb and the base plinth.

Plate 13. Test Pit 1 from the southwest.

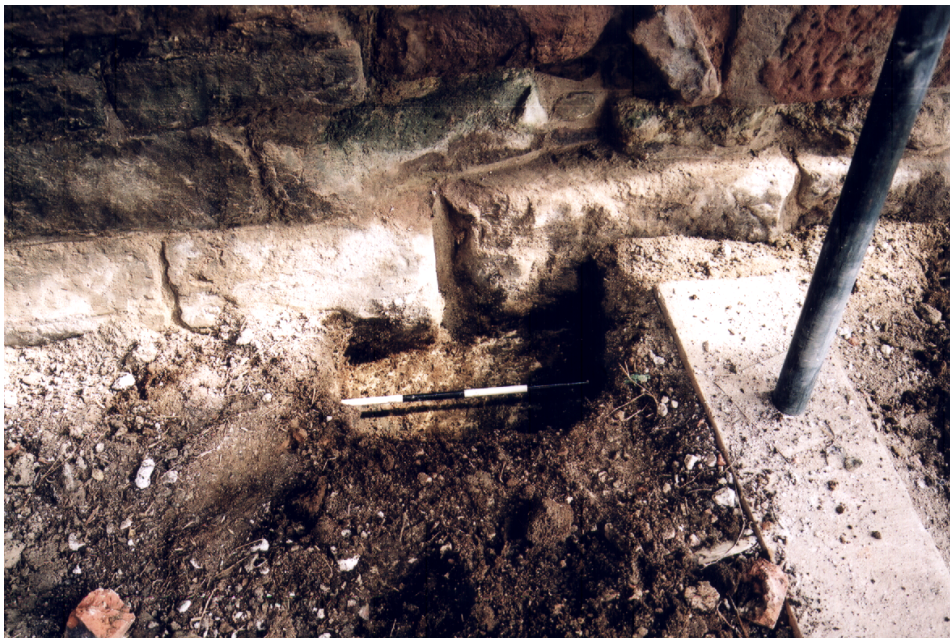
Test Pit 2 was situated at the junction of the medieval fabric and the blocking to the south of the two recesses. A compacted ashy-floor surface was uncovered approximately 25cm (10") below the top of the plinth, which did not continue into the area of blocking. This floor surface may be post-medieval in date because it is higher.

Plate 14. Test Pit 2 from the west.

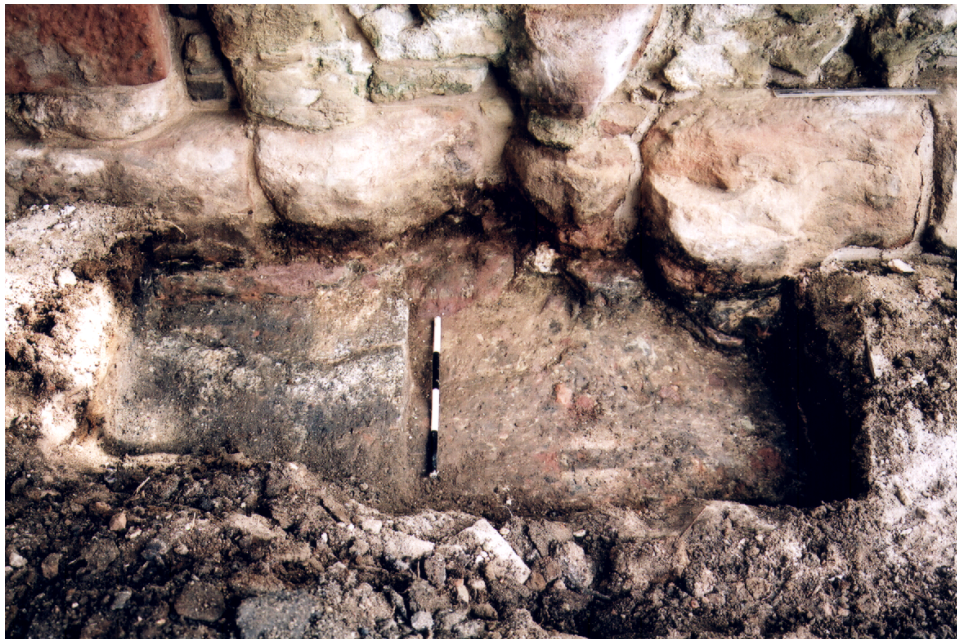
Excavation of a test pit at the foot of the east-west wall scar revealed a thin floor surface of compacted ash and plaster. This was clearly post-medieval in date because where it was cleaned in half section compacted clay and rubble, presumably associated with the foundation of the former east-west wall, was found immediately underneath.

Plate 15. Test Pit 3 from the west.

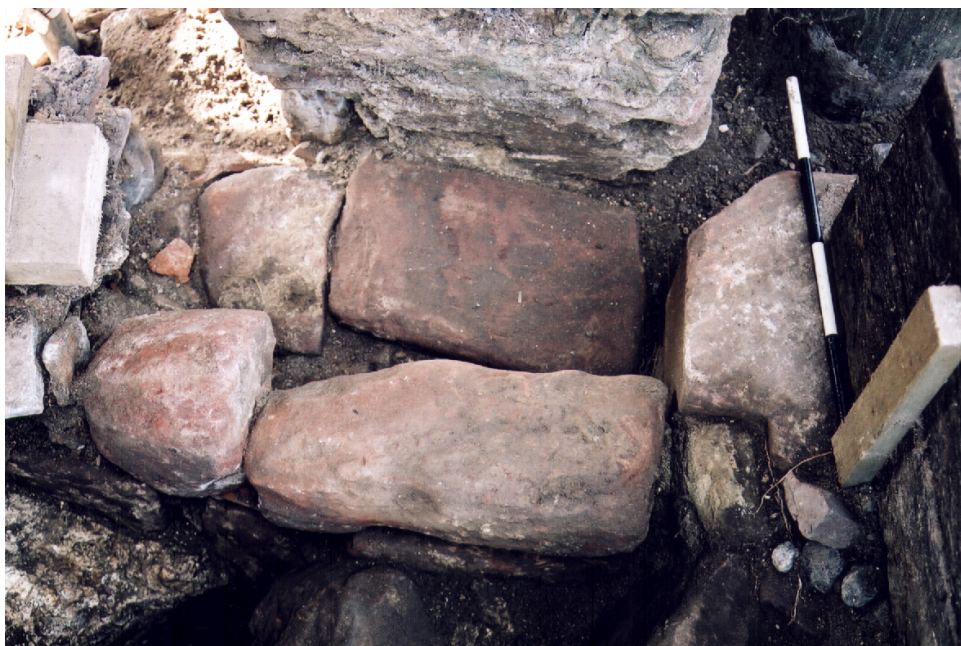
Test Pit 4 revealed further footings beyond the current south end of the wall. The uppermost stones were laid loosely, but the underlying masonry was set in mortar and was four feet, or 1.2m, wide. On the south side of the trench was a large flat-topped stone, with a chamfered edge towards the north, and a square rebate in its southwest corner. This was reset, and was probably a plinth stone. It is similar in character to Stone 1, and has three straight sides, suggesting that it formed a corner stone, possibly for a buttress.

Plate 16. Test Pit 4 from the south.

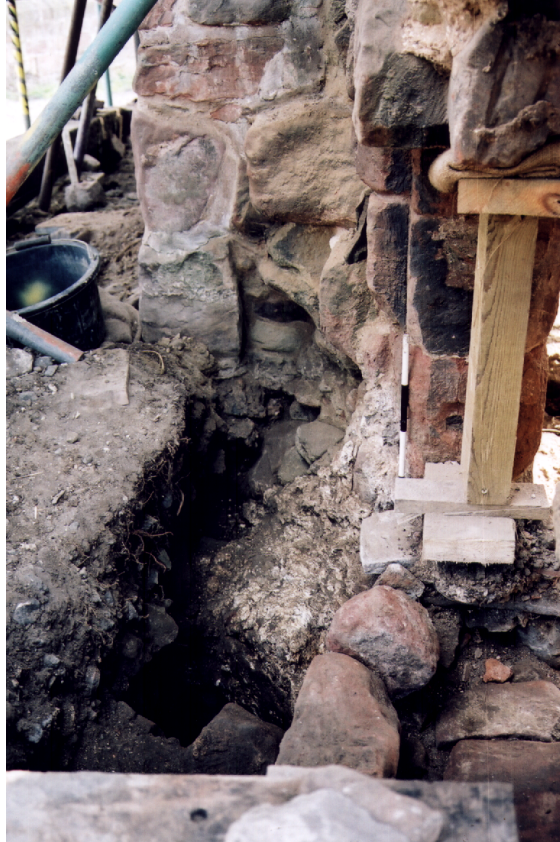
Test Pit 5 was dug into a large 20th-century rubble-filled pit containing tarmac, Dreadnought tile and a fragment of a Robinson's Barley Water bottle. Within the former door opening itself were several courses of rough dry-stone walling, presumably installed to act as a foundation for blocking work above. On the south side of the trench, stratified beneath a patch of masonry infill on the east face of the wall, was some modern-looking concrete.

Plate 17. Test Pit 5 from the east.

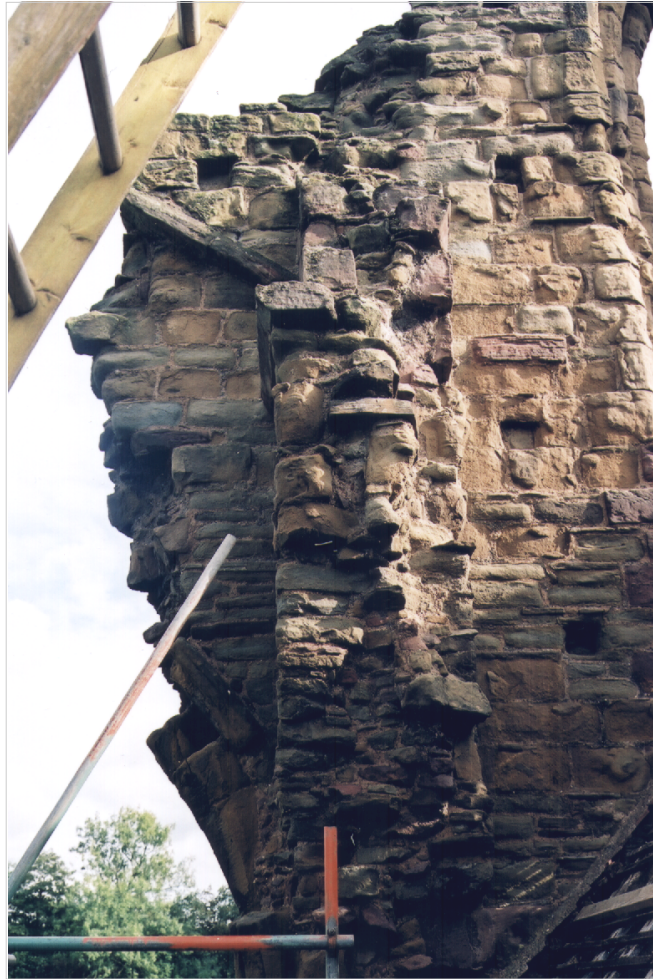
supported a square-sectioned shaft, standing proud of the hood mould, of which only the lower two stones survive. On the north side of the window a number of putlog holes are visible, one above another (Plate 19).

Plate 19. Putlog holes in the west elevation of the south transept.

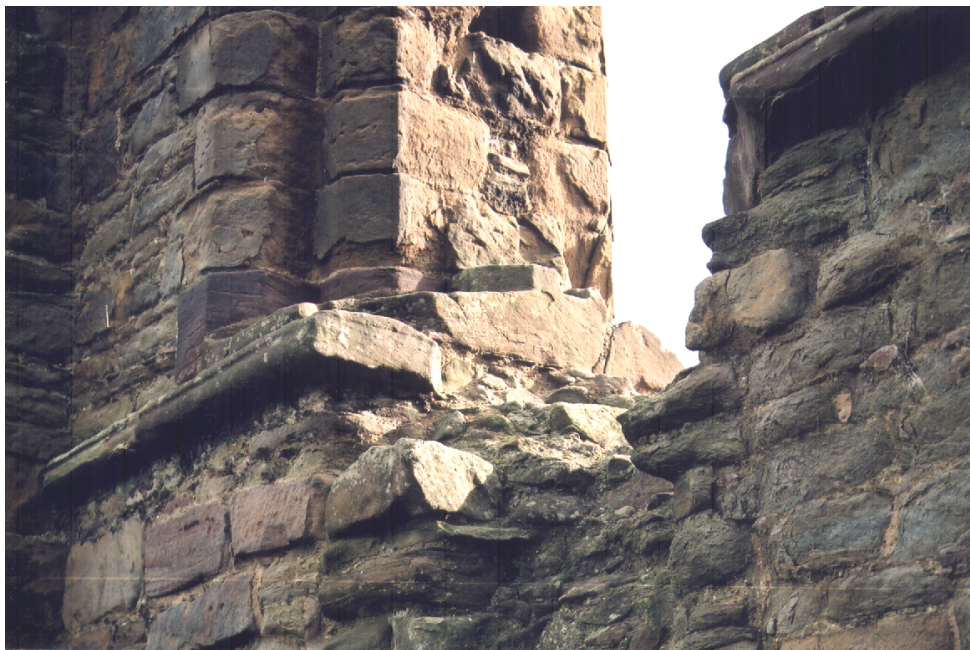
Inside, the window lights also comprise two chamfered orders and immediately beneath them is a scroll-moulded string course (Plate 20). Two stone courses above the string course was a series of square blockings, the southernmost of which was filled with a carved stone. They denote former openings, possibly sockets for a timber gallery. Higher up are the remains of ribbed-vaulting springing from corbelled, moulded imposts. The south wall of the transept retains, at its west end, the doorway from the dormer to the former night stair (Plate 21).

Plate 20. String course on the interior of the south transept west wall.
