**Archaeological Recording
at the Old Farmhouse and
Dairy, Merridale,
Wolverhampton, Black
Country**

Birmingham University Field Archaeology Unit

Birmingham University Field Archaeology Unit
Project No. 1015
December 2002

by
Malcolm Hislop

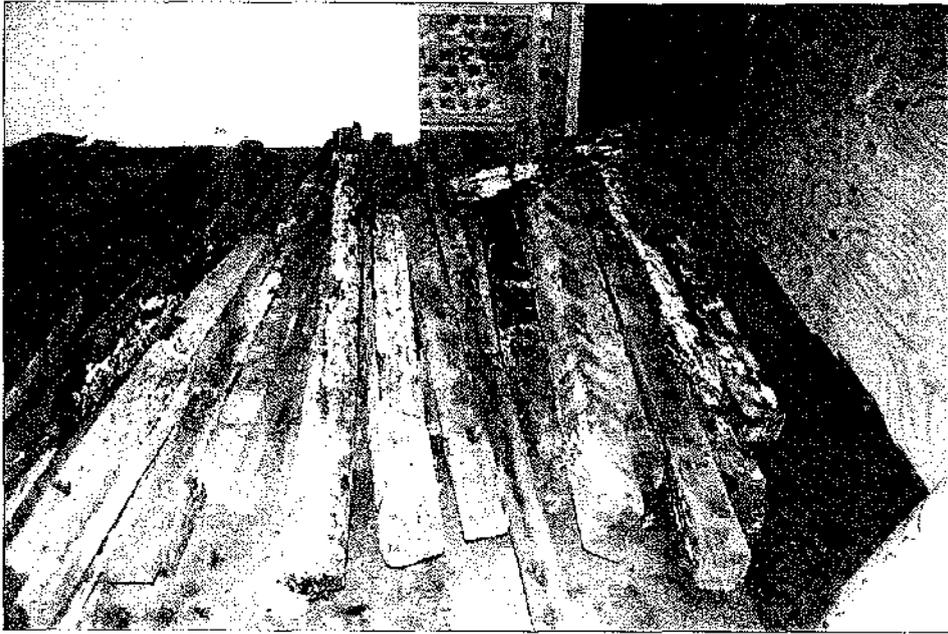
Plate 3. Floor joists from the cross-wing

The timbers taken from the floors over U1 and U2 (Plate 3) were examined in order to assess their historical significance. These timbers were mostly 4½”x 4” (0.115m x 0.10m) unchamfered floor joists, one of which had a shorter piece jointed at right angles to it, possibly to accommodate a trap in the floor. None were reused pieces, and all are post-medieval in date; in view of their former association with the floor beams in U1 and U2 they probably date from the 17th century. There were no possible medieval timbers.

- The timbers that were taken from the floors over U1 and U2 are probably 17th century in date, though there are grounds for believing that they were not *in situ* when they were removed. Probably, they represent a part of the historic fabric that has been reconstructed, and ought to be retained if structurally feasible.

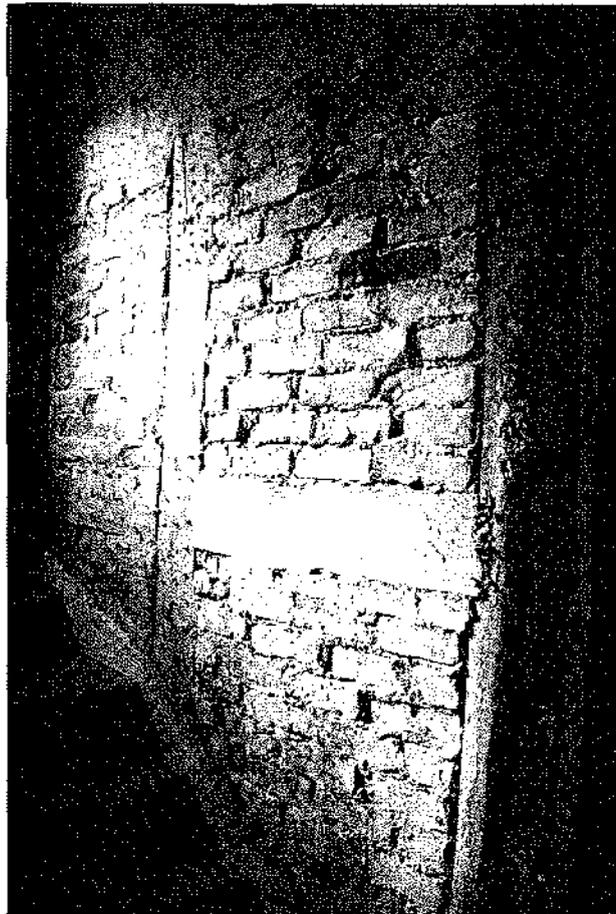
Plate 4. Blocked doorway to G2
from the southeast

North wall: doorway to G2 is an insertion; it has been formed by cutting through a cross-rail, the peg holes of which survive on the eastern flanking post (the western post has been cut back at this point so corresponding evidence does not survive here). Although the archaeological evidence is slightly ambiguous, it is probable that the original doorway occupied the next timber panel to the west (Plate 4). Here the cross-rail (the reused piece visible from G2) appears to be an insertion; its east end is spliced, rather than jointed, into the stud, and it is not pegged at either end. In the stud on the east side of this possible doorway, approximately 1.88m above the concrete floor is a peg hole, though there is no corresponding peg on the west side. A further piece of evidence comes from the rail of the next panel to the west, which is pegged at its west end but not at its east end. The probable explanation is that the stud on the west side of the doorway has been replaced.
